# **Sortation Module Diverter Arm Connector Sleeve Improvement**

How precision machining solved a tiny misalignment causing big trouble in sortation modules

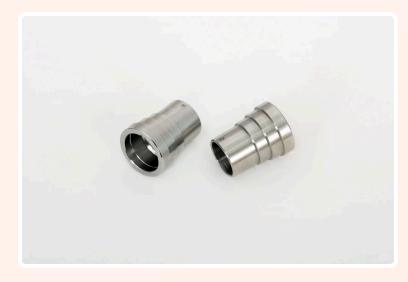
## **Stainless Steel Connector Sleeve**

Used to couple drive shaft with pivoting arm

Inner bore with poor concentricity tolerance led to rotational misalignment during operation.

- Sharp Step Transitions
  Created localized stress points and reduced fatigue strength at transition points.
- Progressive Vibration Shift

Sleeve gradually lost positional accuracy due to cumulative vibration over time.

316L stainless steel for **higher vibration fatigue resistance**

**Multi-radius chamfer transitions** minimize stress concentration

**One-pass mill-turn machining** ensures full coaxial integrity

Internal/external diameters within ±0.01 mm
