# COPV irreversible-damage localization on published BAM sensor geometry (180 kHz)

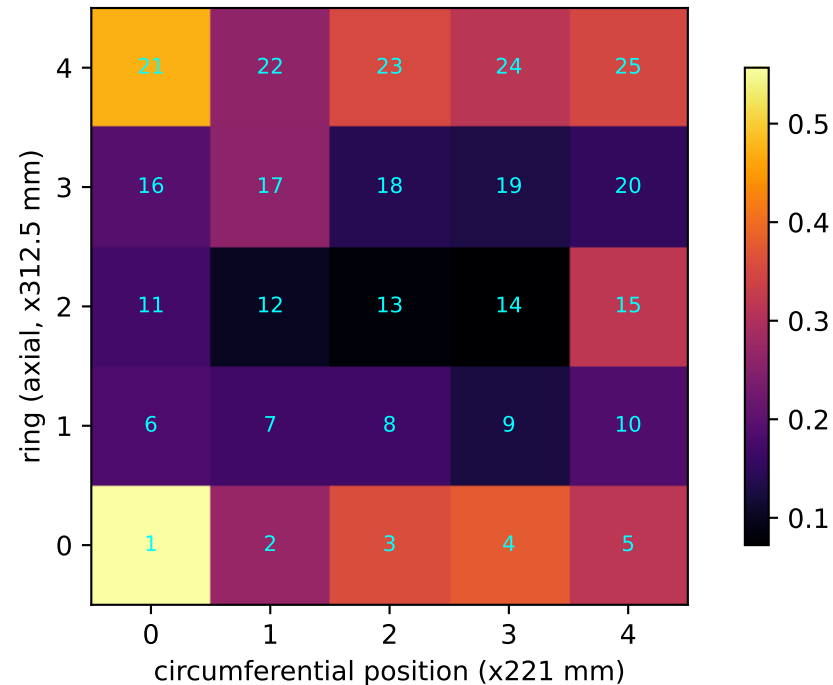
(A) per-PZT damage involvement [R]  
(true 5x5 ring x circumference)

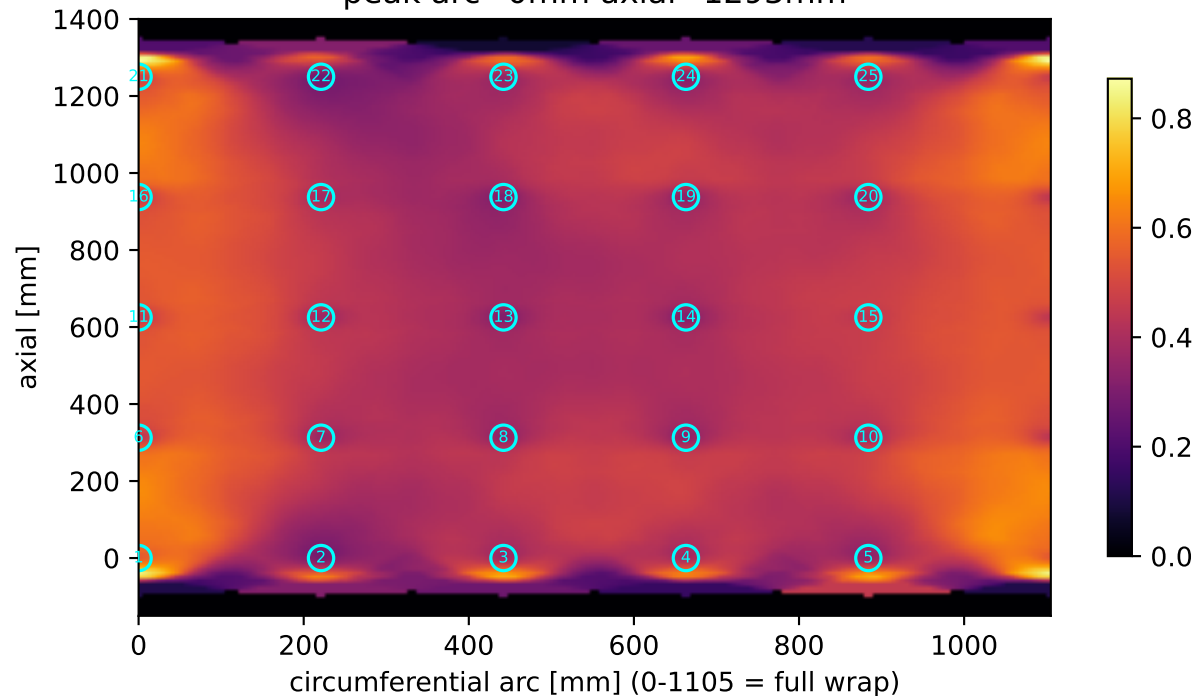
(B) RAPID damage image on TRUE unrolled cylinder [R]  
peak arc=0mm axial=1293mm
