PROJECT REVIEW REPORT

EVALUATION OF THE URETEK DEEP INJECTION (UDI) PROCESS FOR IMPROVING PERFORMANCE OF US 65 CARROLL COUNTY, MISSOURI

**Subject: Project Review Report for US 65, Carroll County, Missouri
(Emergency Stabilization of Roadway, May 2011)**

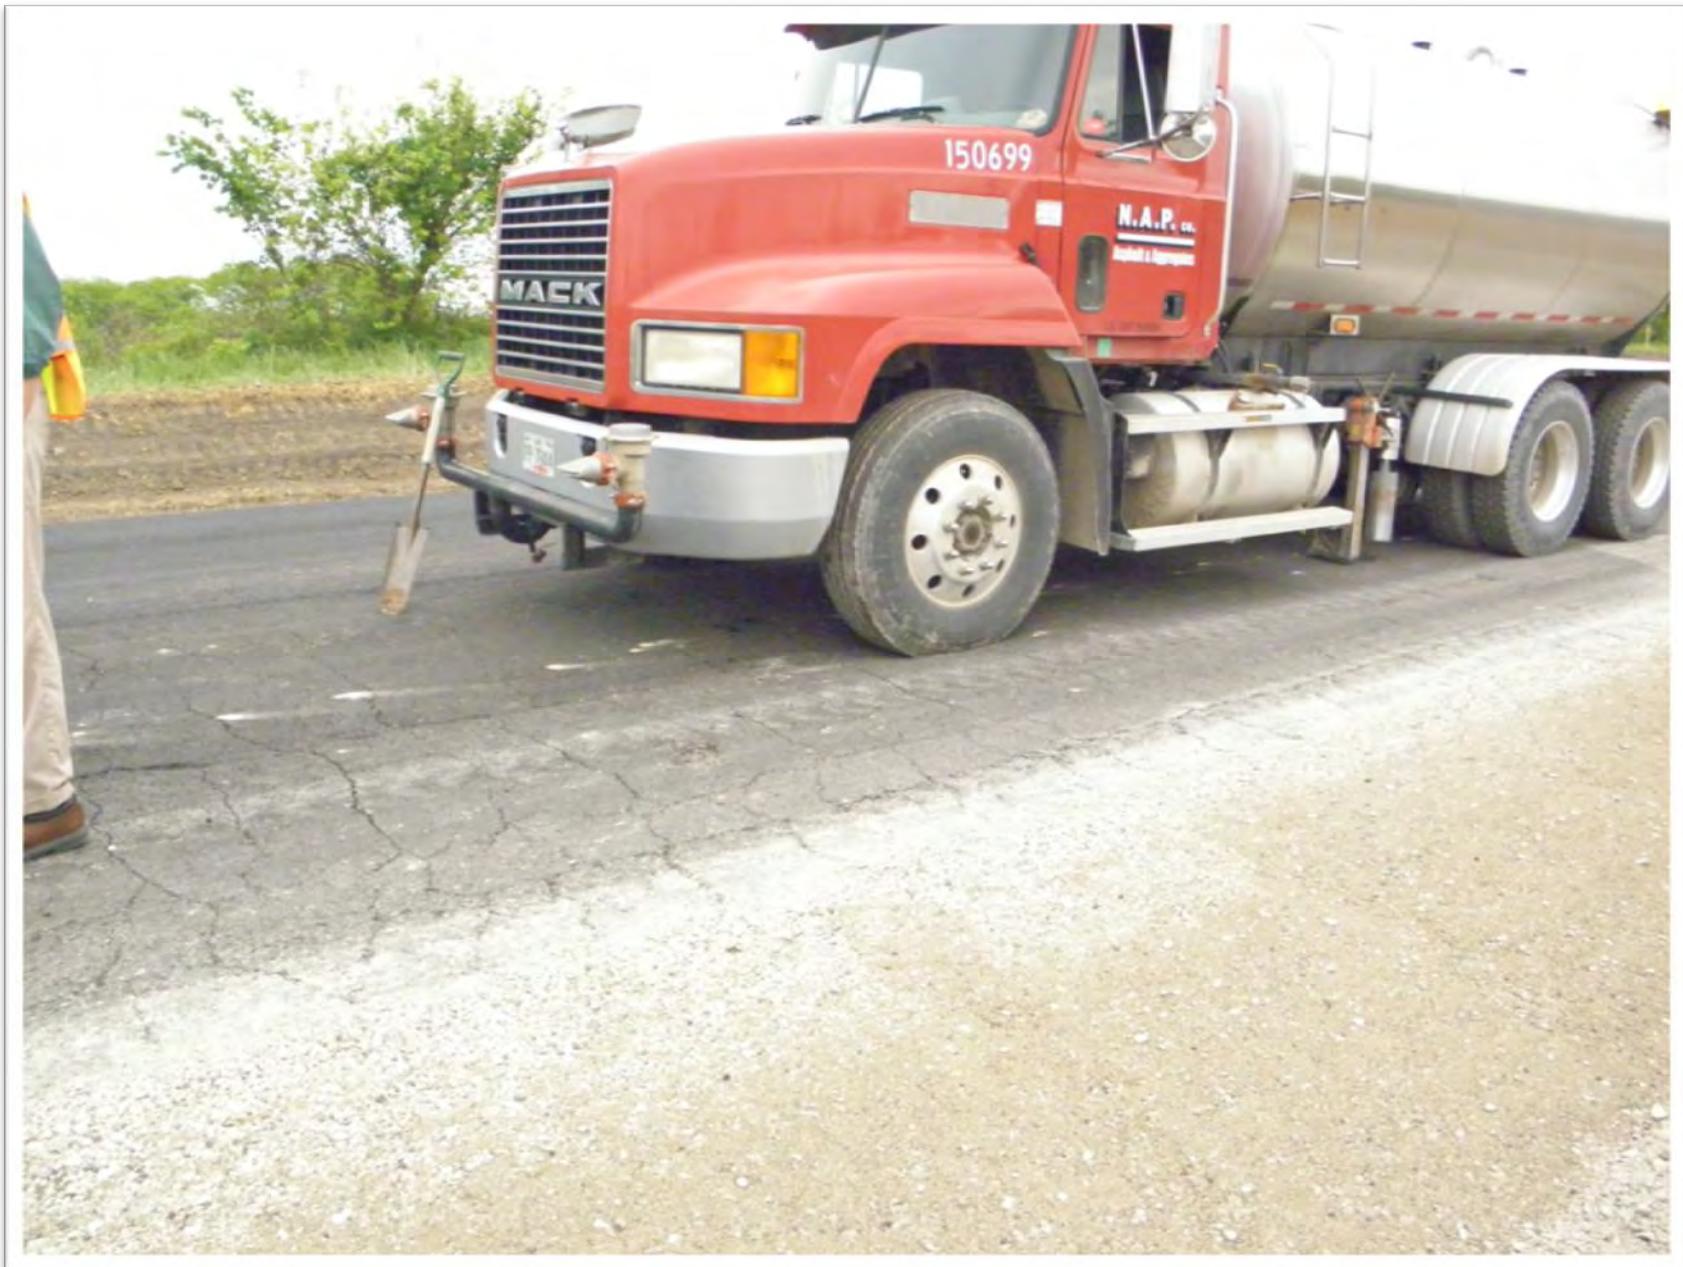
MoDOT – US65 in Carroll County, Image P5180 235

Water Truck used for coring – caused ruts in base material.

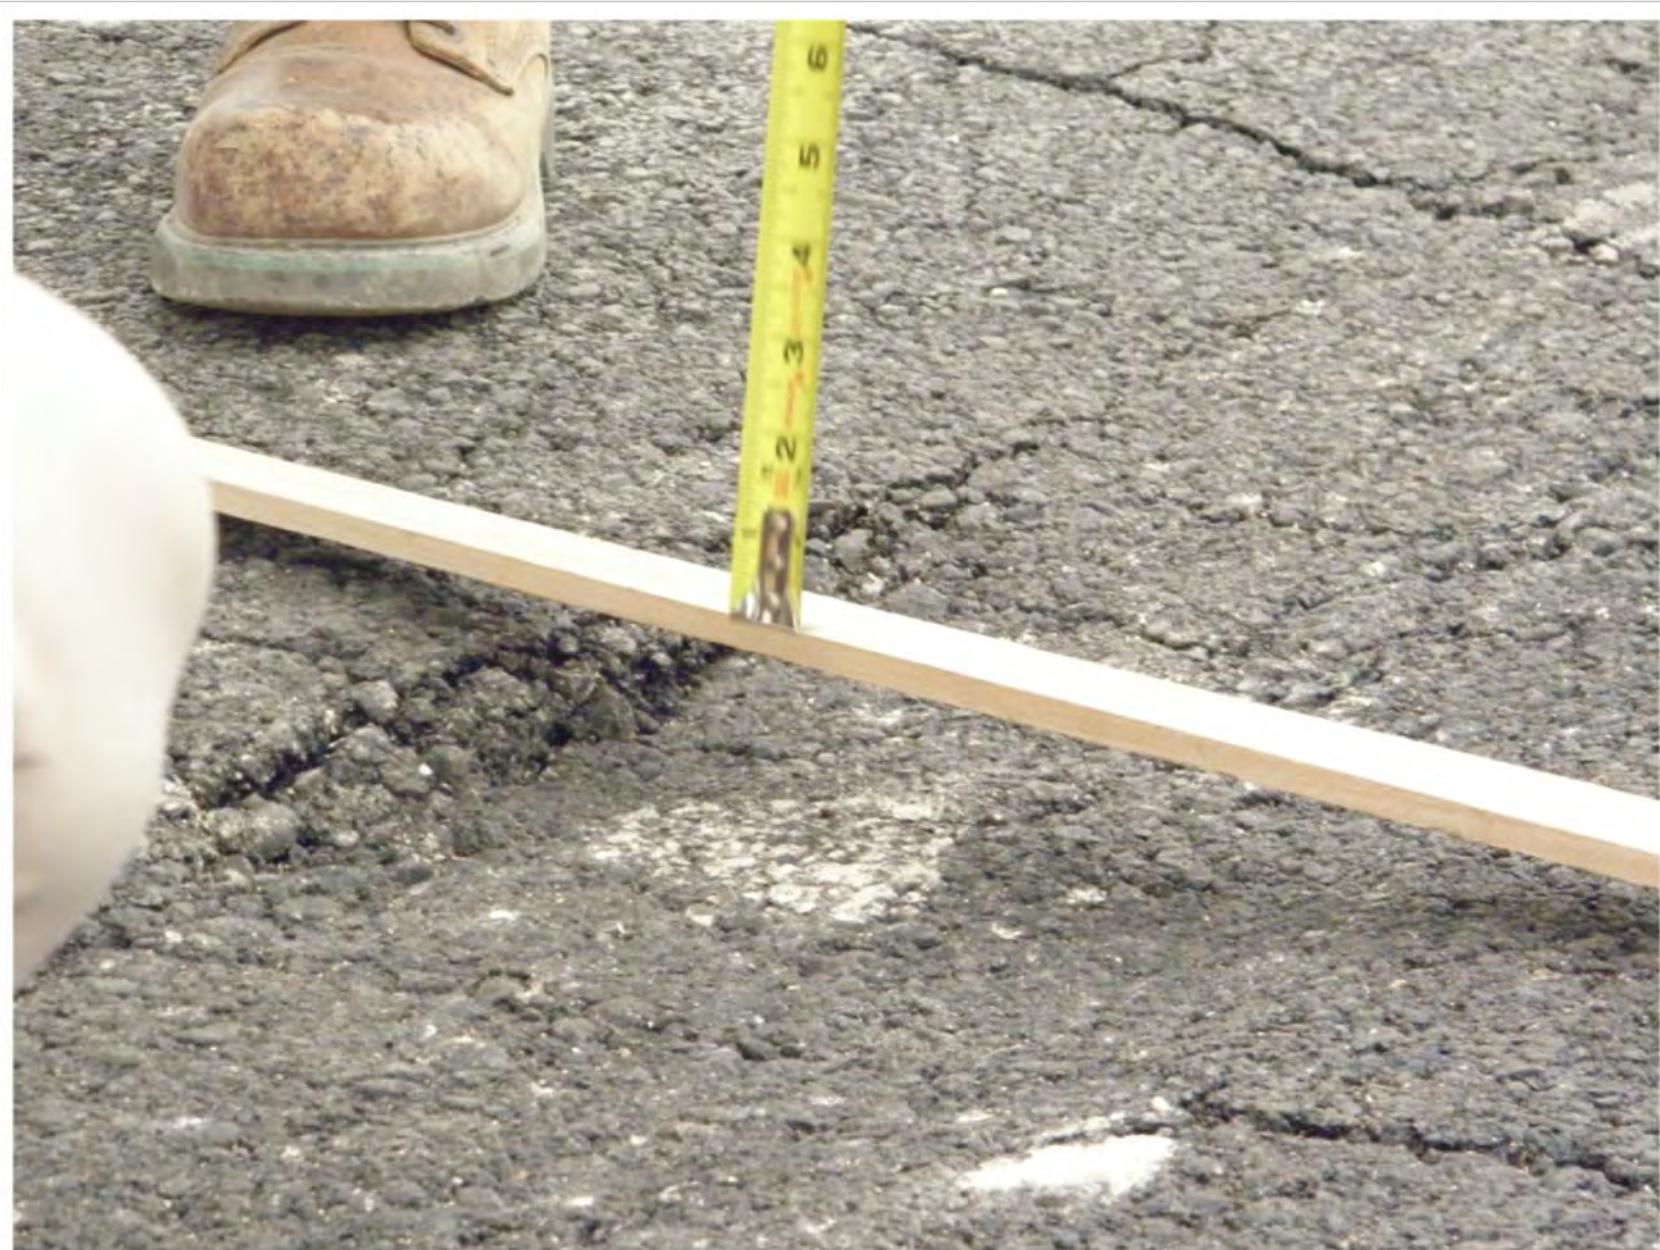
MoDOT – US65 in Carroll County, Image P5180 236

When John and I arrived at the job site, MoDOT had just finished coring the asphalt base material. The coring rig slowly moved away from the core and caused a 2" rut in the base material. Earlier that day, MoDOT had observed an empty 18-wheeler passing over the area that caused cracks wide enough to stick your fingers into.

2" rut caused by water truck.

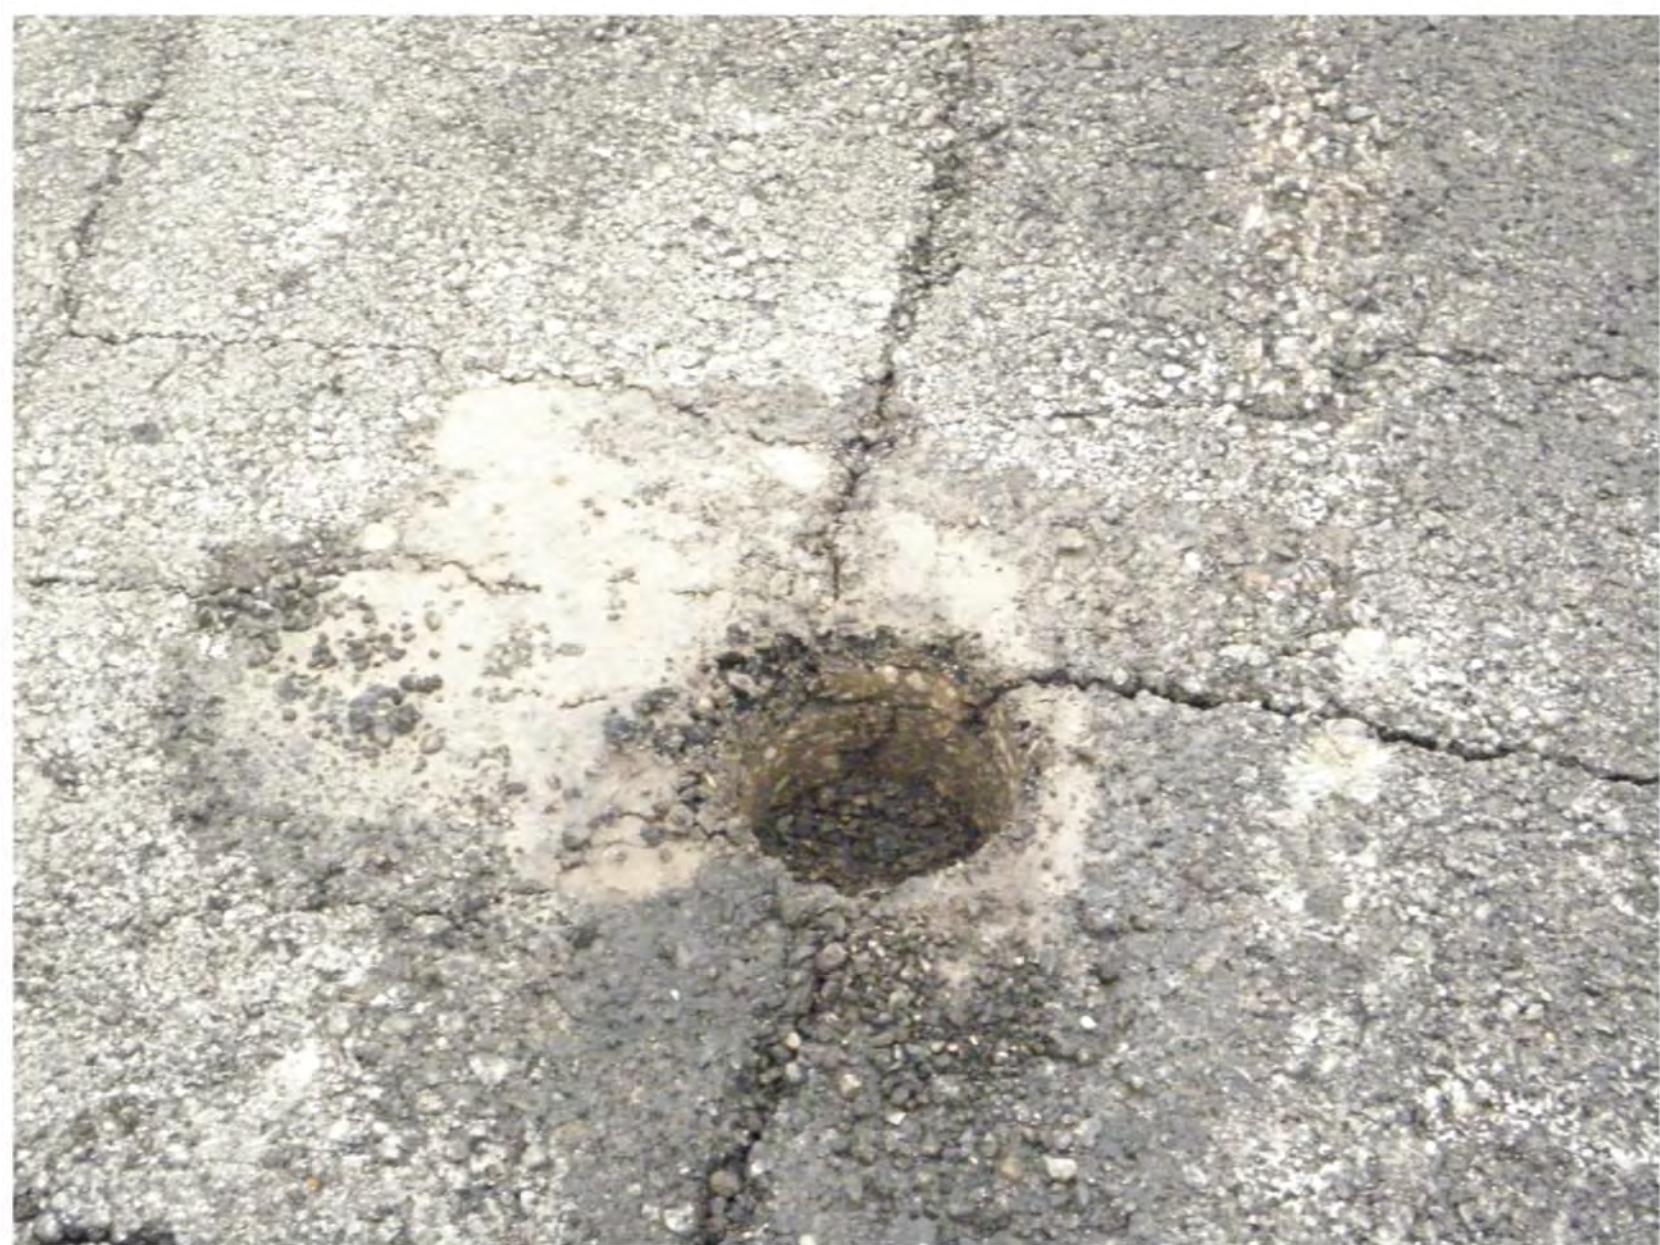
MoDOT – US65 in Carroll County, Image P5180 237

Core of asphalt base material – 10 to 12" thick.

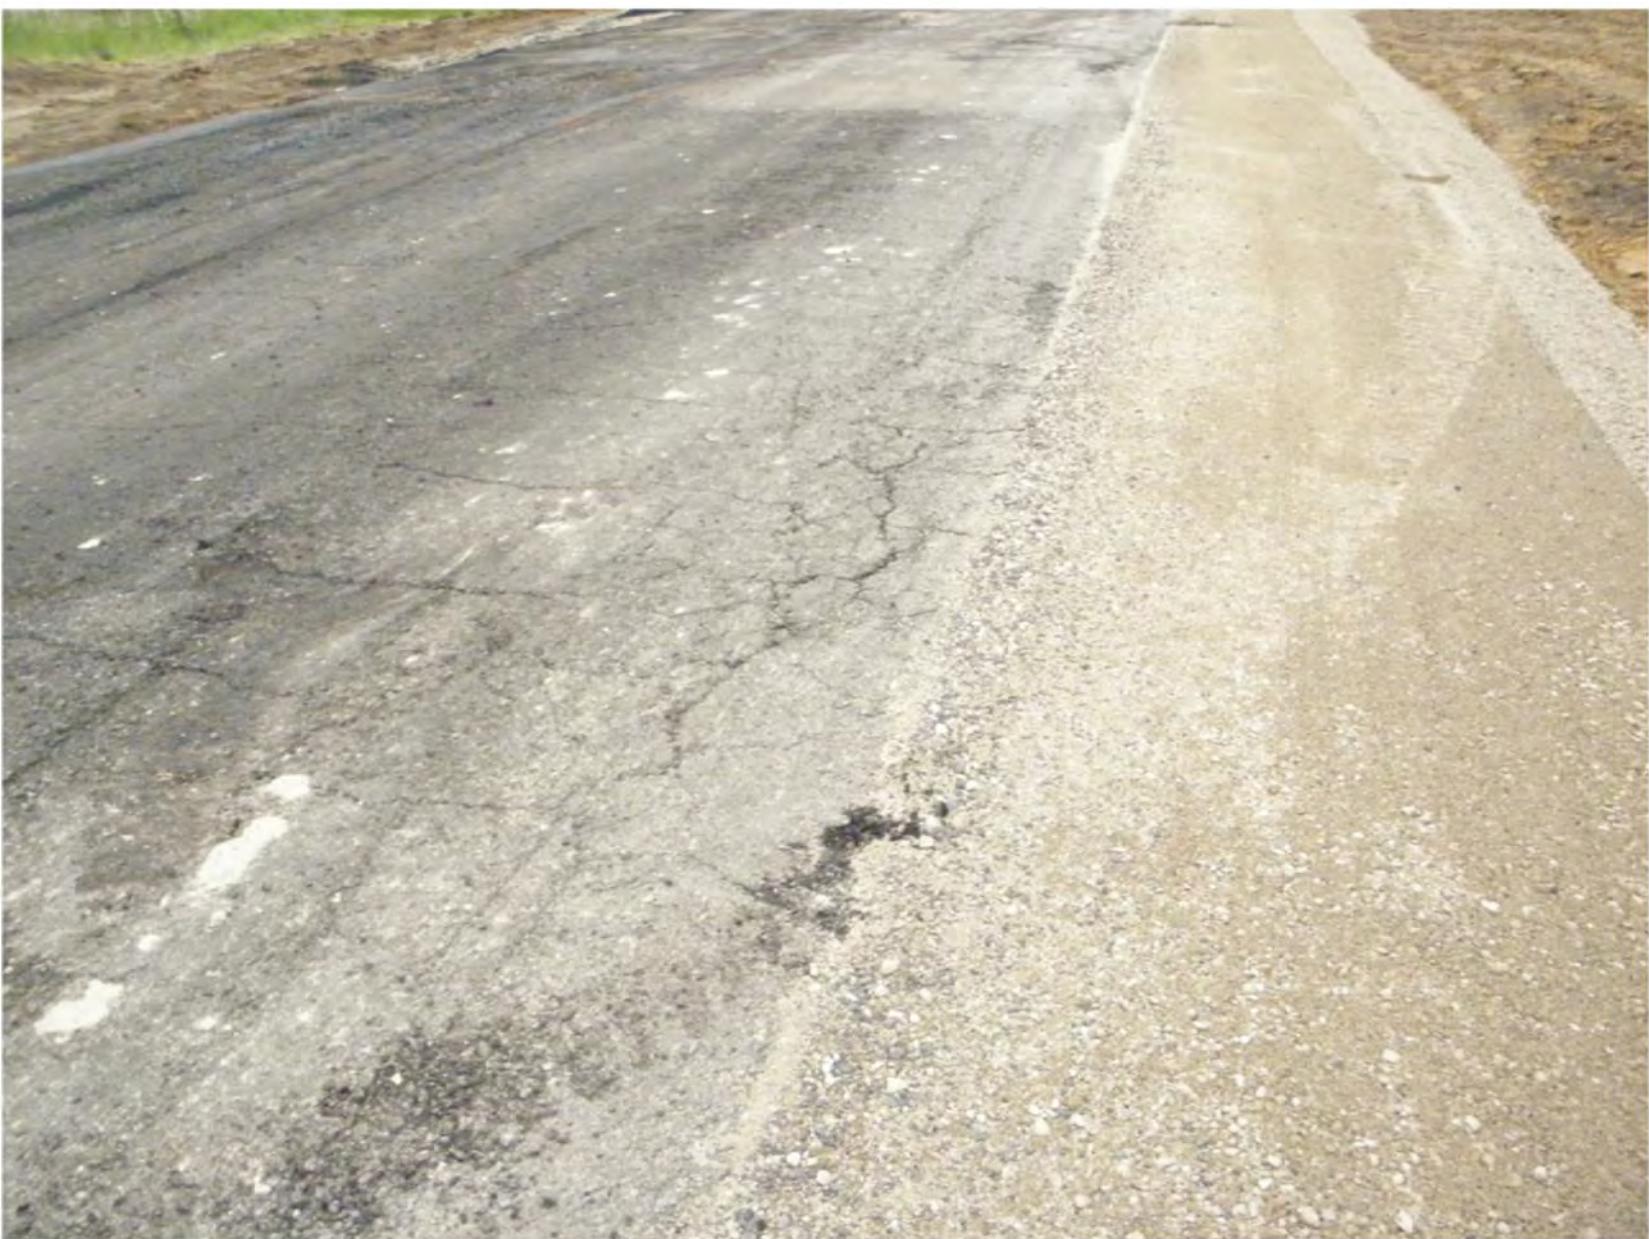
MoDOT – US65 in Carroll County, Image P5180 241

Condition of base & reason for concerns.

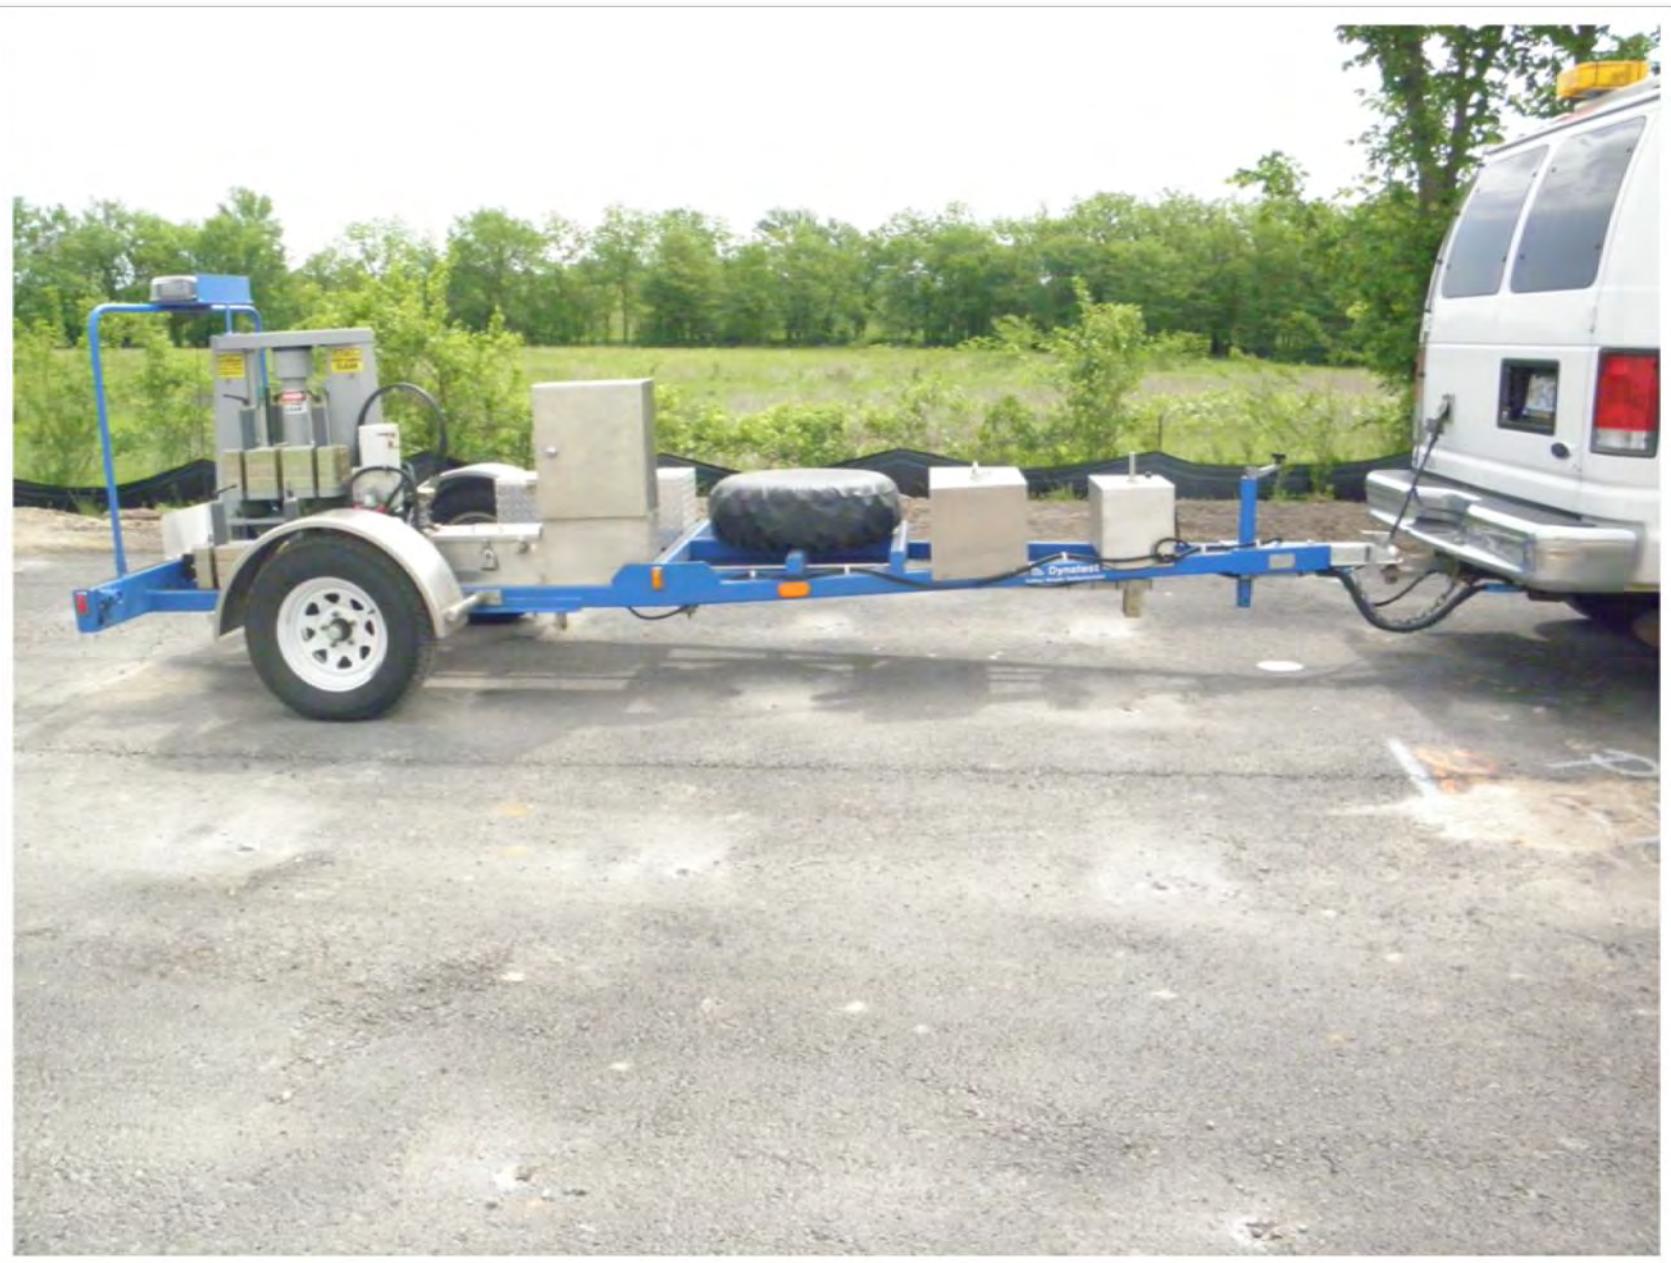
MoDOT – US65 in Carroll County, Image P5240 250

MoDOT's falling weight deflectometer trailer.

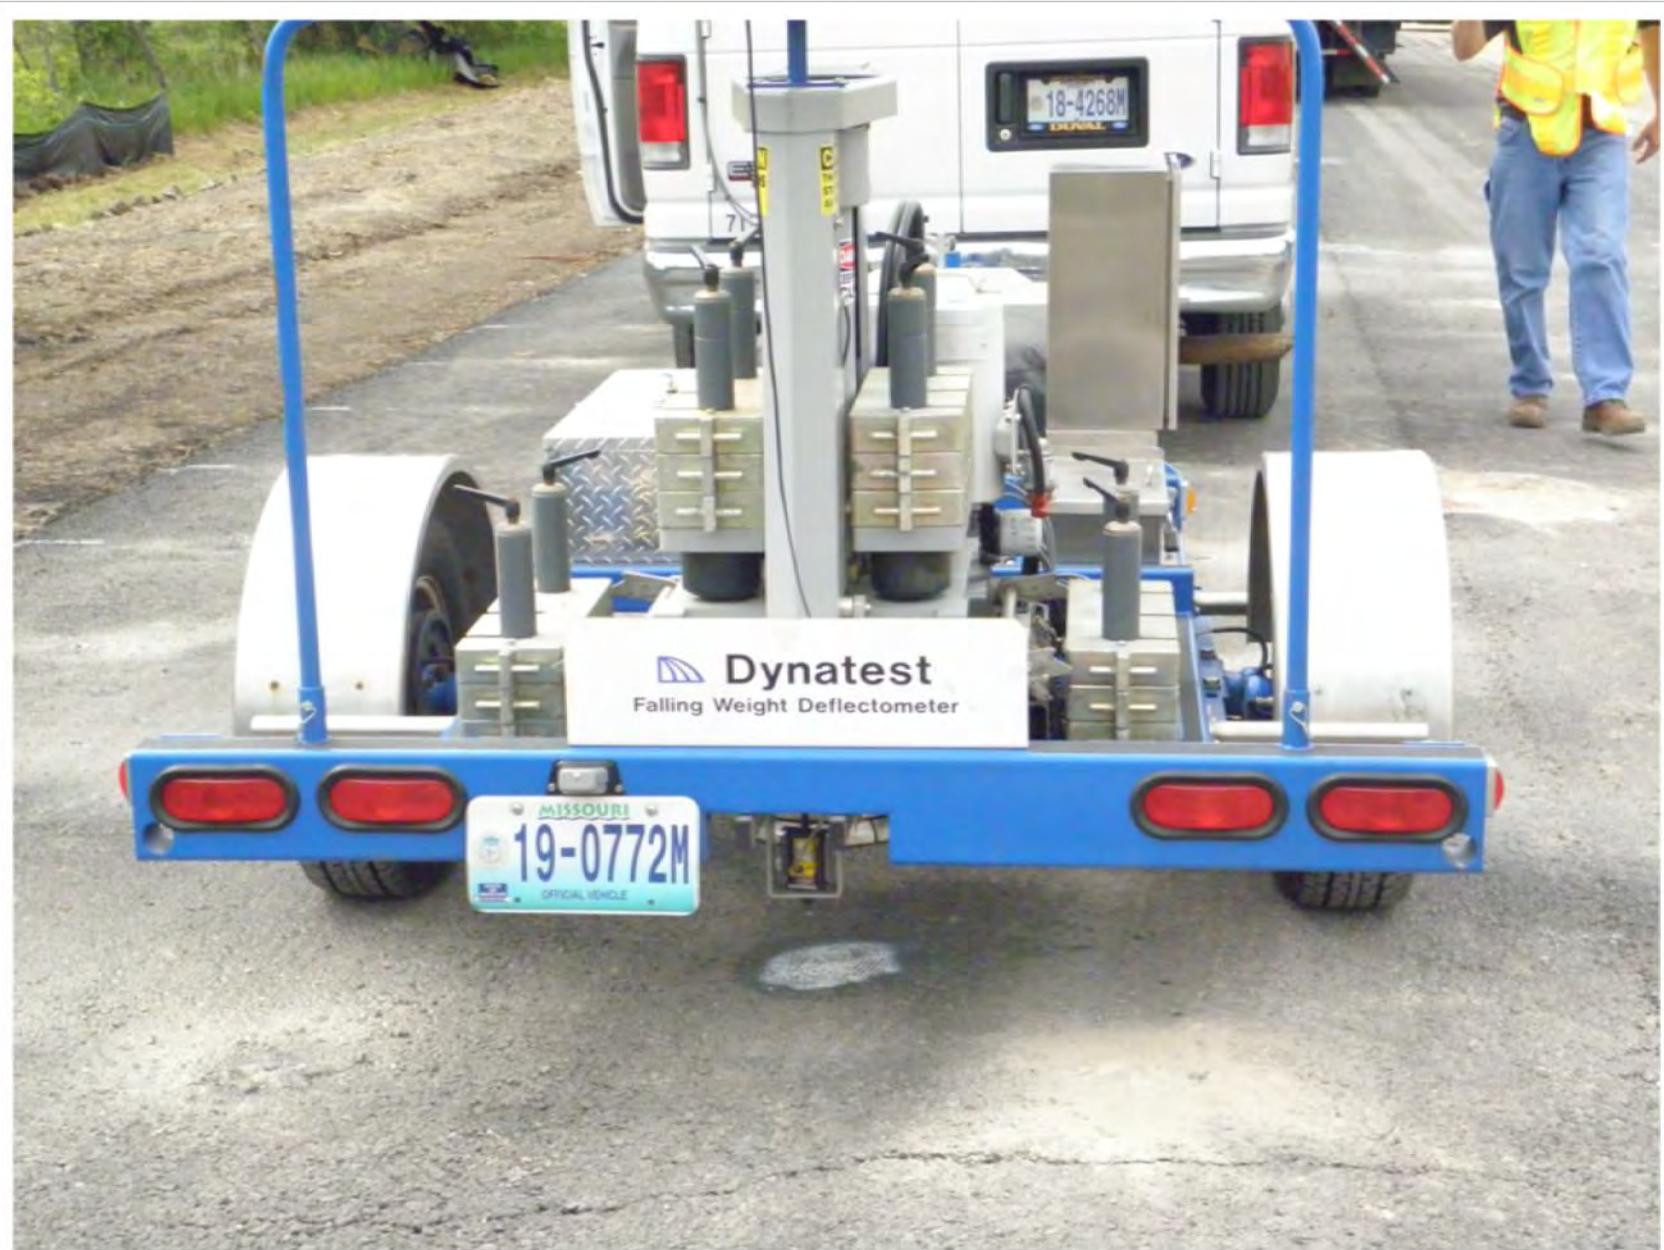
MoDOT – US65 in Carroll County, Image P5240 251

MoDOT's falling weight deflectometer trailer.

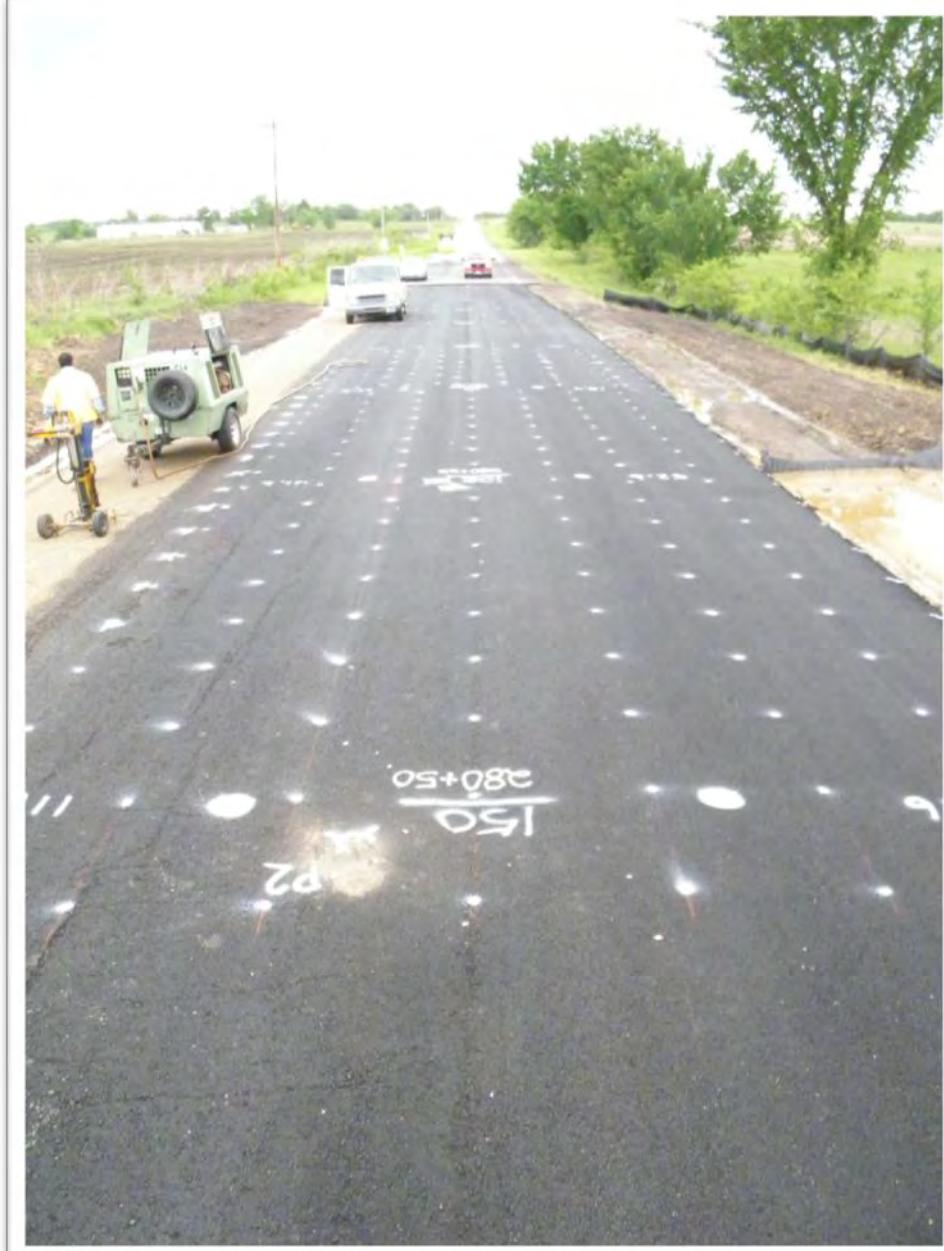
MoDOT – US65 in Carroll County, Image P5250 252

Hole spacing: 4' centers, each way (near), 3' centers (far)
Photo shows Station Marks, DCP locations, and FWD locations (large white dots).

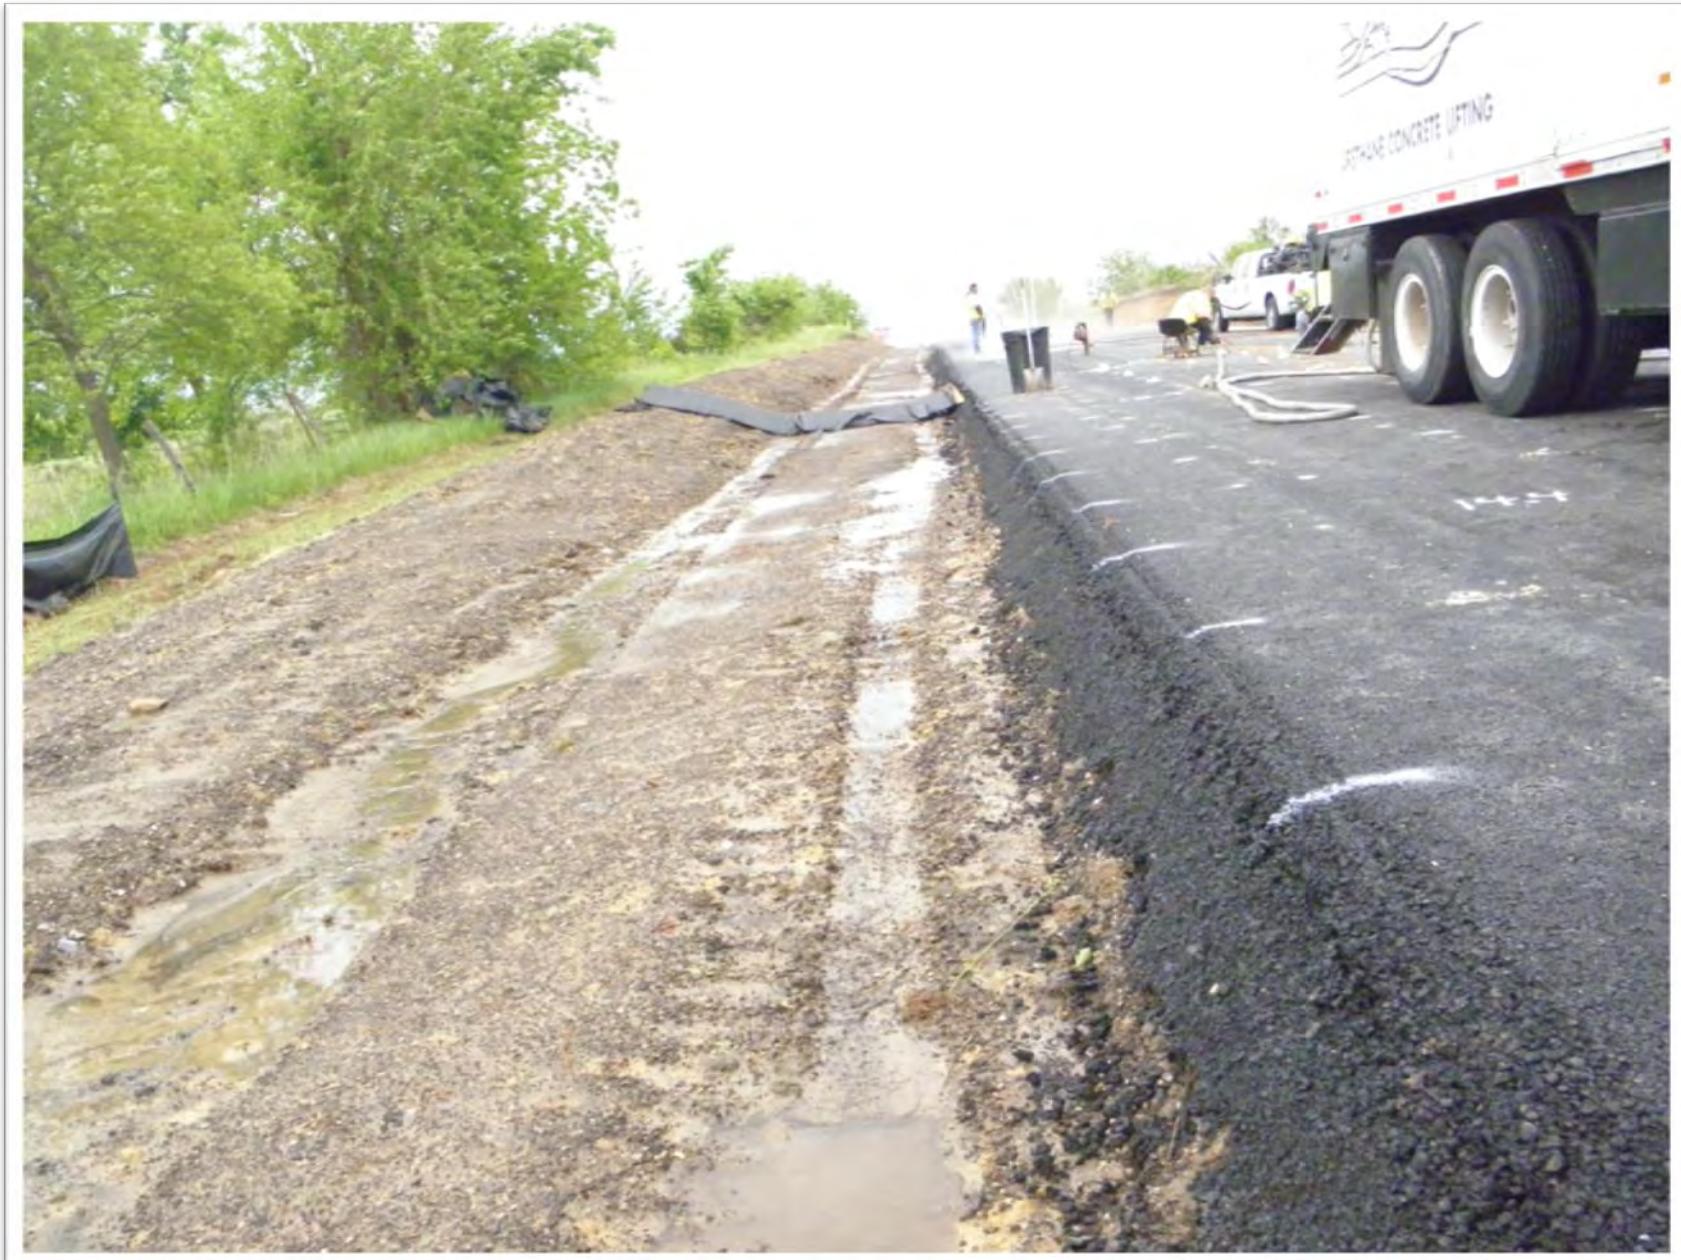
MoDOT – US65 in Carroll County, Image P5250 256

North bound shoulder before gravel was added. Shows depth of base material.

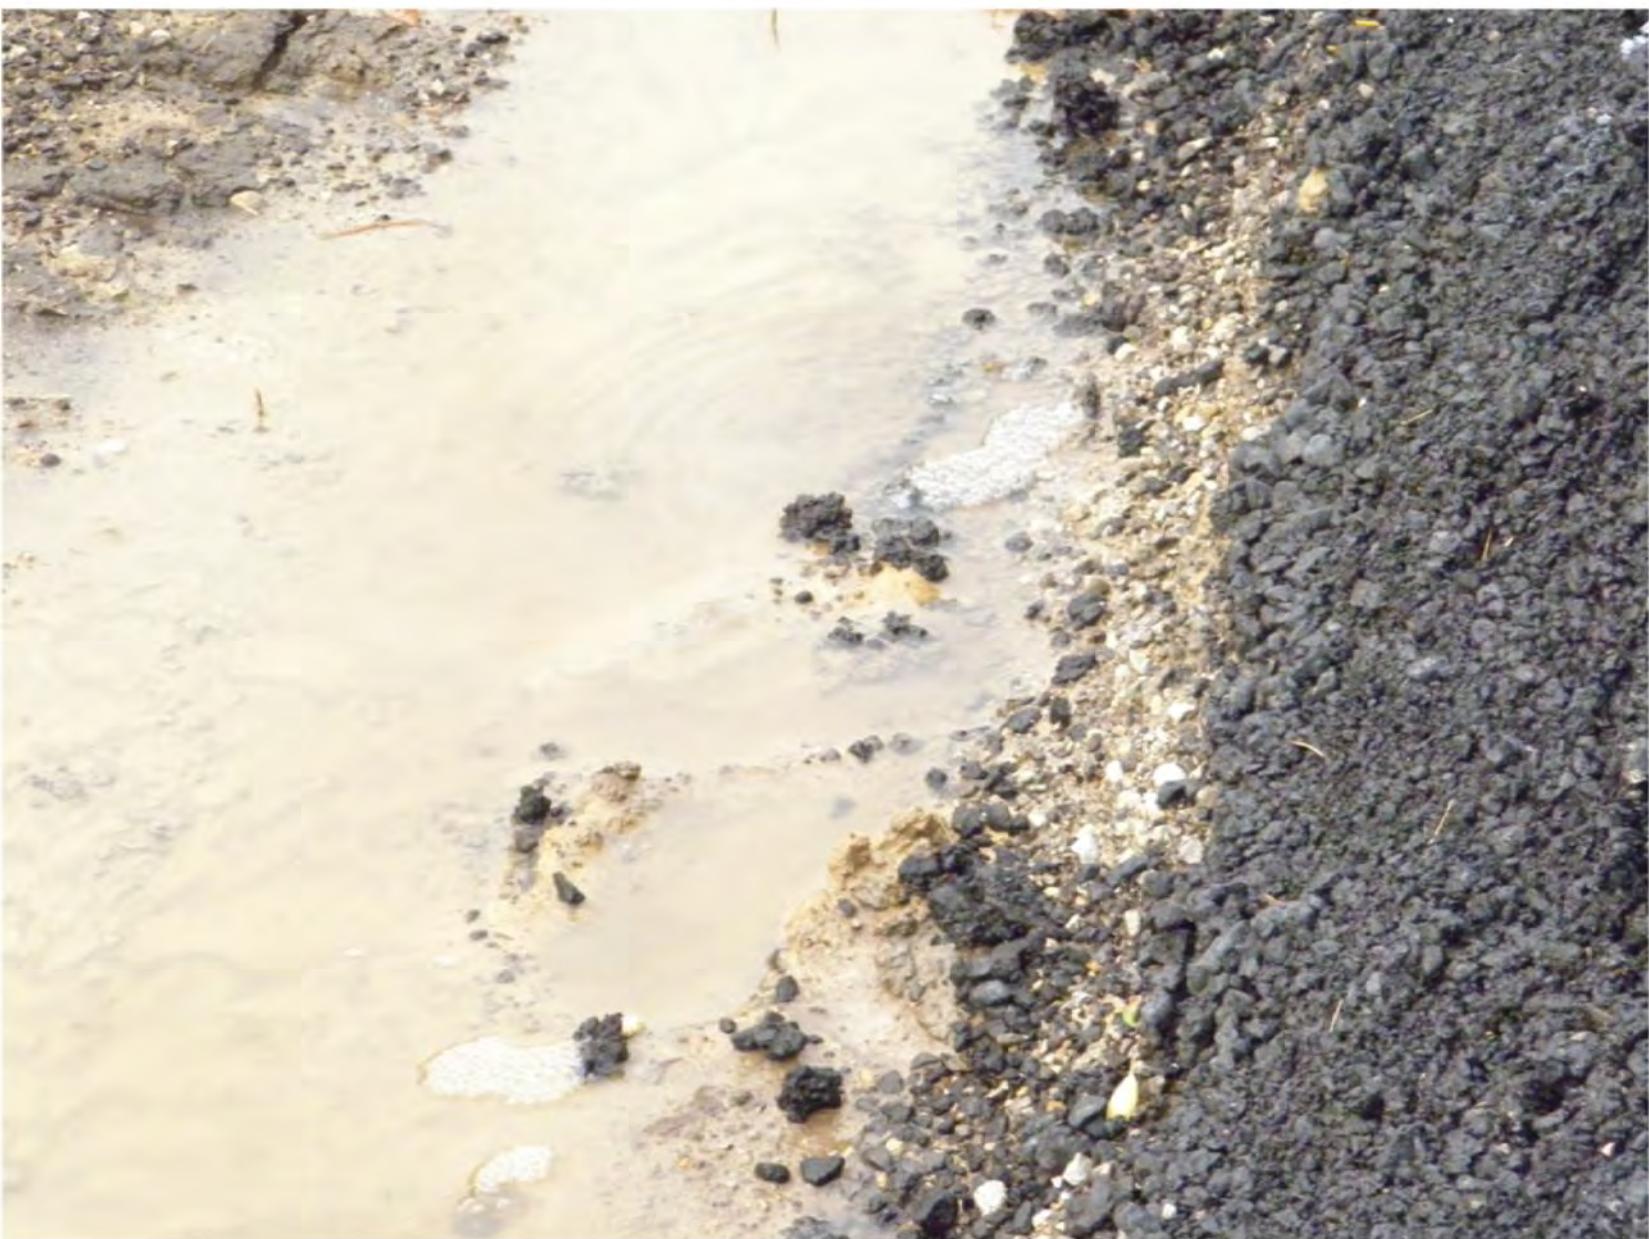
MoDOT – US65 in Carroll County, Image P5250 257

Bubbles in shoulder during UDI

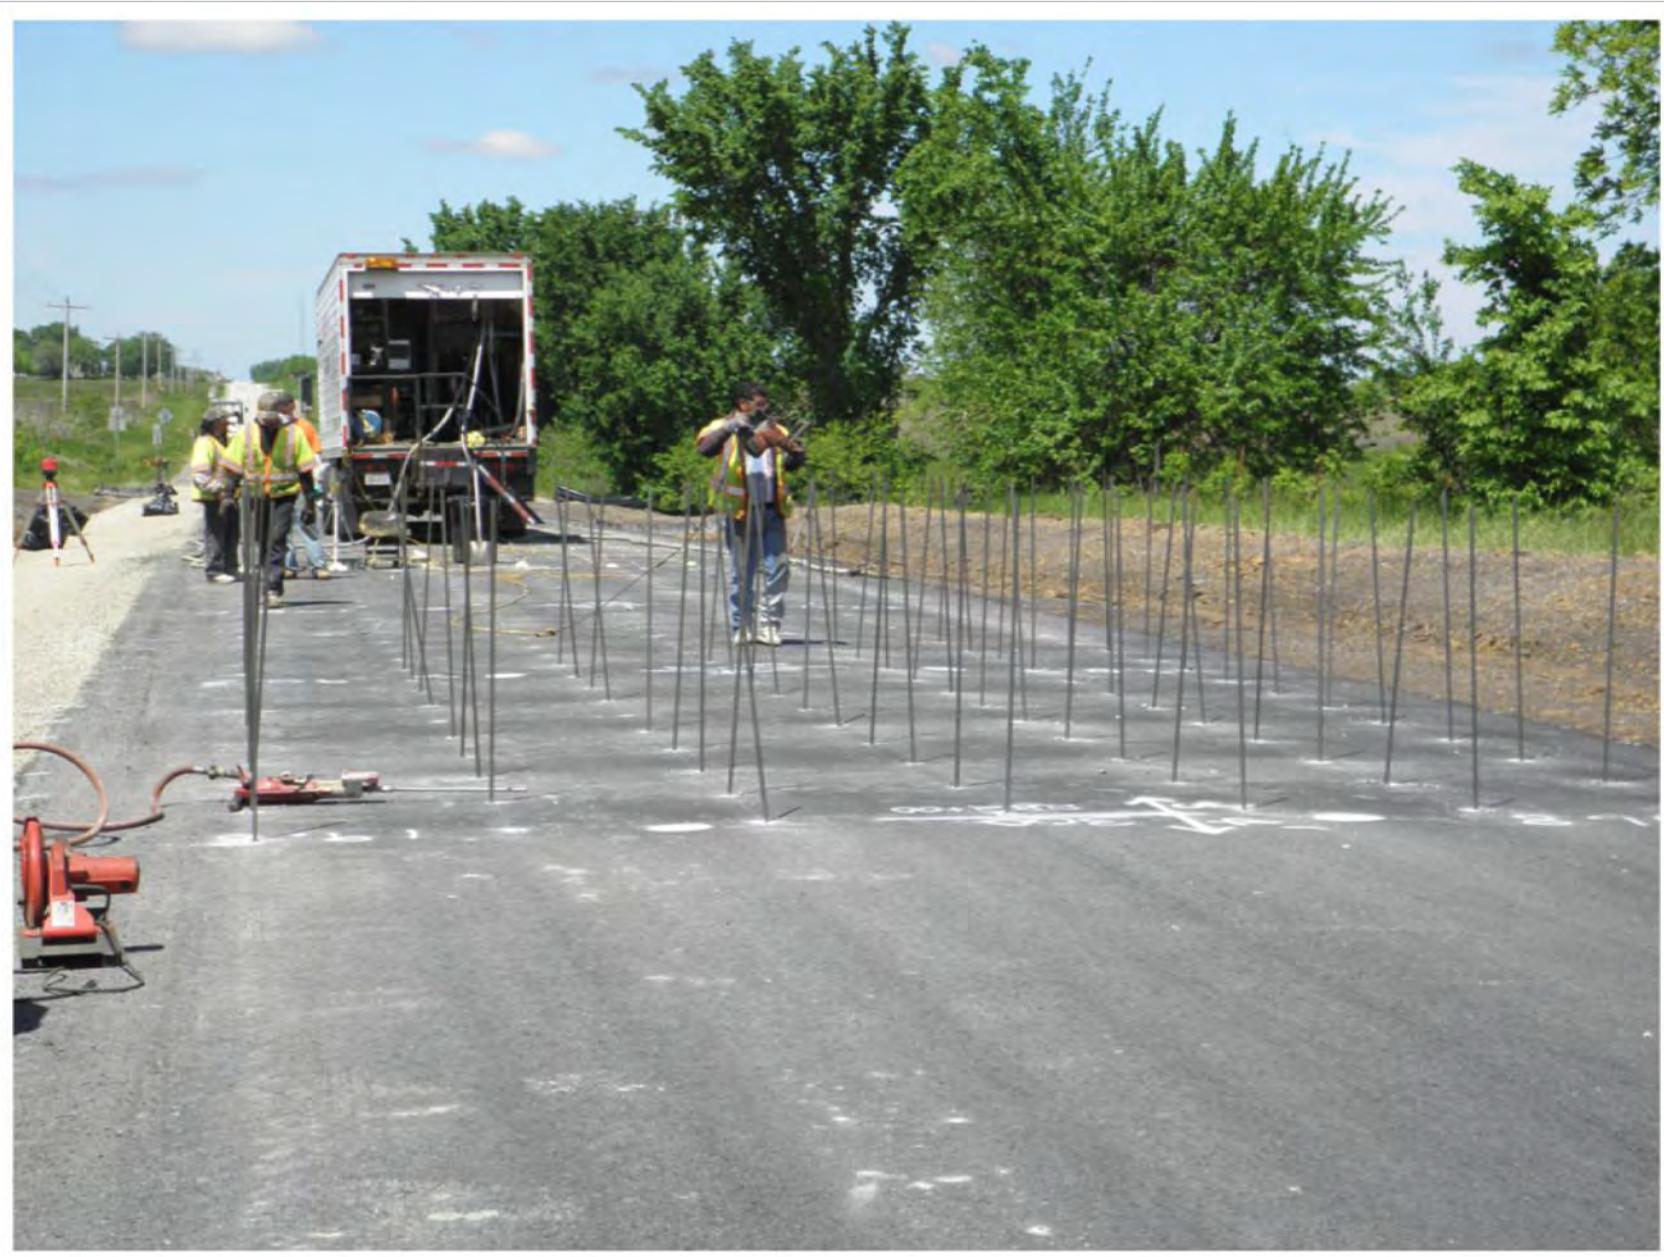
MoDOT – US65 in Carroll County, Image P5250 262

Tubes being installed in a typical 25 LF x 24' wide section

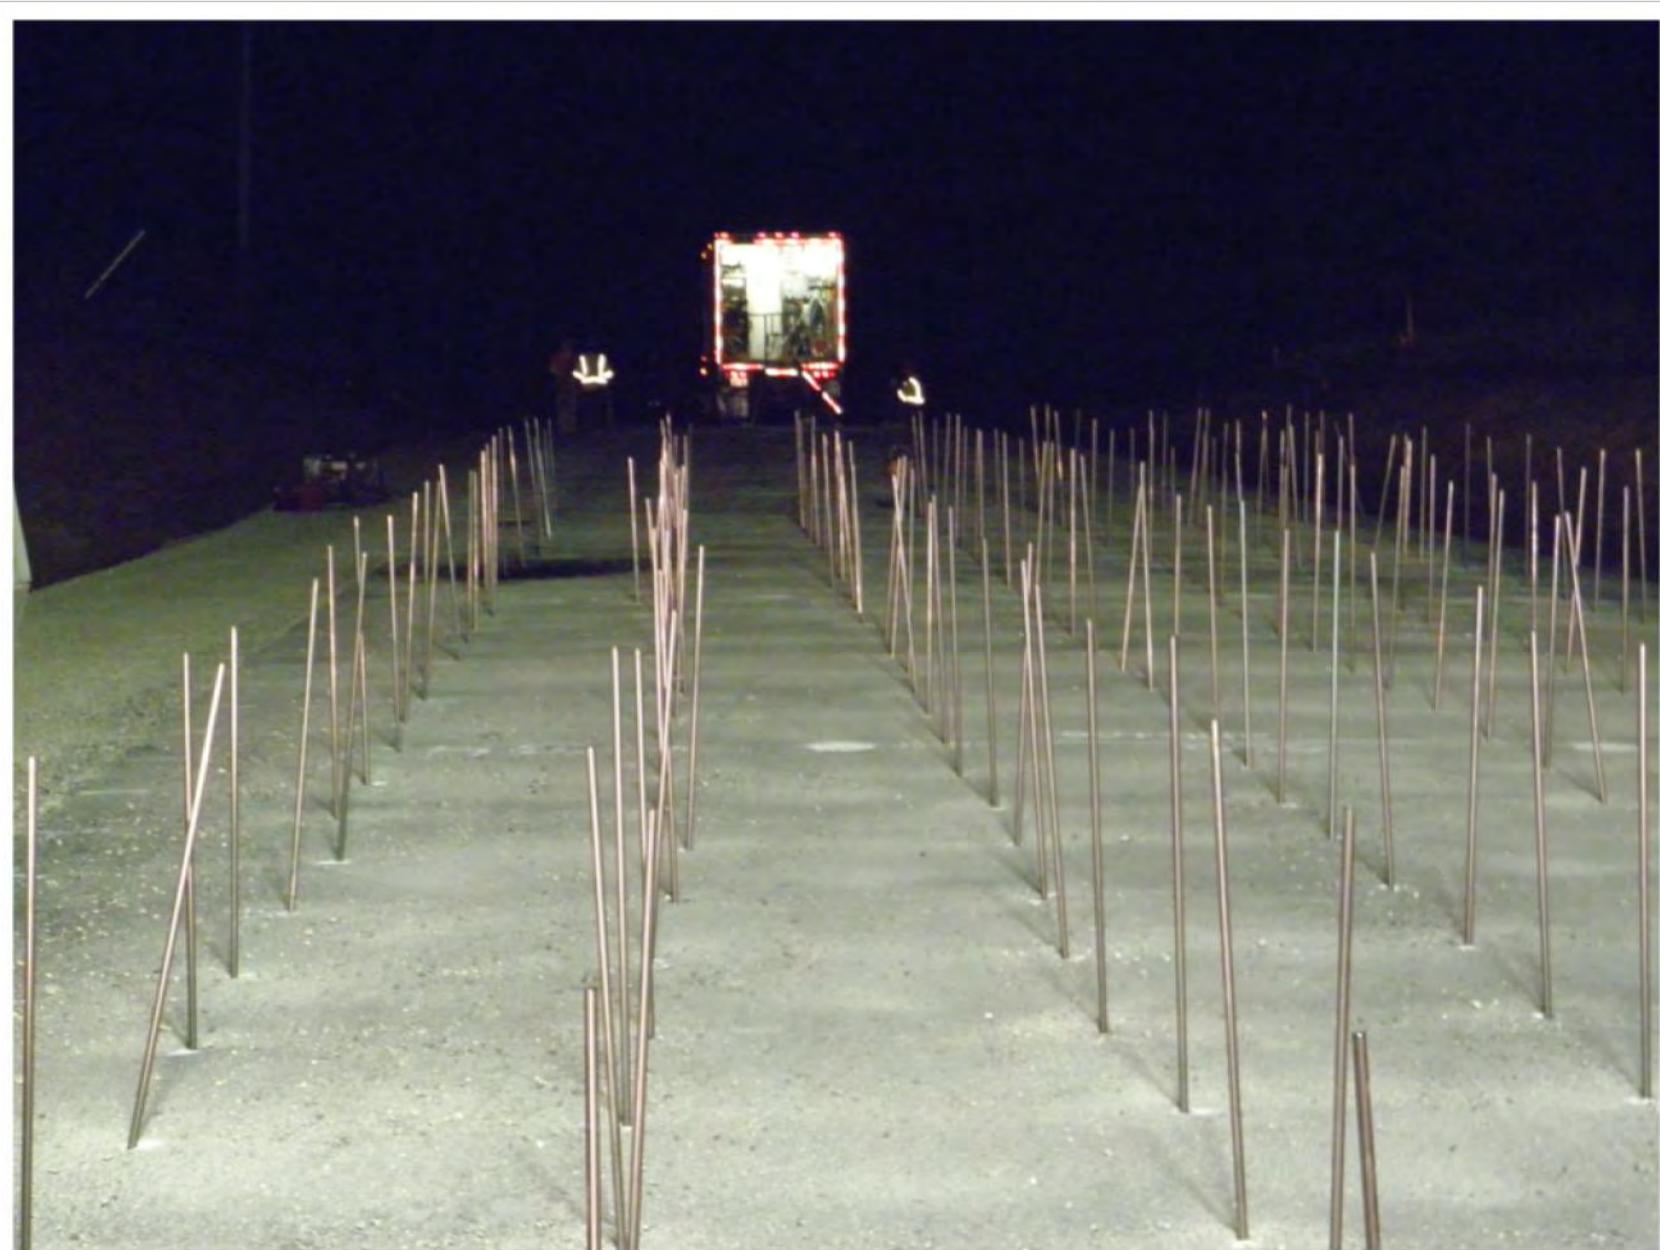
MoDOT – US65 in Carroll County, Image P5250 281

Tubes being installed at night.
