PROJECT REVIEW REPORT

EVALUATION OF THE URETEK DEEP INJECTION (UDI) PROCESS FOR IMPROVING PERFORMANCE OF US 65 CARROLL COUNTY, MISSOURI

**Subject: Project Review Report for US 65, Carroll County, Missouri
(Emergency Stabilization of Roadway, May 2011)**

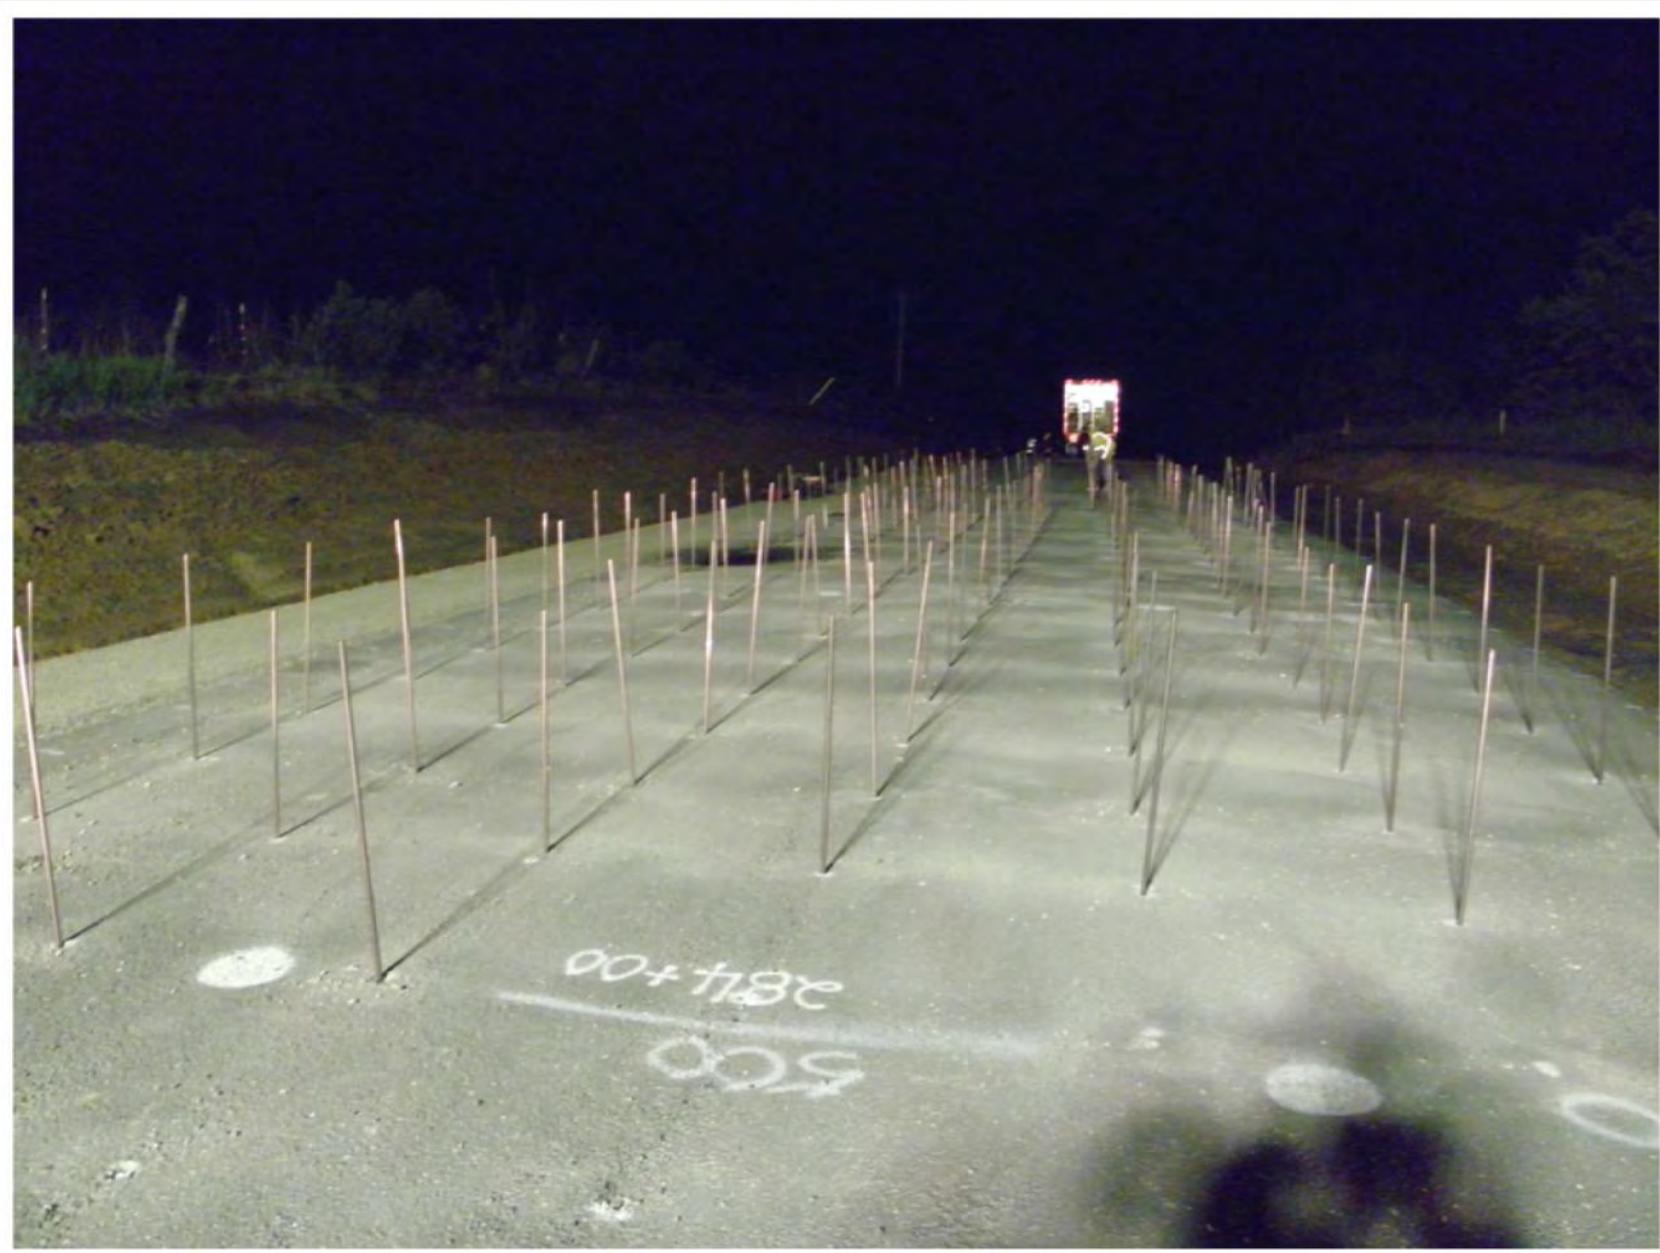
MoDOT – US65 in Carroll County, Image P5250 276

Tubes being installed at night.

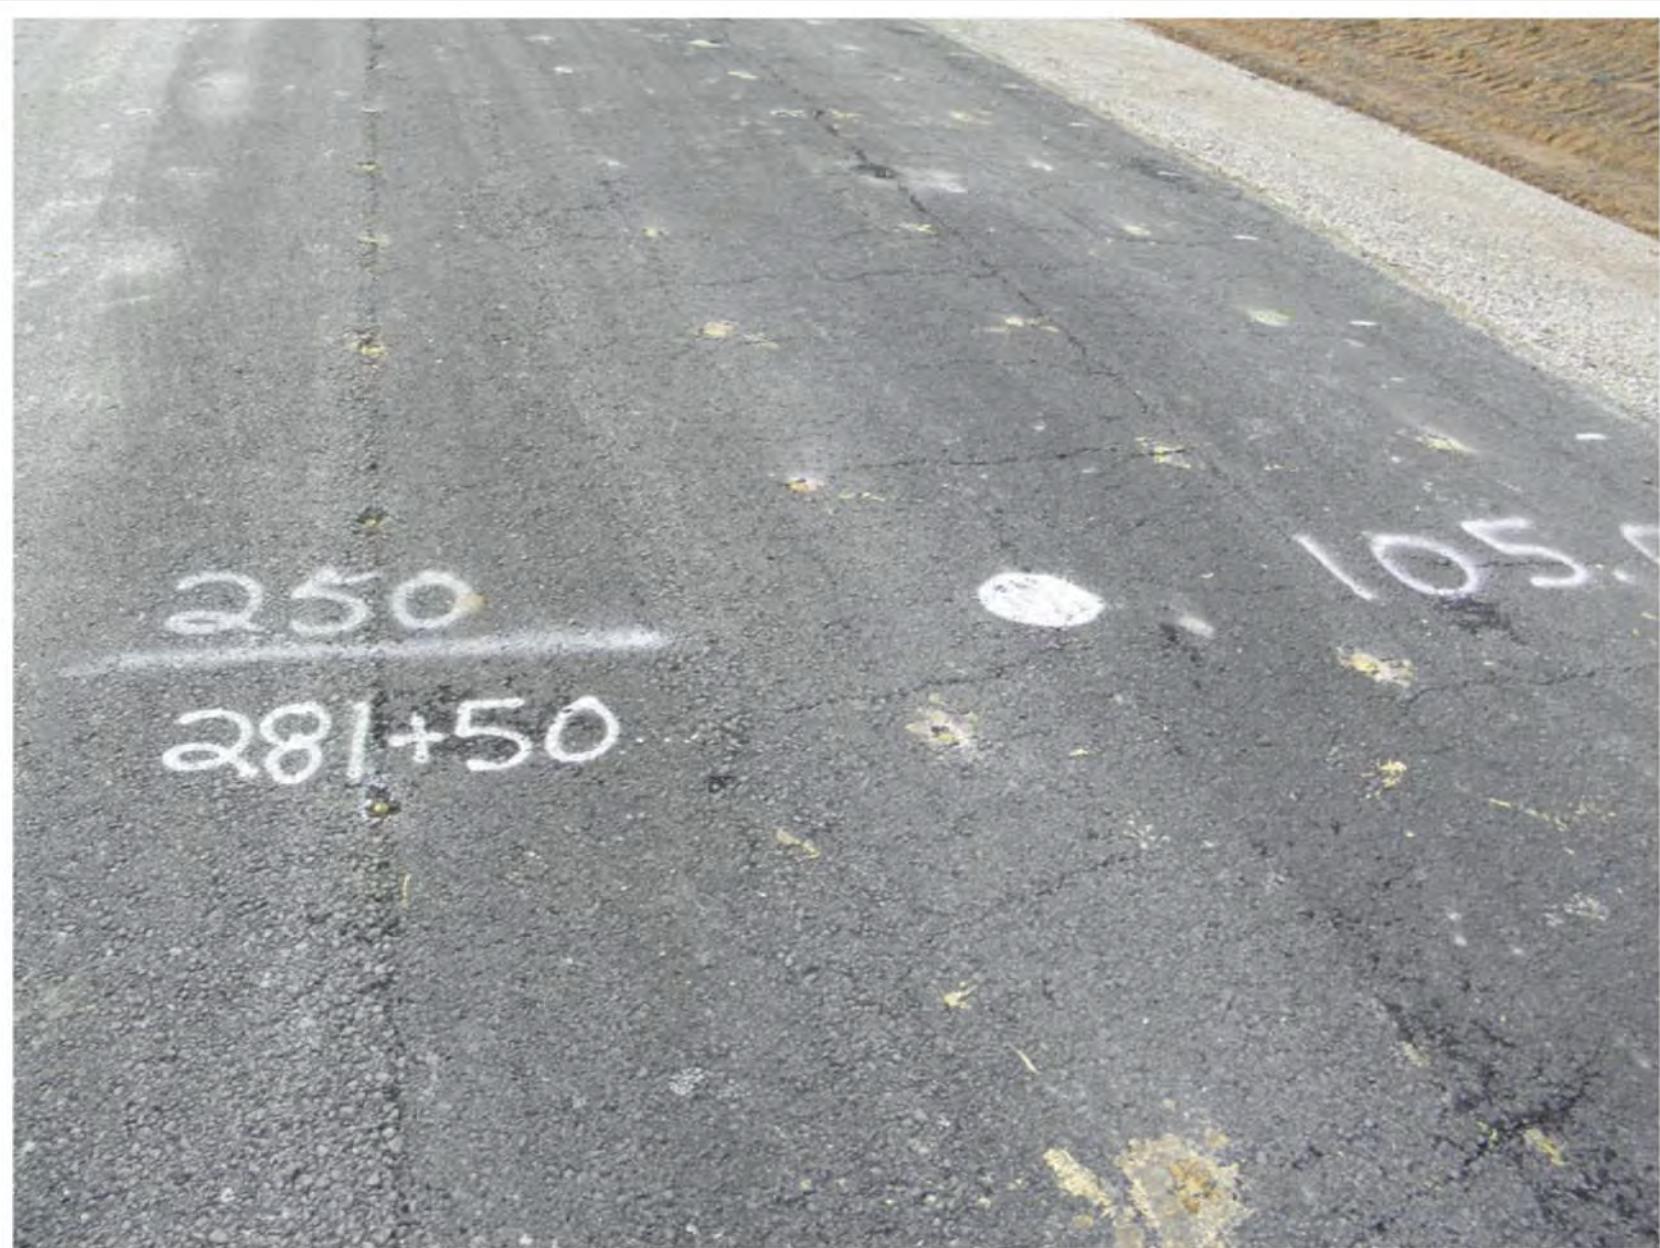
MoDOT – US65 in Carroll County, Image P5310 288

Site after UDI.

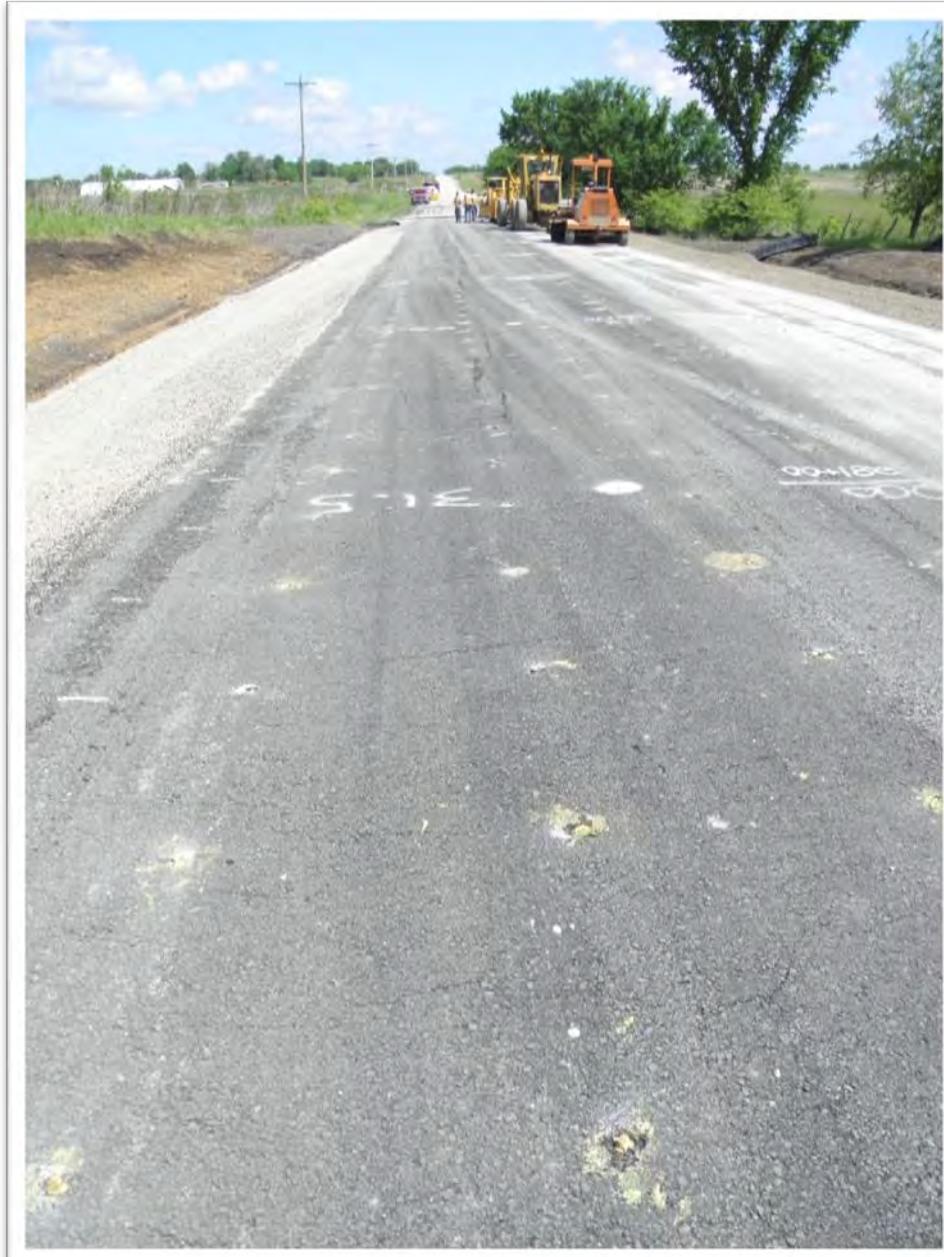
MoDOT – US65 in Carroll County, Image P5310 289

Site after UDI and contractor adding gravel to shoulder.

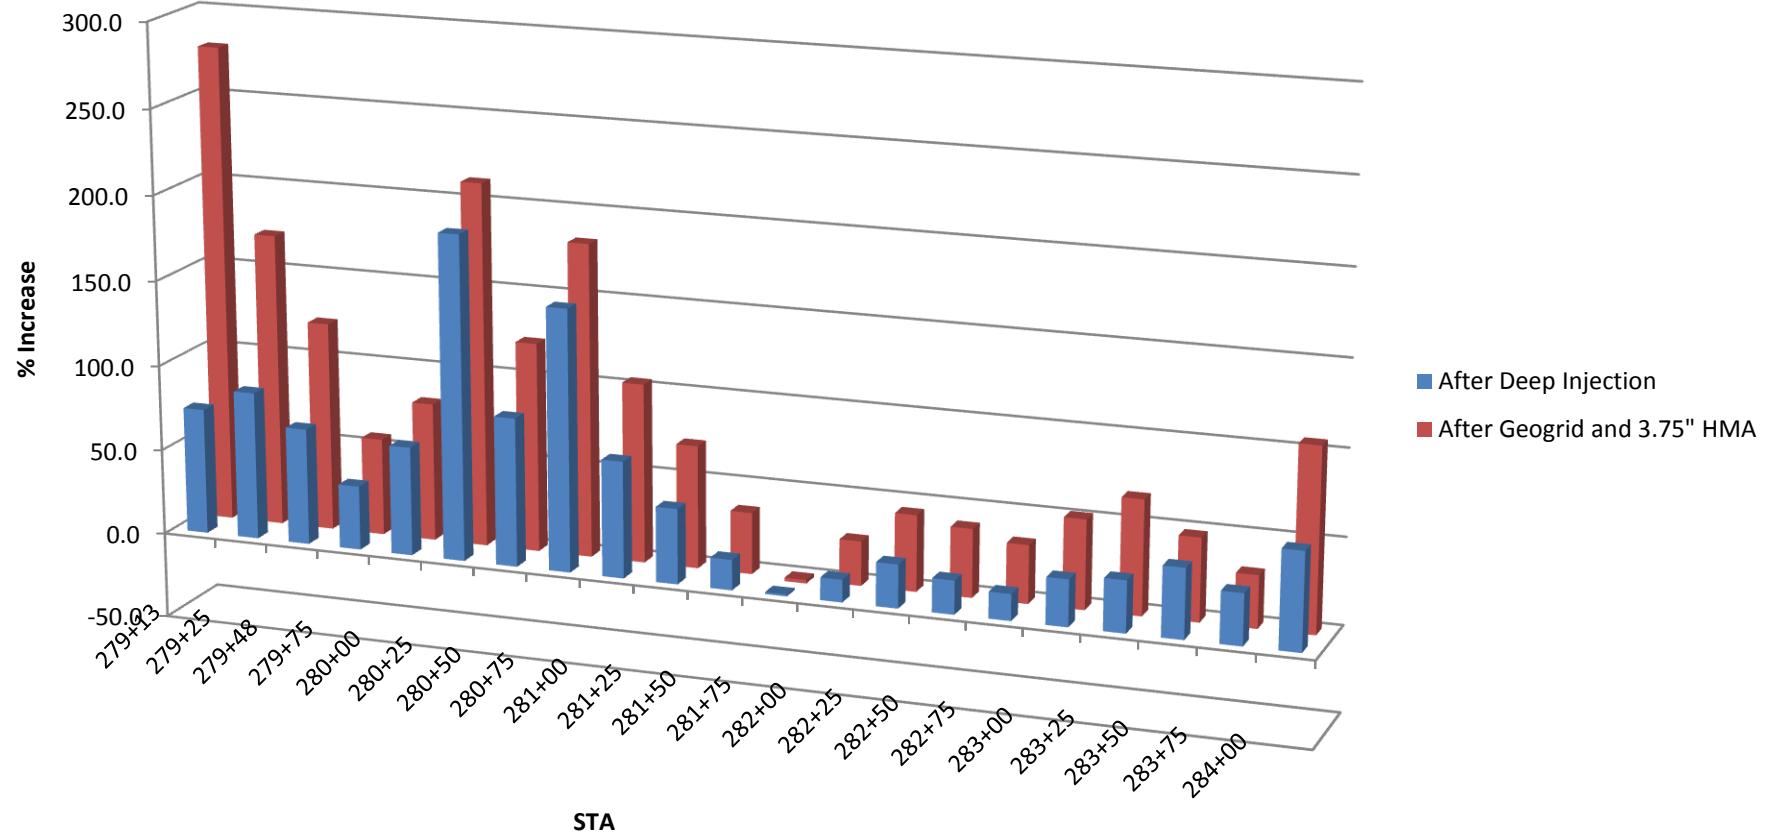
Percent Increase in Subgrade Modulus @ 24" Radius for NB US 65

- Average increase in subgrade modulus after UDI = 60%

Brown's Comment: This finding means UDI produces an increase in soil stiffness which results in the pavement system being better able to support loads
