PROBLEM

LOCATION: Hamilton County, Ohio, Interstate 275, West of Weil Rd

SOLUTION

URETEK Deep Injection Process

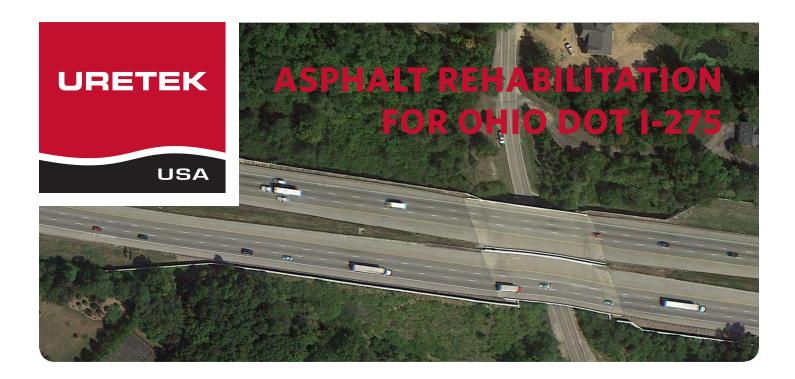
Ohio DOT had a 2 to 6 inch dip across 6 lanes of full depth asphalt in this section of Interstate 275. This problem was caused by a compromised corrugated metal pipe at -50 feet. The leaking pipe was allowing soils to be drawn down and

out from under the roadway. We had performed similar projects for ODOT in the past. ODOT contacted URETEK USA because they were familiar with our technology. They also knew that our process is an effective repair, saving time, money and reducing delays for the traveling public.

Dynamic Cone Penetrometer testing data was taken down to 45' to confirm and locate the weak soil zones.. The URETEK Deep Injection process was used at various depths but mostly targeted the weakest areas in the upper 10' providing direct support to the pavement system.

The possible need to mill and repave the asphalt to provide a smooth ride must always be considered when injecting expansive polymer into the soils beneath a flexible pavement system. This asphalt roadway was brought back up to grade with minimal pavement undulations;

therefore, milling and filling was not required for this project.

URETEK Deep Injection along with the corrugated metal pipe repair was less than 10% of the proposed reconstruction cost. There were zero daytime lane closures as URETEK performed the work in a period of 12 nights, which further reduced any impact to the traveling public.
