## **PROBLEM**

LOCATION: ANDREWS AIR FORCE BASE, MARYLAND

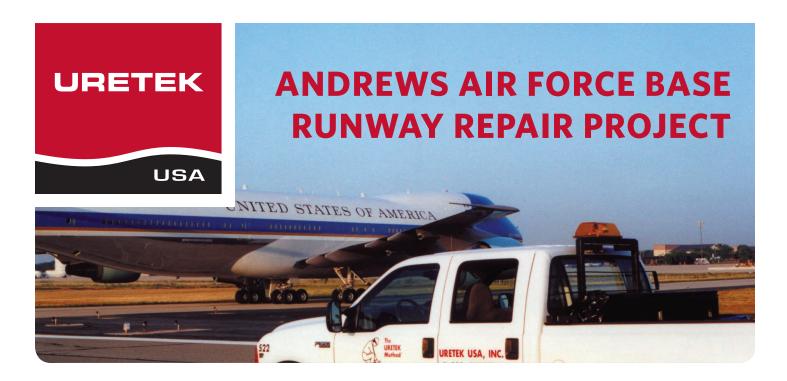
A significant dip (2" deep) had developed Runway 1L/19R at Andrews Air Force Base, Maryland. An engineering investigation revealed the settlement was caused by water infiltrating the pavement system and

transporting soil particles through a leaking culvert underlying the runway. The settlement presented operational problems, particularly for small aircraft.

- Initial Slab Lifting Using High-Density Polyurethane
- URETEK Deep Injection® (UDI) Soil Stabilization
  This unique process relies on a two-part polymer system, injected
  beneath the concrete through pre-drilled holes of 5/8-inch diameter
  (penny-size). The polymer system travels through tubing to elevations
  beneath the pavement surface characterized by weak soils (determined
  by cone penetration testing). Expansion of the polymer compacts the

surrounding soils - eliminating voids in the soil mass and improving bearing capacity.

- Leaking Culvert Repair by Injecting Resin (from inside the culvert)
- Final Slab Alignment Using High-Density Polyurethane
- Pavement Joint and Crack Sealing Using Urethane Caulk

- URETEK USA realigned the 15 slabs fully encompassed in the 60' x 88' work area.
- URETEK USA stabilized the soft soils in the work area down to -14' elevation (measured from the surface) using the UDI process.
- Acting as Prime Contractor, URETEK USA oversaw repair of the leaking culvert and pavement joint/crack sealing by hand-picked subcontractors.
