# Road Safety Audit Report

Claremont, New Hampshire

New Hampshire Route 11 (Washington Street)

Claremont Compact – Dane Avenue to Winter Street

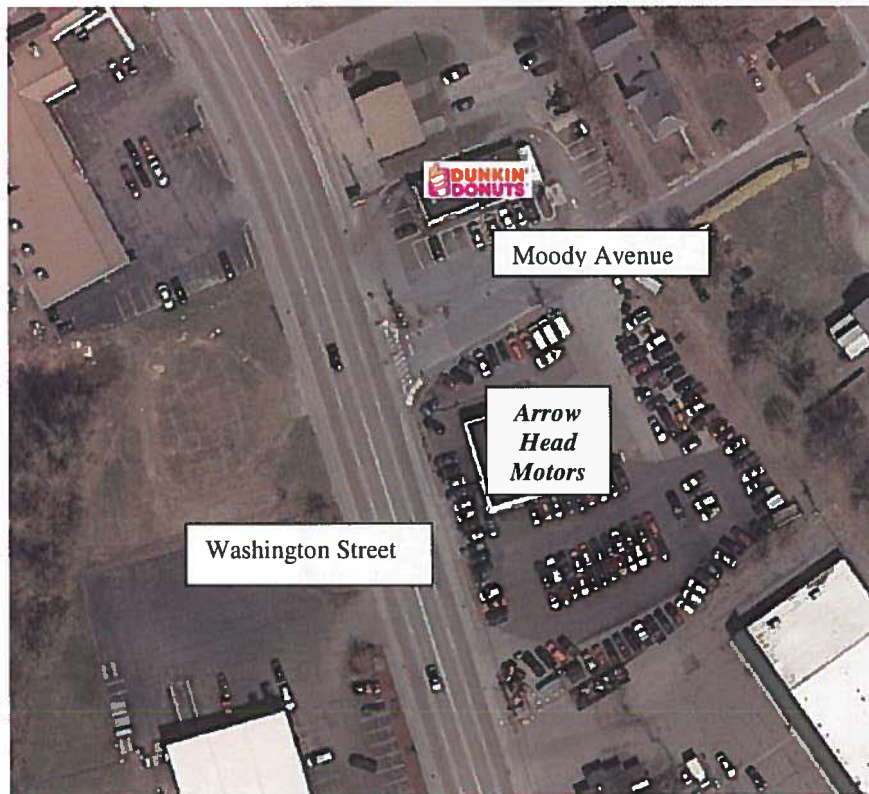
**Location:** Intersection of Moody Avenue and Washington Street

**Description of Safety Issues:** Moody Avenue provides primary access to Washington Street for approximately forty residences, and secondary access for two businesses. The business (Arrow Head Motors) on the southeast corner of Moody and Washington Street has recently closed down an access point on Washington Street that was in close proximity to Moody Avenue. However, the manner in which they display their vehicles restricts the sight distance for vehicles entering Washington Street from Moody Avenue. City planning staff indicated that a new business may be opening in the vacant space on the west side of the intersection.

**Suggestions:** The obvious suggestion at this location is to work with the business on the southeast corner to open up the sightline for vehicles turning left or right onto Washington Street from Moody Ave. Other recommendations include restricting Moody Avenue to “right out” only movements. Further enhancements depend on the proposed development on the west side. Channeling traffic from existing and future business to one access point and installing a signal is a potential option.
