Low visibility turn onto Old County Road

Subject: Low visibility turn onto Old County Road

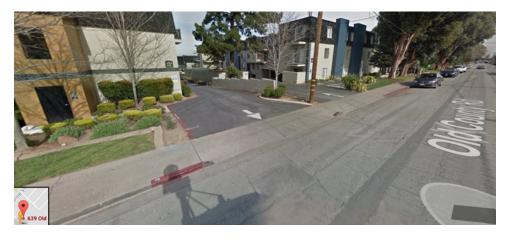
I live at the Madison Belmont Apartments, and my girlfriend and I turn onto Old County Rd via the driveway at 635/6399 Old County Road, pictured here:

About 300 Belmont residents share this same driveway. Making a left or right turn out of this driveway feels unsafe at any time of day or night. It is really difficult to see cars approaching on Old County Road, due to the cars parked immediately

to the right of the driveway, and in the position occupied by the blue car in the photo. There are almost always cars parked in these positions, because they are prime parking spots for the Madison Belmont apartments.

The easiest way to observe the problem is to try to make a left or right turn out of the driveway on a weekday around 8-9am or 5-6pm. I encourage you to try this. To see the approaching traffic, you have to inch out far enough that the hood of your car is in oncoming traffic. I resort to trying to see cars approaching from the left in the reflections of cars parked across the street. Suffice to say, that is not very safe.

I eyeballed the corner sight distance for this driveway. For cars approaching from the left, I generously measured a corner sight distance of 45 paces, roughly 150 feet. For cars approaching from the right, I measured 20 paces, or 60 feet. These are 50 feet and 140 feet short of the recommended guidelines, and those guidelines assume cars are traveling 30mph, which they frequently exceed.

- Increase the red curb areas to the left and right of the driveway, so the corner sight distance is at least 200 feet. The effect of this would be to push one or two cars from right in front of the apartments to an area further down Old County toward Marine View Ave. There are frequently empty parking spaces near Marine View Ave; I would be fine walking an extra hundred yards to my car in exchange for a safer turn out.

- **Designate areas closest to the driveway as "commercial loading only."** Uber/Lyft are really popular with Madison Belmont residents, if those spaces in front of the building were only available for cars to park for short durations, this would increase visibility and make it safer a lot of the time for cars turning onto the main road.

- Add mirrors across the street so it's easier to see oncoming traffic in each direction.
- Add a median so the driveway is right turn only. I wouldn't be too happy with this, but it would be all right if there was an opportunity to do a U-turn shortly after merging.
