# Glessner House

## Exterior & courtyard audit

Photographic completion study • 1904-07-01 target • reviewed 2026-10-08

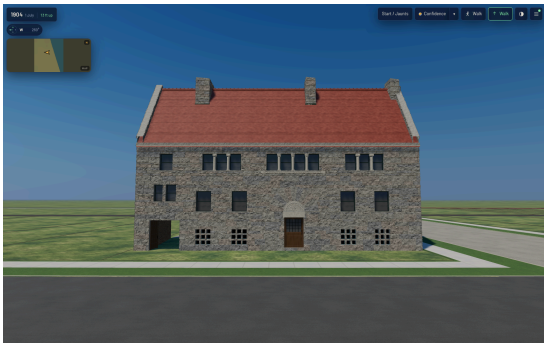
Current model — prairie

| Masonry and openings | Street rock-face texture is noisy; courtyard material calibration must respect documented pink common brick and limestone. Door ironwork and unique window/stone profiles remain incomplete. | GA-09–15, 17, 19 |

**Finding:** Broad banding dominates the street roof; overhead views show large smooth roof planes beside dense tile patterns. The material does not read consistently as fine overlapping clay tiles.

**Finding:** Close-ups show noisy faceted stone and highly uniform joint treatment; at street distance the texture overwhelms coherent masonry. Shaded walls lose the intended rock-face relief.

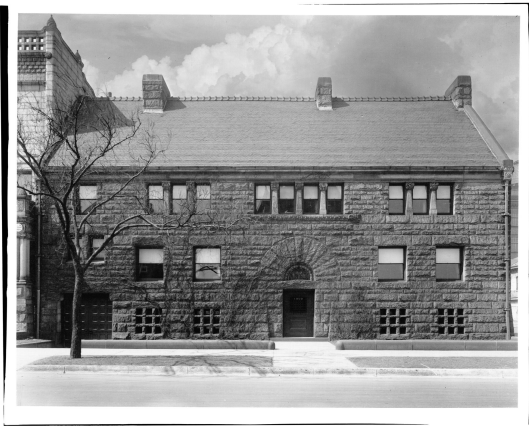
Reference #115 — Street facade: coherent coursing, openings and roof detail. See source ledger for date and catalog.

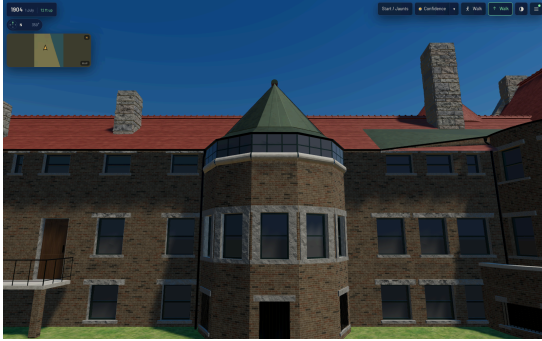
Current model — courtyard

| Area | Finding and confidence | Draft items |
|---|---|---|
| Enclosure and ground | South courtyard wall absent in audit views; grass crosses the entry and carriage passage; court edging and curved hall-step cheek are unfinished. | GA-03-04, 16, 21-22 |

**Finding:** The audited scene opens the courtyard to surrounding grass; the continuous south enclosure is absent. Museum documentation attests a common-brick wall with vines since 1887.

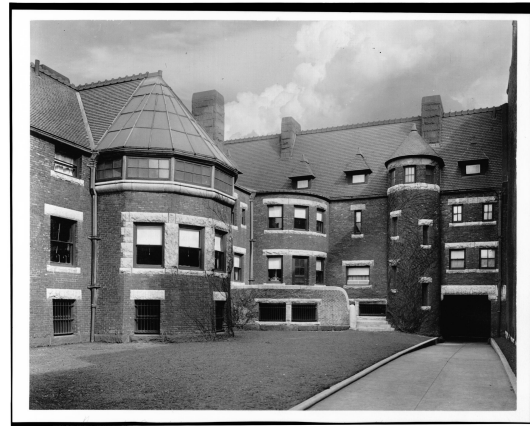
Reference #118 — Courtyard: bow roofs, steps, brick/stone and planting. See source ledger for date and catalog.

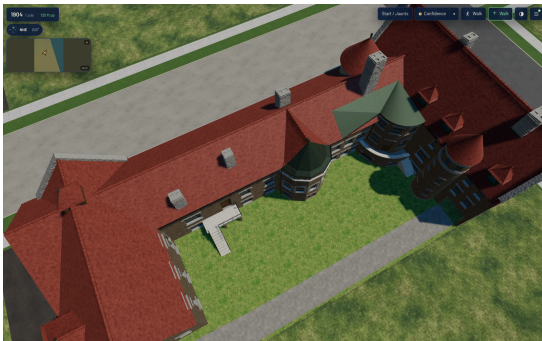
Current model — roof

| Area | Finding and confidence | Draft items |
|---|---|---|
| Roof and stable | Tile appearance changes markedly by plane/distance; cresting and edge details simplified. Stable cupola/loft fittings need a source-based refinement. Roof proportions and inferred stacks require measurement before alteration. | GA-05-08, 18, 20 |

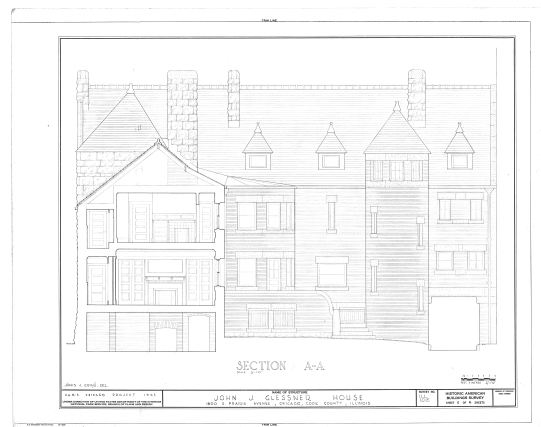
Reference #146 — Roof/courtyard: current overview versus HABS section. See source ledger for date and catalog.
