# **INVESTIGATION OF WIND PROJECTILE RESISTANCE OF EMMEDUE M2 PANELS**

**Mr. Angelo Candiracci, Chairman  
EMMEDUE S.p.A. —*Advanced Building System*  
Via Toniolo 39/B Z.I. Bellocchi  
61032 Fano (PU) Italy**

**February 11, 2005**

Wind Science and Engineering  
Texas Tech University  
Lubbock, Texas 79409

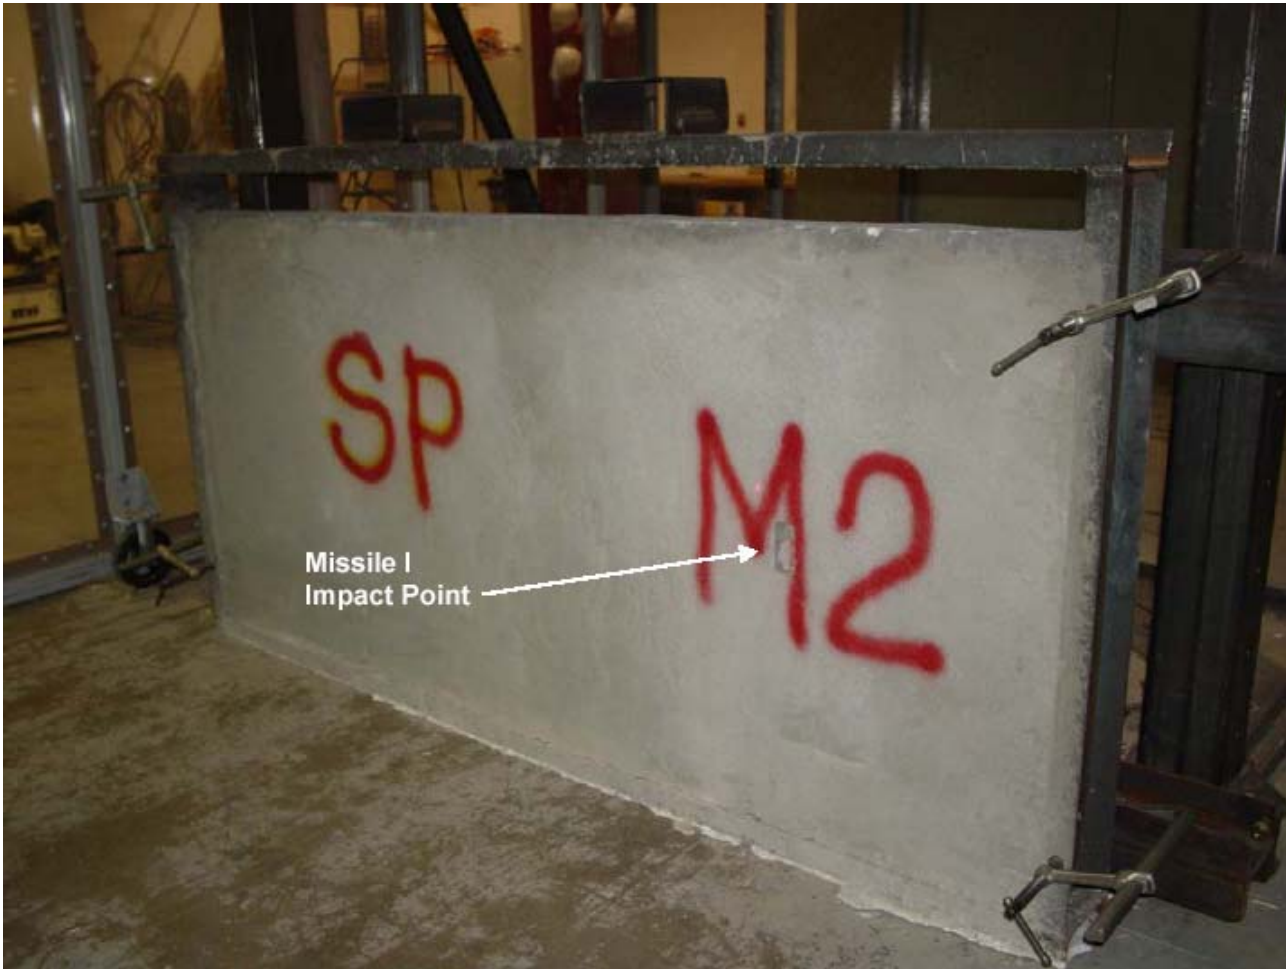
The Series 1 PSME80 panel was mounted against the test frame. The missile impacted the center right half of the specimen producing a 2-in. x 4-in. impact print  $\frac{1}{4}$ -in. deep. There was no remarkable damage to the backside of the panel.

**Series 1 Panel Impacted by Missile I**

**Series 1 Panel after Impact 1**

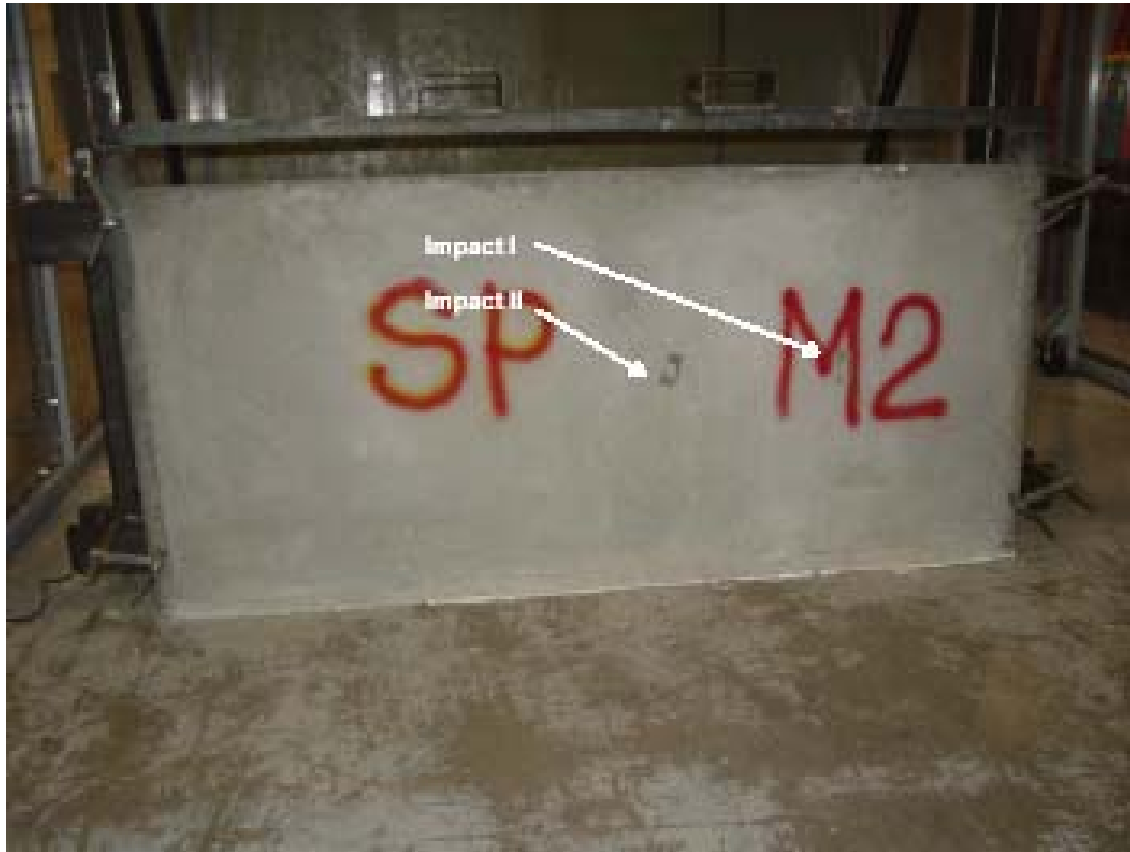
The Series 1 specimen was impacted by the hurricane missile left of the previous impact. The missile left a 2-in. x 4-in. imprint 1 ¼-in. deep. There was no remarkable damage to the backside of the panel.

**Series 1 Specimen Impacted by Hurricane Protocol Missile II**

**Impact Face of Series 1 Panel after Missile II**

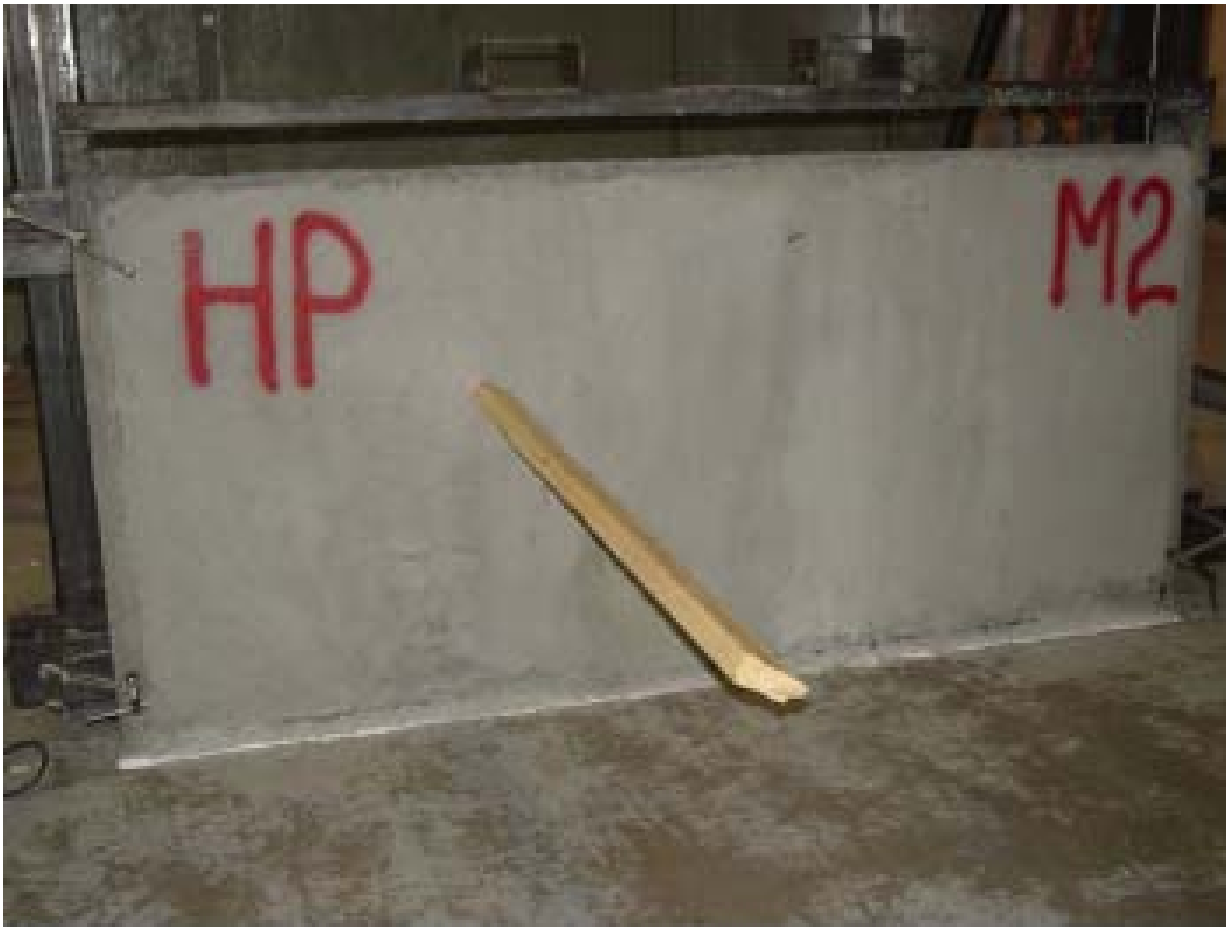
The missile impacted the Series 2 PSM 80 specimen in the left center of the panel penetrating the panel 4 ½-in. The exterior face wire reinforcing was failed by the impact and the polystyrene insulation was compressed against the backside layer. The backside of the panel exhibited radial cracking ranging in width from hairline to .002-in. in thickness. Cracking radials extended from the impact point to the top, bottom, left edge and near the panel center. The cracked plaster was not spalled or propelled into the safe compartment.

**Hurricane Shelter Impact on Series 2 Specimen**

**Impact Side of Series 2 Panel after Impact I by Hurricane Shelter Missile**

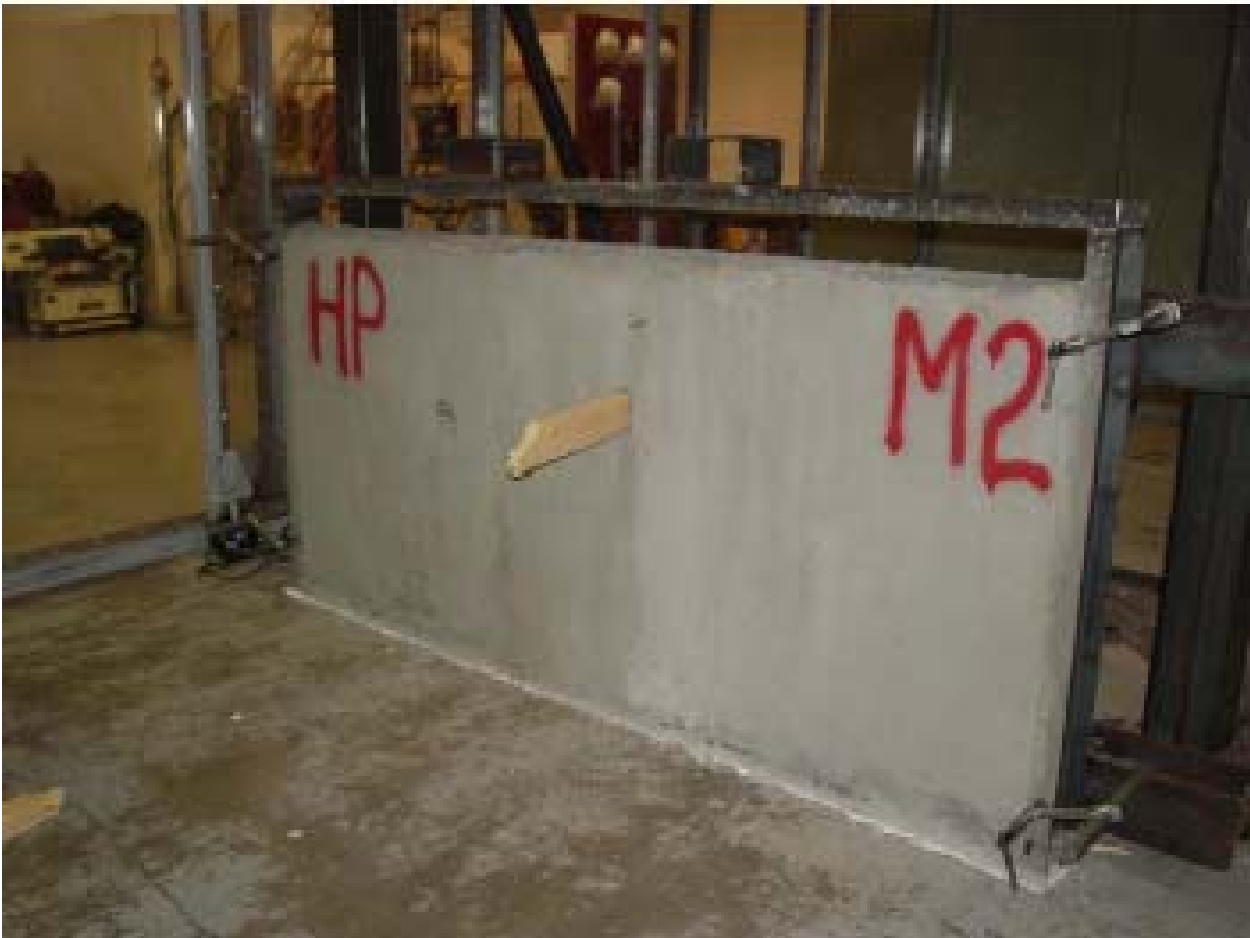
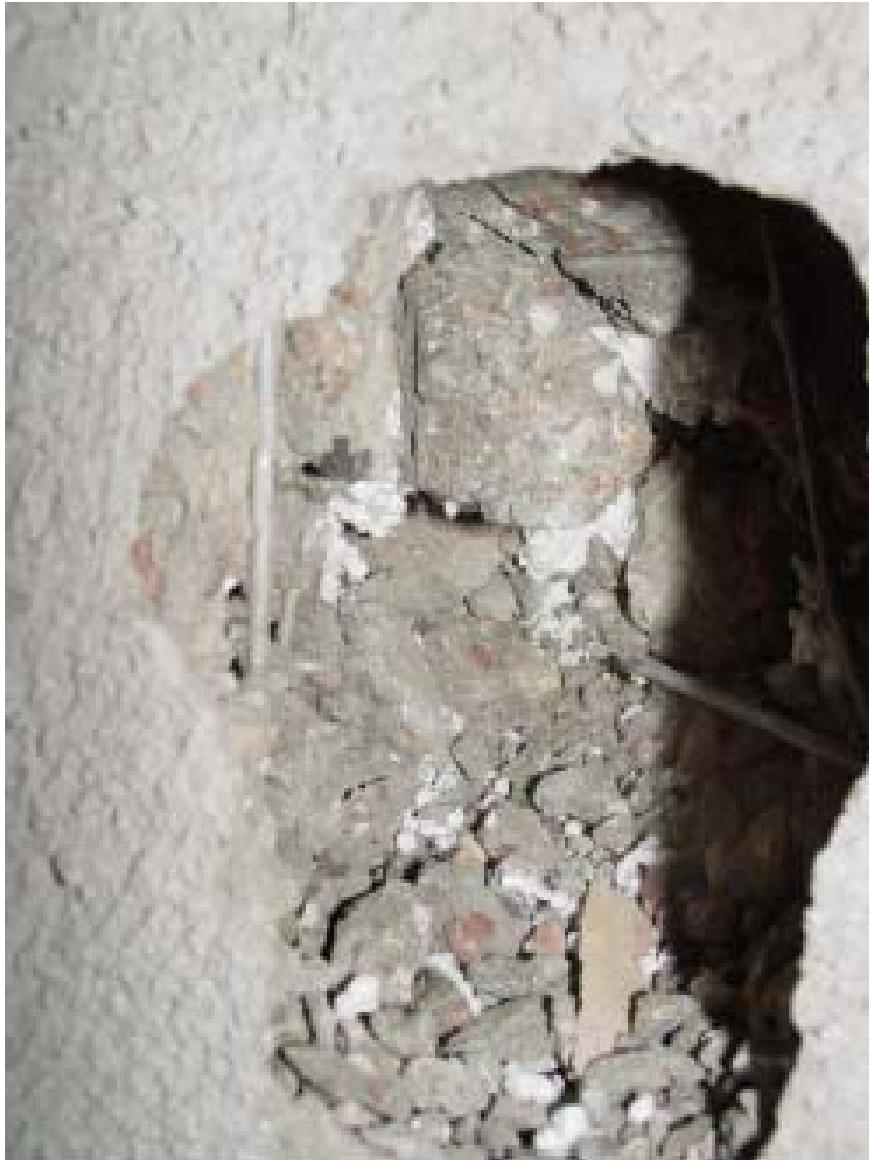
The missile impacted the Series 2 PSM 80 specimen in the center of the panel penetrating the panel 4-in. The exterior face wire reinforcing was failed by the impact and the polystyrene insulation was compressed against the backside layer. The backside of the panel exhibited similar radial cracking as Impact I. The cracked plaster was not spalled or propelled into the safe compartment.

**Series 2 Panel Impacted by the Second Hurricane Shelter Missile**

**Impact Hole from Series 2 Hurricane Shelter Missile**

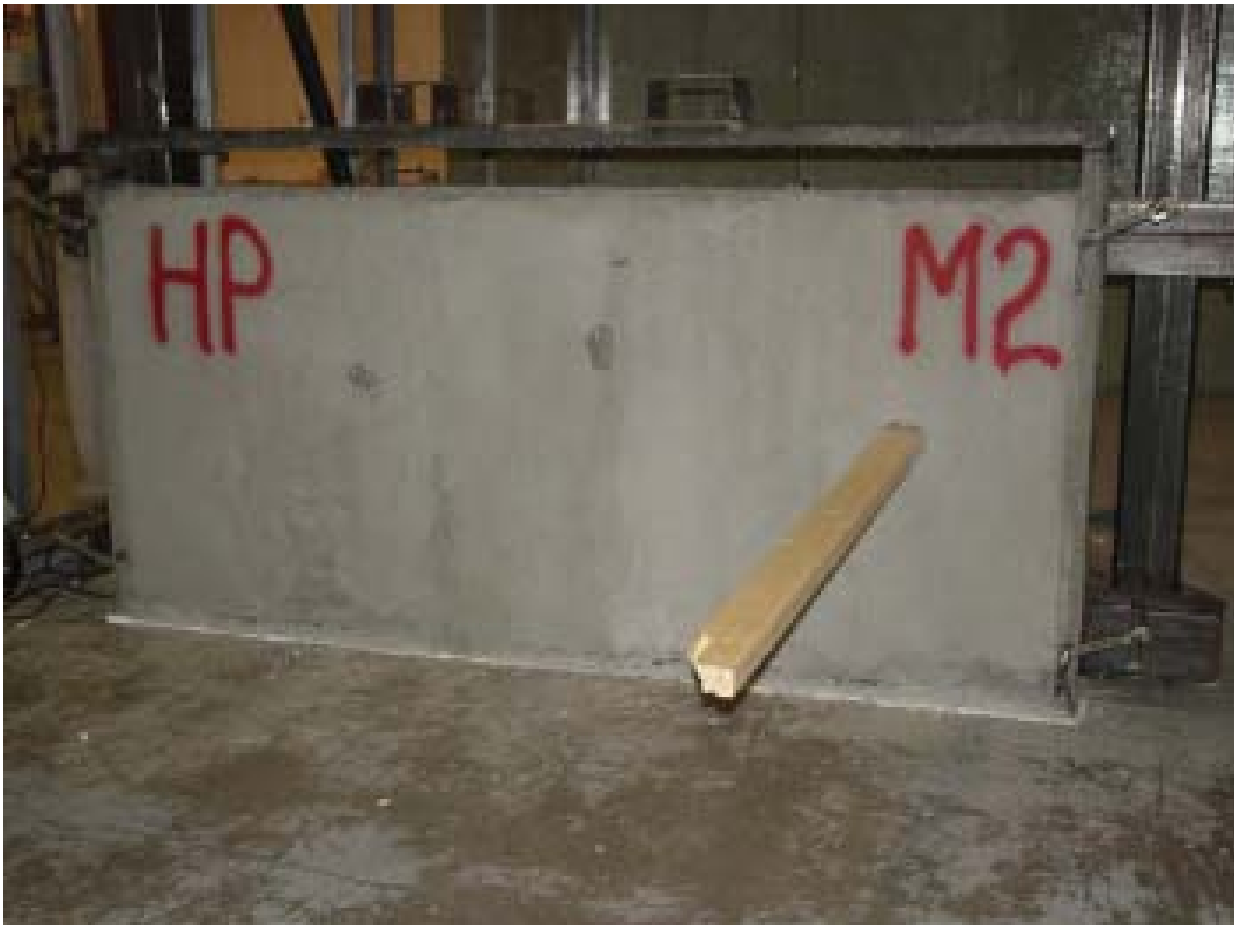
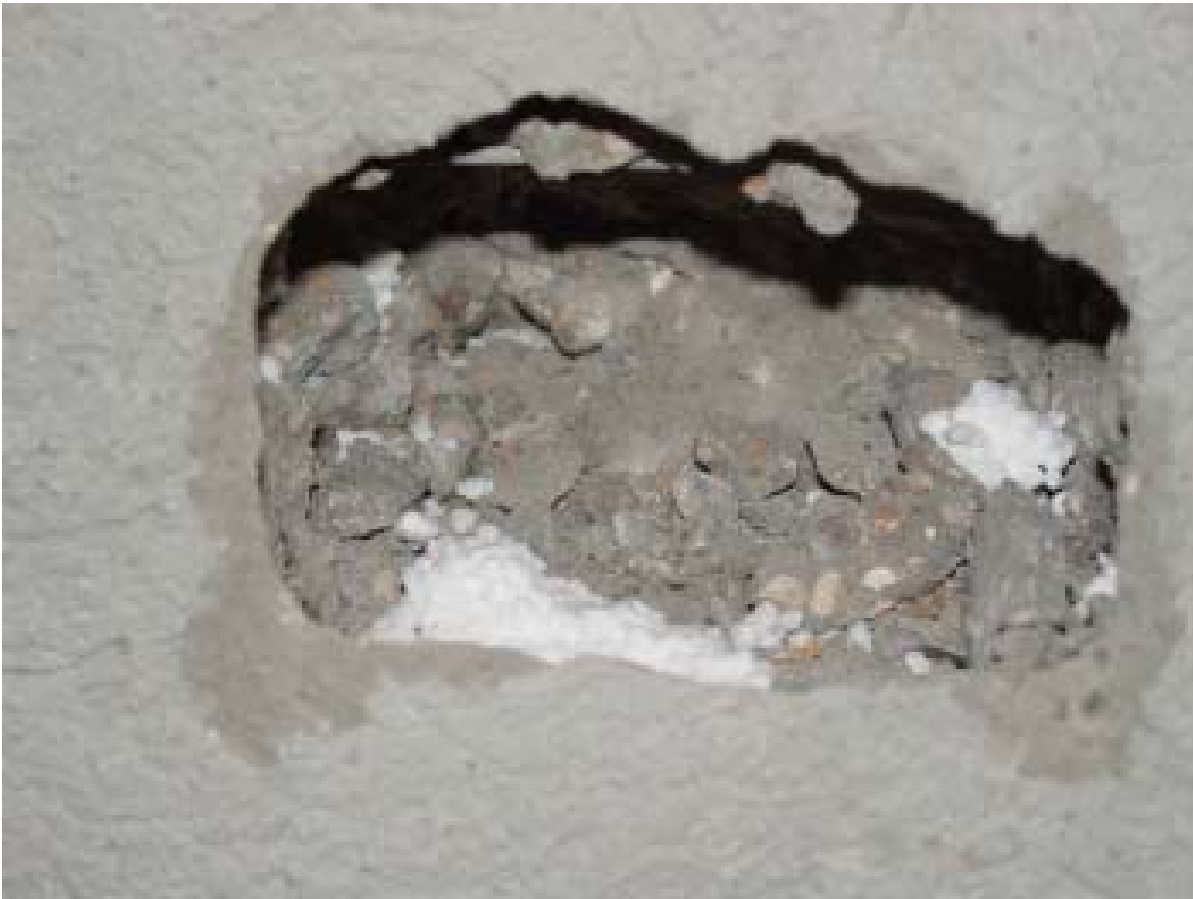
The missile impacted the Series 2 PSM 80 specimen on the right center of the panel penetrating the panel 4-in. The exterior face wire reinforcing was failed by the impact and the polystyrene insulation was compressed against the backside layer. The backside of the panel exhibited further radial cracking ranging in width from hairline to .002-in. in thickness. Cracking radials extended to the panel edges and connected with the cracks from the previous impacts. The cracked plaster was not spalled or propelled into the safe compartment.

**Series 2 Protocol 2 Hurricane Shelter Impact III**

**Impact Damage from Missile III on Series 2 Protocol 2**

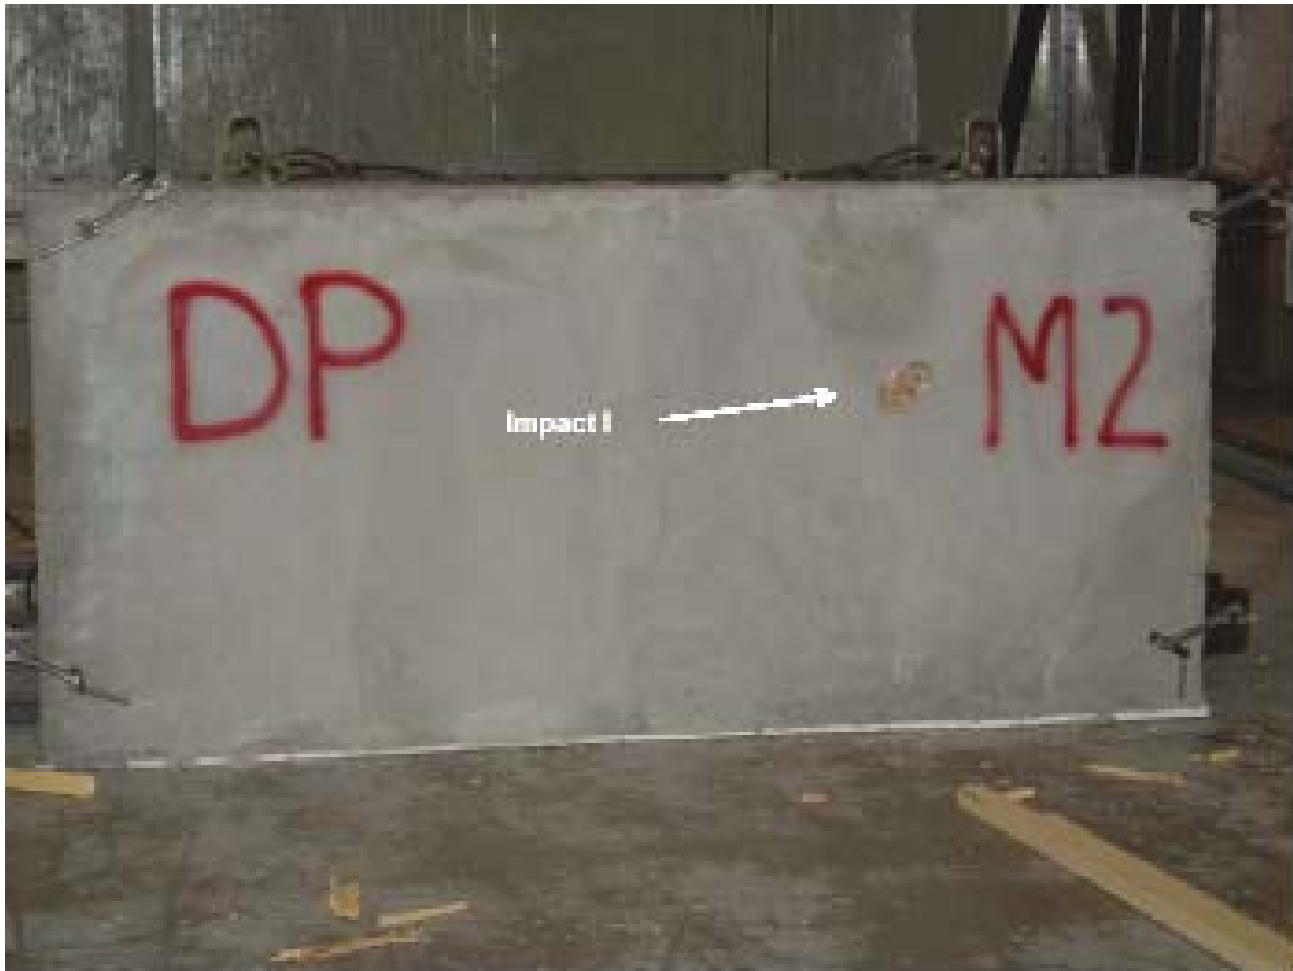
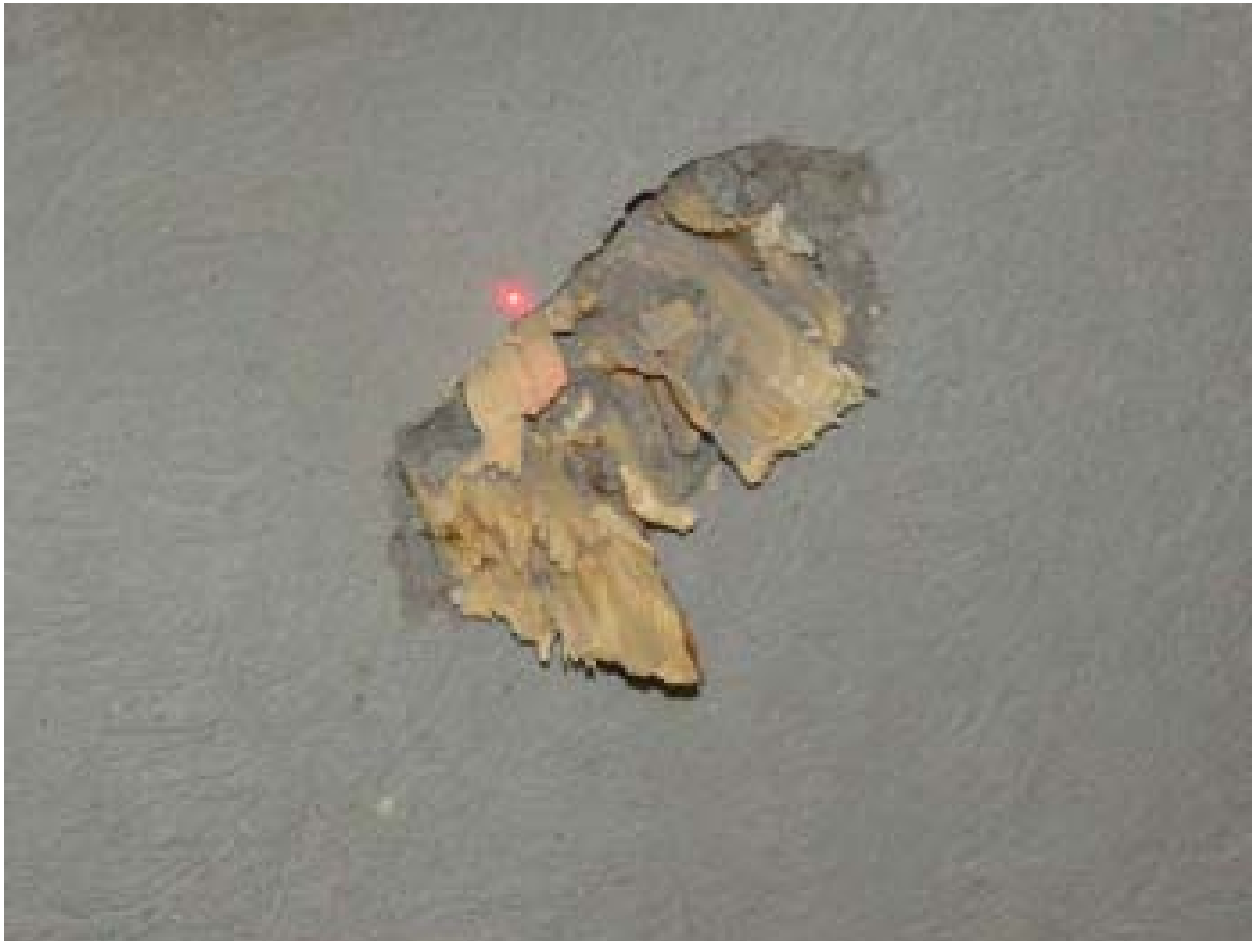
The Series 3 PDME100 specimen was impacted on the right corner by the tornado missile. The missile penetrated the panel 2  $\frac{3}{4}$ -in. stopping at the concrete core. There was no remarkable damage to the backside of the panel.

**Series 3 Panel Impacted by Tornado Missile I**

**Series 3 Panel Impacted by the Tornado Missile I**

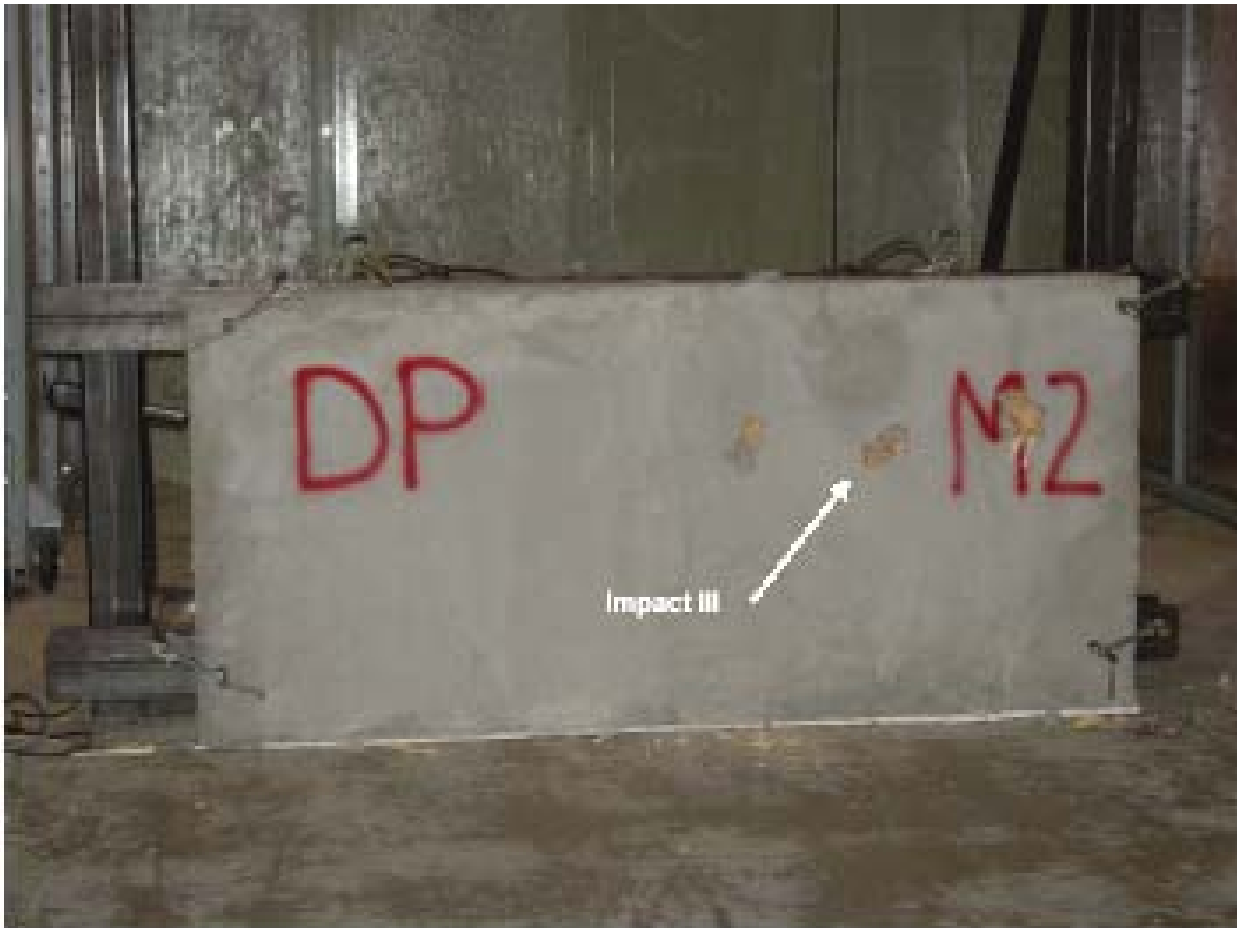
The Series 3 PDME100 specimen was impacted between the two previous impacts by the tornado missile. The missile penetrated the panel 2  $\frac{3}{4}$ -in. stopping at the concrete core. There was no remarkable damage to the backside of the panel.

**Series 3 Panel Impacted by the Third Tornado Missile**
