P/N: 11618-06517

| Captive Socket Head Cap Screw | | ORDER # | |

**Subject:** Re: P5121032050PSS (11618-06517) 10-32X0.50",SOC.HD SS CAPTIVE

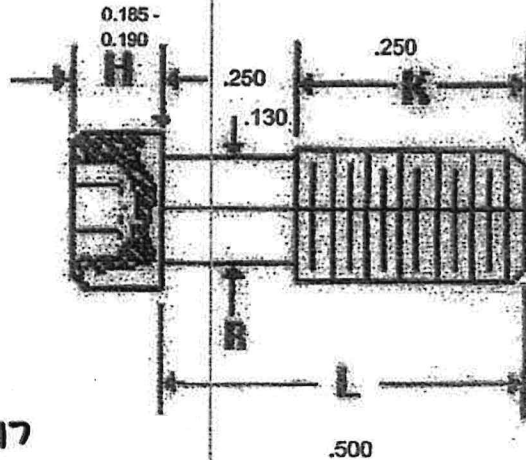
Plunge Grind .130 Tolerance + / - .005

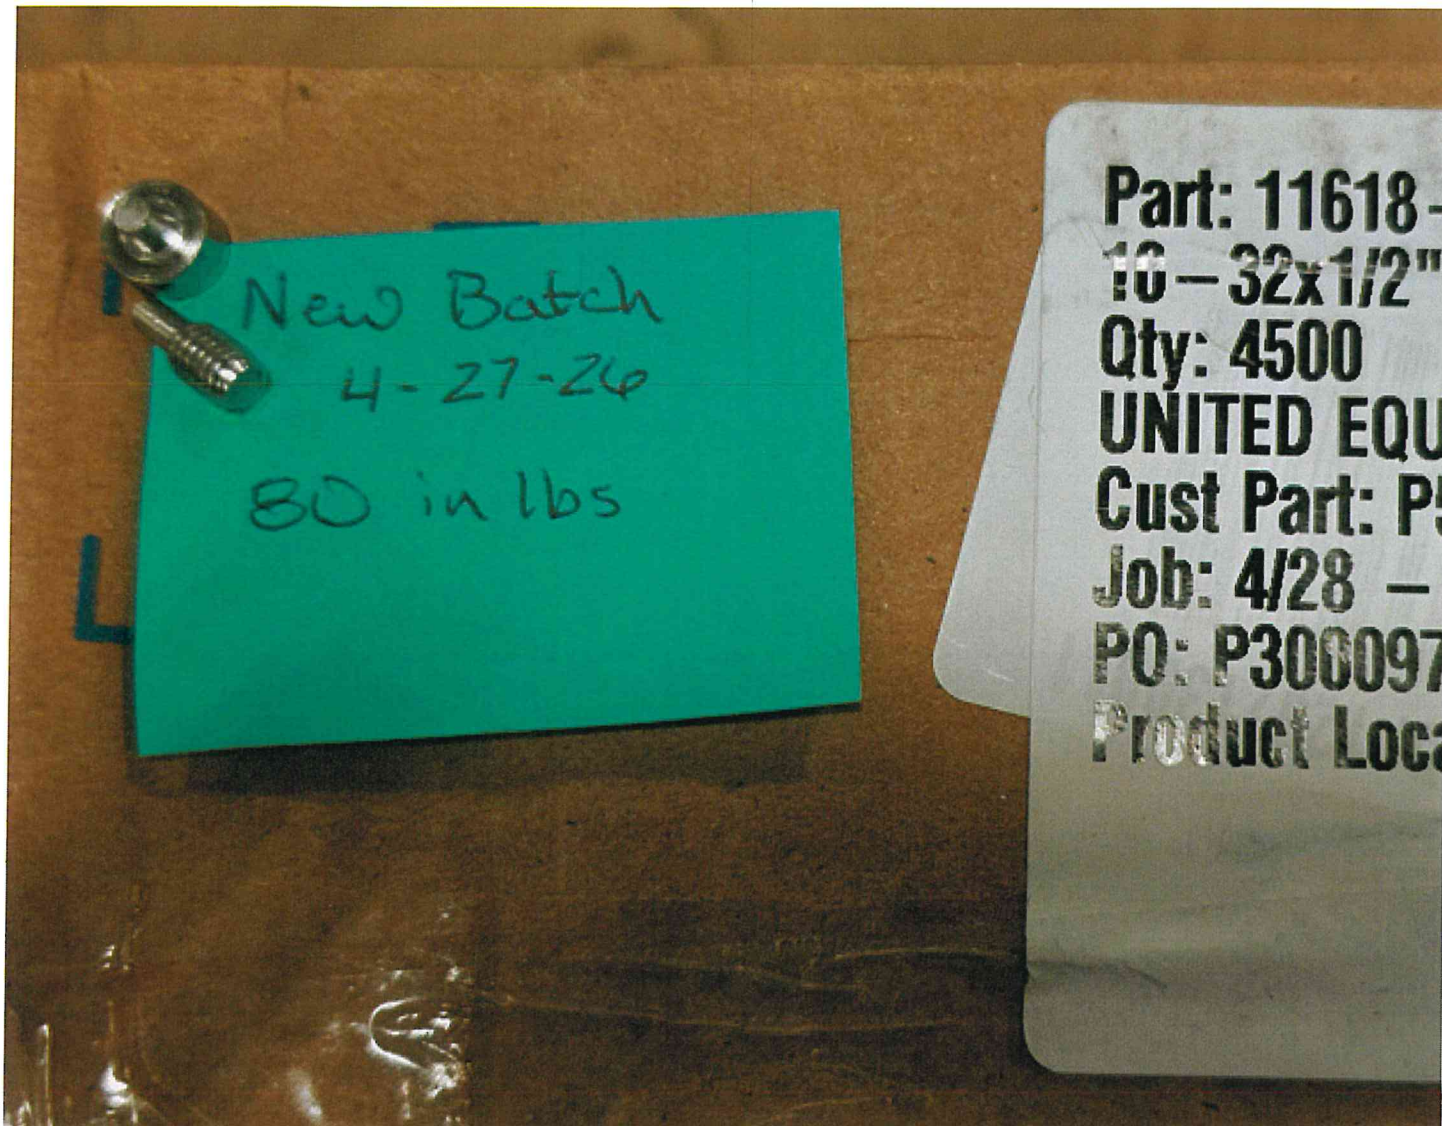
We just performed a quick test of the fasteners from two different boxes and could not come even close to the manufacturers stated value of "135 in-lbs. of torque and the screw was twisting below the head". I'm not sure what method was used to get this. We just quick double jam nut them at the base of the threads. Then used a torque wrench and found that the older box from PO# P300095231 twisted and brock at 55 in-lbs. The newer box cleanly just snapped at 80 in-lbs. See the images below. This was performed with a calibrated tool.

Was their measurement from the head of the fastener being seated to a surface (tightened down) or a fixed thread position as we performed?

For our testing method, we applied two jam nuts at the base of the threads and locked them together. The screw was then secured in a vise at the jam nuts. Using a calibrated in-lb. torque wrench, we applied torque in 5 in-lb. increments until failure. Images of each test were previously provided.

- PO# P300095231 failed at 55 in-lbs (twisted and broke)
- PO# P300097118 failed at 80 in-lbs (clean snap)
