Etch chamber RCA

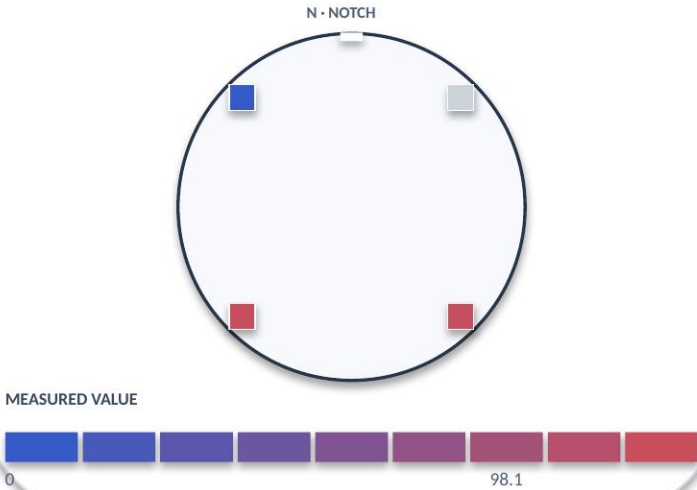
W07 affected yield by die

Wafer W07 · Lot L2407 · Tool ETCH-08 · Chamber A · Recipe REC-17 · Process Etch  
4 observations · 1 missing · Value 0 to 98.1

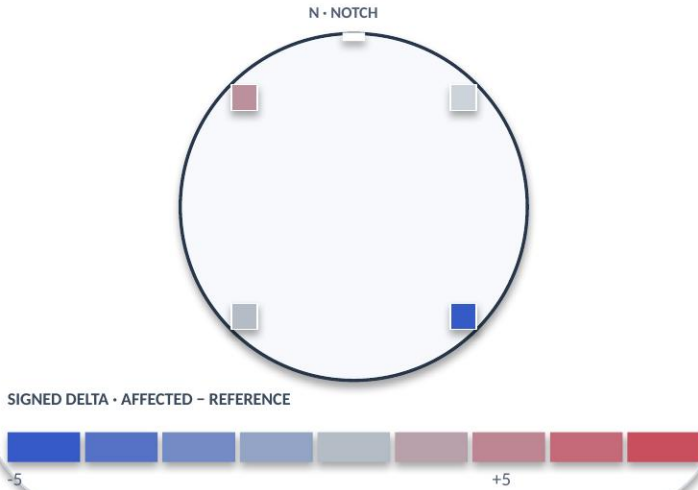
W07 signed affected – reference

Wafer W07 · Lot L2407 · Tool ETCH-08 · Chamber A · Recipe REC-17 · Process Etch  
4 observations · 1 missing · Delta -5 to +2
