Executive Statement

Lot WQ-7314 shows a localized edge-band yield loss after the September 18 ETCH-08 chamber A run.

Wafer WQ-7314 · route R17B · ETCH-08 / chamber A · inline metrology sample 4,812 · paired reference wafer WQ-7298.

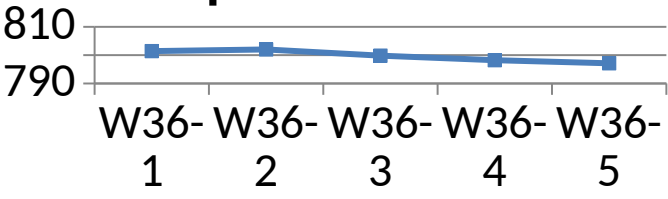
Process stability and specification

Signal · WQ-7314 edge-band yield is below the paired reference. Nine lower-right edge-band records average 91.8% versus a 98.0% paired-reference mean. Pressure shift begins after PM-44719; cause remains unconfirmed. Keep the lot contained through endpoint calibration and matched rerun.

Do not release the lot from one correlated pressure trace. Verify endpoint calibration and a matched chamber B rerun.
