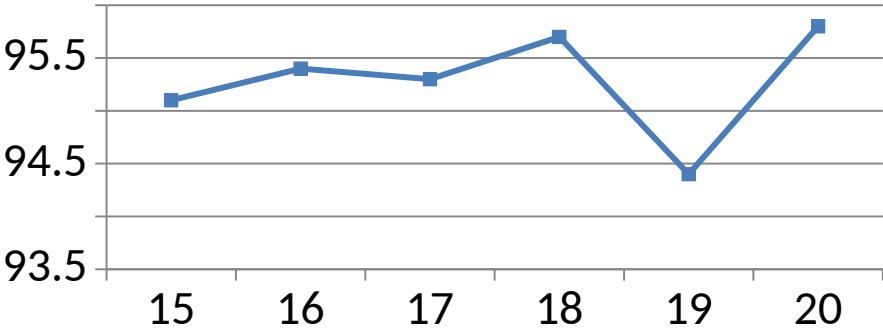
Critical measurement trend

**Body Narrative** · First-pass yield improved from 94.6% to 96.2% after the valve service. Downtime remains 7.4 hours, above the 6-hour limit. Sample 19 is outside the SPC centerline pattern but inside the product specification; treat this as a process signal for investigation, not a customer defect or capability claim.

**Risk Callout** · **Keep Friday capacity release conditional**  
Await pressure calibration, matched sample 20, and Quality sign-off. A point inside specifications can still warrant a control-chart investigation.  
· **Review**
