Site #4344: AVONDALE #1B, Jefferson, Louisiana

Entergy Louisiana

SITE CHANGE DETECTION & BASELINE MONITORING

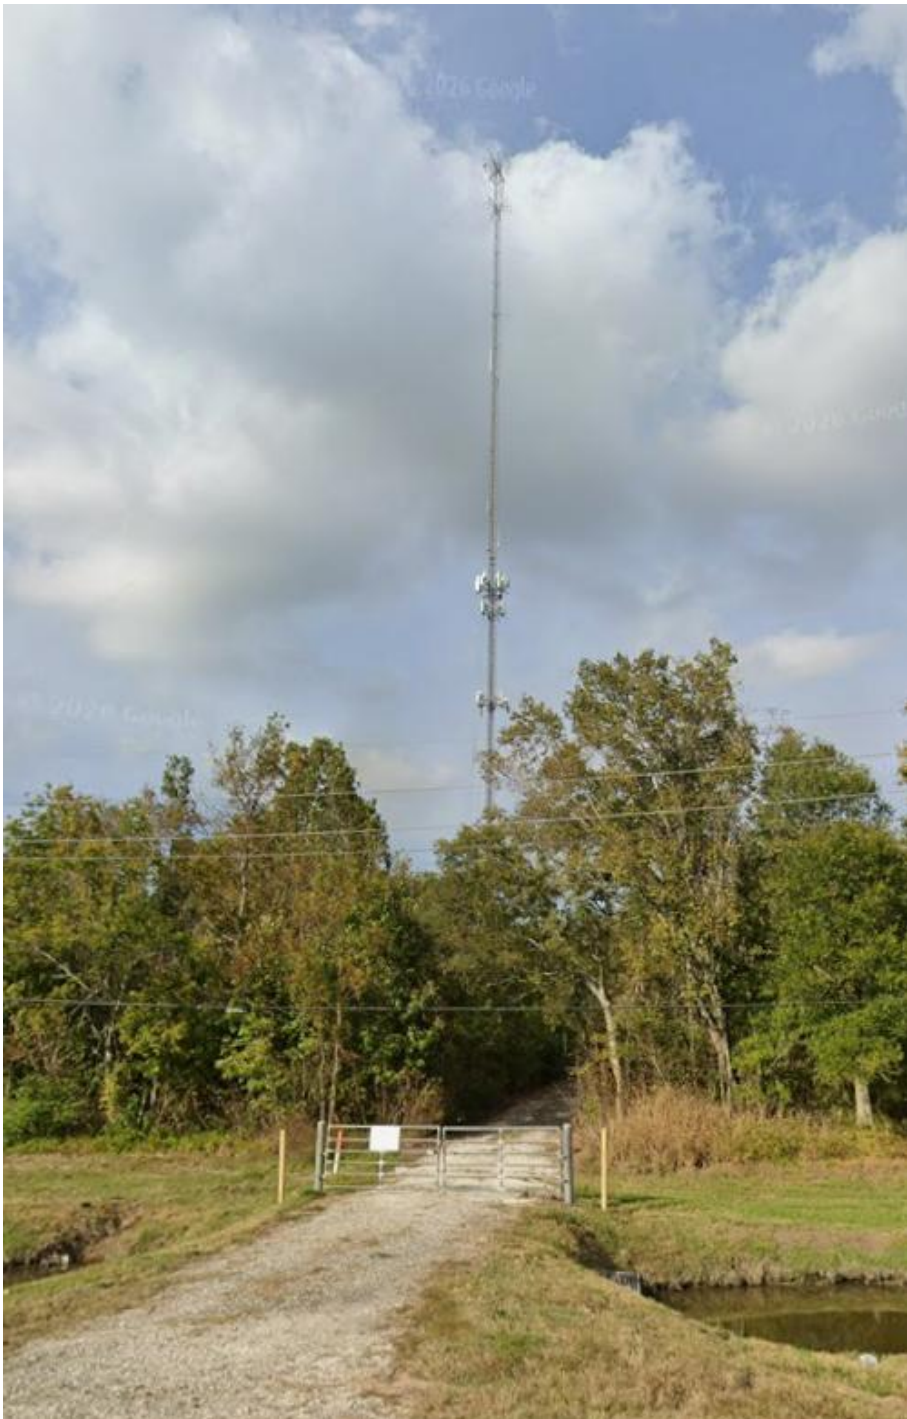
Veg. Encroachment
