VERDICT: PARTIAL MATCH (49% MATCH CONFIDENCE)

Claim Discrepancy & Cross-Check Matrix

Itemized Damage & Repair Cost Breakdown

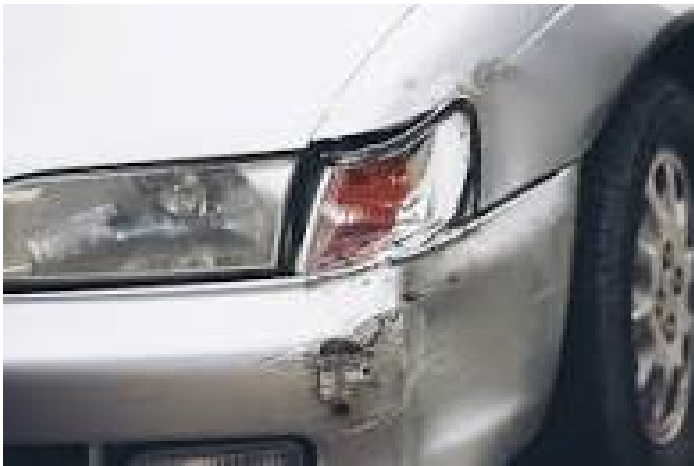
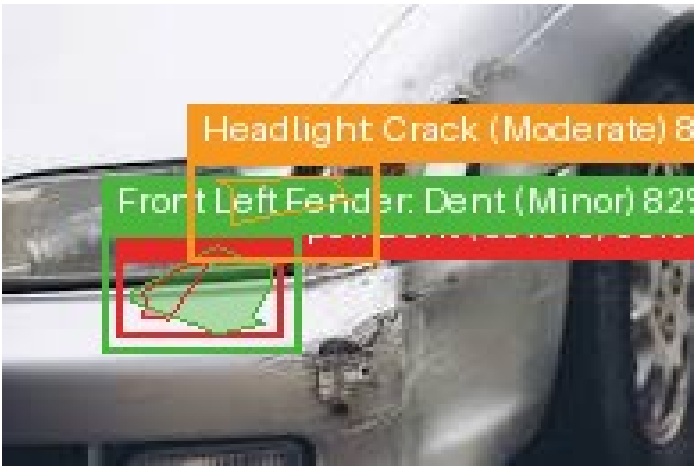
Photographic Evidence & AI Segmentation Overlay

Partial consistency detected (49% match). Detected damages partially overlap with claimed description, but discrepancies exist in severity or secondary parts. Desk review recommended.

| # | Part | Damage Type | Severity | AI Confidence | Est. Cost Range |
|---|---|---|---|---|---|
| 1 | Front Bumper | Dent | Severe | 93% | INR 22,000 – 45,000 |
| 2 | Front Left Fender | Dent | Minor | 82% | INR 2,500 – 6,000 |
| 3 | Headlight | Crack | Moderate | 84% | INR 6,000 – 15,000 |
| 4 | Front Bumper | Dent | Minor | 92% | INR 2,500 – 6,000 |
| 5 | Front Right Fender | Mirror Damage | Minor | 82% | INR 3,000 – 12,000 |
| 6 | Rear Bumper | Panel Deformation | Moderate | 95% | INR 12,000 – 35,000 |

**Settlement Recommendation:** Partial Match
