# MANUFACTURING QUALITY ASSURANCE REPORT

Session Identifier: Multiple Clips

| INSPECTION DATE | 2026-02-13 08:40:45 |

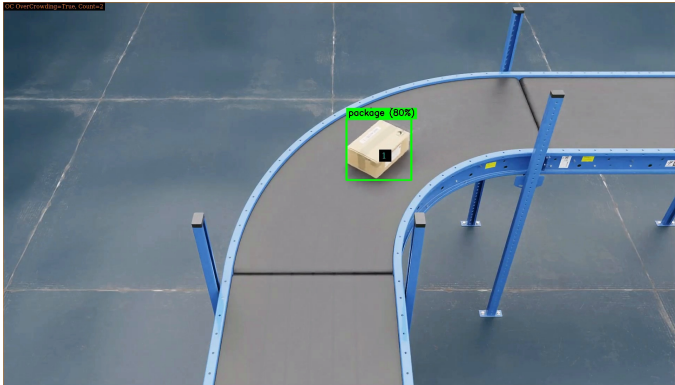
### Finding 1: Inspection Finding

TIMESTAMP 08:39:53  
SOP SECTION PPE & Safety Protocols  
COMPLIANCE SCORE 100%

The observer reported no visible signs of crumpling, tearing, dents, creases, or open flaps on the cardboard boxes throughout the observed period, fully meeting all inspection criteria.

[0.0s - 5.0s]: The cardboard boxes show no visible damage such as crumpling, tearing, dents, creases, or open flaps during their movement on the conveyor belt.

[4.0s - 6.3s]: No visible anomalies detected in the specified focus areas.

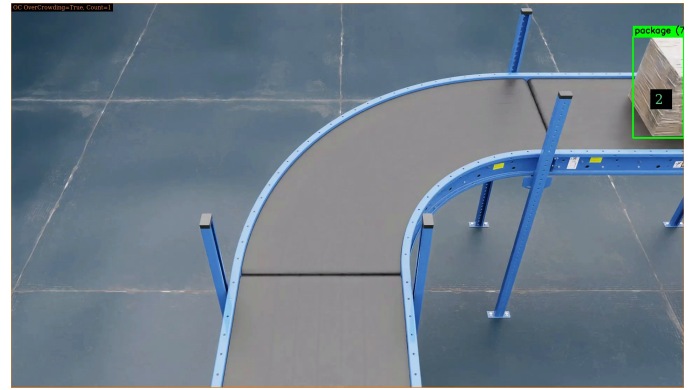
## Finding 2: Inspection Finding

TIMESTAMP 08:40:16  
SOP SECTION PPE & Safety Protocols  
COMPLIANCE SCORE 80%

The observation period initially failed to present the subject of inspection (cardboard boxes on a conveyor belt) for evaluation against the standards. Although, once present, the boxes largely met the inspection criteria except for a minor defect (slight edge creasing) observed towards the end.

[0.0s - 5.0s]: The video does not contain any visible cardboard boxes on a conveyor belt. The scene consists solely of a stationary blue metal structure with vertical poles and horizontal beams against a concrete floor. No moving parts, conveyor belts, or packaging materials are present in the frame.

[4.0s - 9.0s]: The cardboard boxes on the conveyor belt show no signs of crumpling, tearing, dents, creases, or open flaps; they remain intact and uniformly stacked throughout the observed sequence.

[8.0s - 13.0s]: The cardboard boxes on the conveyor belt display no visible crumpling

[12.0s - 17.0s]: Both boxes show no visible damage; flaps remain fully closed, and there are no signs of crumpling, tearing, dents, or creases.

[16.0s - 19.867s]: The box exhibits slight edge creasing from motion; otherwise, it remains undamaged with closed flaps.

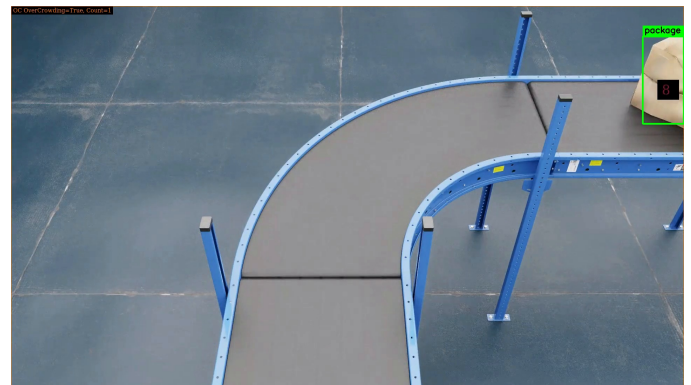
## Finding 3: Inspection Finding

TIMESTAMP 08:40:30  
SOP SECTION PPE & Safety Protocols  
COMPLIANCE SCORE 95%

The observer report indicates that when cardboard boxes were present and assessable, they either showed no visible damage or only minor defects (minor creasing, slightly frayed edges) that do not violate the specified inspection rules. The initial period with no boxes does not impact the verdict as it doesn't indicate non-compliance.

- [0.0s - 5.0s]: None of the specific focus areas (crumpling, tearing, dents, creases, open flaps/boxes) can be assessed as there are no visible cardboard boxes or relevant objects in the video.
- [4.0s - 9.0s]: The cardboard box exhibits minor creasing and slightly frayed edges but no major defects like tearing or dents. It moves steadily along the conveyor path without obstruction.
- [8.0s - 11.4s]: The cardboard box shows no visible damage such as crumpling, tearing, dents, or creases. Its flaps remain closed, and the interior items stay stable during transit.

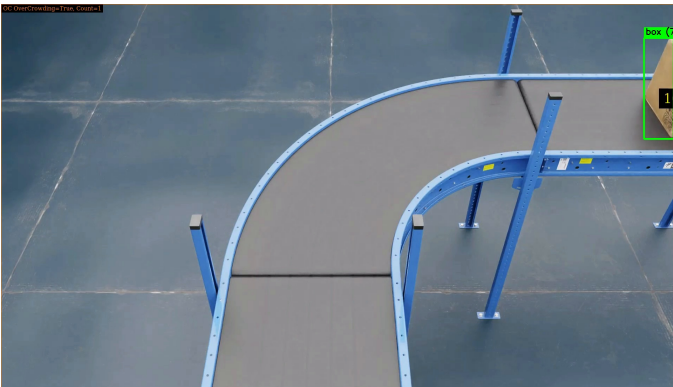
***Finding 4: Inspection Finding***

TIMESTAMP                08:40:45  
SOP SECTION            PPE & Safety Protocols  
COMPLIANCE SCORE **100%**

The observer report consistently indicates no visible defects across all inspected intervals (0.0s-17.0s) for all criteria (crumpling, tearing, dents, creases, open flaps), with boxes observed as intact, properly sealed, and moving smoothly on the conveyor belt.

- [0.0s - 5.0s]: No visible issues such as crumpling, tearing, dents, creases, or open flaps were observed on the conveyor belt or structural components. The scene remained static with no active movement or objects present.
- [4.0s - 9.0s]: The cardboard box exhibits no visible damage such as crumpling, tearing, dents, creases, or open flaps. It remains intact and properly sealed while moving smoothly along the conveyor belt.
- [8.0s - 13.0s]: The cardboard box is intact with no visible crumpling, tearing, dents, or open flaps. Its rectangular shape and smooth surface remain consistent throughout the video.
- [12.0s - 17.0s]: The cardboard box shows no signs of crumpling, tearing, dents, creases, or open flaps; it remains intact and sealed throughout the observed period.
