# MANUFACTURING QUALITY ASSURANCE REPORT

| INSPECTION DATE | 2026-02-13 10:14:23 |
| OVERALL VERDICT | FAIL |

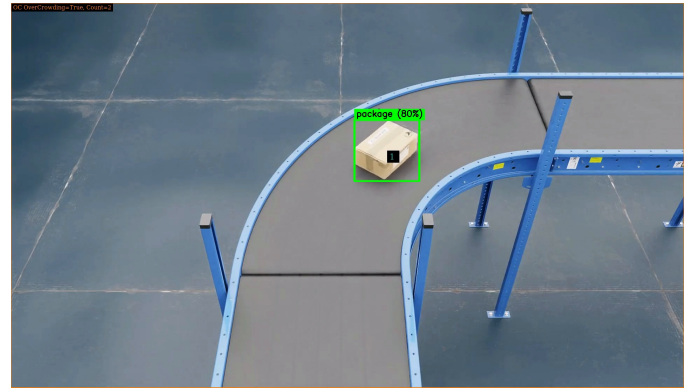
### ***Finding 1: Inspection Finding***

Both observed time frames indicate no signs of crumpling, tearing, dents, creases, or open flaps on the cardboard boxes, fully complying with all inspection rules.

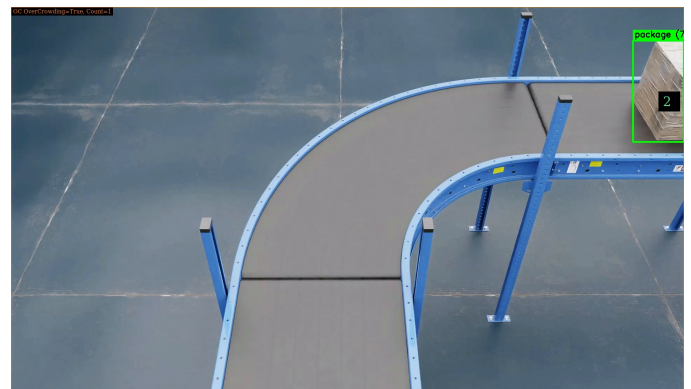
### ***Finding 2: Inspection Finding***

The observer report indicates no visible defects (crumpling, tearing, dents, creases, or open flaps) on any cardboard boxes observed throughout the entire video timeline. Although the initial scene showed an empty conveyor belt, subsequent observations confirmed intact boxes meeting all inspection criteria.

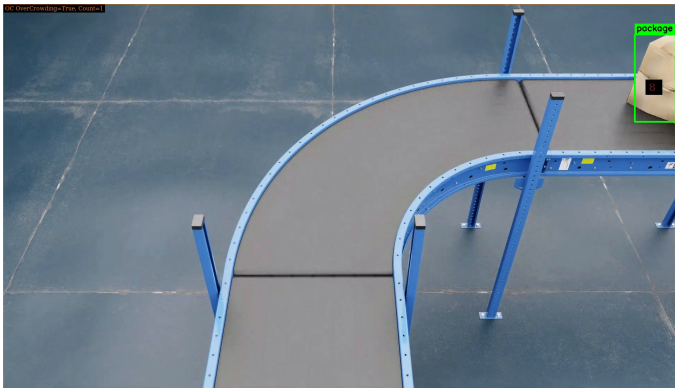
**Finding 3: Inspection Finding**

The inspection revealed multiple defects across observed boxes, including crumpling, creases, and open flaps, which violate the inspection rules. Although not all boxes were defective (initial period with no boxes) and some defects were described as 'slight', the presence of defects in the observed boxes leads to an overall fail. The absence of tearing and dents in all observed boxes partially mitigates the score.

[4.0s - 9.0s]: The inspected cardboard box displays **crumpling** around its edges and corners, **creases** along fold lines, and **open flaps** (implied by the interaction with the robotic arm). No tearing or dents are observed.

[8.0s - 11.4s]: The cardboard boxes exhibit slight crumpling and noticeable creases after colliding on the conveyor belt. No tearing or dents are present.

- Implement stricter quality control to eliminate crumpling, creases, and open flaps as observed in Event 3.
- Clarify inspection rules to explicitly define and penalize 'partial collapse' or similar severe deformations as seen in Event 4.
- Enhance observer consistency to accurately apply scoring, given the discrepancy in scoring logic between fully compliant and partially defective events.

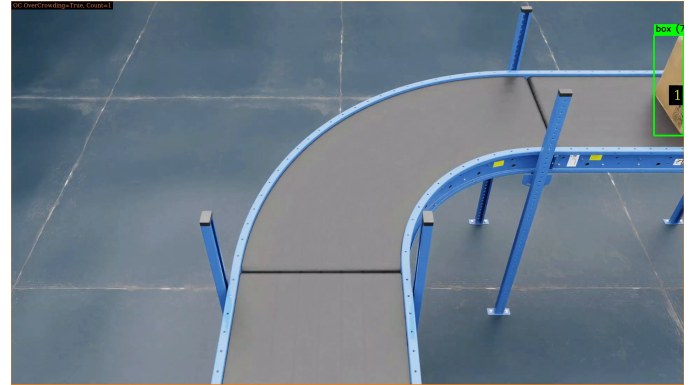
**Finding 4: Inspection Finding**

Although the majority of the observation period showed compliance with all inspection rules, a critical defect (partial collapse) was observed, indicating a failure to maintain structural integrity, which is implied necessary for passing despite not being explicitly listed. However, since 'partial collapse' isn't explicitly defined in the rules but implies a severe form of 'crumpling' or 'deformation not listed', and given the primary rules were mostly met, a high compliance score is still awarded.

[8.0s - 13.0s]: The cardboard box exhibits slight tilting and partial collapse as it slides along the conveyor belt, but shows no visible crumpling, tearing, dents, creases, or open flaps prior to this deformation.
