# MANUFACTURING QUALITY ASSURANCE REPORT

| INSPECTION DATE | 2026-02-13 12:36:00 |
| OVERALL VERDICT | FAIL |

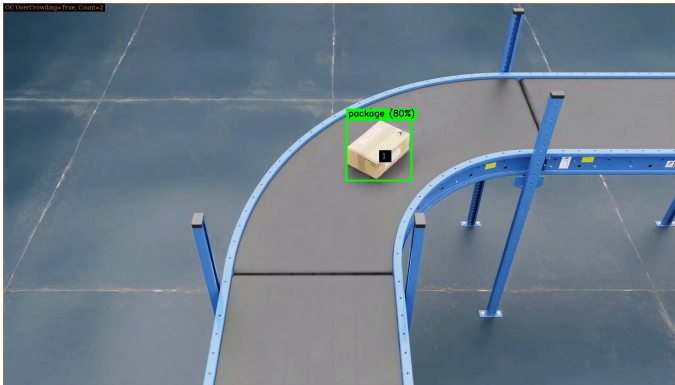
### Finding 1: Inspection Finding

TIMESTAMP 12:35:07  
SOP SECTION Packaging & Shipping Standards  
COMPLIANCE SCORE 100%

[0.0s - 5.0s]: No anomalies or artifacts detected.

[4.0s - 6.3s]: The cardboard box on the conveyor belt shows no visible crumpling, tearing, dents, or excessive creases. Its flaps remain closed and intact.

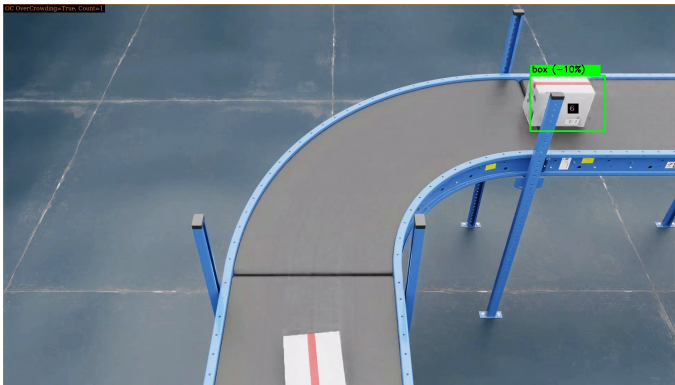
Finding 2: Inspection Finding

TIMESTAMP 12:35:23  
SOP SECTION Packaging & Shipping Standards  
COMPLIANCE SCORE 80%

[12.0s - 17.0s]: No significant anomalies observed. Cardboard boxes display minor dents and creases but remain intact without tearing or open flaps.

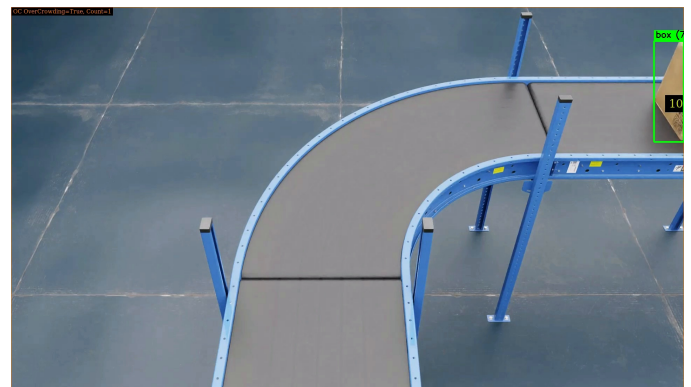
### ***Finding 4: Inspection Finding***

TIMESTAMP 12:35:53  
SOP SECTION Packaging & Shipping Standards  
COMPLIANCE SCORE **80%**

[4.0s - 9.0s]: The cardboard box exhibits minor creasing around its edges and corners but remains intact with closed flaps and no visible tears or dents.
