# MANUFACTURING QUALITY ASSURANCE REPORT

| INSPECTION DATE | 2026-02-17 12:24:04 |
| OVERALL VERDICT | FAIL |

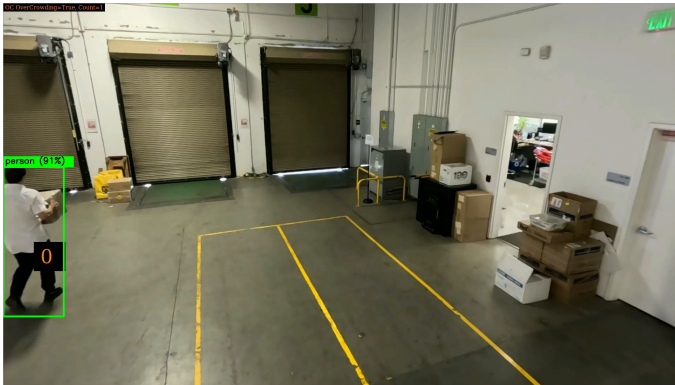
### Finding 1: Inspection Finding

TIMESTAMP 12:23:19  
SOP SECTION PPE & Safety Protocols  
COMPLIANCE SCORE 0%

[0.0s - 5.0s]: No high-visibility safety vests or safety helmets are visibly worn by any individuals in the scene.

[8.0s - 13.0s]: **Final Answer:**  
No instances of non-compliance detected. Both individuals are not wearing high-visibility safety vests or safety helmets. No forklift is visible in motion, so proximity violations cannot be assessed.

[12.0s - 17.0s]: No PPE violations observed. The individual is not wearing a safety vest or helmet. They remain outside the immediate proximity of the forklift throughout the sequence.

[16.0s - 21.0s]: No PPE visible; individual is not wearing a high-visibility vest or safety helmet.

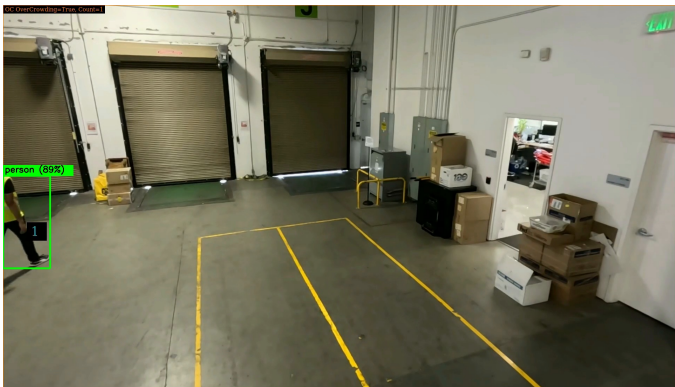
Finding 2: Inspection Finding

TIMESTAMP 12:23:40  
SOP SECTION PPE & Safety Protocols  
COMPLIANCE SCORE 95%

[0.0s - 5.0s]: No PPE observed; no forklift interaction noted.

[4.0s - 9.0s]: Yes, there is one person with protective equipment (yellow safety vest and helmet). They approach a stationary forklift but do not interact with it during the observed frames.

[16.0s - 21.0s]: Yes; Both forklift operators wear yellow safety vests and hard hats, maintaining proper distance from the forklift during operation. The third worker in the background also wears safety gear, indicating full PPE compliance.

[20.0s - 25.0s]: Yes; both wear yellow safety vests and white hard hats, and there is no immediate proximity to the forklift.

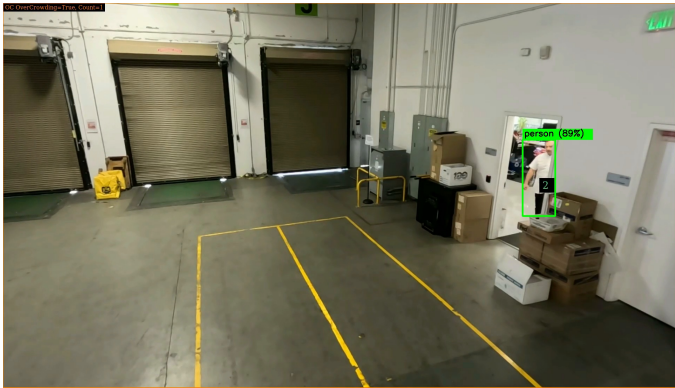
**Finding 3: Inspection Finding**

TIMESTAMP                12:23:57  
SOP SECTION            PPE & Safety Protocols  
COMPLIANCE SCORE **0%**

[0.0s - 5.0s]: No PPE is visible in the scene.

The two individuals are not wearing high-visibility safety vests or safety helmets. No forklift is present in the immediate vicinity of the individuals.

[12.0s - 13.3s]: No, the worker is not wearing any PPE.
