# MANUFACTURING QUALITY ASSURANCE REPORT

| INSPECTION DATE | 2026-02-17 12:30:05 |
| OVERALL VERDICT | FAIL |

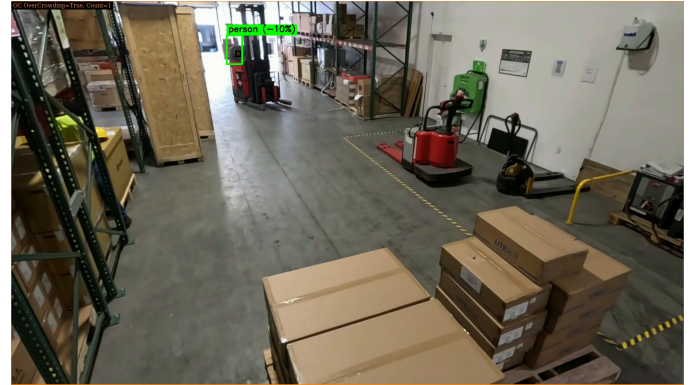
### Finding 1: Inspection Finding

TIMESTAMP 12:29:00  
SOP SECTION Safety Protocols  
COMPLIANCE SCORE 66%

[0.0s - 4.467s]: Yes, both workers are wearing orange safety vests. No helmets are visible. The forklift is in motion but maintains a safe distance from the workers.

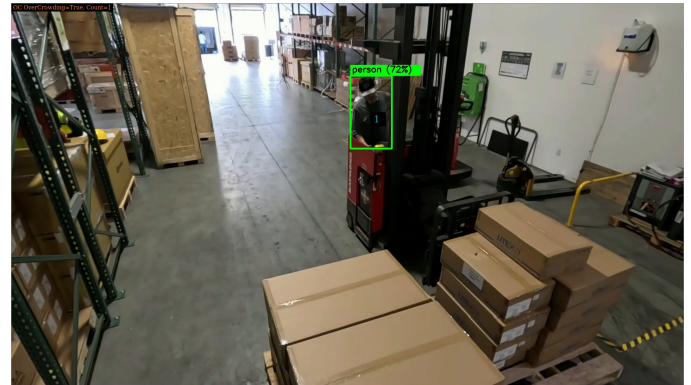
Finding 2: Inspection Finding

TIMESTAMP 12:29:16  
SOP SECTION Safety Protocols  
COMPLIANCE SCORE 33%

- [0.0s - 25.067s]: **Answer:**
- 1) Only one person is wearing a safety vest; others lack visible PPE.
  - 2) No helmets are present among the workers.
  - 3) The operator stays safely seated on the forklift, while others maintain a safe distance.

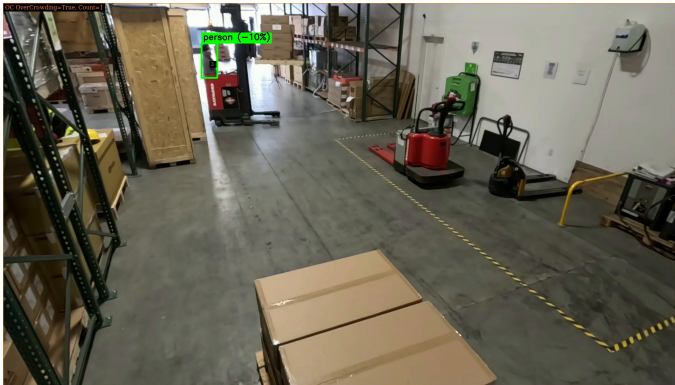
Finding 3: Inspection Finding

TIMESTAMP 12:29:31  
SOP SECTION Safety Protocols  
COMPLIANCE SCORE 100%

[0.0s - 25.067s]: **Answer:**  
Yes, both individuals are wearing yellow safety vests and white hard hats, meeting PPE standards. The forklift operators maintain a safe distance from each other and other personnel, avoiding collisions.

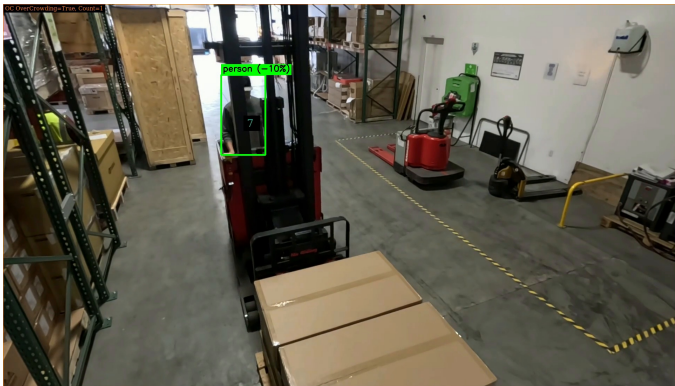
Finding 4: Inspection Finding

TIMESTAMP 12:29:45  
SOP SECTION Safety Protocols  
COMPLIANCE SCORE 0%

[0.0s - 18.833s]: No PPE-related violations were observed. The forklift operated without nearby workers, maintaining safe distancing. No safety vests or helmets were visible on any individuals in the scene.

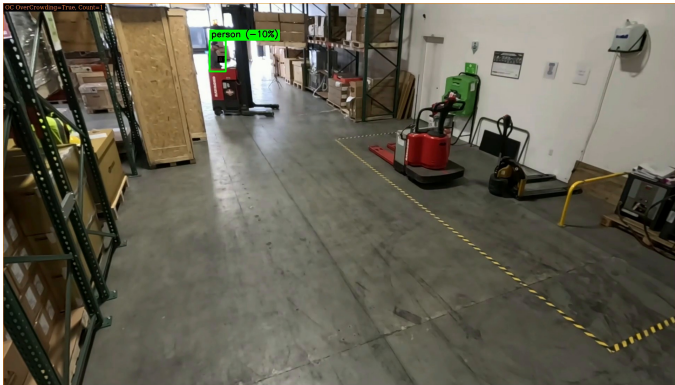
Finding 5: Inspection Finding

TIMESTAMP 12:29:58  
SOP SECTION Safety Protocols  
COMPLIANCE SCORE 66%

[0.0s - 25.067s]: **Answer:**  
The worker operating the forklift is wearing a **red safety vest**, but there is no indication of a **safety helmet** being worn. The **proximity to the forklift** is appropriate, as the operator is seated and actively controlling it. No violations of PPE requirements are evident in the visible details.
