# MANUFACTURING QUALITY ASSURANCE REPORT

| INSPECTION DATE | 2026-02-27 10:43:12 |
| OVERALL VERDICT | FAIL |

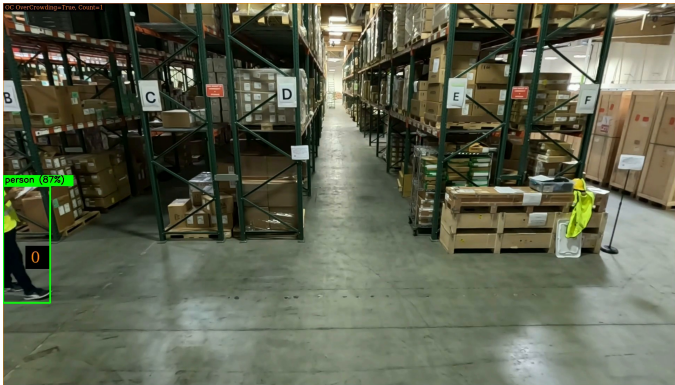
### Finding 1: Inspection Finding

TIMESTAMP 10:42:31  
SOP SECTION Safety Protocols  
COMPLIANCE SCORE 60%

[4.0s - 11.0s]: Yes; both workers wear yellow safety vests. No; neither worker wears a helmet. Not applicable; no forklift is visible in the frames.

[12.0s - 19.0s]: The worker labeled "1" is not present in the frame; therefore, it cannot be determined if they are wearing any PPE. The worker labeled "2" is wearing a yellow high-visibility vest, which indicates adherence to safety protocols for visibility in an industrial setting. No helmets are visibly worn by either individual, though this could be due to the angle or distance of the shot. There is no interaction between the workers and any machinery or vehicles in the immediate vicinity, so proximity to a moving forklift cannot be assessed based on this still image alone.

[16.0s - 23.0s]: Both individuals wear yellow high-visibility safety vests. One person is near stationary shelves, while the other operates a forklift near pallets. No safety helmets are visible. The forklift operator maintains appropriate proximity to the machine during operation.

- **High-Visibility Safety Vests:** Both workers are visibly wearing yellow safety vests, which comply with standard PPE requirements for visibility in industrial settings.
- **Safety Helmets:** Neither worker is wearing a helmet; however, no helmets are visible in the immediate vicinity either.

- The forklift maintains a safe distance from the first worker while passing through the aisle. There is no indication of direct interaction or potential collision risk between the forklift and the stationary worker. The second worker, though closer to the forklift's path, remains focused on their task without apparent interference from the vehicle.

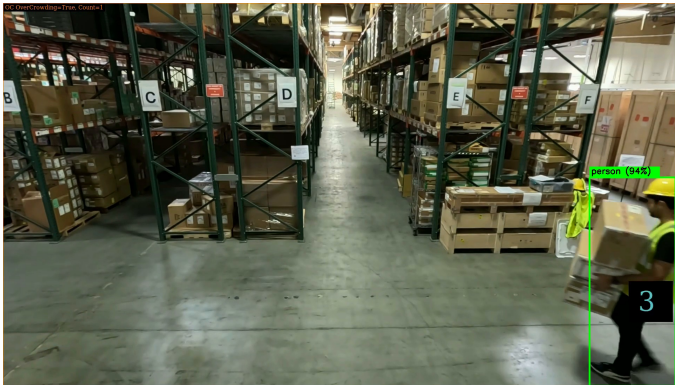
*Finding 2: Inspection Finding*

TIMESTAMP 10:42:45  
SOP SECTION Safety Protocols  
COMPLIANCE SCORE 60%

[0.0s - 7.0s]: **Summary:** In the video, one worker wears a yellow safety vest and a white hard hat while another worker lacks visible PPE. No forklift movement is observed.

[8.0s - 15.0s]: Both workers wear yellow high-visibility vests; no safety helmets are visible. The forklift maintains a safe distance from both workers throughout the observed frames.

[16.0s - 23.0s]: Three people are present in the scene. One person is wearing a yellow safety vest and a white hard hat, while another person is wearing a yellow safety vest but no helmet. The third person is also wearing a yellow safety vest and a white hard hat. There is no indication of proximity to a moving forklift in the current frames.

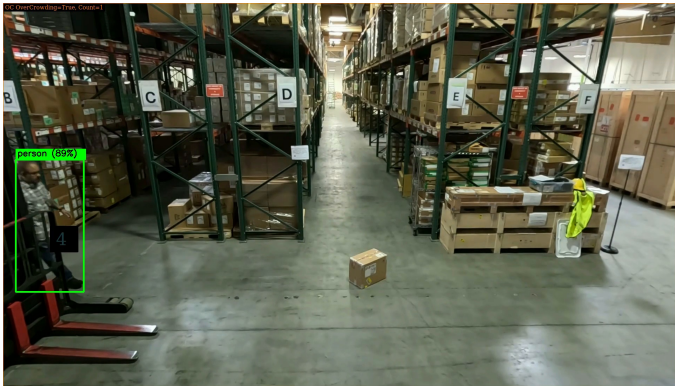
Finding 3: Inspection Finding

TIMESTAMP 10:42:56  
SOP SECTION Safety Protocols  
COMPLIANCE SCORE 50%

- [4.0s - 11.0s]:
1. **Personal Safety Vest:** One worker wears a yellow safety vest (visible), the other does not.
  2. **Safety Helmets:** Neither worker wears a helmet.
  3. **Proximity to Moving Forklift:** No forklift is visible in the frames.

[16.0s - 23.0s]: **Final Answer:**  
The forklift operator is wearing a **yellow safety vest**, while the pedestrian has **no visible PPE**. The pedestrian is **not in close proximity** to the forklift.

- **High-Visibility Safety Vests:** One worker is wearing a yellow safety vest, indicating adherence to PPE requirements for visibility in the workspace.
- **Safety Helmets:** No safety helmets are visibly worn by either worker in this segment of the video.

- The red forklift is stationary and located on the far left side of the frame, maintaining a safe distance from both workers. There is no interaction between the forklift and the workers observed in this clip.

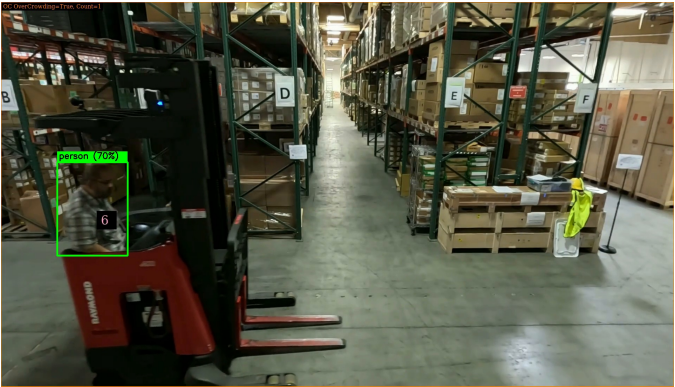
**Finding 4: Inspection Finding**

TIMESTAMP            10:43:07  
SOP SECTION        Safety Protocols  
COMPLIANCE SCORE **50%**

- **High-Visibility Safety Vests:** One worker wears a bright yellow safety vest.
- **Safety Helmets:** No helmets are visibly worn by either worker.

- The worker in the yellow vest is positioned near the forklift but maintains a safe distance as the forklift advances.
- The operator of the forklift is seated inside the vehicle and does not appear to be interacting directly with the other worker.
