# MANUFACTURING QUALITY ASSURANCE REPORT

| INSPECTION DATE | 2026-03-02 12:41:25 |
| OVERALL VERDICT | PASS |

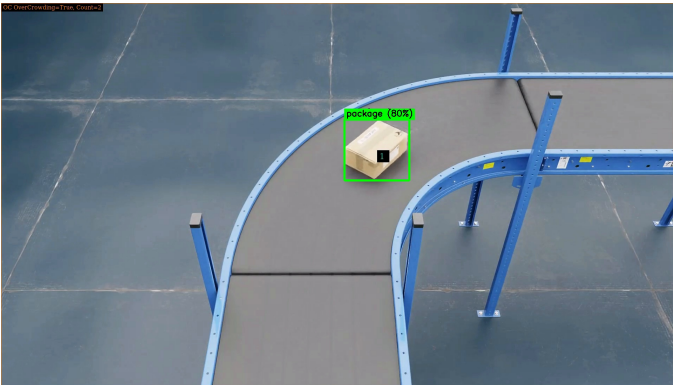
### Finding 1: Inspection Finding

TIMESTAMP 12:40:51  
SOP SECTION Packaging & Shipping Standards  
COMPLIANCE SCORE 100%

[0.0s - 5.0s]: The cardboard box exhibits no visible crumpling, tearing, dents, creases, or open flaps throughout its movement on the conveyor belt.

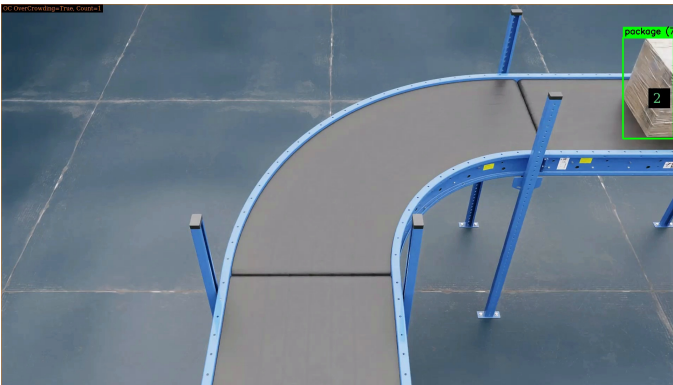
Finding 2: Inspection Finding

TIMESTAMP 12:41:01  
SOP SECTION Packaging & Shipping Standards  
COMPLIANCE SCORE 98%

[4.0s - 9.0s]: No anomalies detected; all boxes are intact with no crumpling, tearing, dents, creases, or open flaps.

1. **Crumpling:** No crumpling observed in either set of boxes.
2. **Tearing:** No tearing detected in either set of boxes.
3. **Dents:** No dents noted in the white boxes; slight surface roughness observed on the brown box.
4. **Creases:** No creases present in the white boxes; minor creasing possible on the brown box due to wear.
5. **Open Flaps:** All white boxes have closed flaps; the brown box shows no open flaps during motion.

[12.0s - 17.0s]: The cardboard boxes show no visible damage; they remain intact with closed flaps, no crumpling, tearing, dents, or creases.

[16.0s - 19.867s]: No anomalies detected; the cardboard box remains intact with no visible damage (crumpling, tearing, dents, creases, or open flaps).

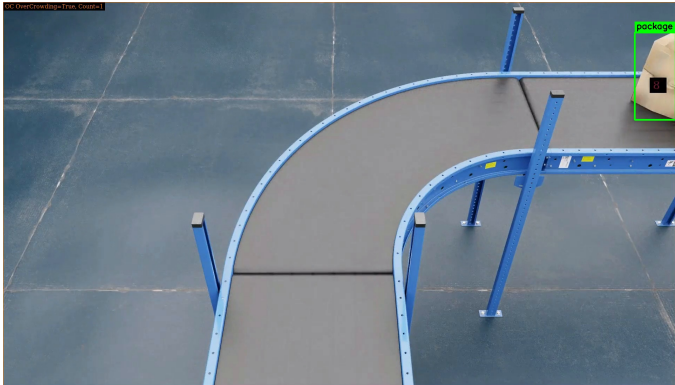
Finding 3: Inspection Finding

TIMESTAMP 12:41:10  
SOP SECTION Packaging & Shipping Standards  
COMPLIANCE SCORE 100%

[0.0s - 5.0s]: No observable items related to the inspection criteria (crumpling, tearing, dents, creases, open flaps) as no cardboard boxes are present on the conveyor belt.

[8.0s - 11.4s]: No observable anomalies or artifacts present. Cardboard boxes show no signs of damage (crumpling, tearing, dents, creases, open flaps).

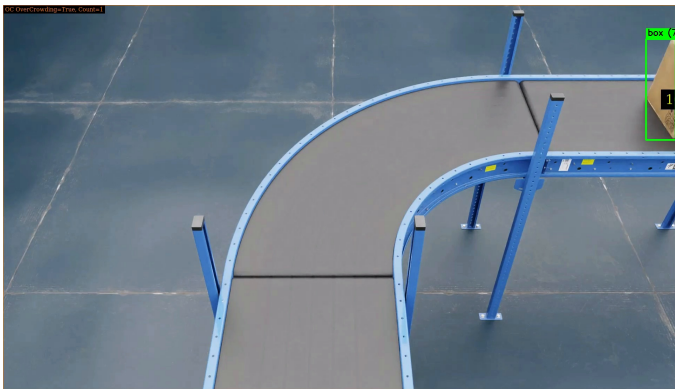
Finding 4: Inspection Finding

TIMESTAMP 12:41:20  
SOP SECTION Packaging & Shipping Standards  
COMPLIANCE SCORE 100%

[0.0s - 5.0s]: None of the specified defects (crumpling, tearing, dents, creases, open flaps) are visible as there are no cardboard boxes or conveyor belts shown in the video. The scene only shows a stationary blue metal structure and a concrete floor.

[4.0s - 9.0s]: The cardboard box shows no visible signs of crumpling, tearing, dents, creases, or open flaps; it remains intact and sealed while moving along the conveyor belt.

[8.0s - 13.0s]: No visible anomalies detected. Cardboard box remains intact, sealed, and undamaged throughout the conveyor belt movement.

[12.0s - 15.633s]: No visible signs of damage (crumpling, tearing, dents, creases) or open flaps on the cardboard box; it remains intact and structurally sound throughout the lifting process.
