# MANUFACTURING QUALITY ASSURANCE REPORT

## EXECUTIVE SUMMARY

| INSPECTION DATE | 2026-03-02 12:49:02 |
| OVERALL VERDICT | FAIL |

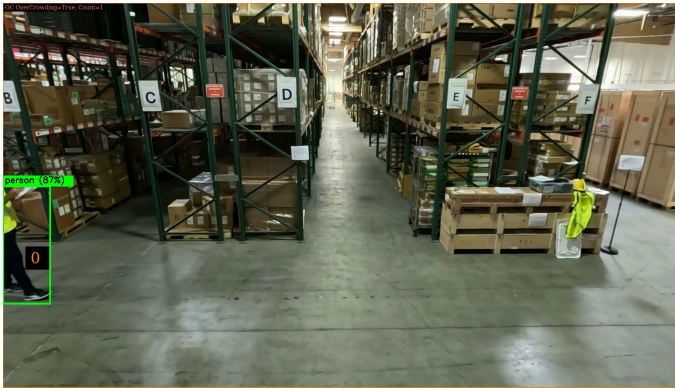
**Finding 1: Inspection Finding**

TIMESTAMP 12:48:20  
SOP SECTION Safety Protocols  
COMPLIANCE SCORE 60%

- **High-Visibility Safety Vests:** Both workers are visibly wearing yellow safety vests, which comply with PPE standards for visibility in industrial settings.
- **Safety Helmets:** Neither worker is seen wearing a helmet; only the upper body and arms are visible, so this cannot be confirmed.

**Proximity to Moving Forklift:** No forklift is visible in the scene, so there is no interaction or risk assessment related to a moving vehicle.

[4.0s - 11.0s]: There are three people in the scene, none of whom are wearing safety helmets. All three are wearing yellow safety vests. None of them are near a forklift.

[8.0s - 15.0s]: Yes; both wear yellow safety vests and white hard hats, meeting PPE standards. No interaction with a moving forklift is observed.

- **High-Visibility Safety Vests:** Present on both workers. One worker wears a yellow vest, and the other also wears a yellow vest. Both remain stationary throughout the frames.
- **Safety Helmets:** Not visibly worn by either worker during the observed frames.

[20.0s - 25.067s]: Both individuals wear yellow high-visibility vests. One person is not wearing a safety helmet, while the other's headwear is obscured. The forklift approaches the first worker without any apparent risk of collision.

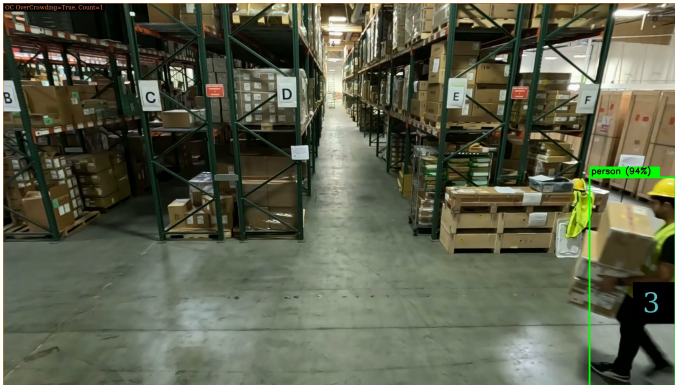
**Finding 2: Inspection Finding**

TIMESTAMP 12:48:31  
SOP SECTION Safety Protocols  
COMPLIANCE SCORE 60%

[0.0s - 7.0s]: Two individuals wearing yellow safety vests and hard hats are present; one walks past the other while carrying a box. No forklift is visible in motion.

- **High-Visibility Safety Vests:** Both workers are visibly wearing yellow safety vests, complying with standard PPE requirements for visibility in industrial settings.
- **Safety Helmets:** No safety helmets are observed being worn by either worker in the provided frames.

- Neither worker is shown in close proximity to the stationary forklift; both remain in separate sections of the aisle, maintaining a safe distance from the machinery.

- **High-Visibility Safety Vests:** All workers are visibly wearing yellow high-visibility safety vests with reflective stripes.
- **Safety Helmets:** At least two workers are wearing hard hats, while others may have them off but remain within safe zones relative to machinery like forklifts.

[16.0s - 23.0s]: Two workers wear high-visibility safety vests; one is near the center-left, and the other is toward the right side. A third worker without a vest walks through the aisle. No forklift is present.

In the video, one person is wearing a yellow safety vest and a white hard hat, while another individual's PPE is unclear. The worker in the yellow vest is near a forklift that appears to be in operation.

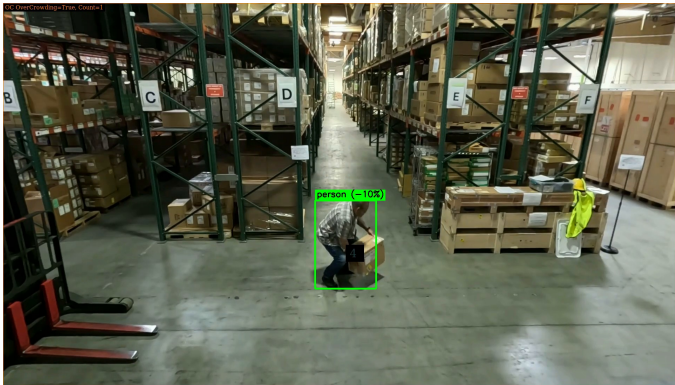
Finding 3: Inspection Finding

TIMESTAMP 12:48:44  
SOP SECTION Safety Protocols  
COMPLIANCE SCORE 60%

[8.0s - 15.0s]: No PPE detected; no interaction with forklift

- **High-Visibility Safety Vests:** One worker is wearing a bright yellow safety vest, which is clearly visible and covers most of their torso. The vest includes reflective stripes for enhanced visibility.
- **Safety Helmets:** The same worker in the yellow vest is also wearing a matching yellow hard hat, properly secured on their head.

- The red forklift is stationary throughout the observed frames and does not move closer to any individuals in the scene. There is no interaction between the forklift and the workers present.

[16.0s - 23.0s]: No PPE detected; individual lacks high-visibility vest or helmet.

[20.0s - 25.067s]: Two individuals wear yellow safety vests and white hard hats, while one worker lacks visible PPE. Two individuals are wearing white hard hats. No forklift is visible in motion.

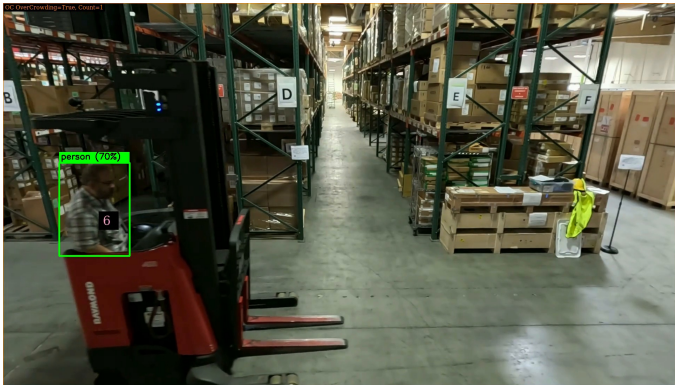
*Finding 4: Inspection Finding*

TIMESTAMP 12:48:56  
SOP SECTION Safety Protocols  
COMPLIANCE SCORE 40%

- **High-Visibility Safety Vests:** One worker on the right side of the frame is visibly wearing a yellow safety vest, which is appropriate for visibility in an industrial setting. No other individuals are seen wearing similar vests.
- **Safety Helmets:** None of the workers in the scene are wearing safety helmets.

- The worker interacting with the forklift maintains a safe distance while standing beside it, allowing the forklift to operate without obstruction. There is no indication of unsafe proximity between the two.

In the video, one worker (on the right) wears a **yellow safety vest** and a **white hard hat**, meeting PPE standards. The second worker (left) lacks visible PPE. Both remain at a **consistent distance from the stationary forklift** throughout the frames. No violations or unsafe behaviors are evident in their positioning relative to the forklift.
