August 19, 2020

RE: Report of Findings: Microbial Consulting Services and Moisture Assessment

Arium Verona View (Apt 169)
10900 NW 17th Street, Plantation, FL 33322

ATC Project No. NPPGIM2053

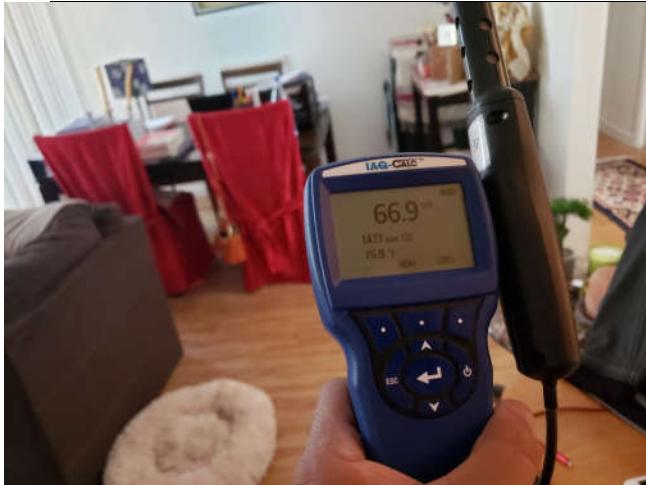
Photo 1: View of humidity and temperature readings

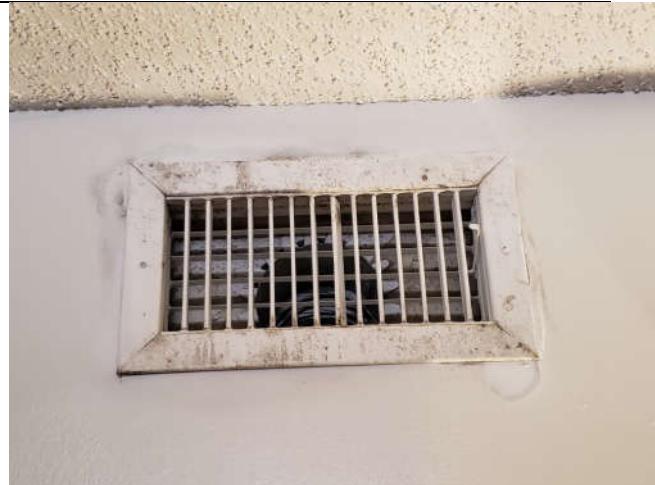
Photo 2: View of suspect VMG on vent in kitchen

1. Vertical and horizontal surfaces, particularly those with VSMG, within the apartment should be thoroughly cleaned using an odorless anti-microbial solution. This includes, but is not limited to the drywall walls and vent covers. Furniture with VSMG should be steam cleaned or replaced. This should be conducted by a State of Florida licensed mold remediation contractor.

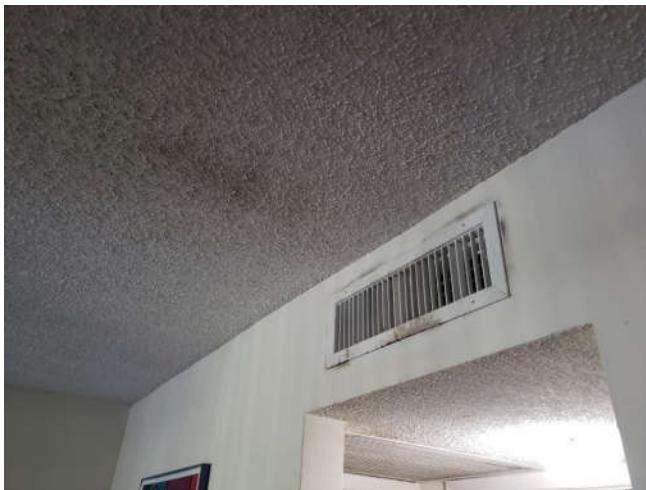
Photo 3: View of suspect VMG on vent in living room and ceiling

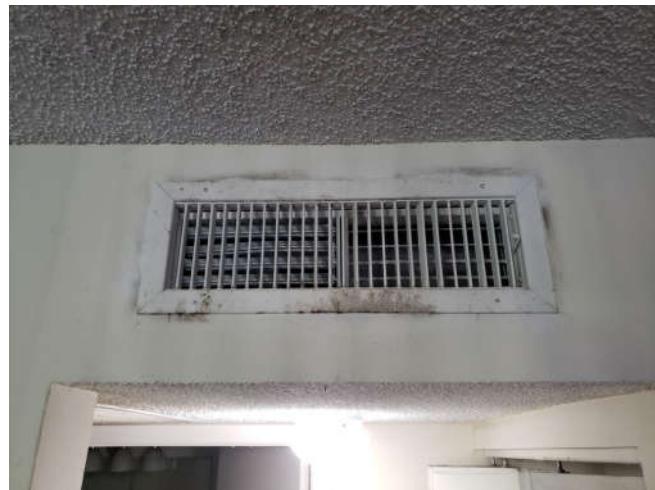
Photo 4: Close-up view of suspect VMG on vent in living room

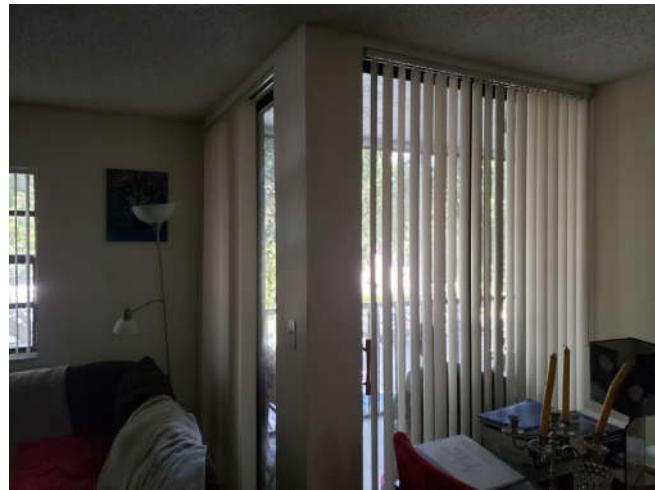
Photo 6: View of suspect VMG on west corner wall in living room

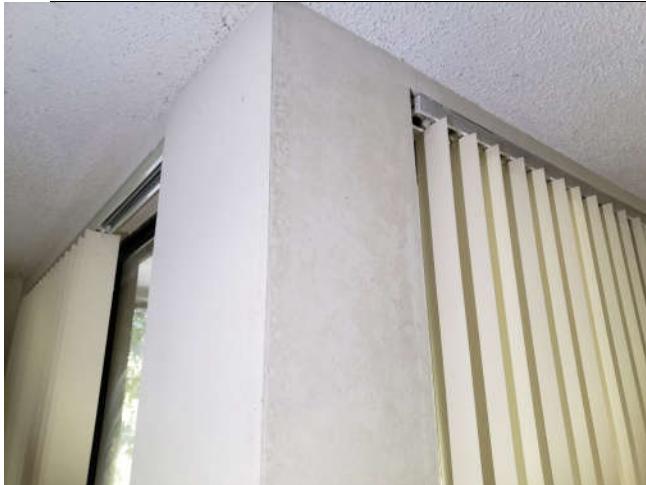
Photo 7: Close-up view of suspect VMG on west corner wall in living room

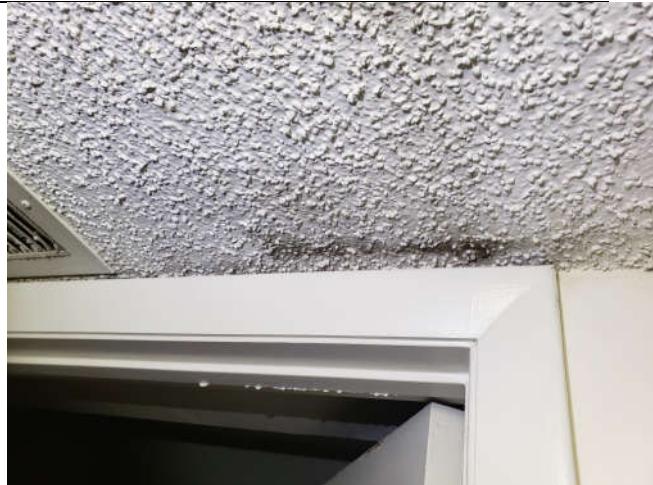
Photo 8: View of suspect VMG on ceiling in hallway

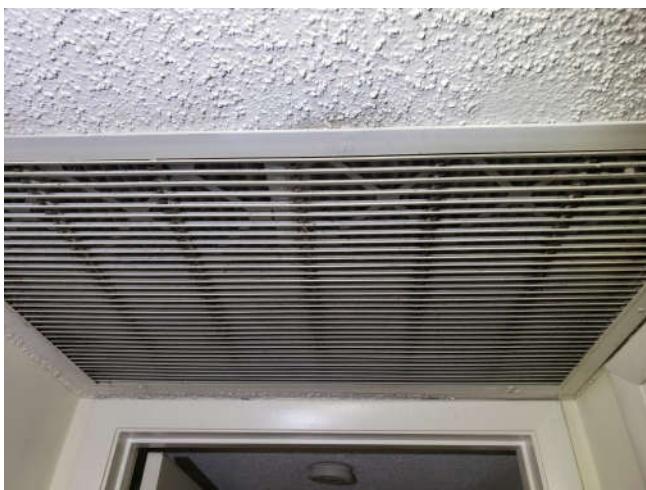
Photo 9: View of dirty air return grille in hallway

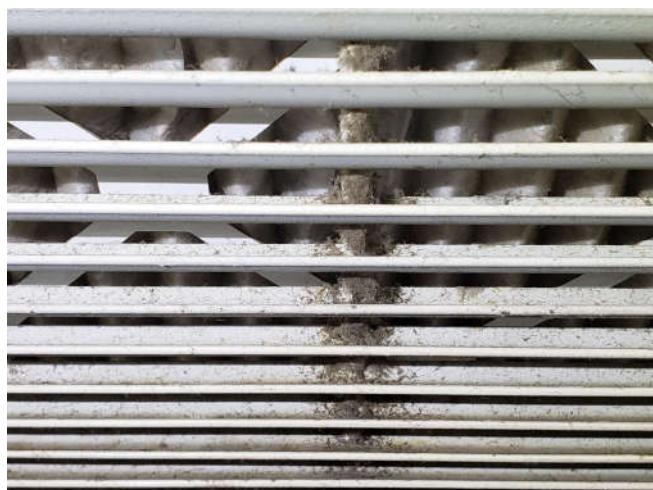
Photo 10: Close-up view of dirty air return grille in hallway

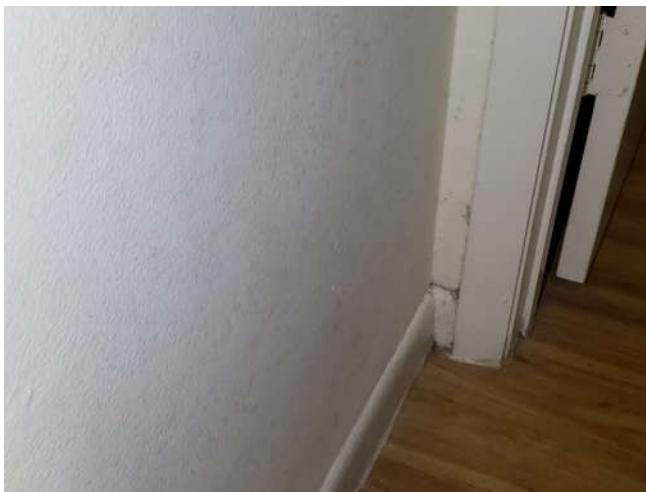
Photo 11: View of suspect VMG on west wall in hallway

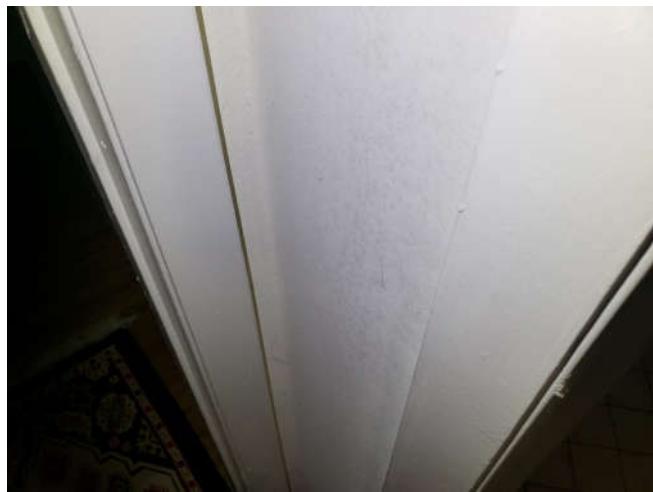
Photo 12: View of suspect VMG on east wall in hallway

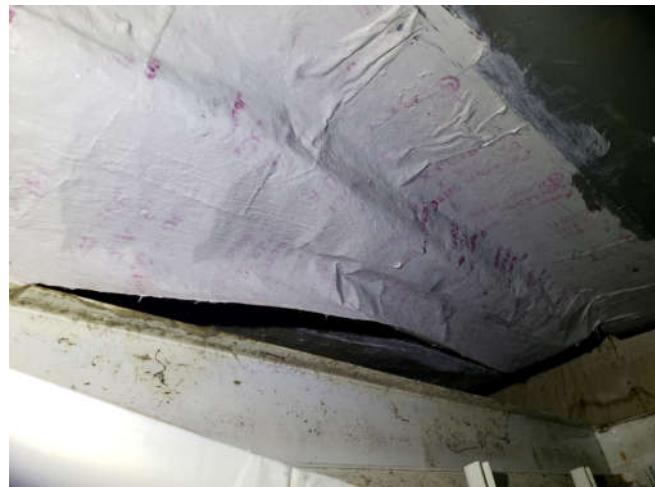
- No musty odors were detected during the site visit.
- The relative humidity (RH) levels for the tested areas within the apartment were elevated at 67% when compared to the maximum ASHRAE standard of 65%. In addition, the dew point calculations were above the upper acceptable threshold levels of 62.2 °F.
- VSMG was observed on several walls throughout the apartment. See attached marked-up floor plan depicting these locations found in **Appendix A**.
- VSMG was observed on the supply diffuser and return air grille vents within the apartment.
- Loose ductwork tape was observed on the bottom region of the AHU. Air appears to leak from this area. See photograph number 22 in the photo log in **Appendix A**.

Photo 22: View of loose tape on AC plenum

2. The AHU should be thoroughly inspected and cleaned or replaced if not feasible. The hole on the ductwork should be sealed or repaired. The condensate drain line for the AHU should be sloped away from the AHU to discharge water properly from the condensate pan. This should be conducted by an HVAC service contractor or in-house maintenance staff.

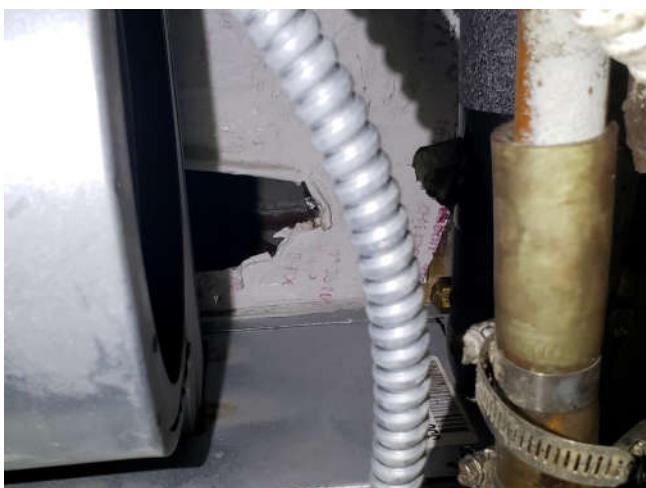
- A hole can be seen on the AC plenum on an area of breached ductwork tape on the ductwork. See photograph number 23 in the photo log in **Appendix A**.

Photo 23: View of hole on AC plenum

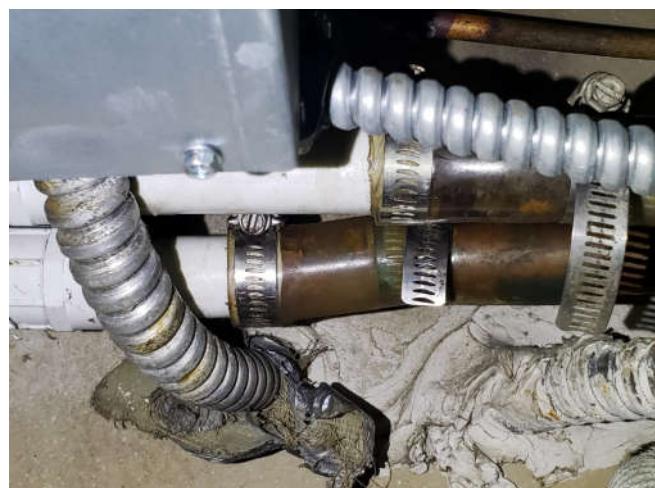
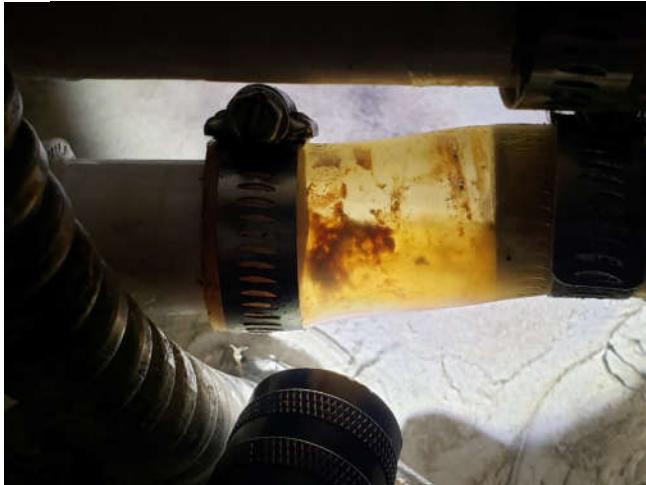
- The condensate drain line appears to be improperly sloped away from the AHU drain pan. In addition, a section of the plastic condensate drain line appears to have dried out leaving a water stain mark inside the drain line. See photograph numbers 24 and 25 in the photo log in **Appendix A**.

Photo 24: View of condensate drain line appears to be improperly sloped away from drain pan

Photo 25: View of a section of the plastic condensate drain line appears to be dried out leaving a water stain mark line

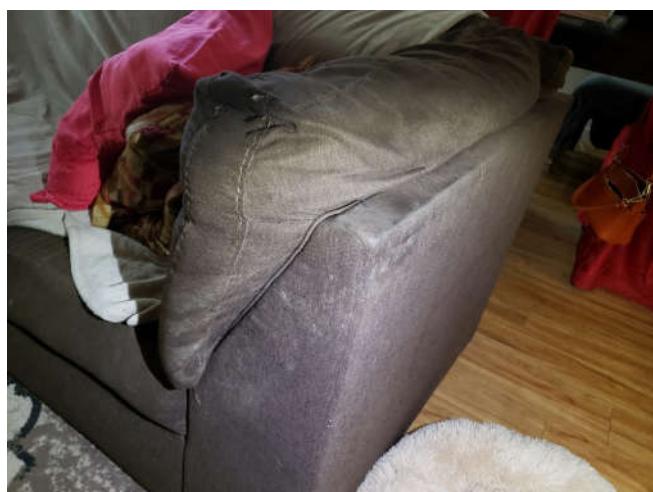
- VSMG was observed on the sofa in the living room. See photograph number 28 in the photo log in **Appendix A**.
- VSMG was observed underneath two (2) tables in the living room. See photograph numbers 29 and 30 in the photo log in **Appendix A**.

Photo 28: View of suspect VMG on sofa in living room

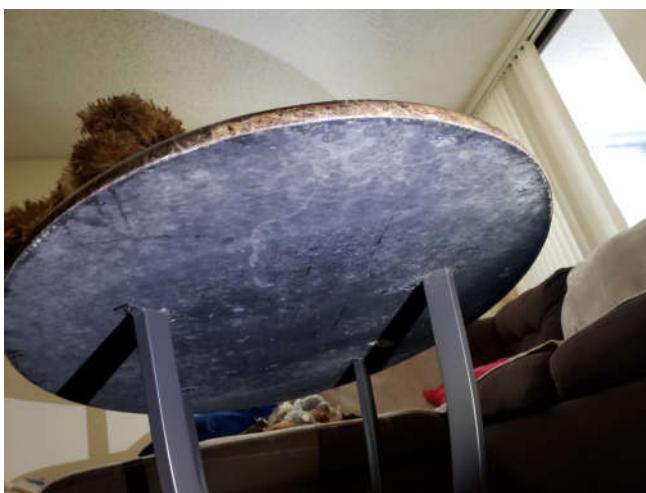
Photo 29: View of suspect VMG beneath coffee table in living room

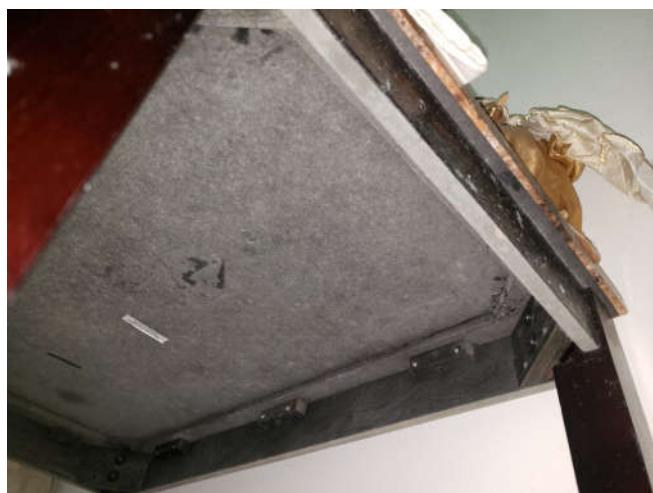
Photo 30: View of suspect VMG beneath table in east region of living room
