**James L. Loring, P.G.
Geo-Consulting Services**

**Subsurface Exploration and Geotechnical Engineering Analysis
and Limited Site Assessment (LSI) Report
Proposed Retail Development
Sibley Lincoln Plaza
1319 East Sibley Blvd.
Dolton, Illinois**

Project No LG2113A

Geotechnical Engineering Report Sibley Lincoln Plaza

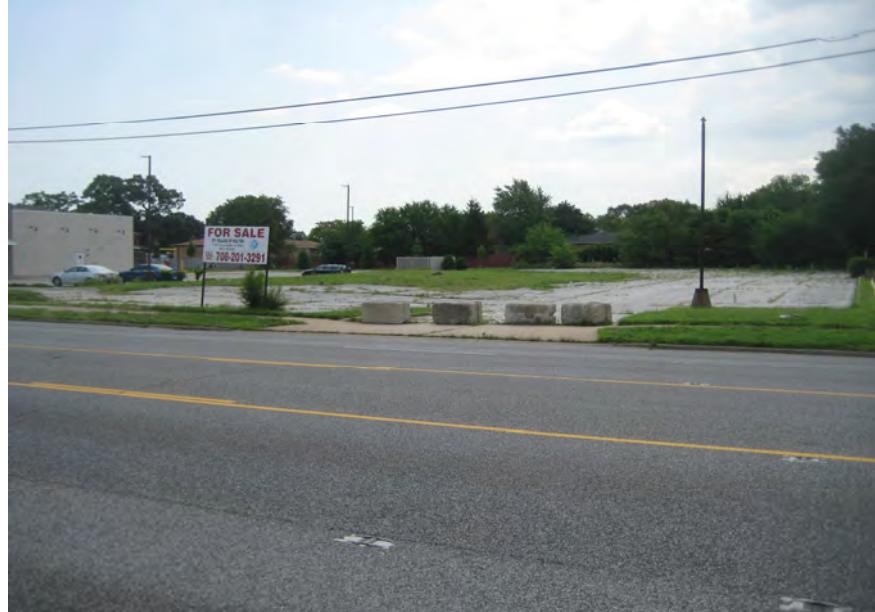
Photograph No. 1

View of subject property facing southeast from north side of East Sibley Blvd.

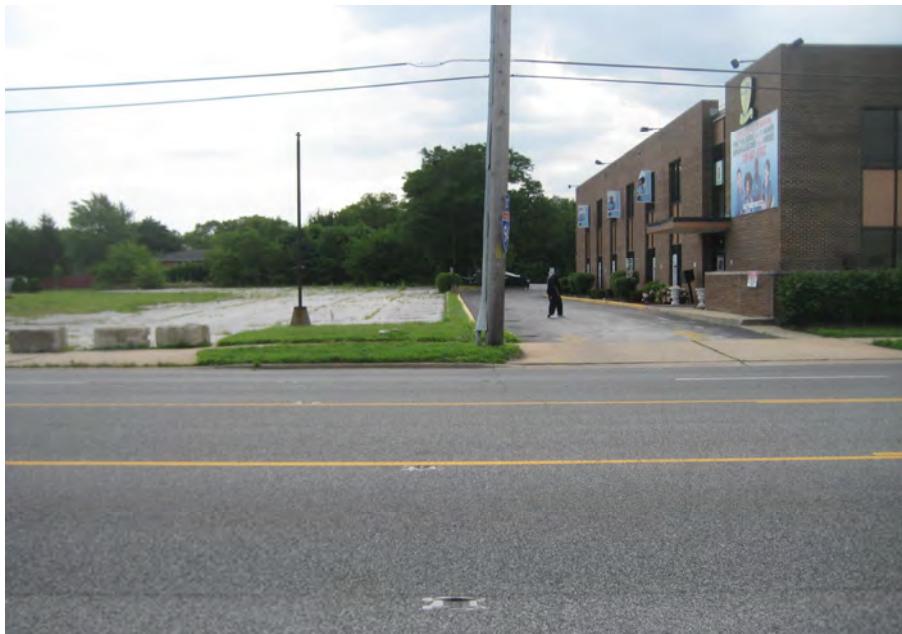
Photograph No. 2

West and north property elevations

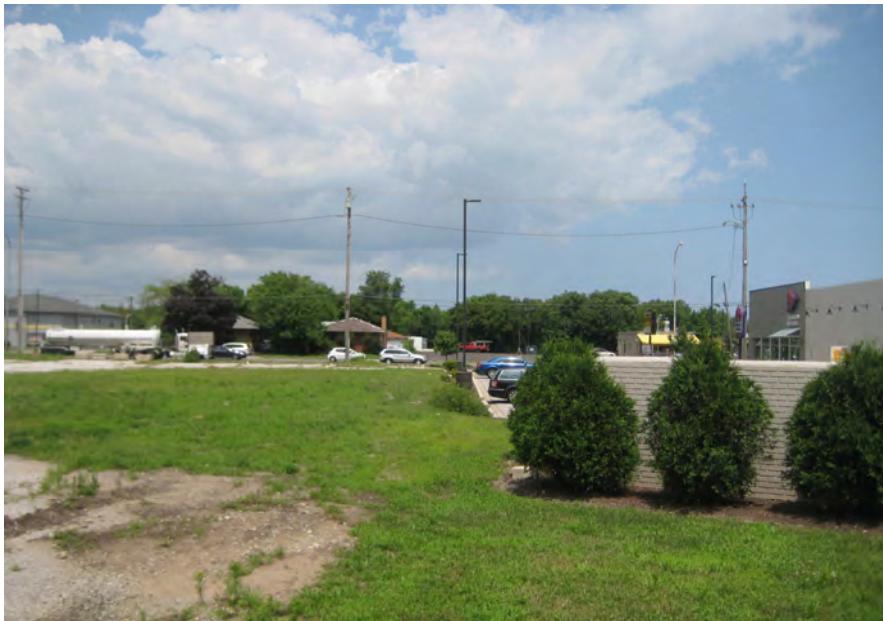
Photograph No. 3

View facing north along east property boundary from SE property corner

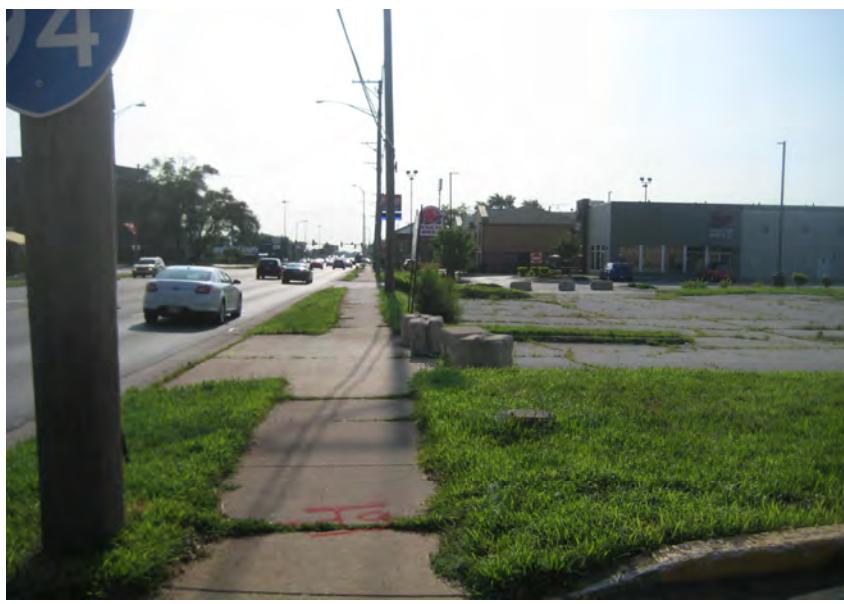
Photograph No. 4

View facing east along north property boundary at NW property corner and E Sible Blvd.

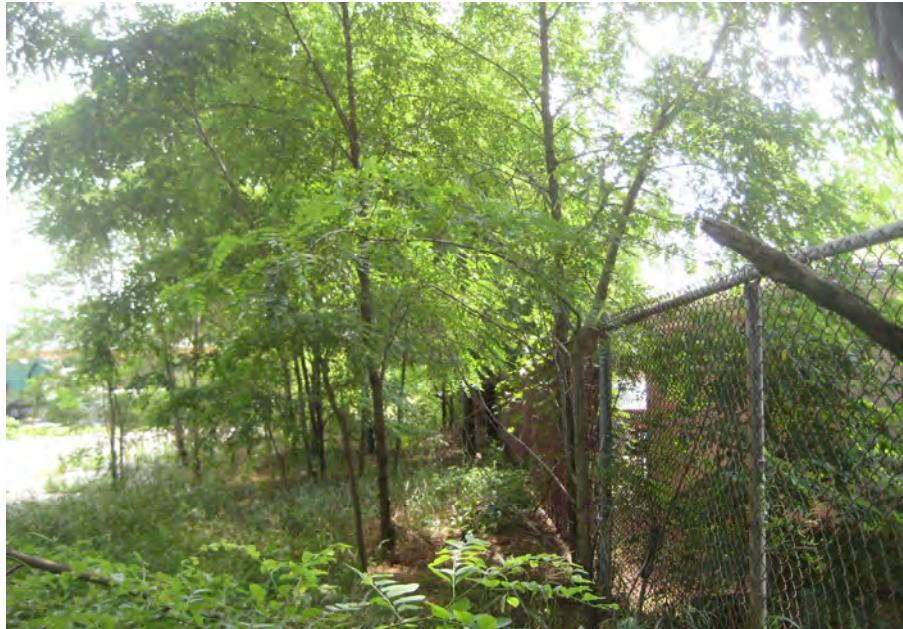
Photograph No. 5
South property boundary overgrown

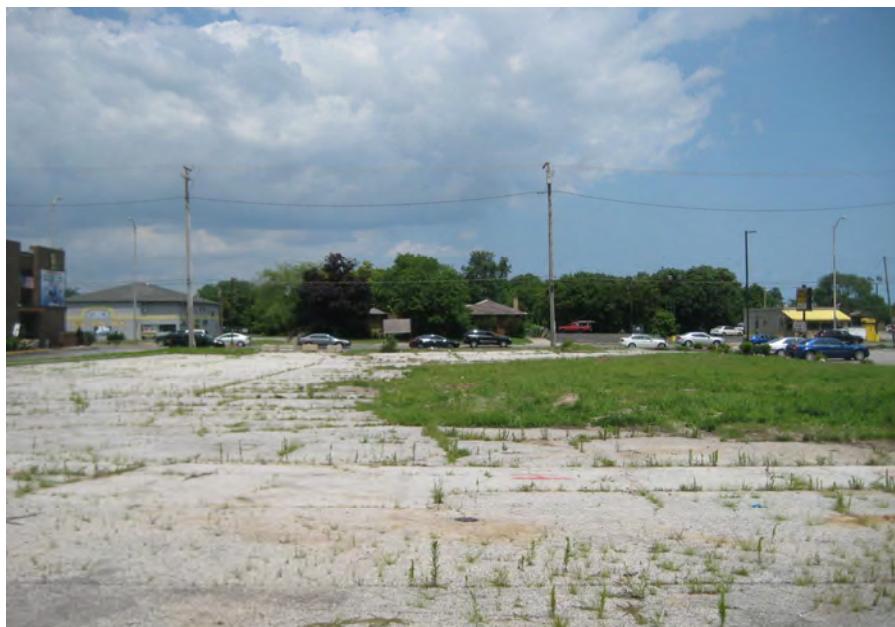
Photograph No. 6
Central portion of property

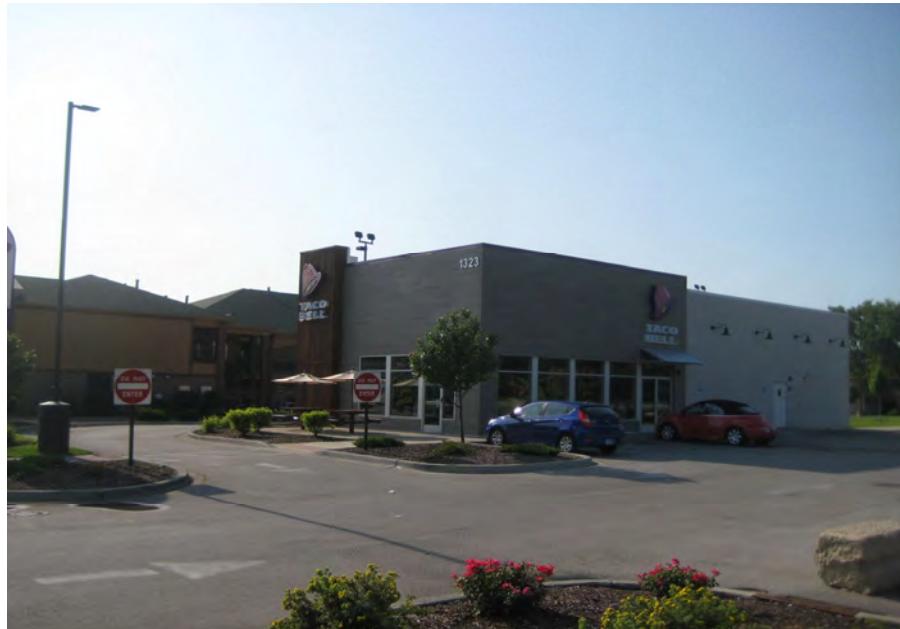
Photograph No. 7

East adjacent Taco Bell restaurant

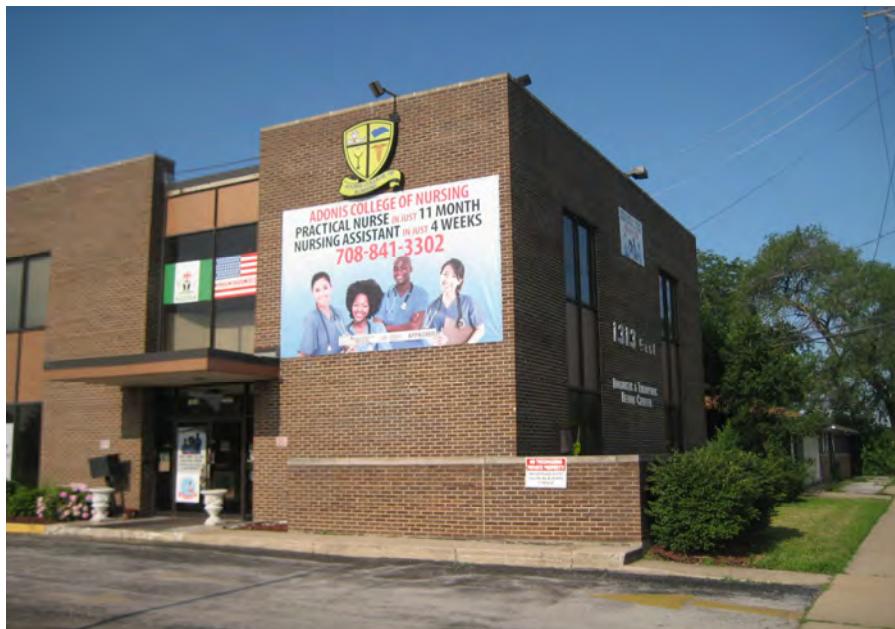
Photograph No. 8

West adjacent school;

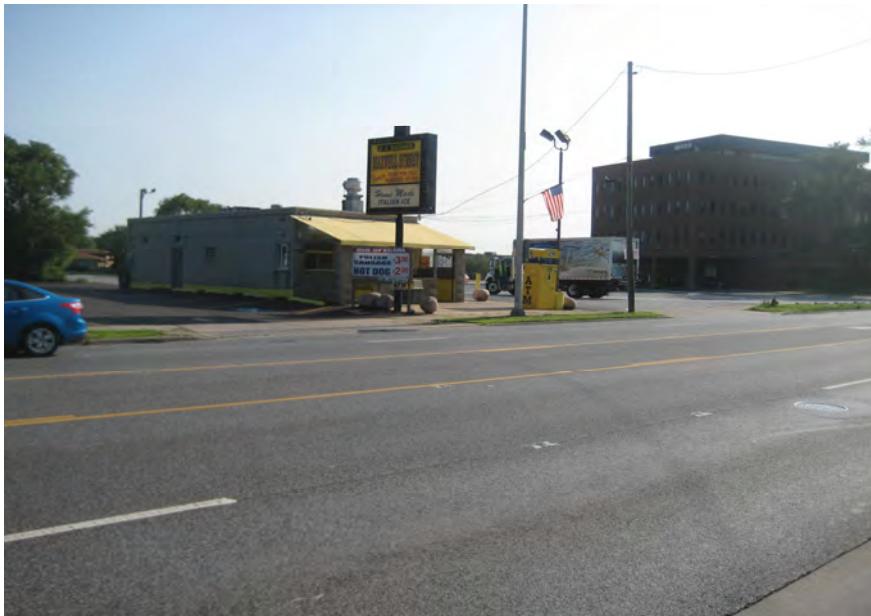
Photograph No. 9

Restaurant to NE on north side of E. Sibley Blvd

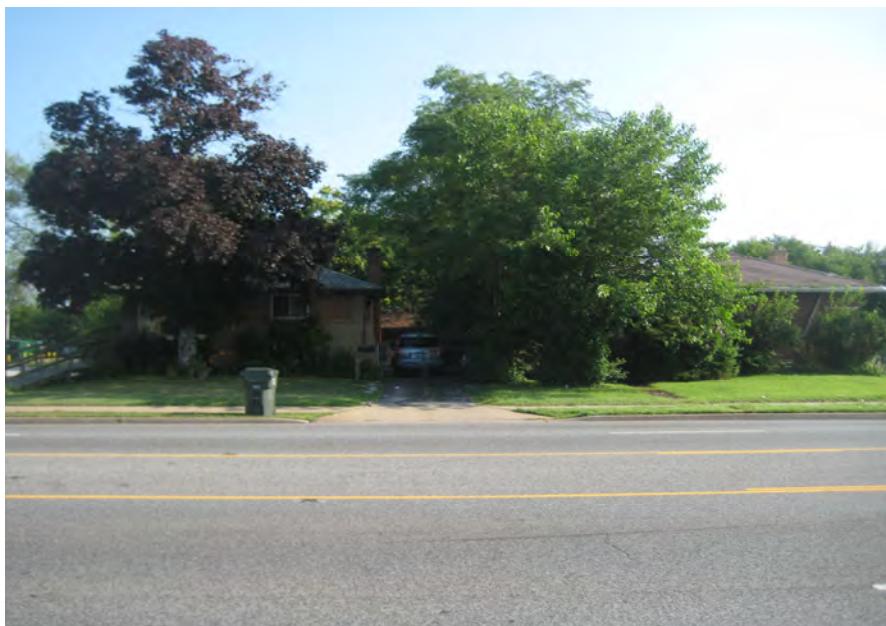
Photograph No. 10

Residential structures on north side of E Sibley Blvd

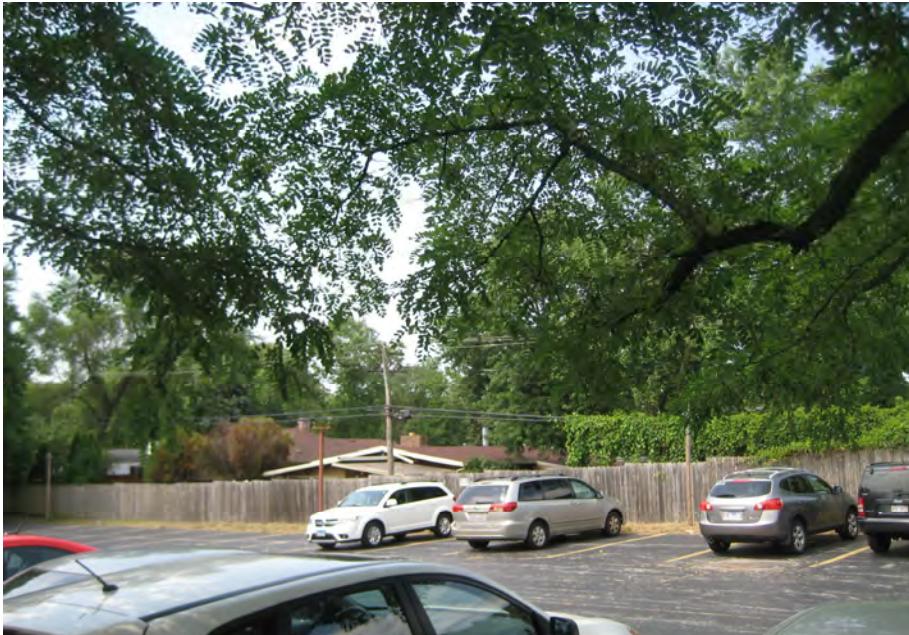
Photograph No. 11

Nursing school parking lot and residential areas to south

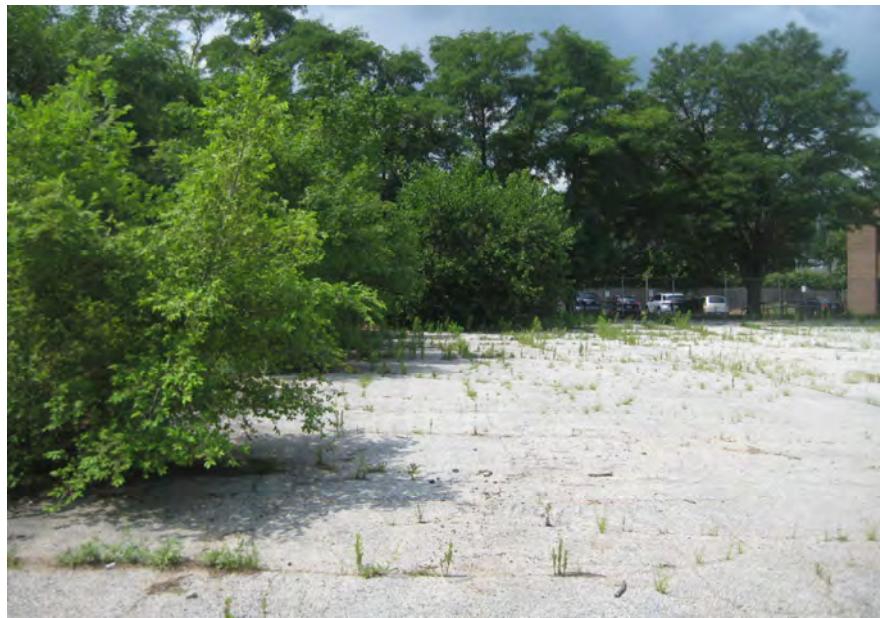
Photograph No. 12

View facing west across southern portion of property
