# The Nicoll Highway Collapse

D. W. Hight  
T.O. Henderson + A.R. Pickles  
S. Marchand

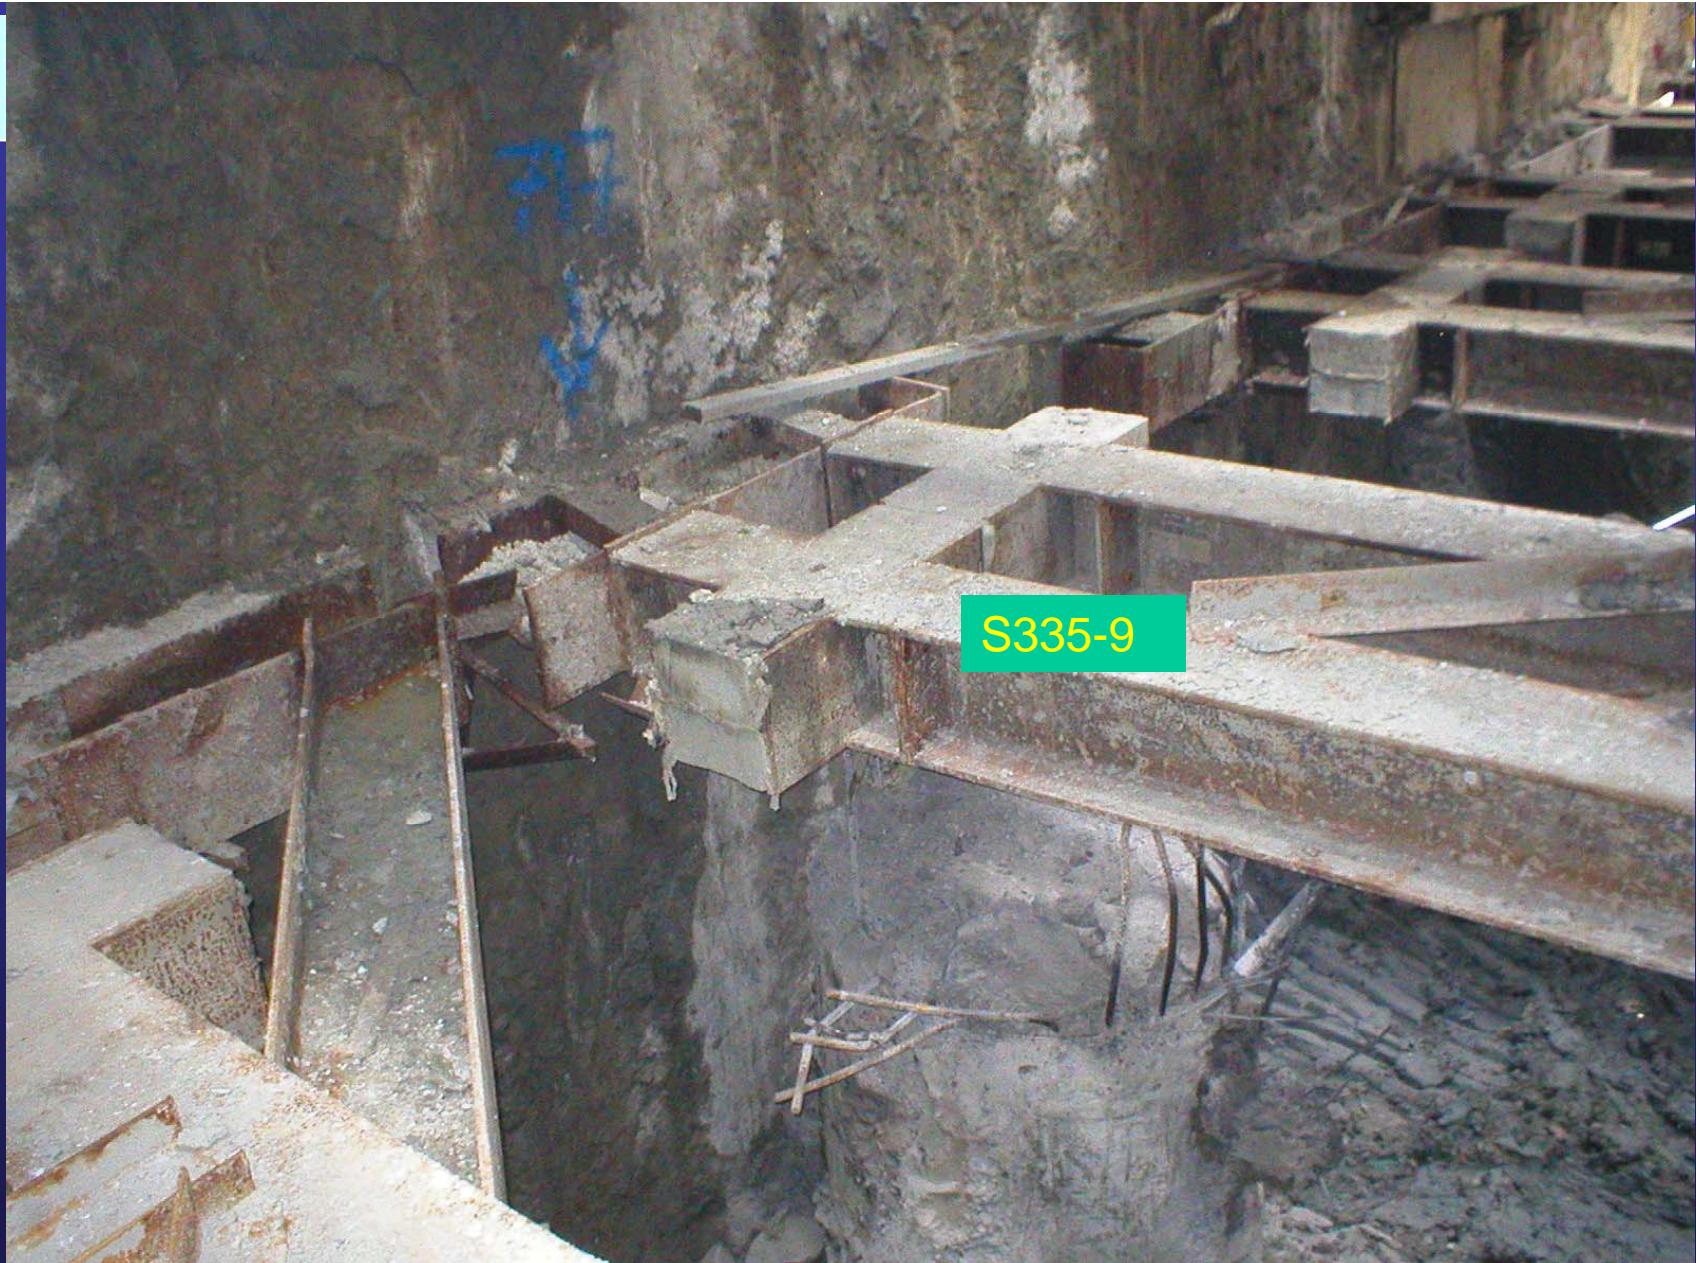
*Strut 335-9 south wall*

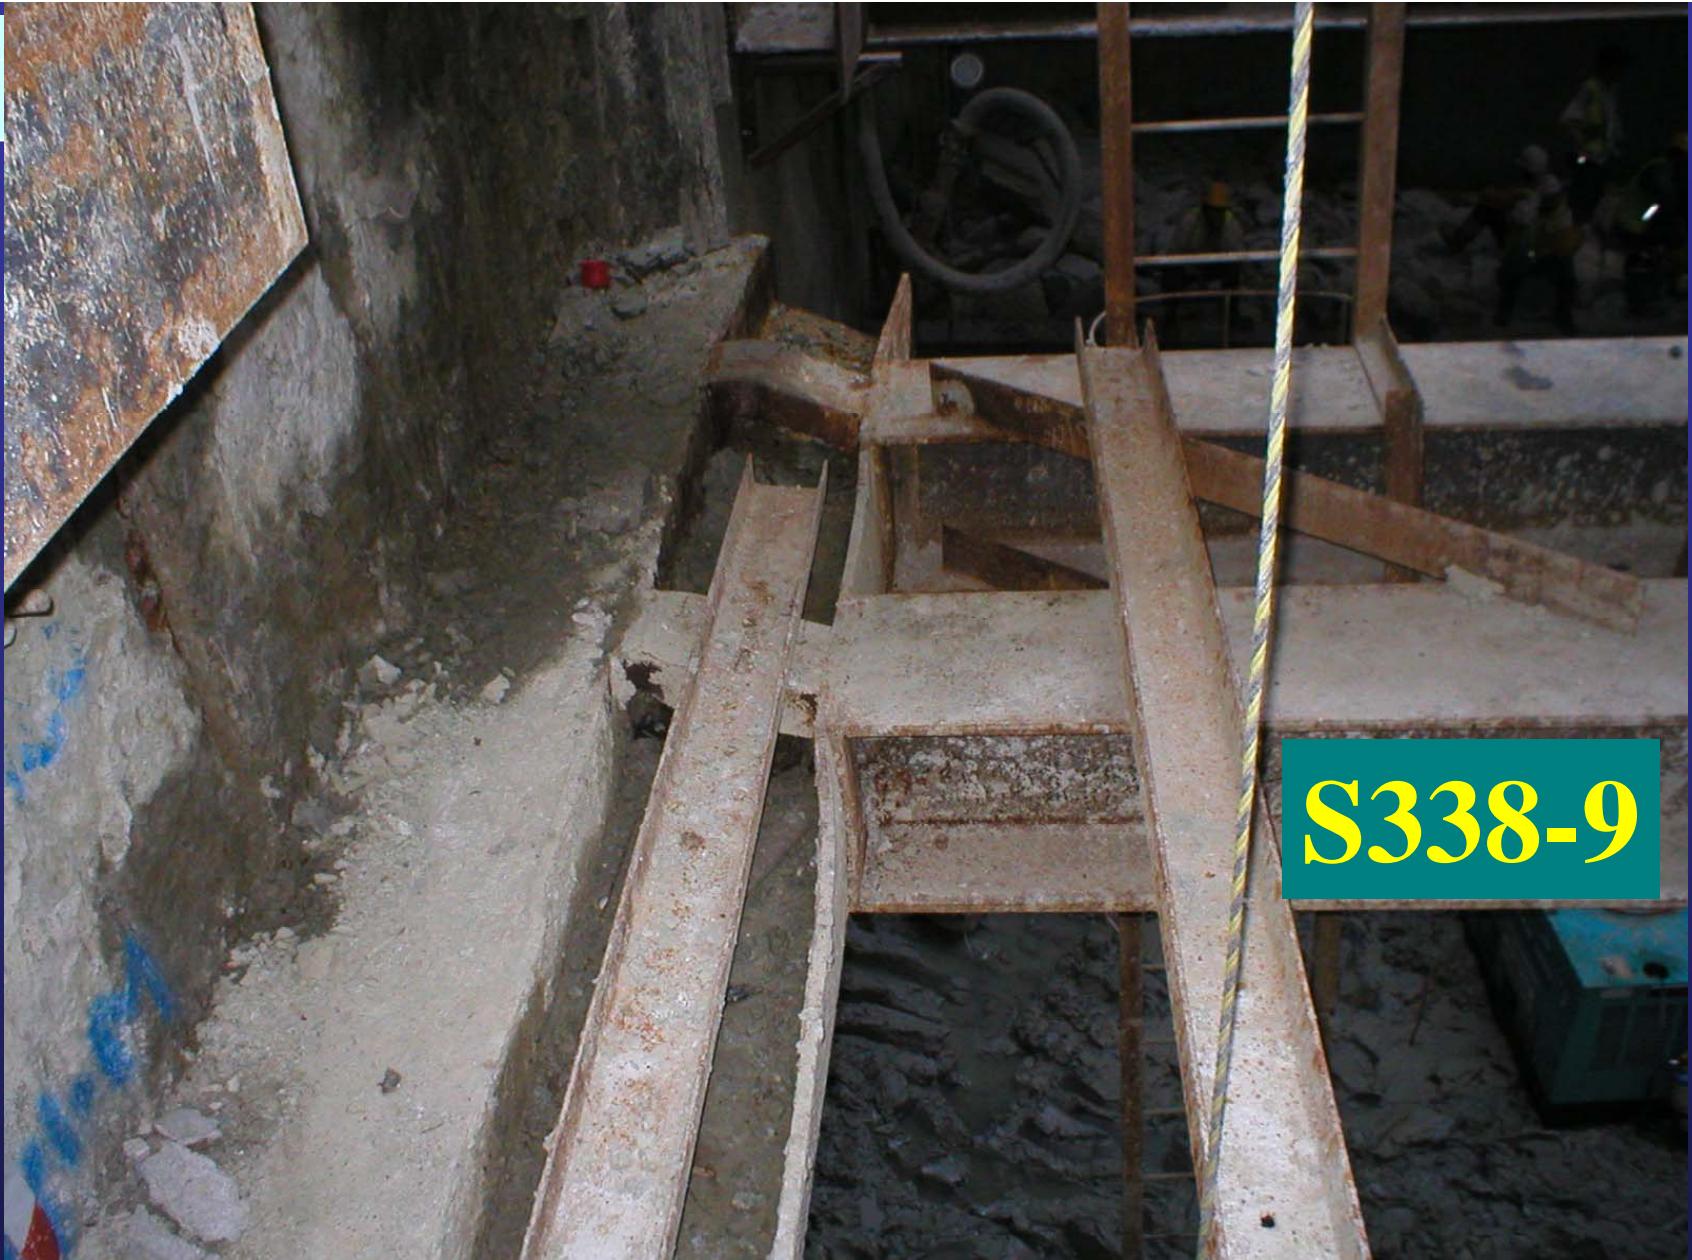
S338-9

*Strut 338-9 north wall*
