# Sleipner A offshore platform sprung leak

## Singapore cut and cover collapse

Krishna Kumar  
Based on Presentations by  
Prof. Soga, D.W. Hight  
and NCE Report

# Nicoll Highway, Singapore

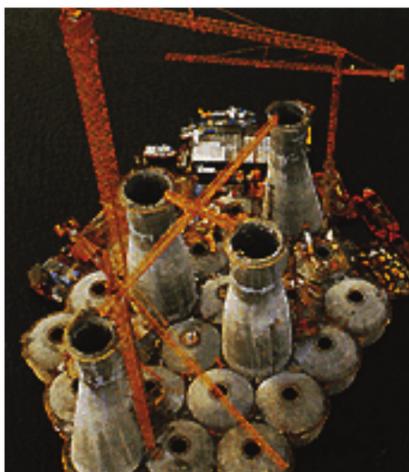
*Concrete substructure during manufacturing on shore. Finite element mesh of a tricell detail. A tricell is a triangular concrete frame placed where three cells meet.*

Second, the shear stresses at the boundary have been quadratically extrapolated using the shear forces at points A, B and C. We know however from beam theory that the shear force distribution is linear so that the shear force at the boundary is underestimated by  $\approx 40\%$

To make matters worse, the necessary reinforcement was automatically dimensioned based on the finite element results without any checking by an engineer.

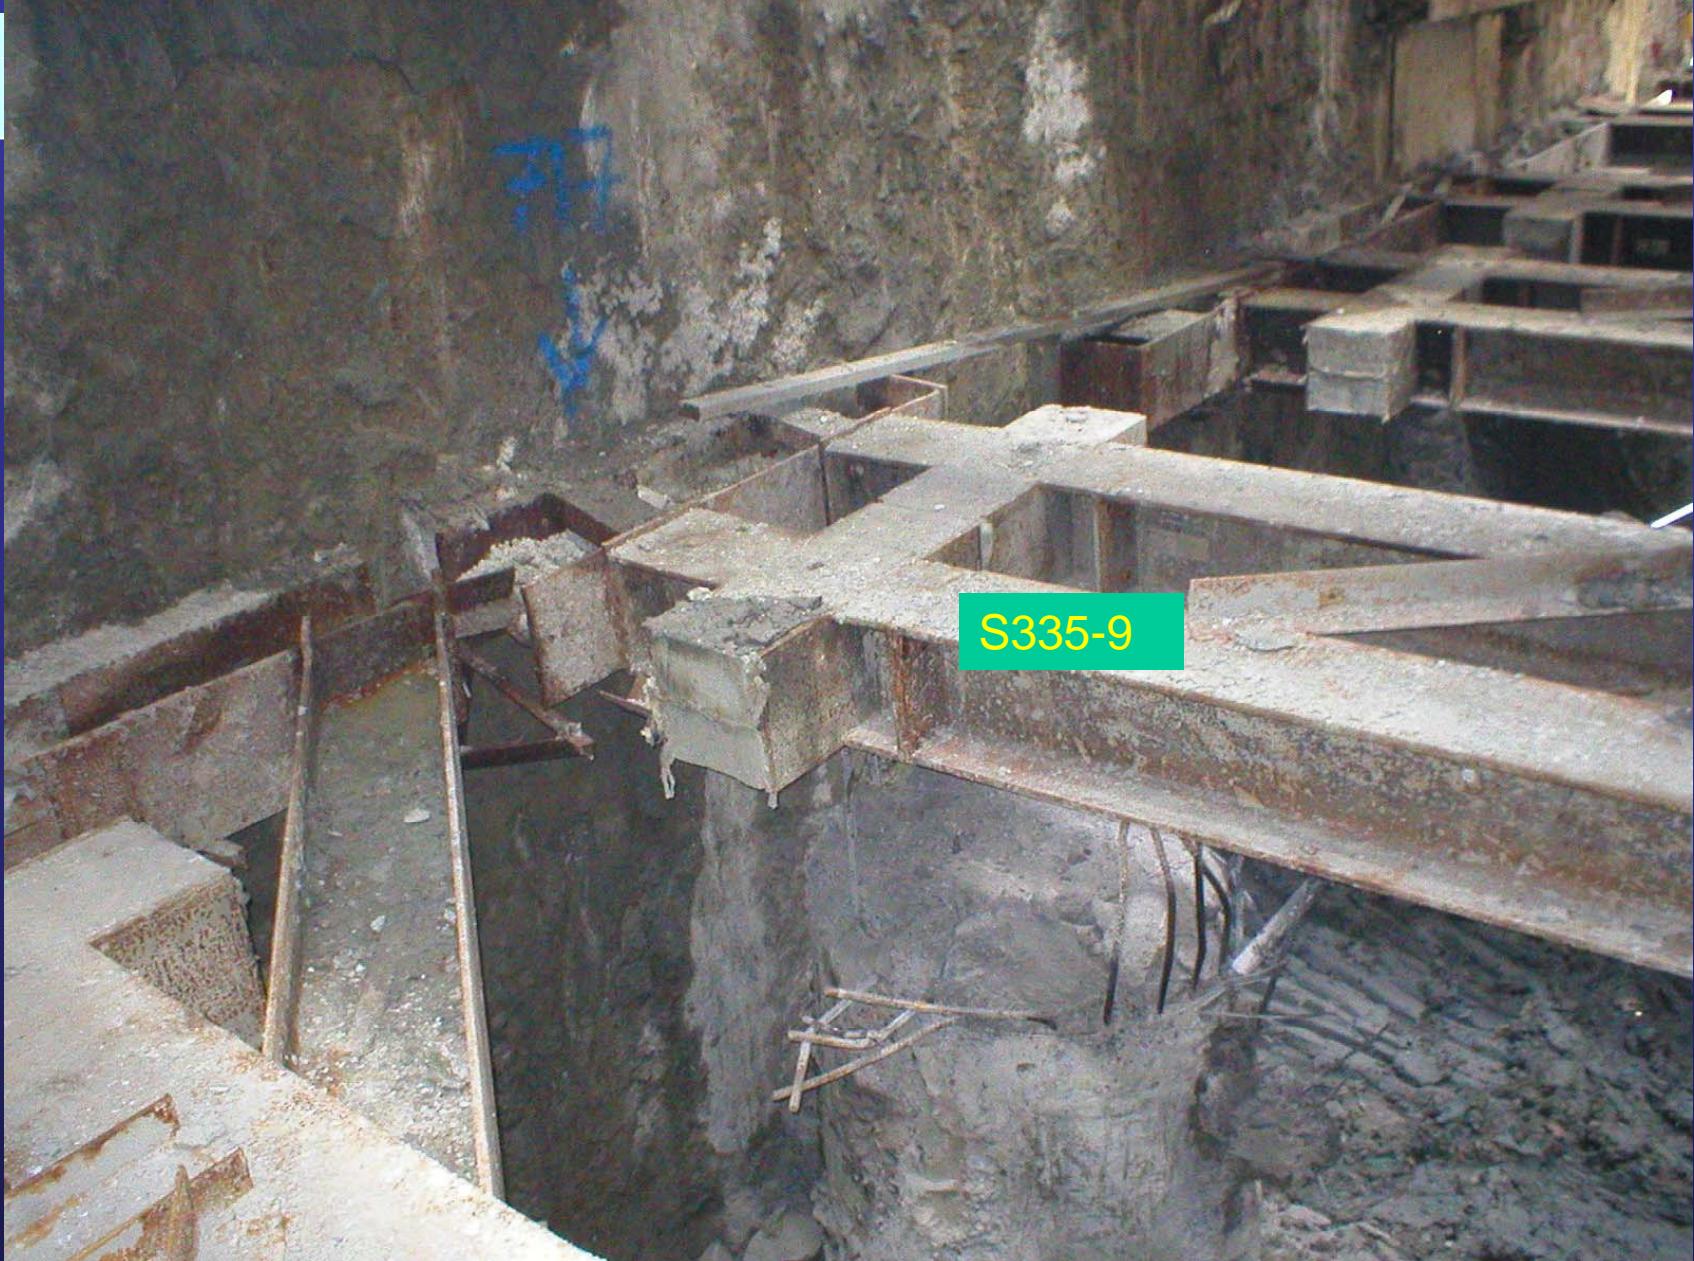
*Strut 335-9 south wall*

- S338-9 stood for 8 days under load and was 20m from excavation front
- S335-9 stood for 2.5 days under load and was over 8m from excavation front
- Both S335-9S & S338-9N buckled within 10 minutes
- Load in S335-8 and S335-9 was almost constant between 18 April and initiation of collapse
- All C-channel connections failed downwards at both ends
- The south wall was pushing the north wall back

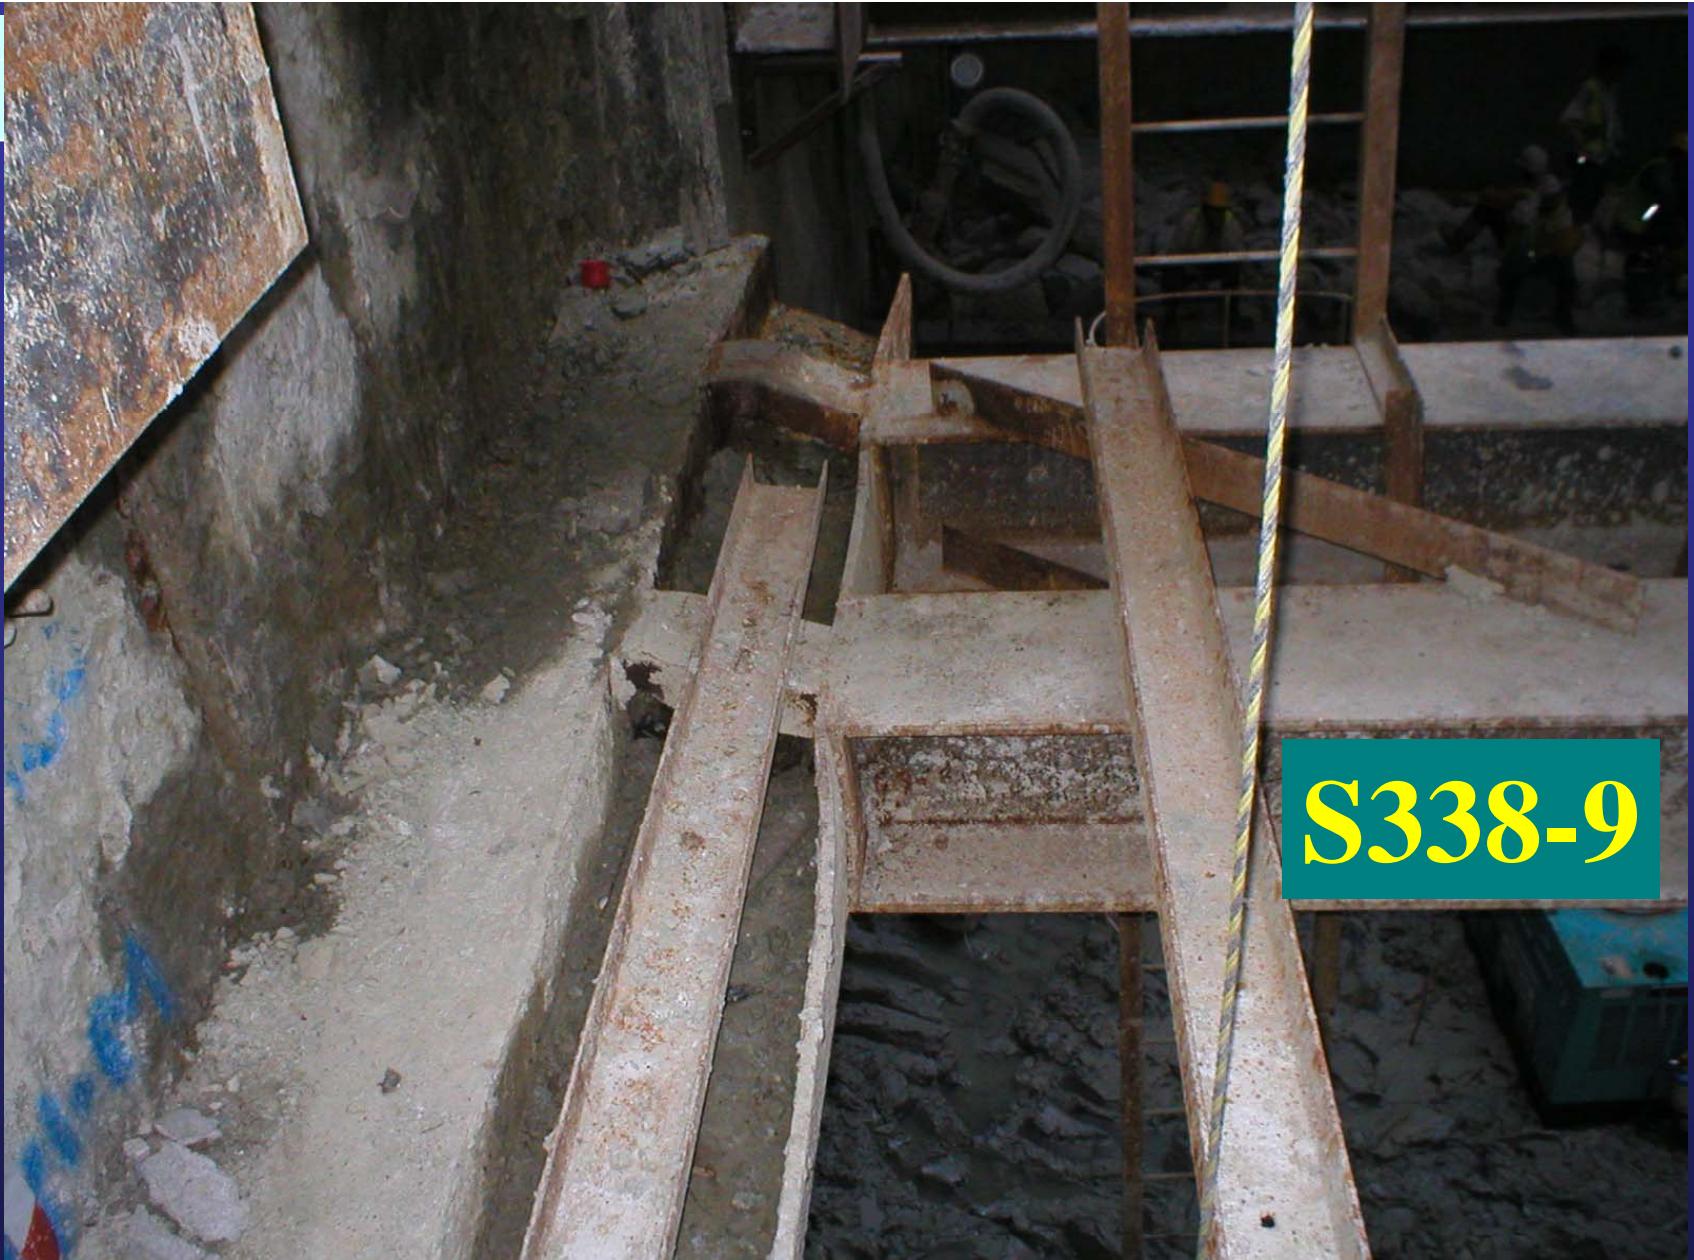
S338-9

*Strut 338-9 north wall*
