CE394M: Finite Element Analysis in Geotechnical Engineering

2 Nicoll Highway Collapse, Singapore

- The Collapse
- Post collapse investigation

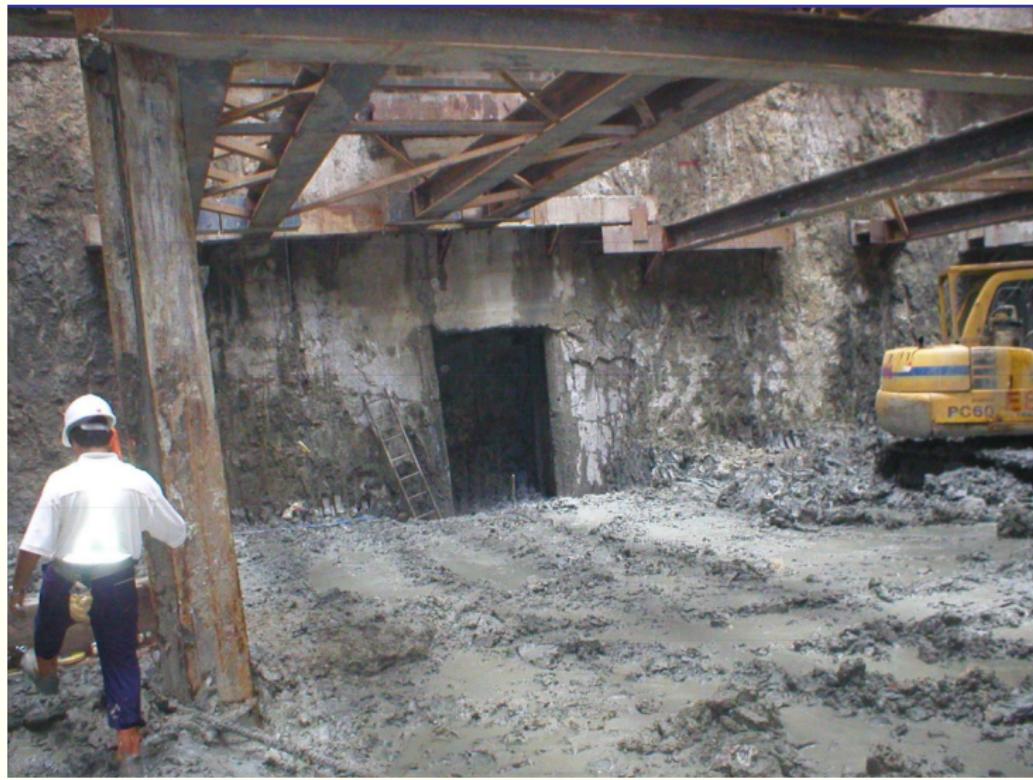
Excavating 10th level of struts

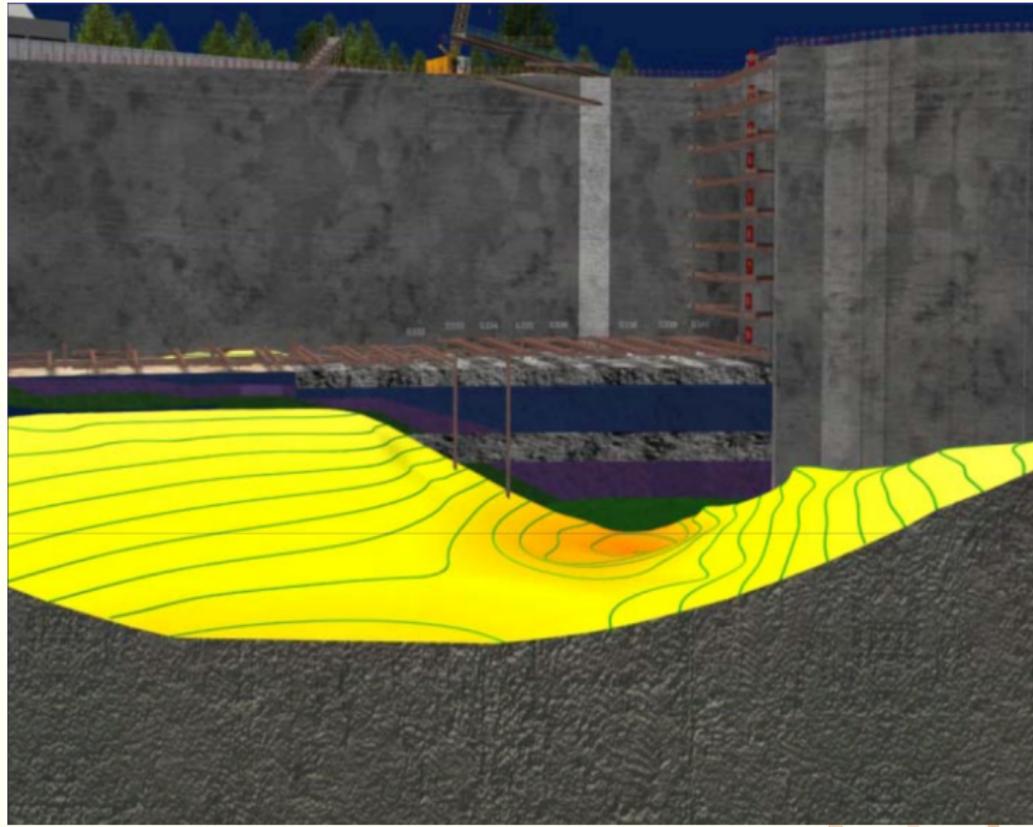
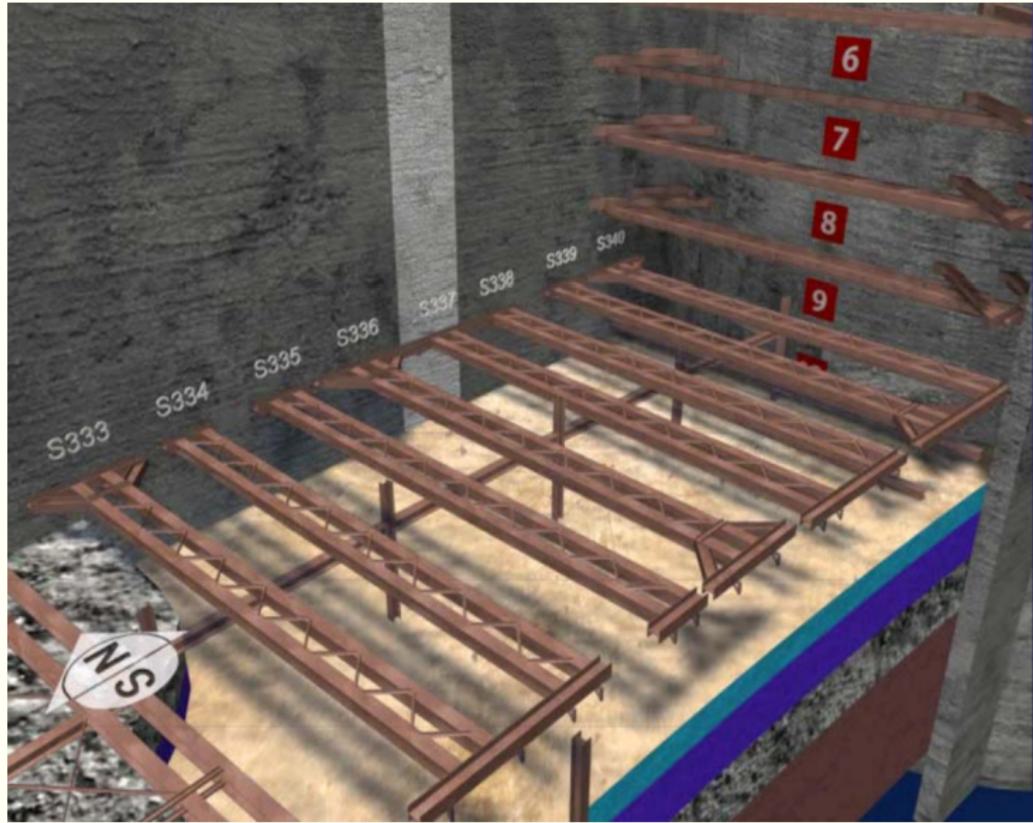
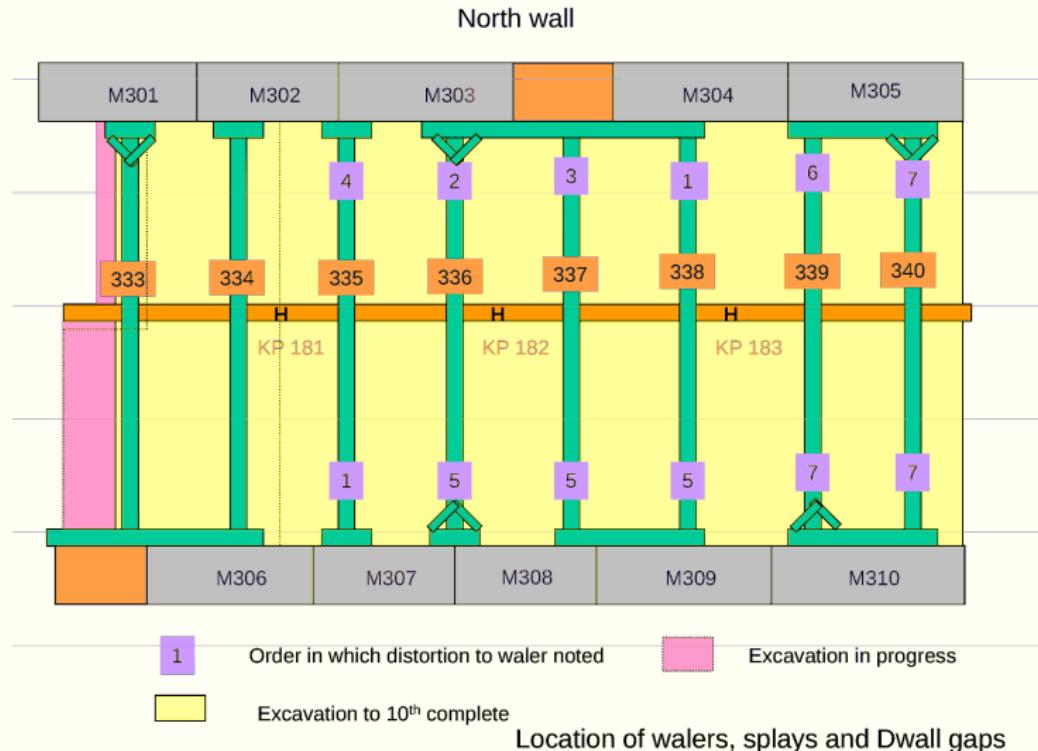
On the morning of collapse

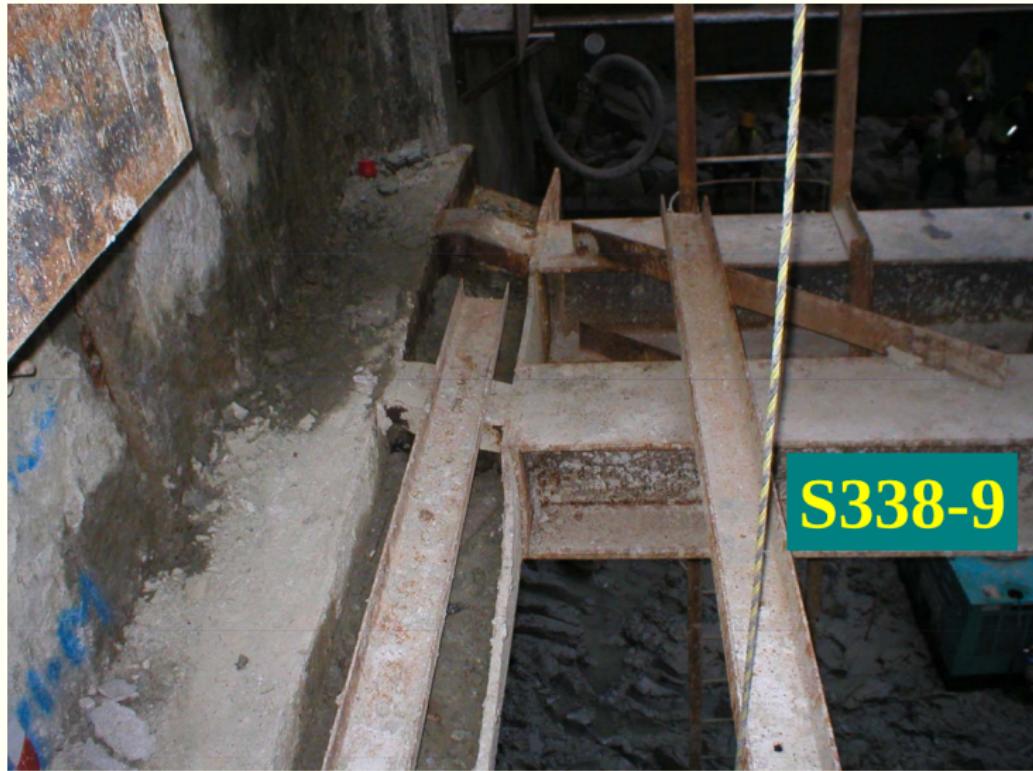
Strut 338 North side

On the morning of collapse

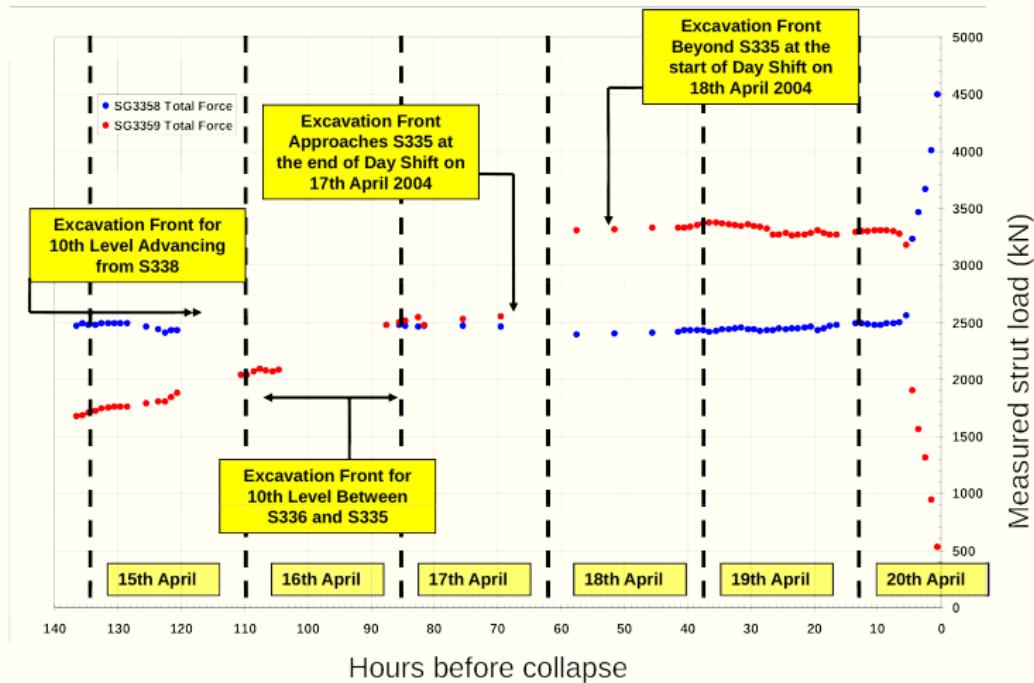
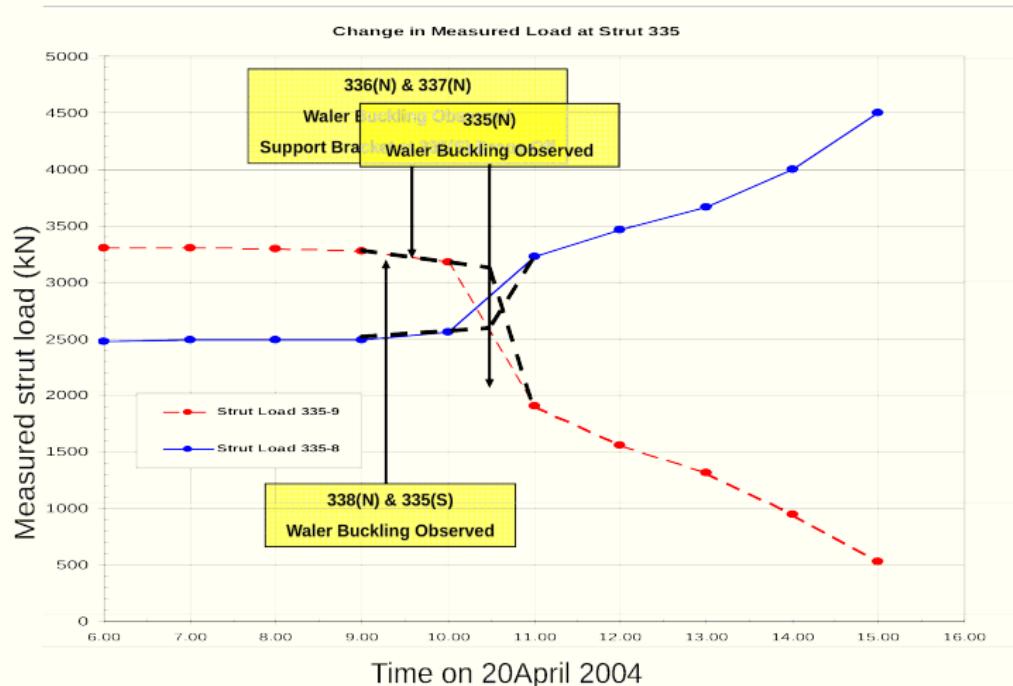
Hours before collapse

The trends were consistent with there being yielding of the 0th level strut-waler connection when the excavation passed beneath but with no further significant changes in load in either the 9th or 8th level struts until the collapse was initiated.

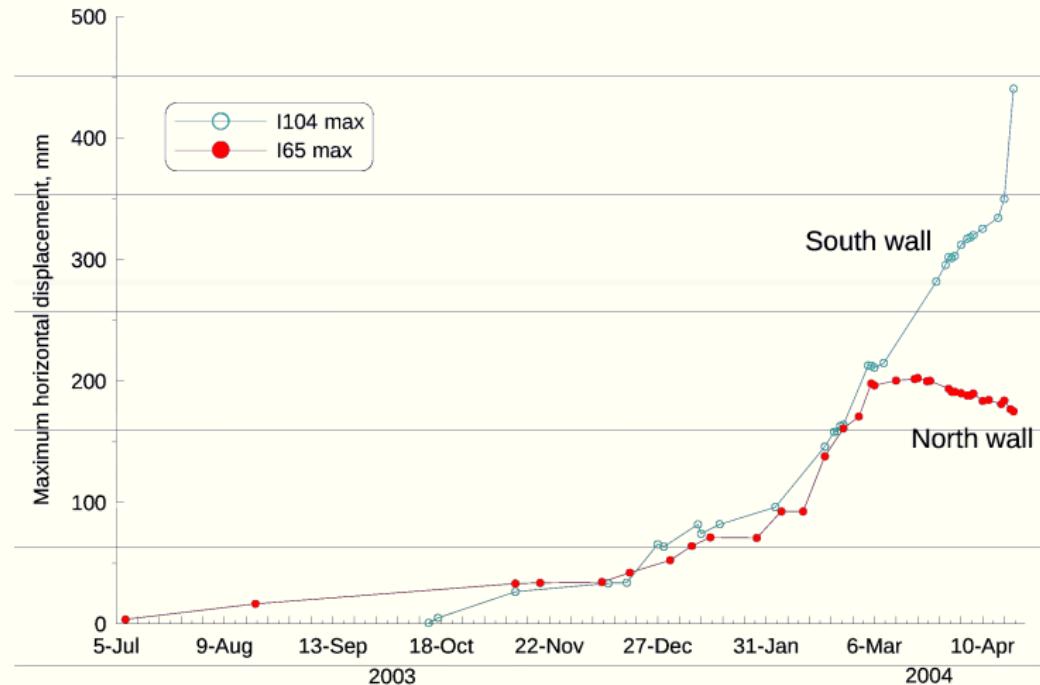
Leading up to the collapse: Inclinometer

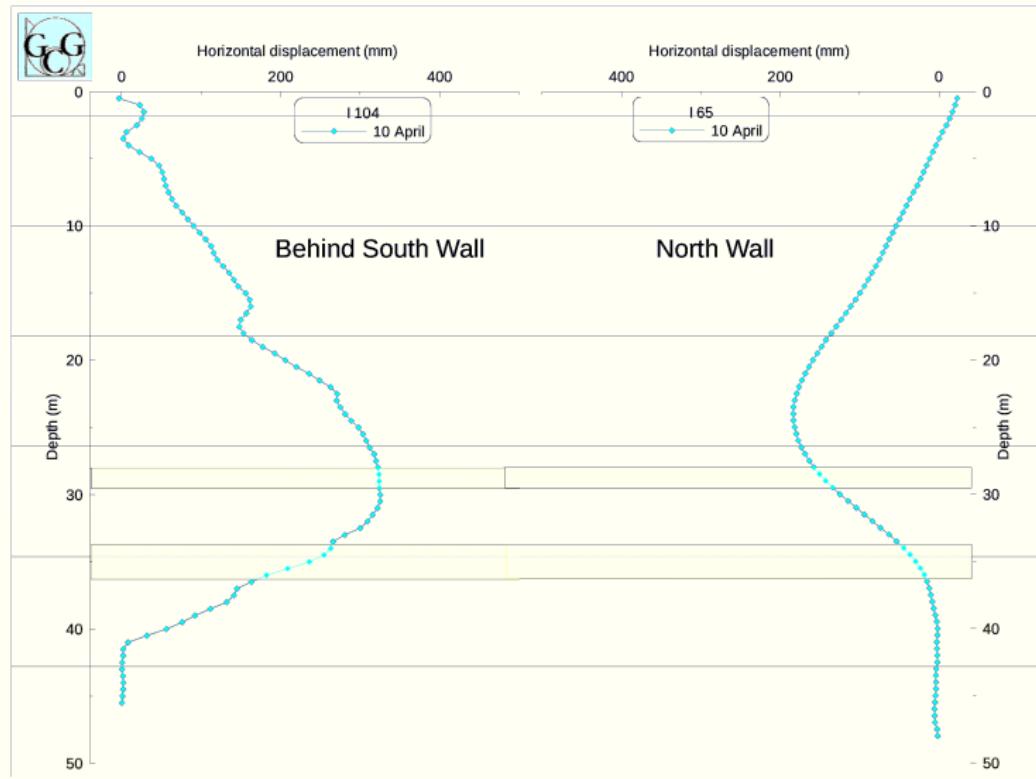
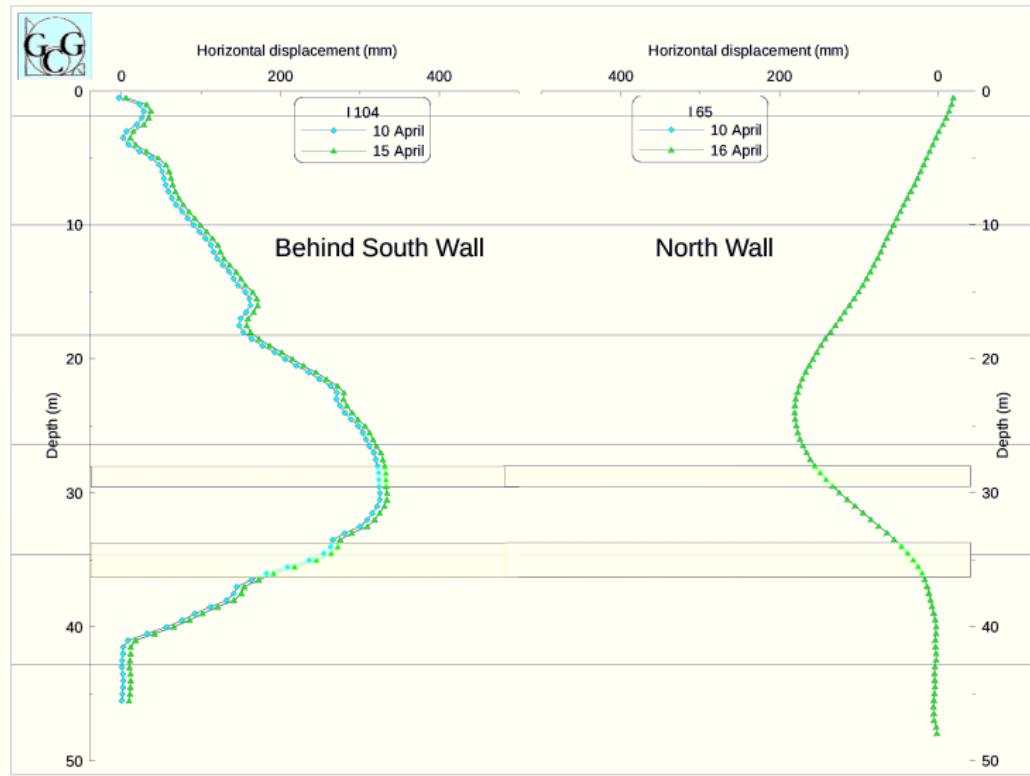
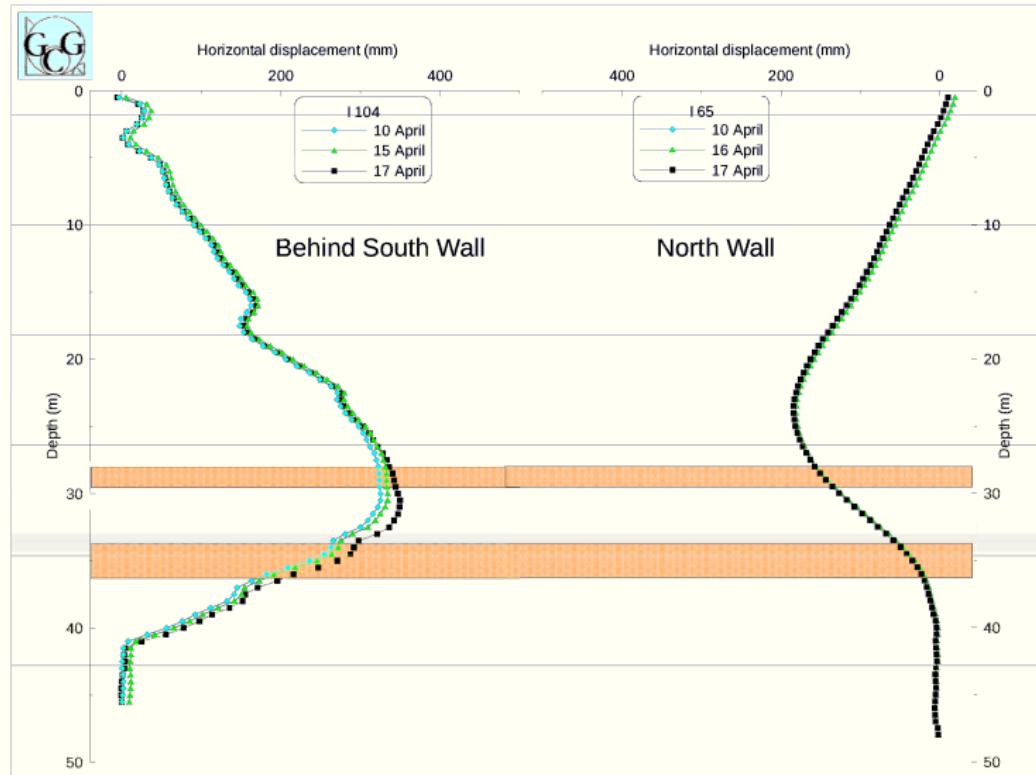
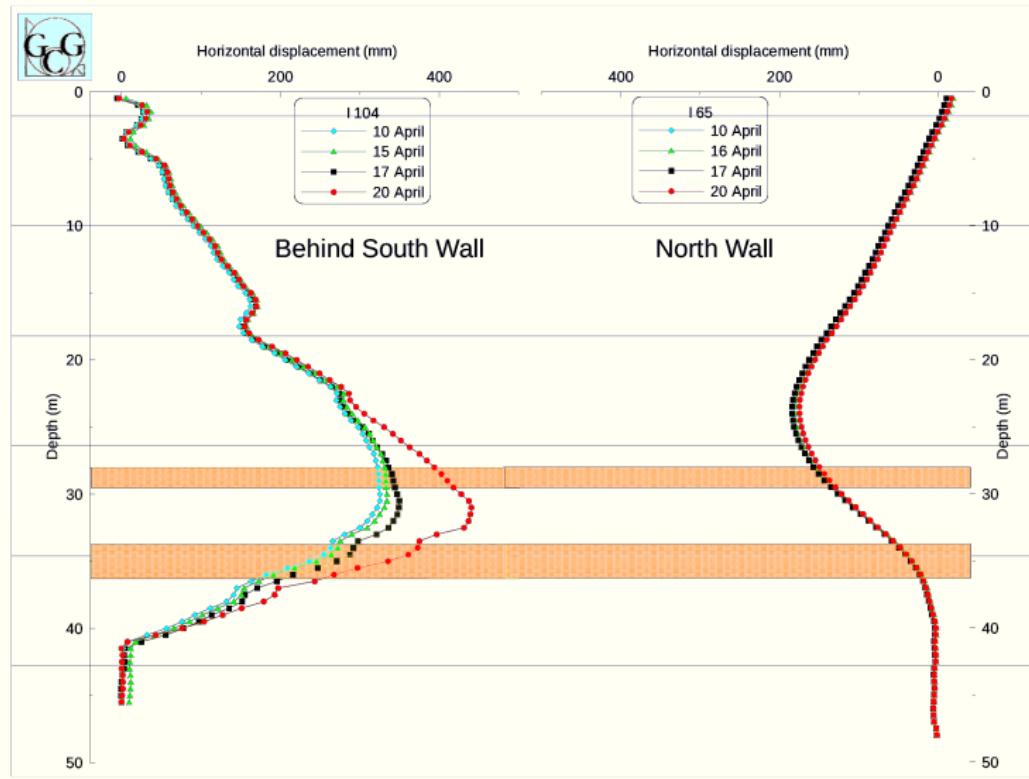
Leading up to the collapse: Wall displacements

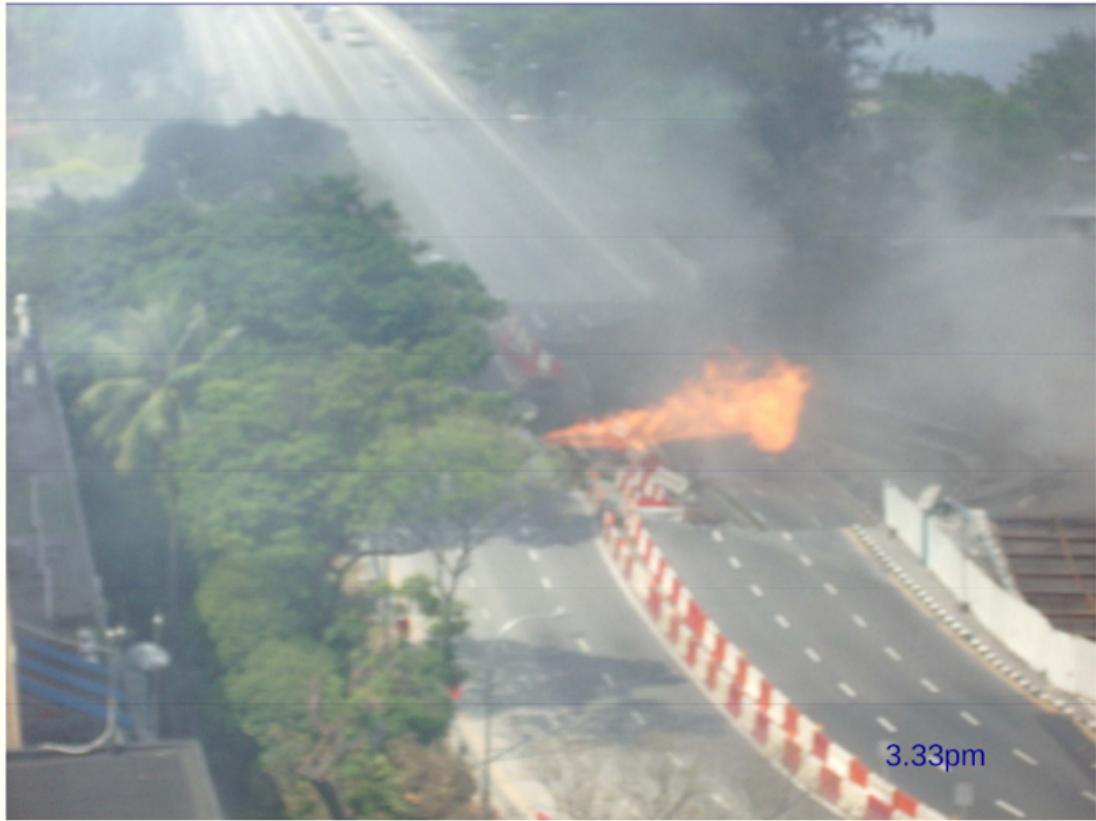
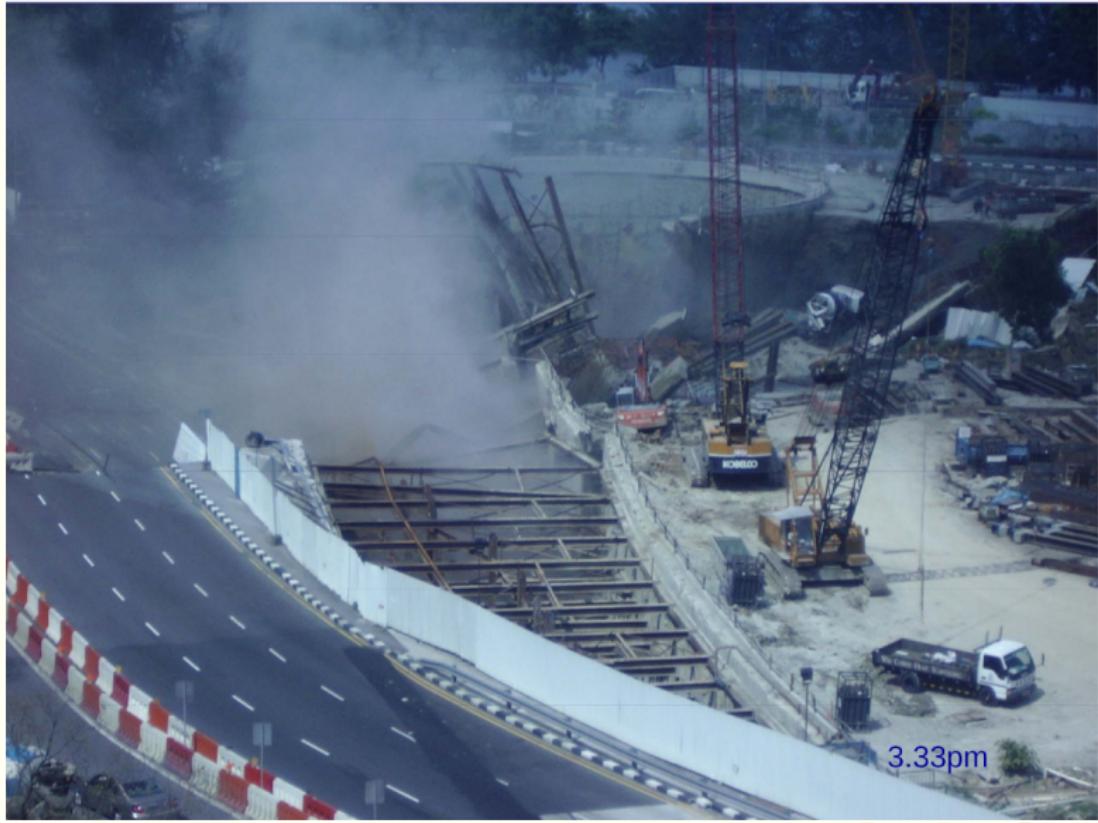
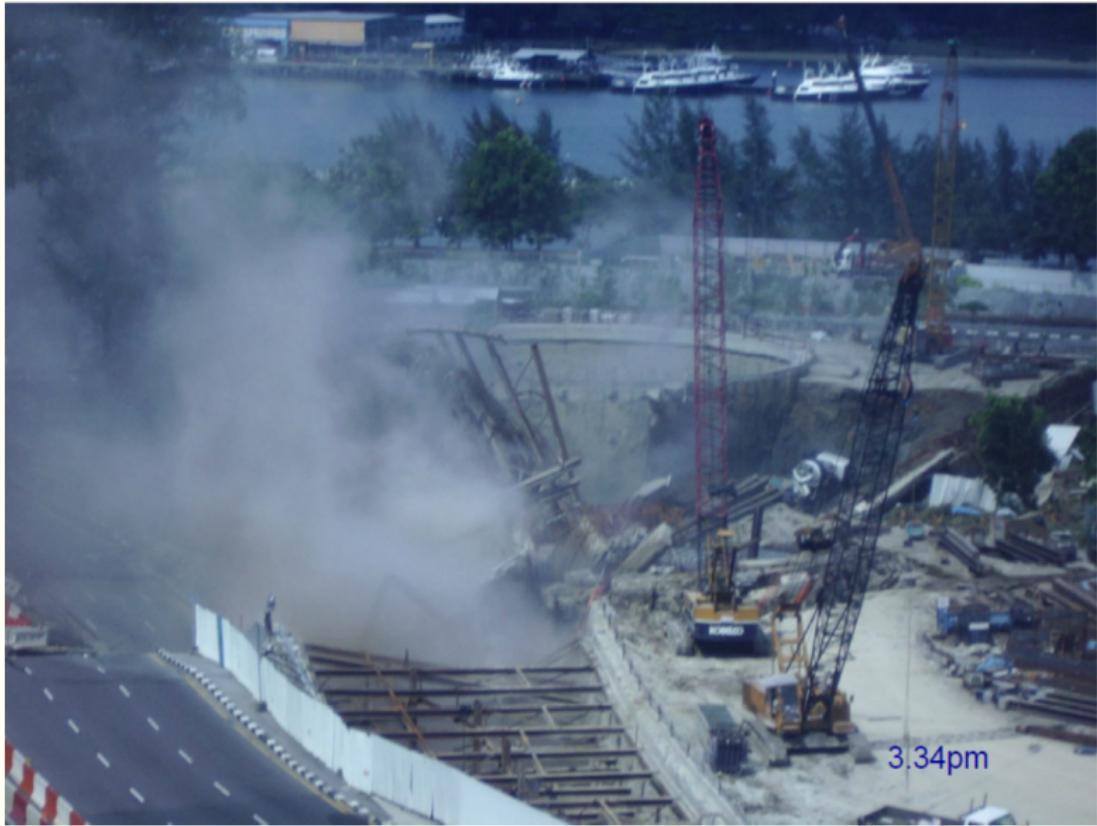
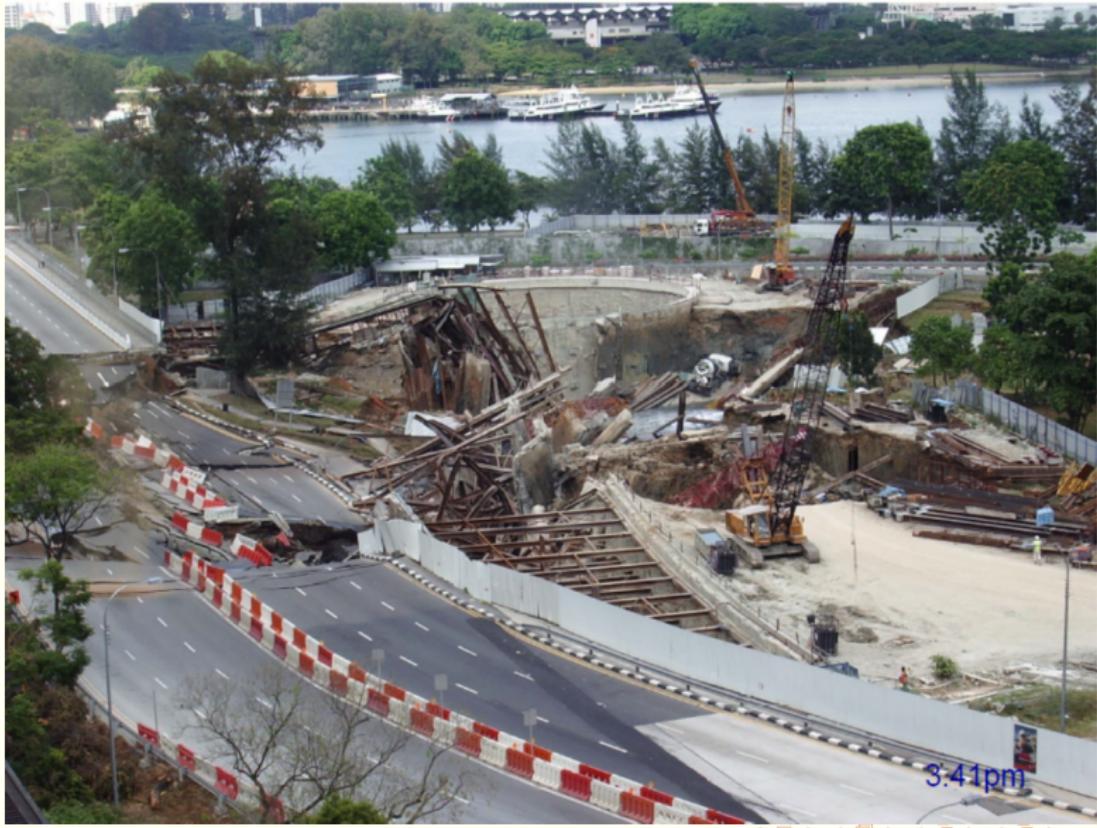
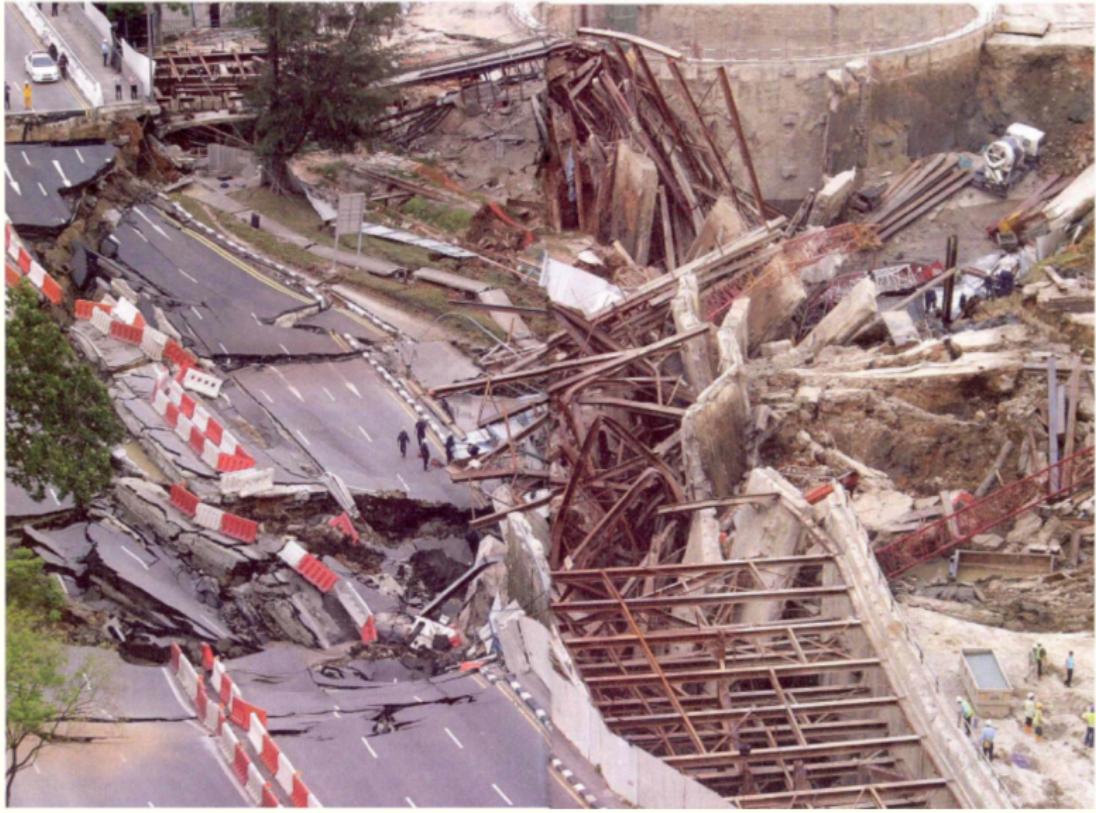
The collapse

Another chief reason for the failure was the under design of the waler-strut connection. Designers misinterpreted the **stiff bearing length for the C-channels as per BS 5950 to 400 mm instead of using 65 mm**. Waler connections with C-channels were designed with the effective length factor of 0.7, where the end conditions were unrestrained and a factor of 1.2 should have been used. This resulted in axial design capacity that was about 70% of the assumed design load for the connection (COI 2005, pp 1-16). Also in some locations the splays in the waler strut connection had been omitted during construction (NCE, 2005). These design and construction errors resulted in the failure of the 9th level strut-waler system. The under designed diaphragm wall could not resist the redistributed loads as the 9th level strut-waler system failed resulting in the collapse of the tunnel.

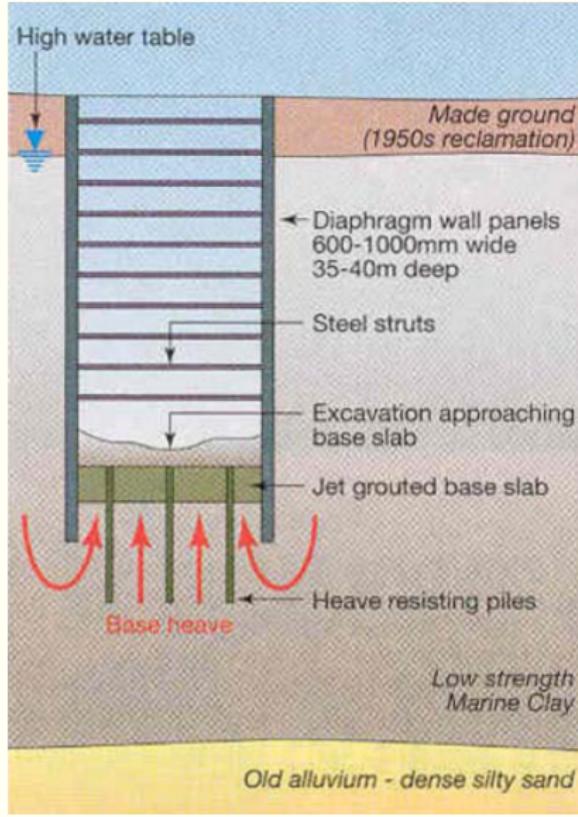
Reasons for collapse

1. Problem with jet grouting at the base of the slab.
2. Struts design - connectors
3. Use of effective stress parameters to do an undrained excavation.

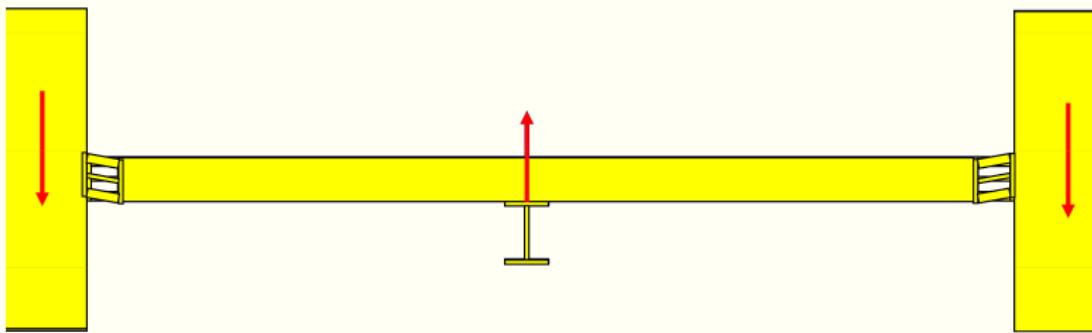
Strut design: Relative vertical displacements

Relative vertical displacement between the King Post and the Dwall

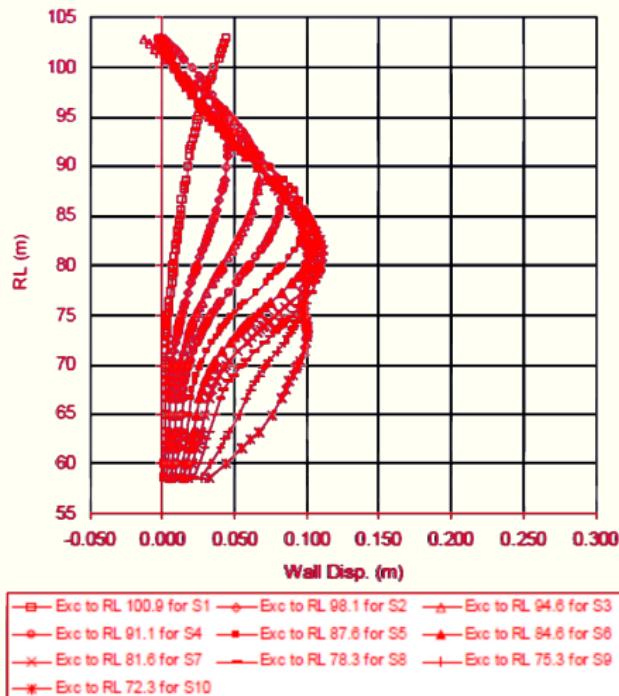
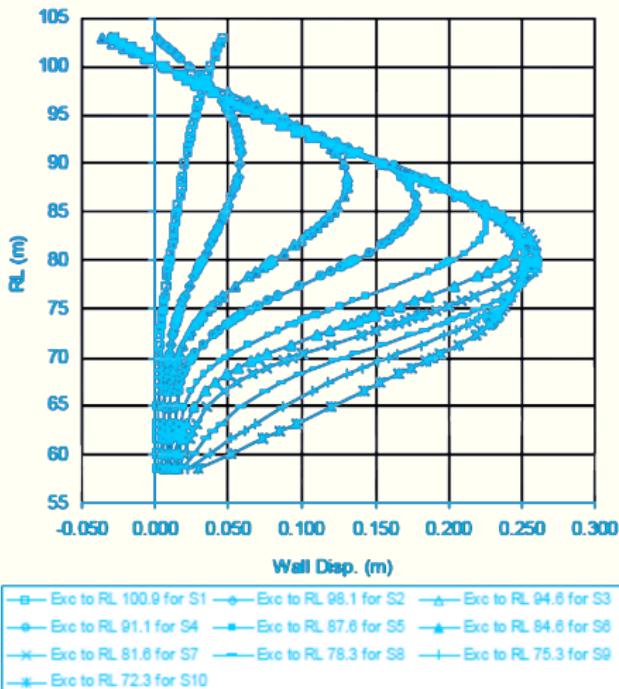
Wall displacements: Effective stress vs Undrained strength

- Method A over-estimates the undrained shear strength of normally and lightly overconsolidated clays
- Its use led to a 50% under-estimate of wall displacements and of bending moments and an under-estimate of the 9 th level strut force of 10%
- The larger than predicted displacements mobilised the capacity of the JGP layers at an earlier stage than predicted
