CE394M: Finite Element Analysis in Geotechnical Engineering

1 Nicoll Highway Collapse, Singapore

- The Collapse
- Post collapse investigation

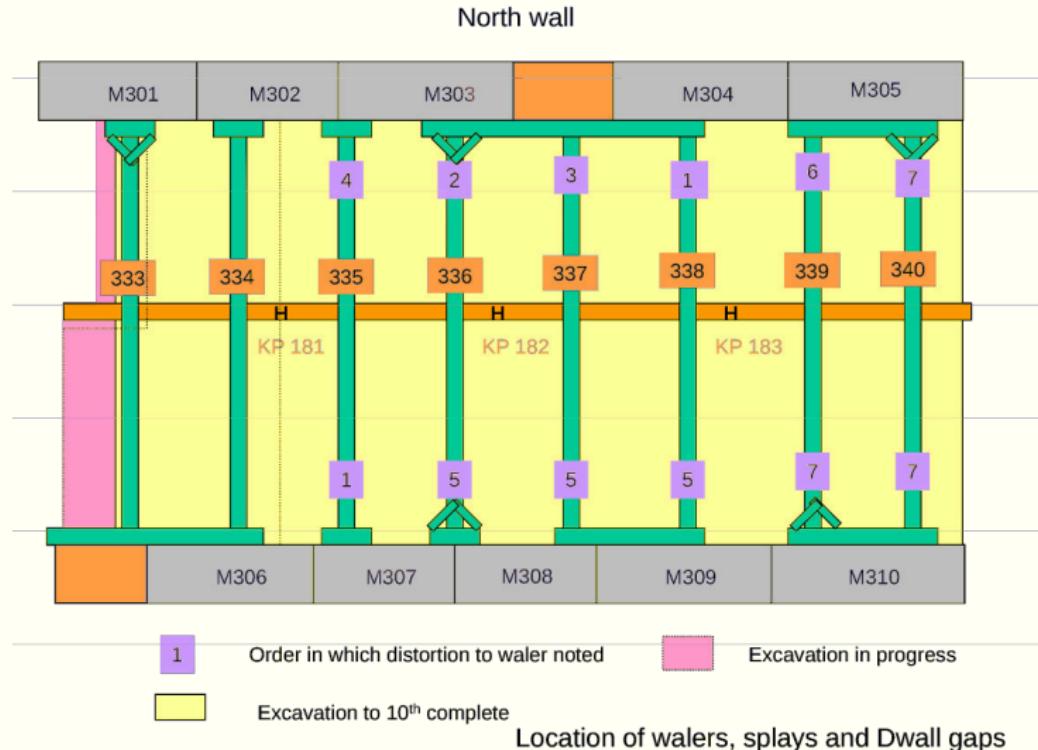
On the morning of collapse

In the meanwhile the excavation progressed to about the 10th level of struts. The temporary layer of jet grout piles below the 10th level which was constructed to add to the stability of the excavation was now removed to finish the excavation of the tunnel. Two more temporary struts were added to stabilize the excavation. By 19th April the excavation of the tunnel was completed and the last bit of the tunnel section connecting it with the other section of the tunnel was cut out and the tunnels were connected. On the day of the collapse the 20th of April at around 8:00 am the workers at the site heard sounds from the multi-level strut system. The strange sounds were investigated by the senior engineers of the contractor and they found that a lot of the waler-strut connections had yielded. They immediately instructed everyone to leave the worksite.

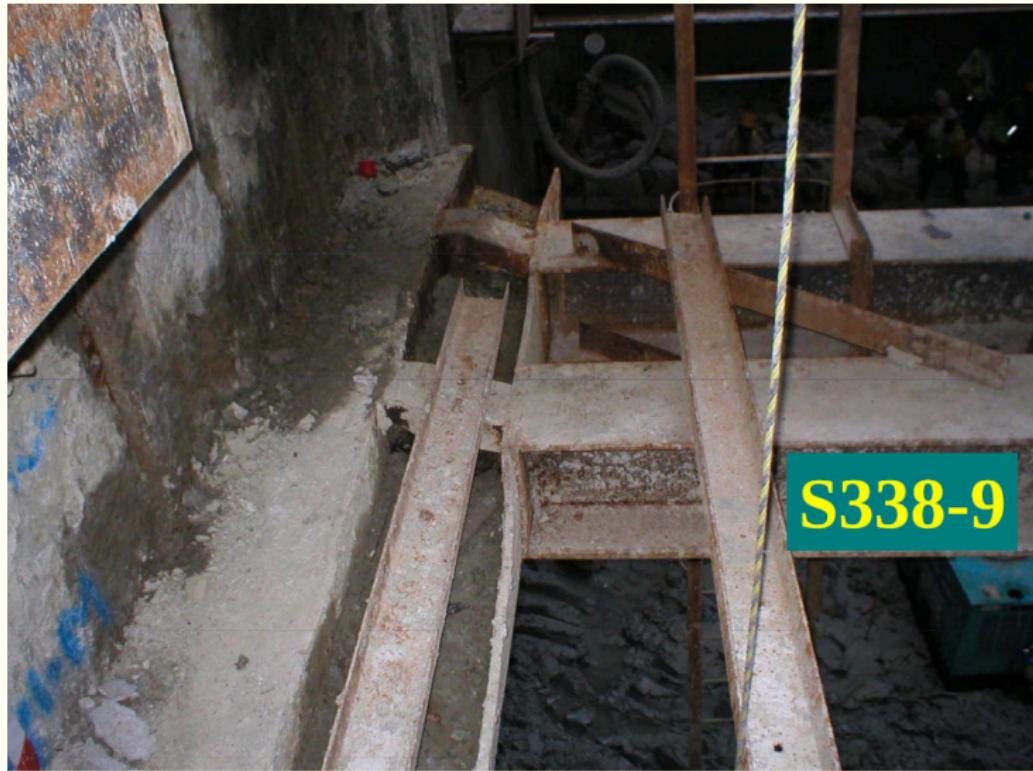
Strut 338 North side

On the morning of collapse

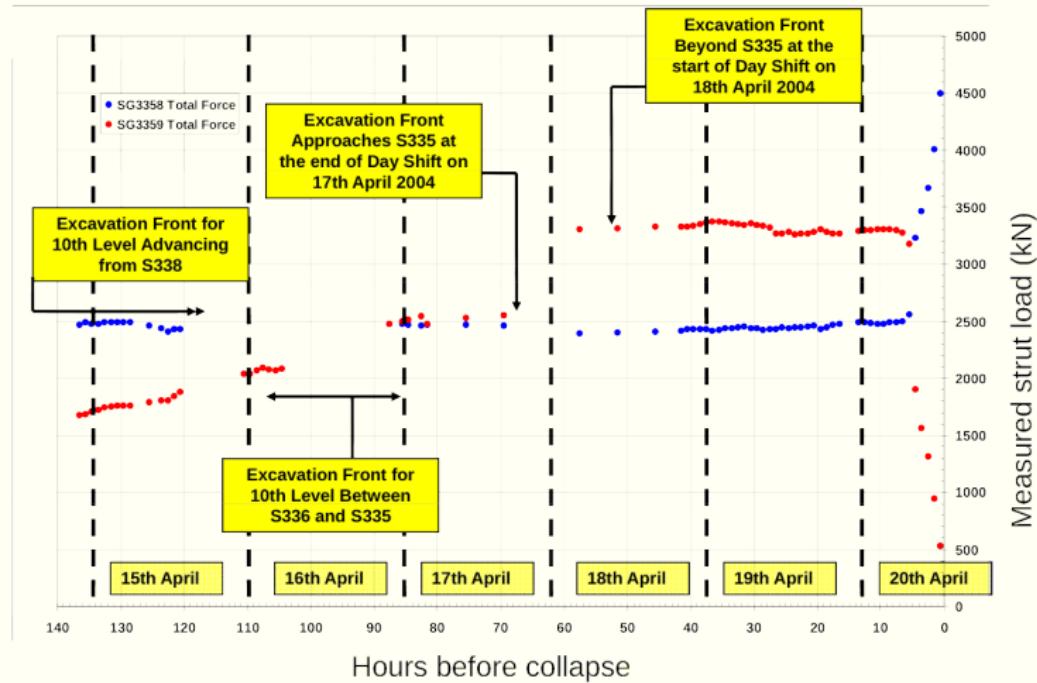
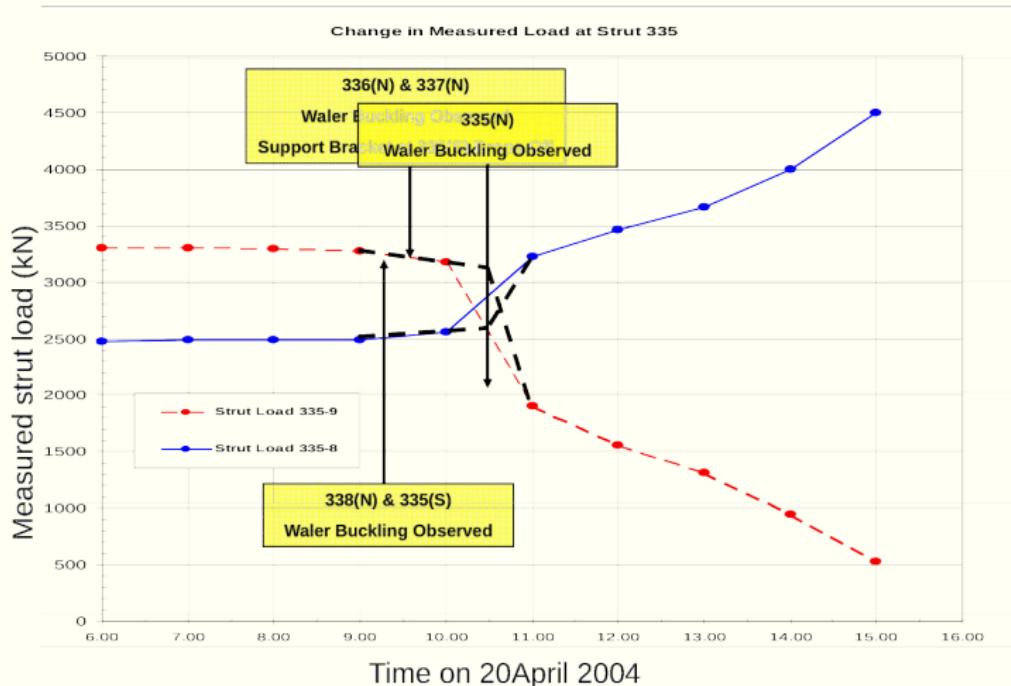
Hours before collapse

By noon engineers from the owner's side were also present at the worksite and they along with the contractor's engineers decided to pour concrete at the 9th level of the strut to stabilize the excavation and prevent it from caving in. By 3:30 pm the temporary system gave away and the tunnel had caved in.

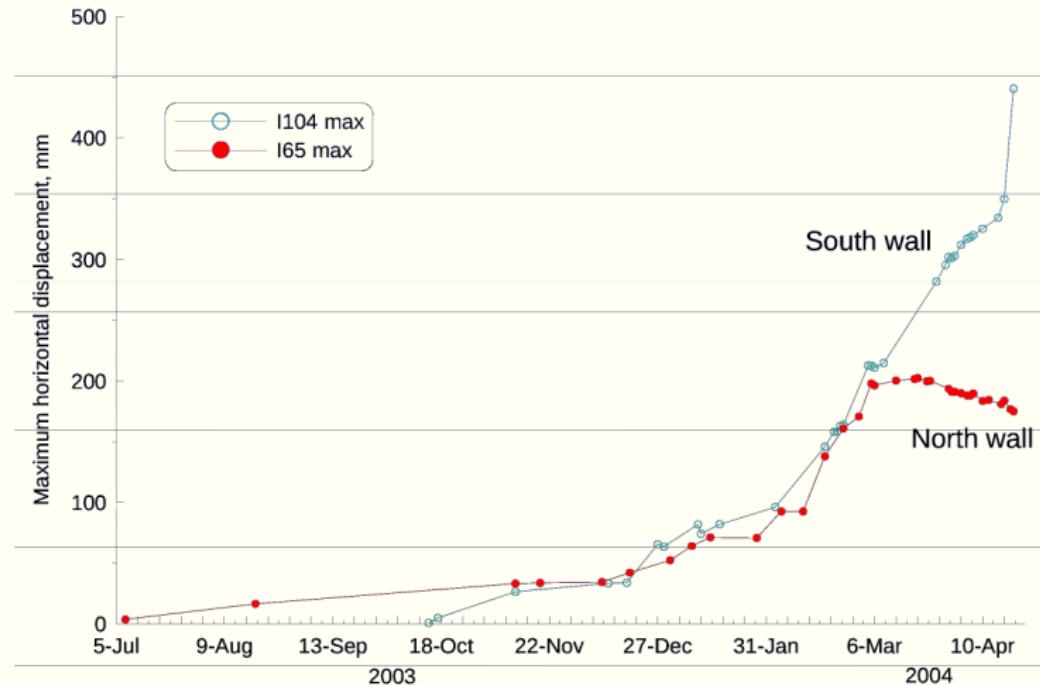
Leading up to the collapse: Inclinometer

The trends were consistent with there being yielding of the 0th level strut-waler connection when the excavation passed beneath but with no further significant changes in load in either the 9th or 8th level struts until the collapse was initiated.

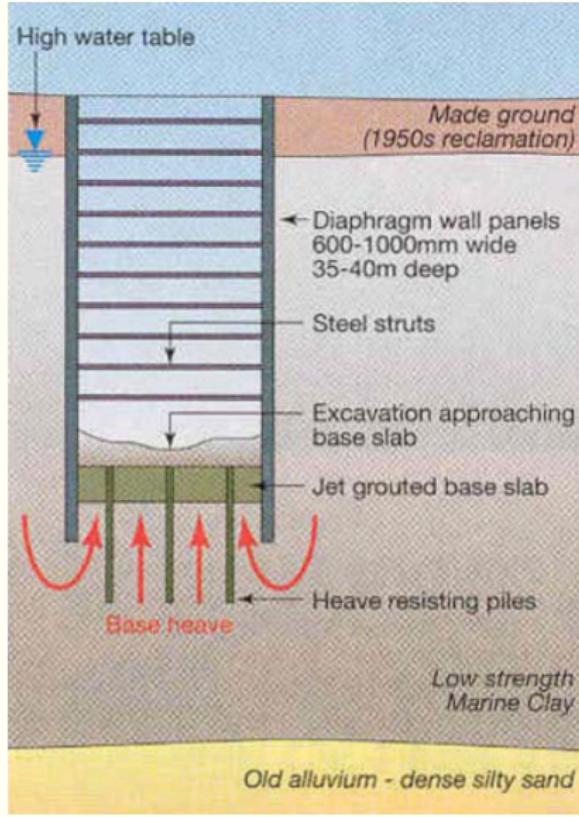
Reasons for collapse

1. Problem with jet grouting at the base of the slab.
2. Struts design - connectors
3. Use of effective stress parameters to do an undrained excavation.

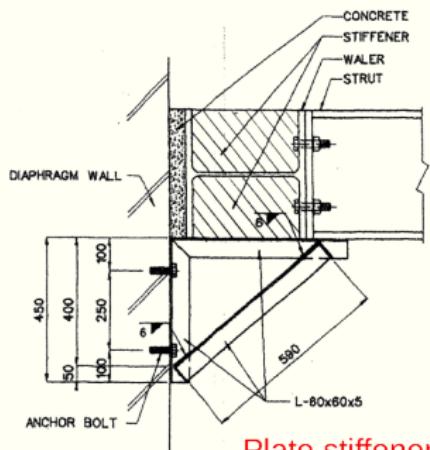
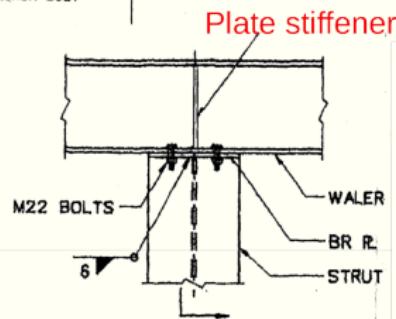
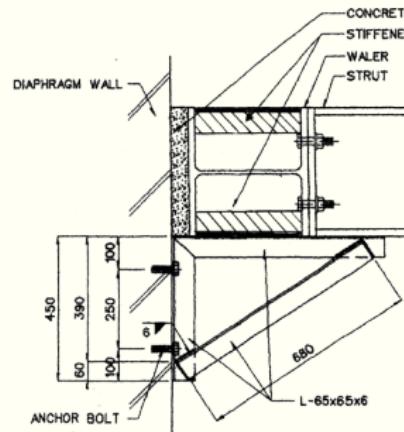
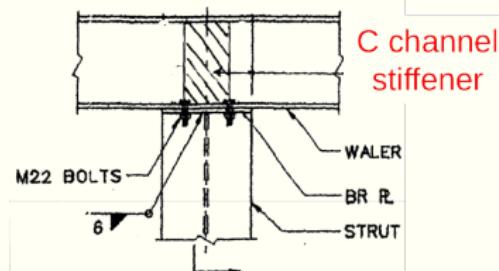
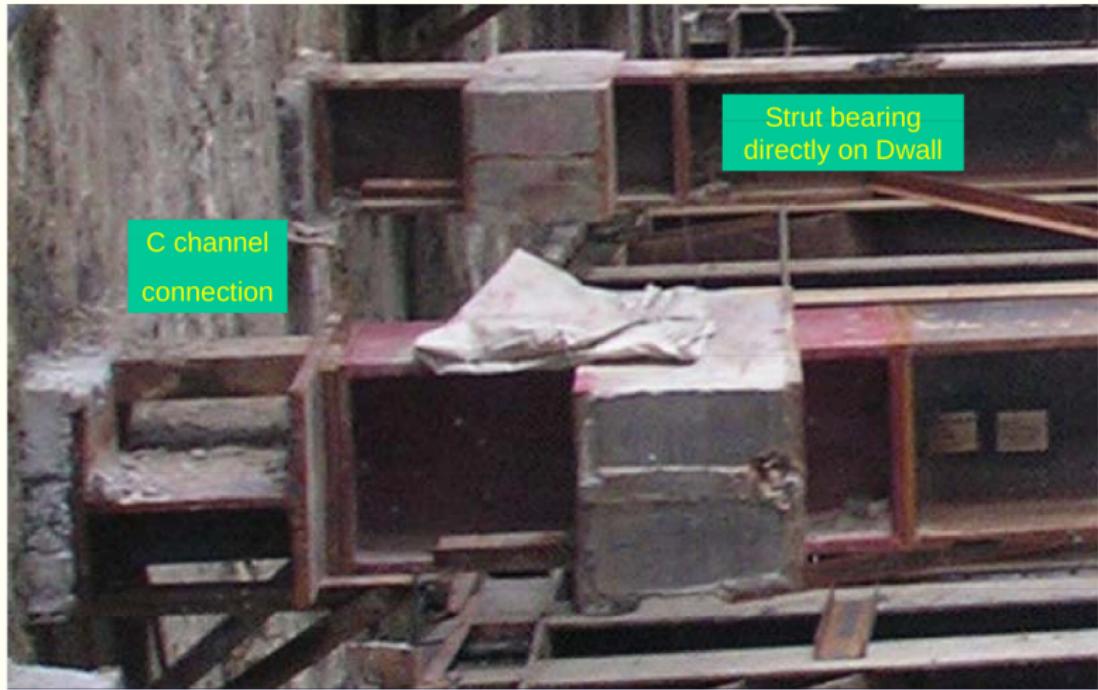
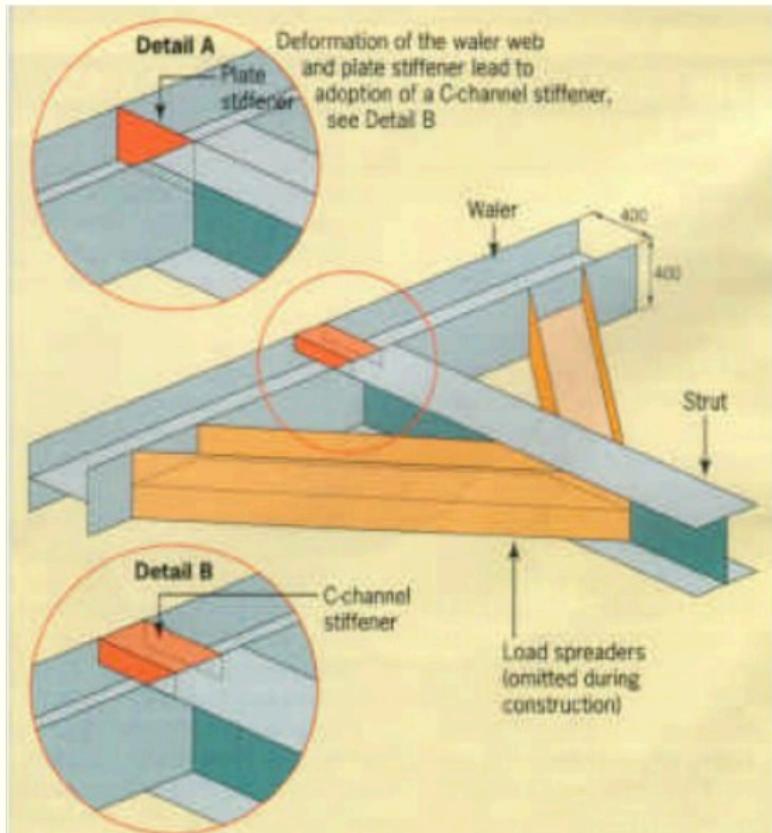
Strut design: Waler connection

Another chief reason for the failure was the under design of the waler-strut connection. Designers misinterpreted the **stiff bearing length for the C-channels as per BS 5950 to 400 mm instead of using 65 mm**. Waler connections with C-channels were designed with the effective length factor of 0.7, where the end conditions were unrestrained and a factor of 1.2 should have been used. This resulted in axial design capacity that was about 70% of the assumed design load for the connection (COI 2005, pp 1-16). Also in some locations the splays in the waler strut connection had been omitted during construction (NCE, 2005). These design and construction errors resulted in the failure of the 9th level strut-waler system. The under designed diaphragm wall could not resist the redistributed loads as the 9th level strut-waler system failed resulting in the collapse of the tunnel.

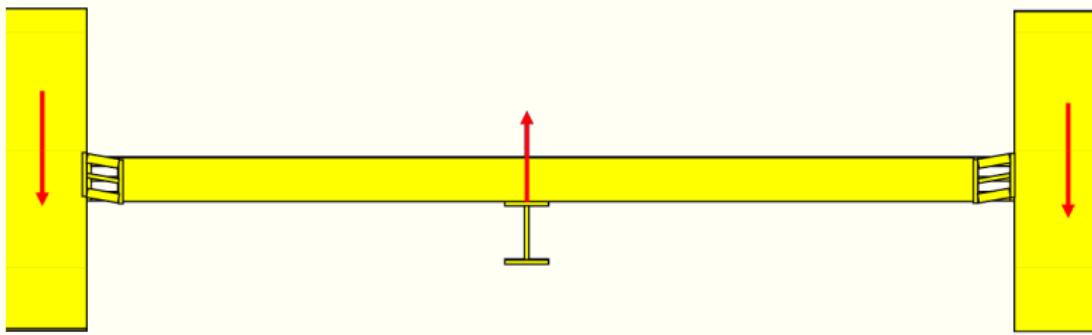
Strut design: Relative vertical displacements

Relative vertical displacement between the King Post and the Dwall

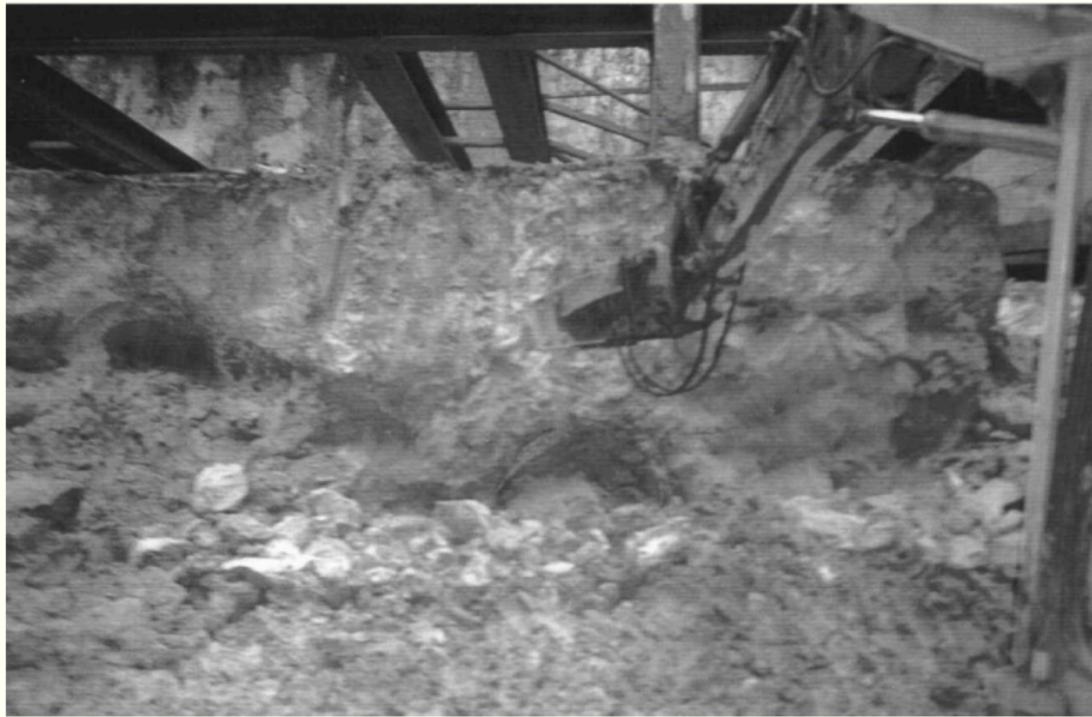
Excavation of sacrificial jet grout

There were two layers of interlocking jet grout piles. The upper layer of the jet grout pile was 1.5 m thick and was temporary and the lower layer of the jet grout pile was 2.5 m thick and formed the base of the tunnel. Jet grout pile layers were built to minimize the deflection of the walls while the tunnel was being excavated. Bored piles were constructed to support the rail boxes. Excavation was supported by a system of steel king post and 10 levels of struts placed at 4m center to center. As the excavation progressed the struts were constructed and before the construction of the 10th level of strut the temporary layer of the jet gout pile was removed.

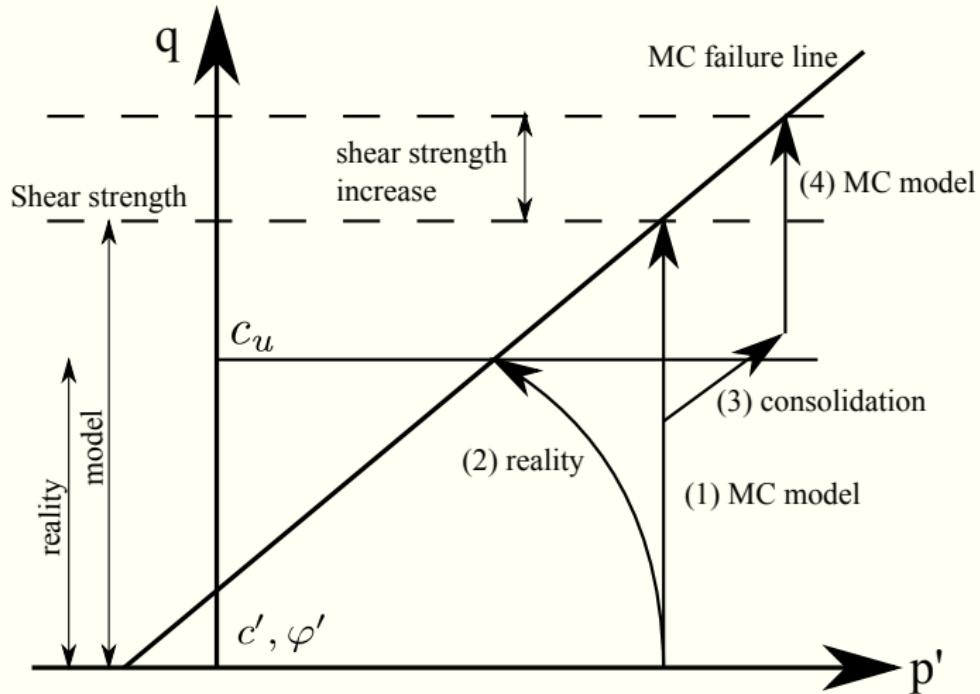
Undrained effective stress analysis

- Method A and Method B refers to 2 alternatives modeling of undrained behaviour in Plaxis.
- Method A is an effective stress analysis** of an undrained problem it assumes an isotropic elastic behavior and a Mohr-Coulomb failure criterion.
- As a result mean effective stress p' is constant until yield.
- Method A was being applied to marine clays which were of low over-consolidation or even under-consolidated because of recent reclamation.

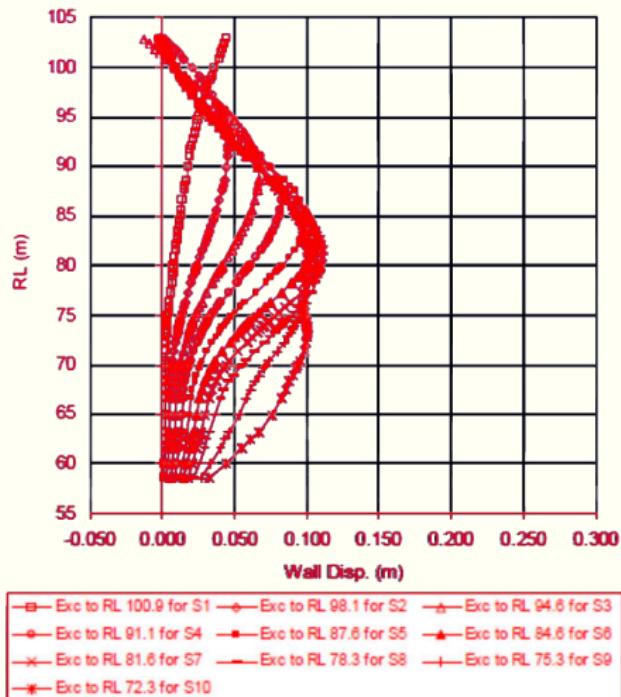
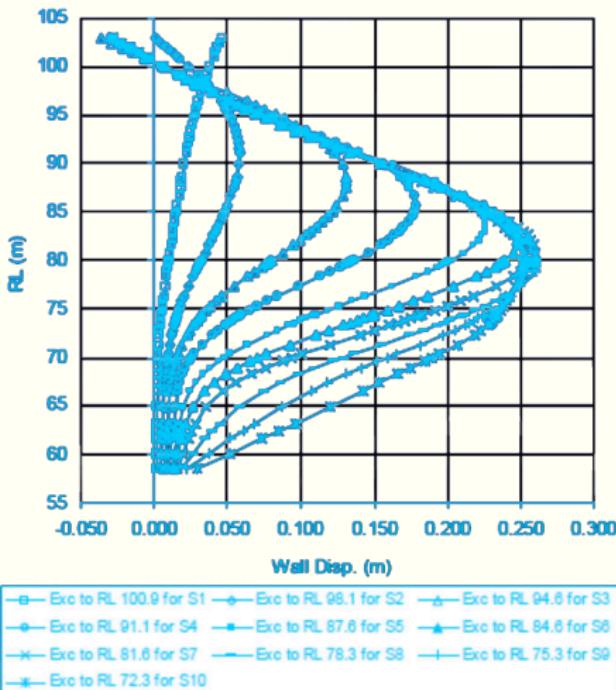
Wall displacements: Effective stress vs Undrained strength

- Method A over-estimates the undrained shear strength of normally and lightly overconsolidated clays
- Its use led to a 50% under-estimate of wall displacements and of bending moments and an under-estimate of the 9 th level strut force of 10%
- The larger than predicted displacements mobilised the capacity of the JGP layers at an earlier stage than predicted
