CE394M: Finite Element Analysis in Geotechnical Engineering

1 Nicoll Highway Collapse, Singapore

- The Collapse
- Post collapse investigation

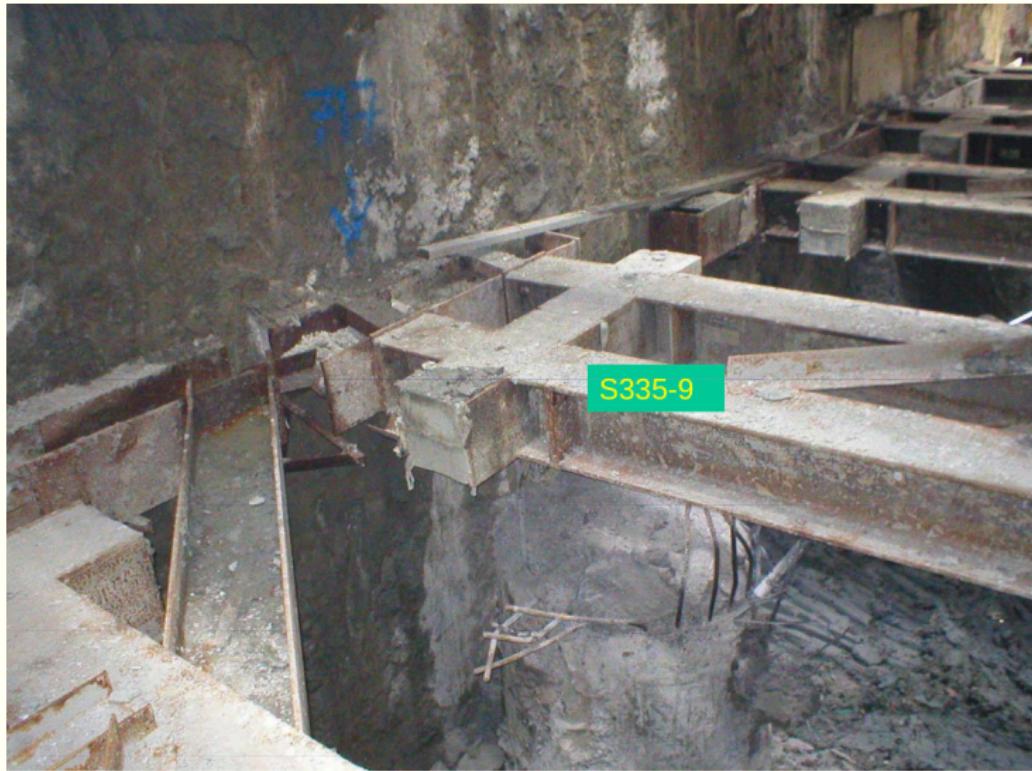
Strut 338 North side

On the morning of collapse

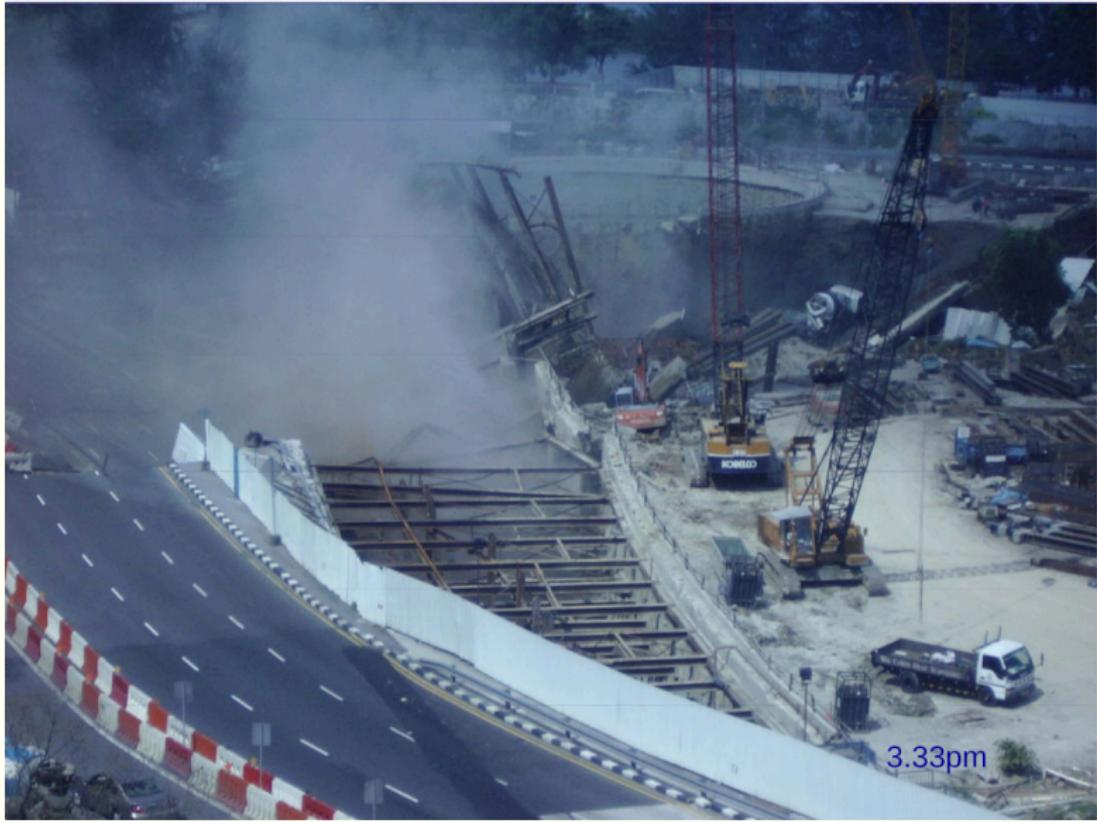
3.33pm

The collapse

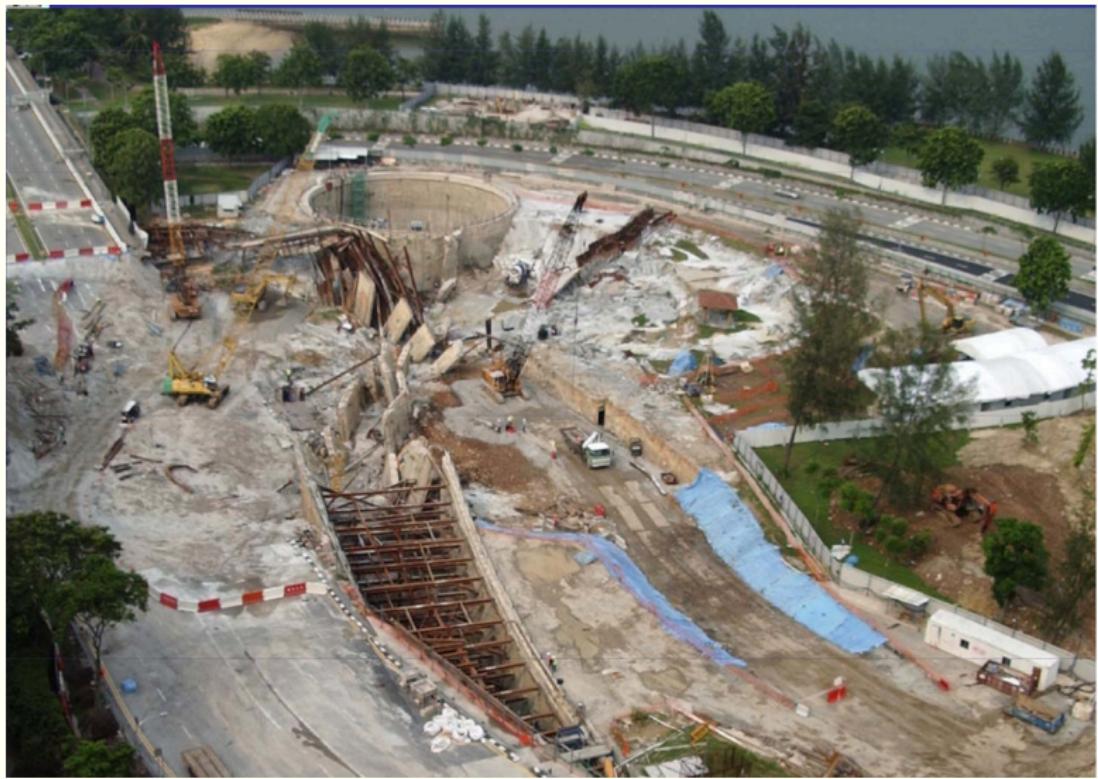
Post collapse

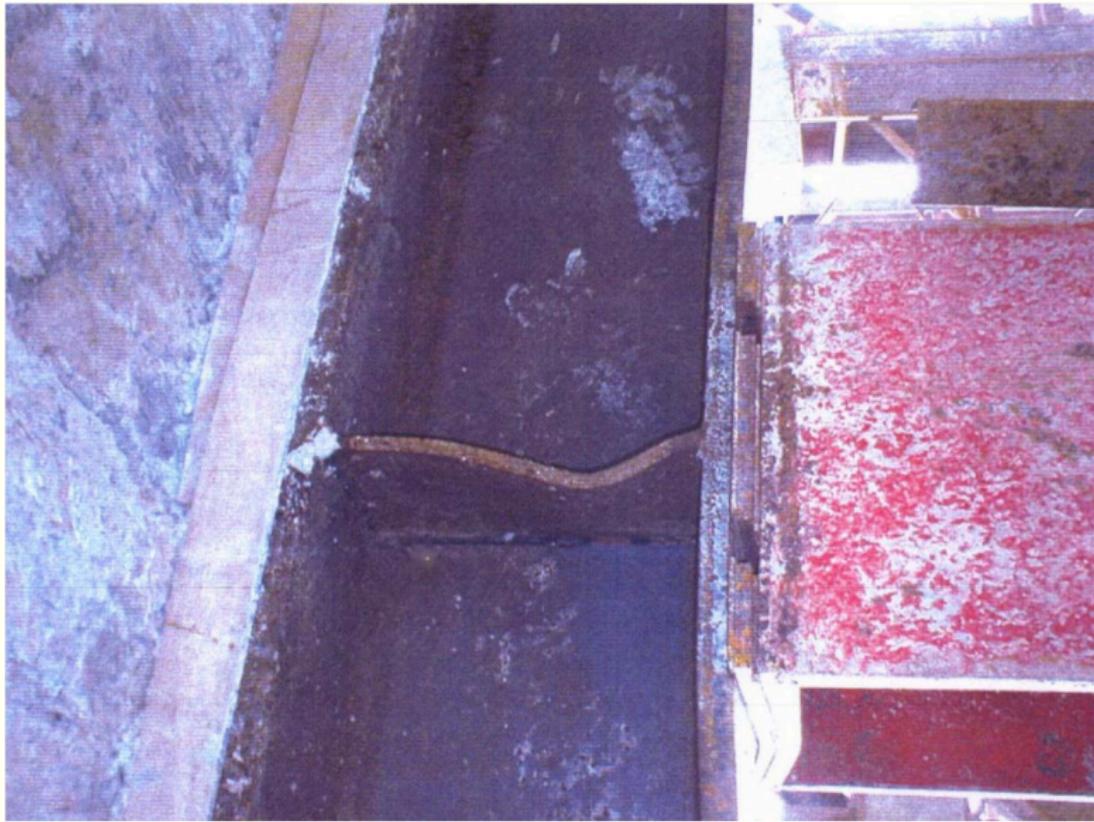
Strut design: Replacing plate-stiffener with C-channel

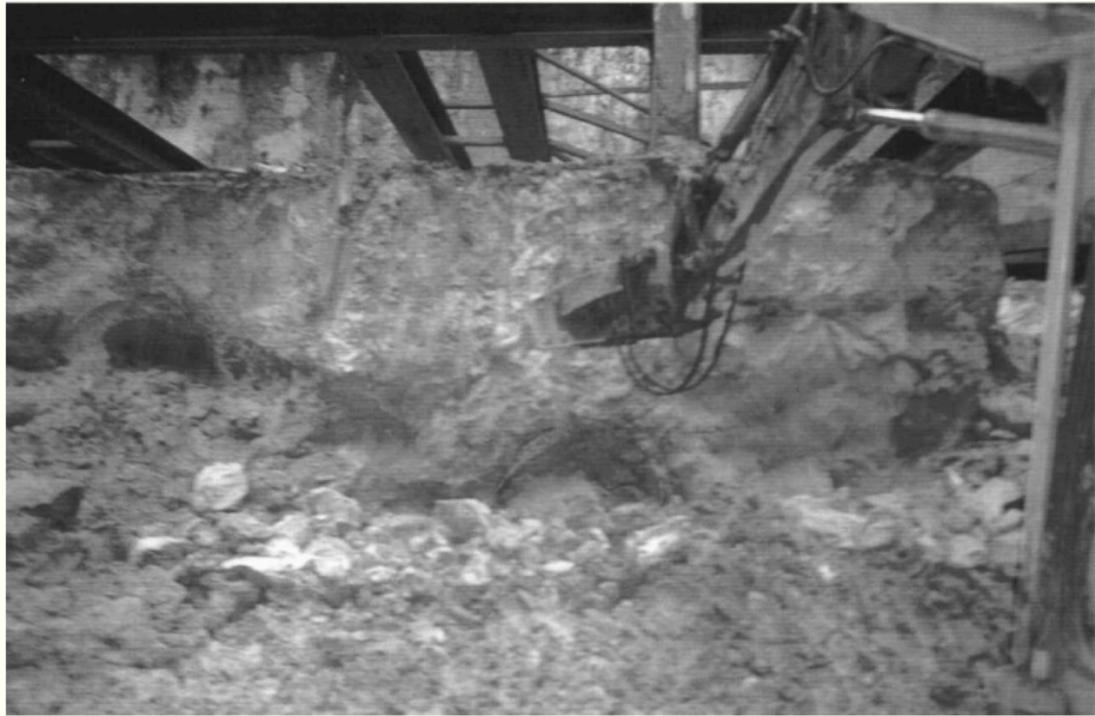
Excavation of sacrificial jet grout
