CE394M: Finite Element Analysis in Geotechnical Engineering

2 Nicoll Highway Collapse, Singapore

- The Collapse
- Post collapse investigation

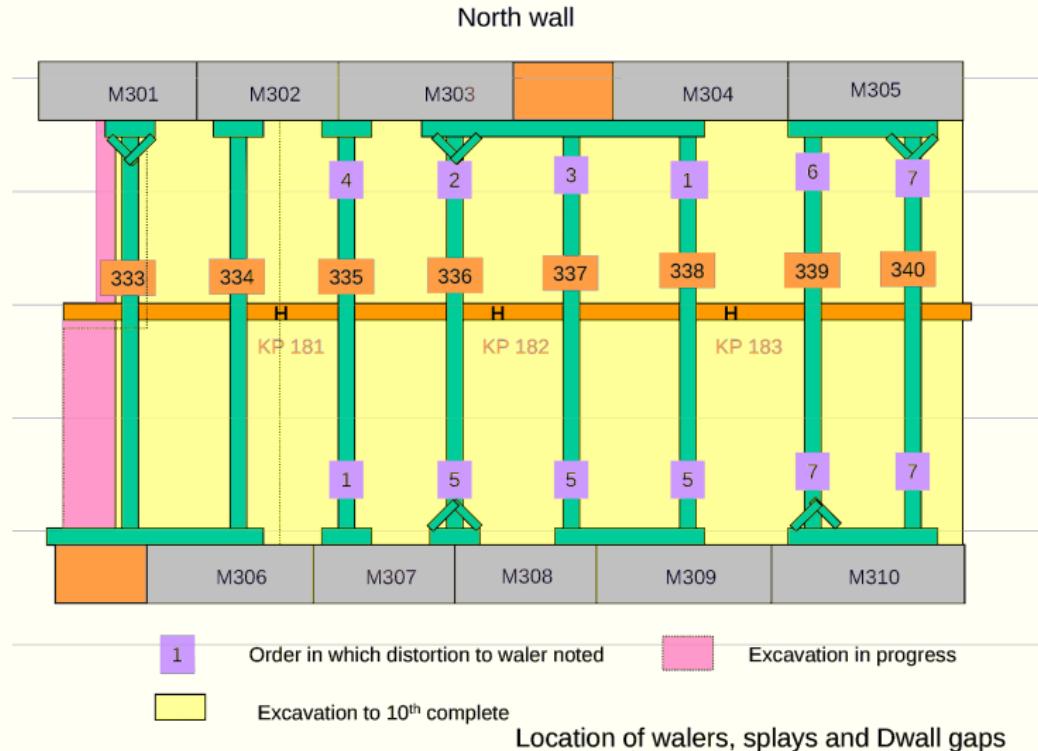
On the morning of collapse

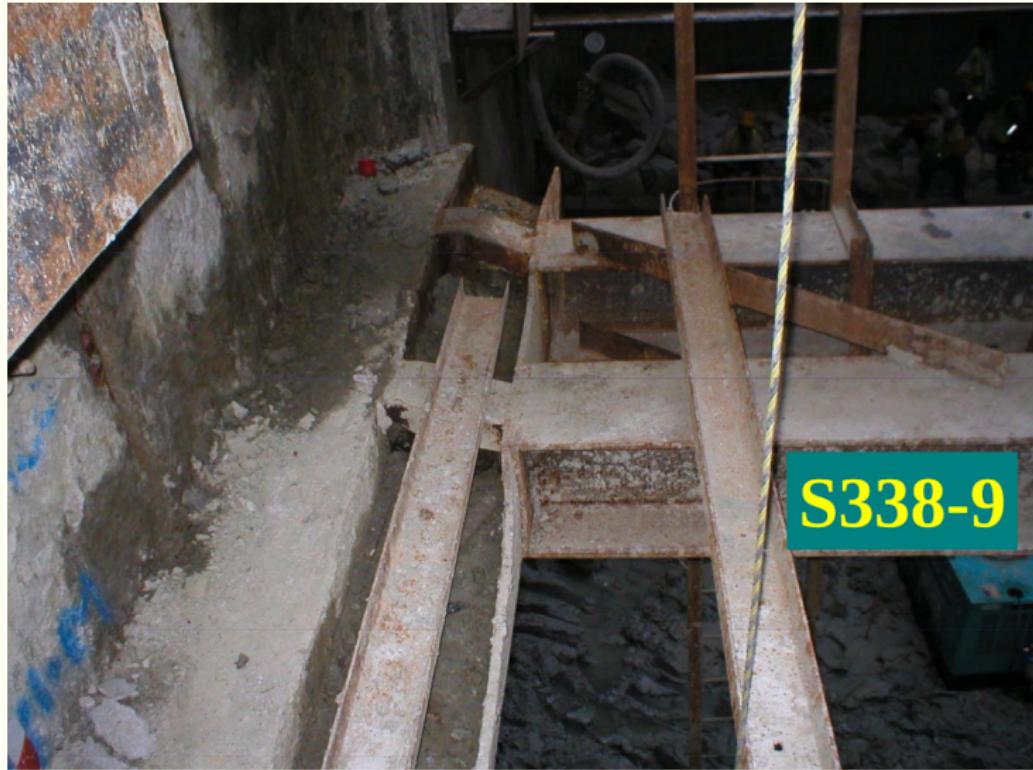
Strut 338 North side

On the morning of collapse

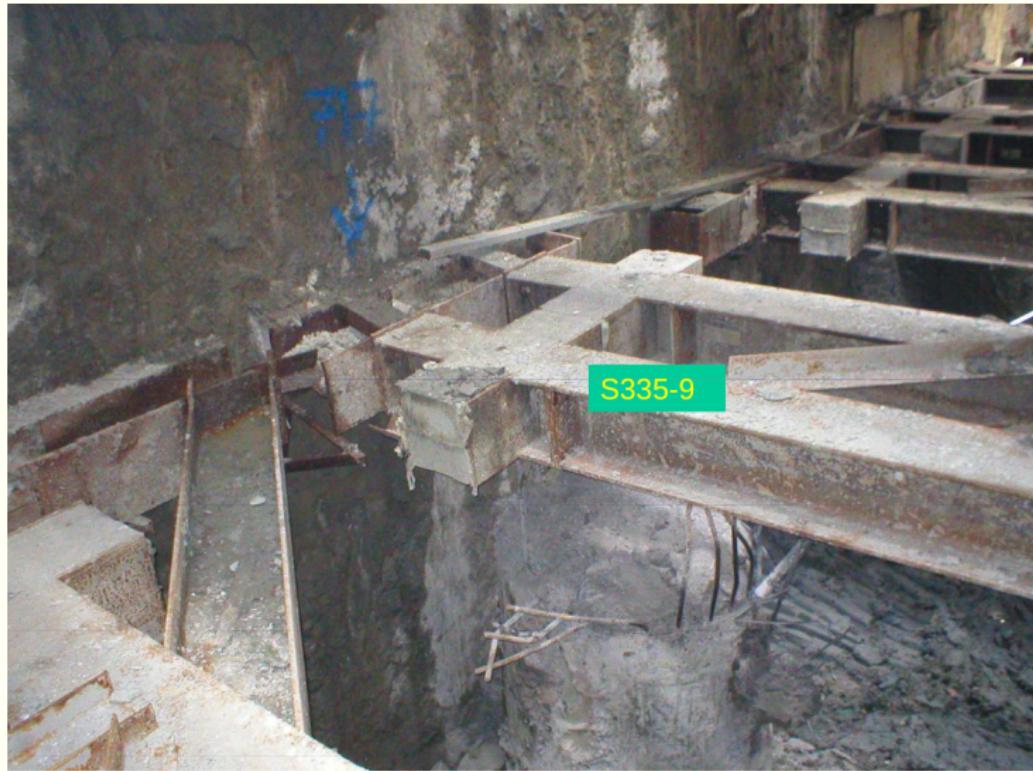
Strut 335 Sorth side

Hours before collapse

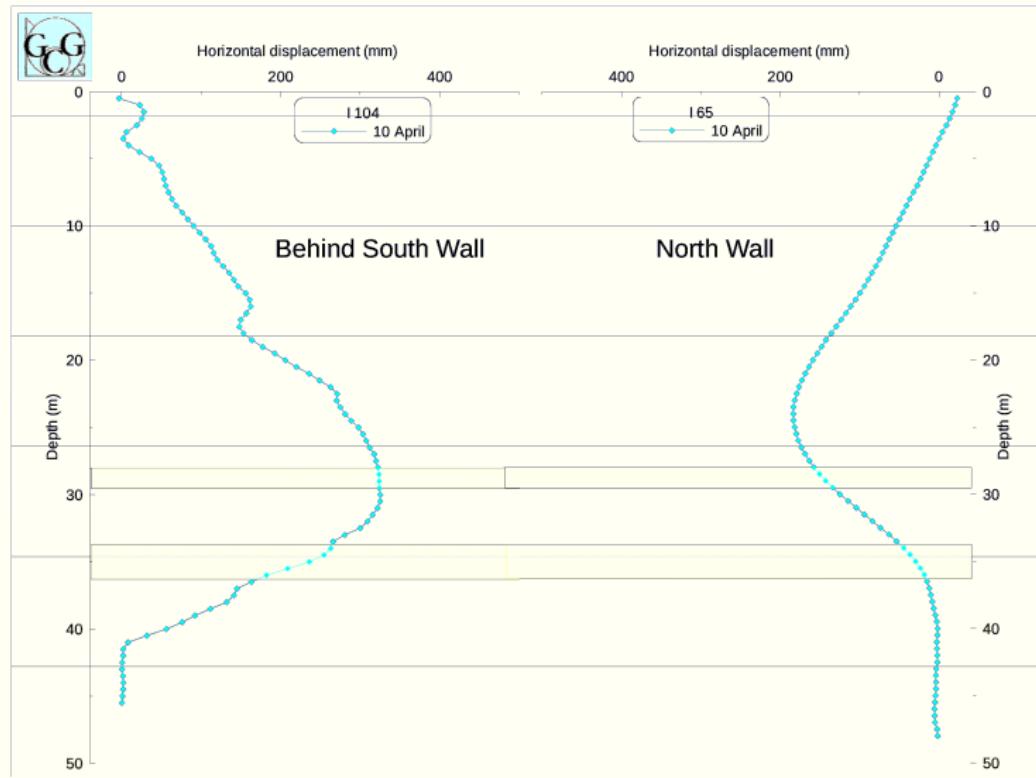
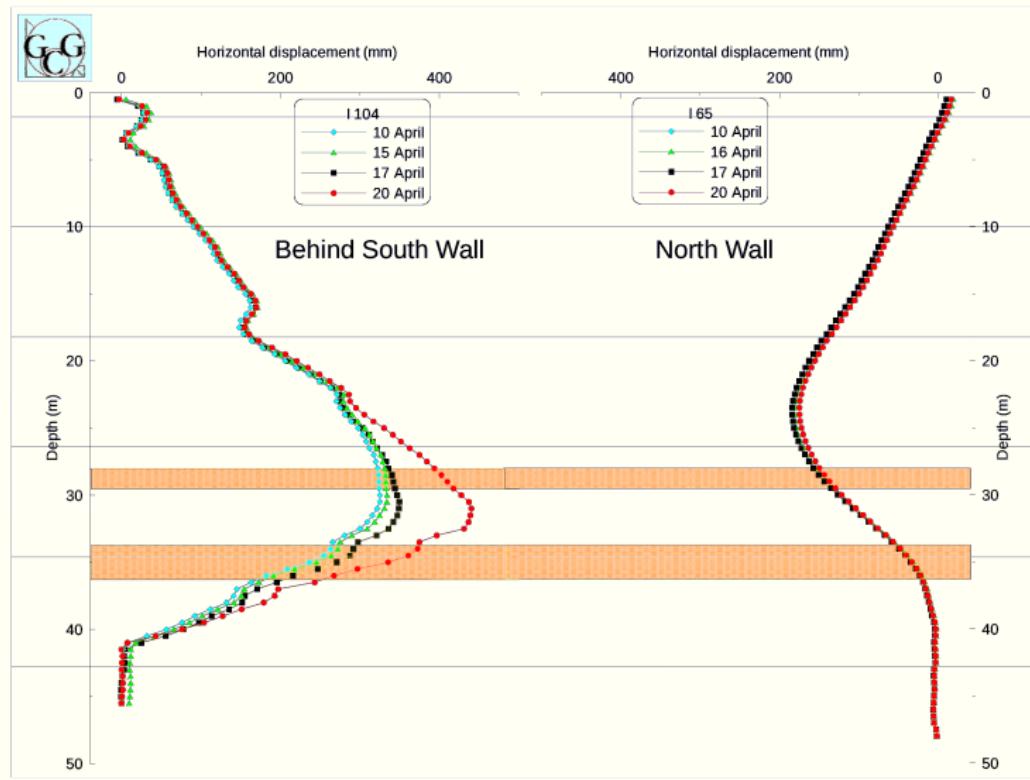
Leading up to the collapse: Wall displacements

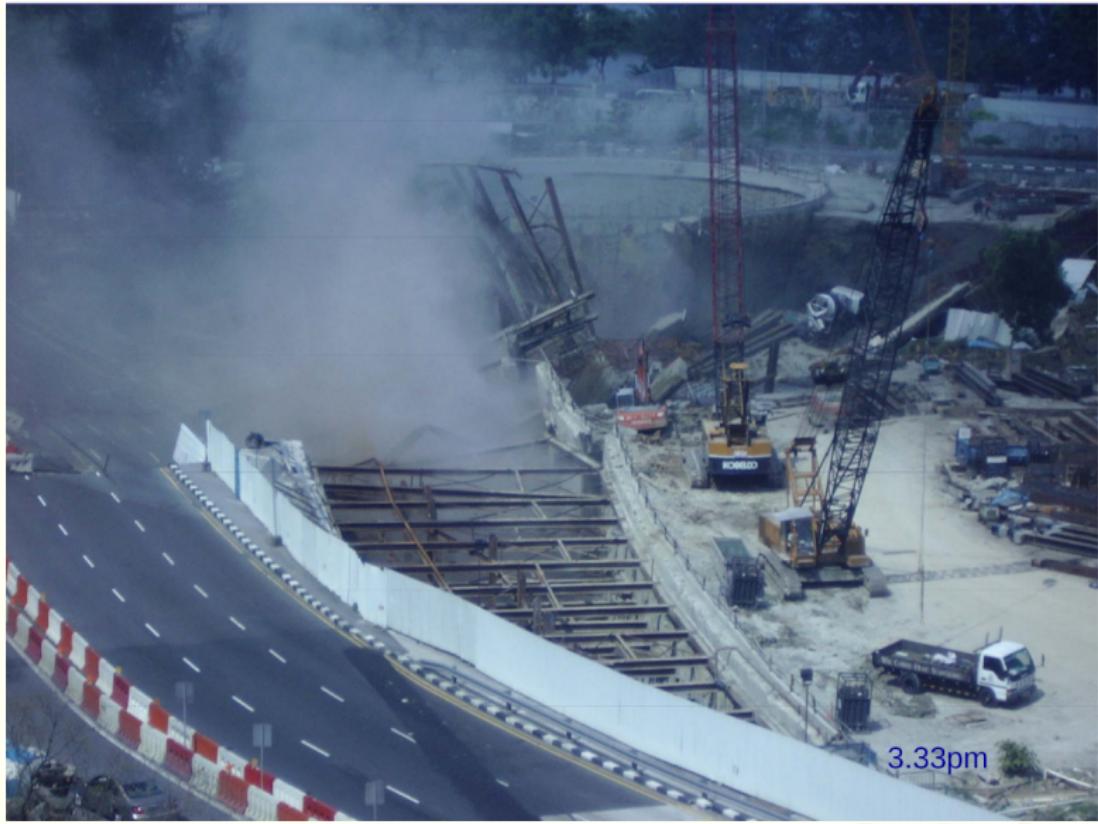
The collapse

Another chief reason for the failure was the under design of the waler-strut connection. Designers misinterpreted the **stiff bearing length for the C-channels as per BS 5950 to 400 mm instead of using 65 mm**. Waler connections with C-channels were designed with the effective length factor of 0.7, where the end conditions were unrestrained and a factor of 1.2 should have been used. This resulted in axial design capacity that was about 70% of the assumed design load for the connection (COI 2005, pp 1-16). Also in some locations the splays in the waler strut connection had been omitted during construction (NCE, 2005). These design and construction errors resulted in the failure of the 9th level strut-waler system. The under designed diaphragm wall could not resist the redistributed loads as the 9th level strut-waler system failed resulting in the collapse of the tunnel.

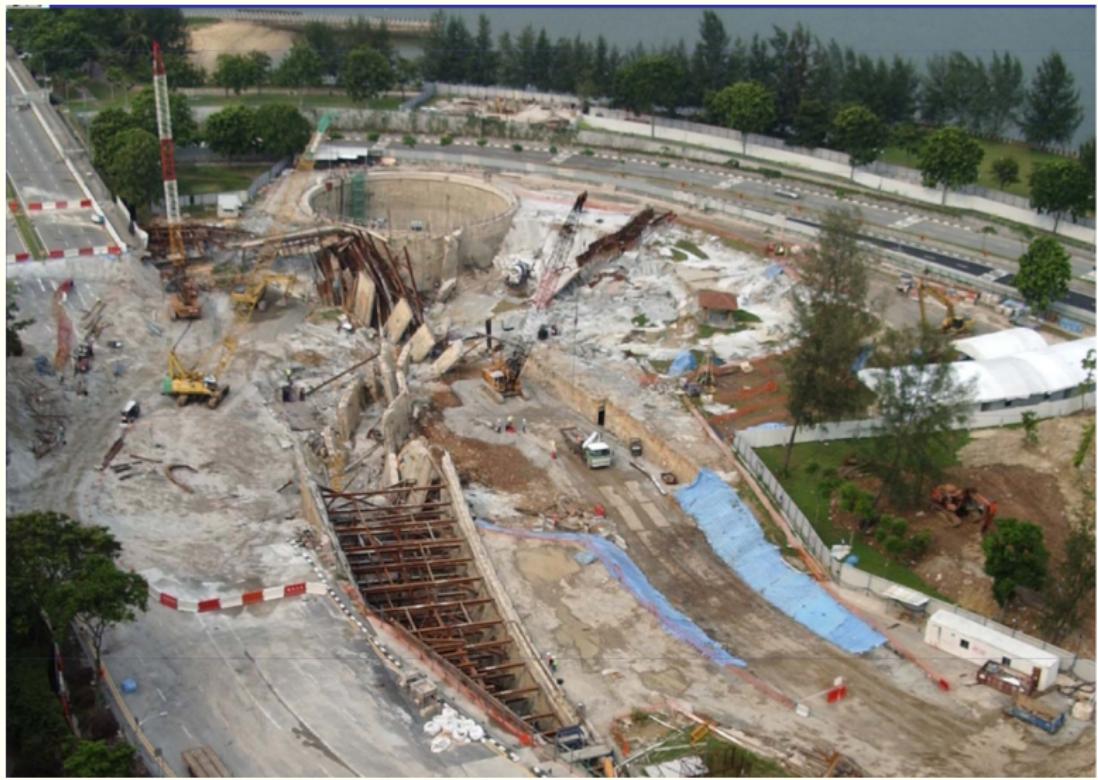
Post collapse

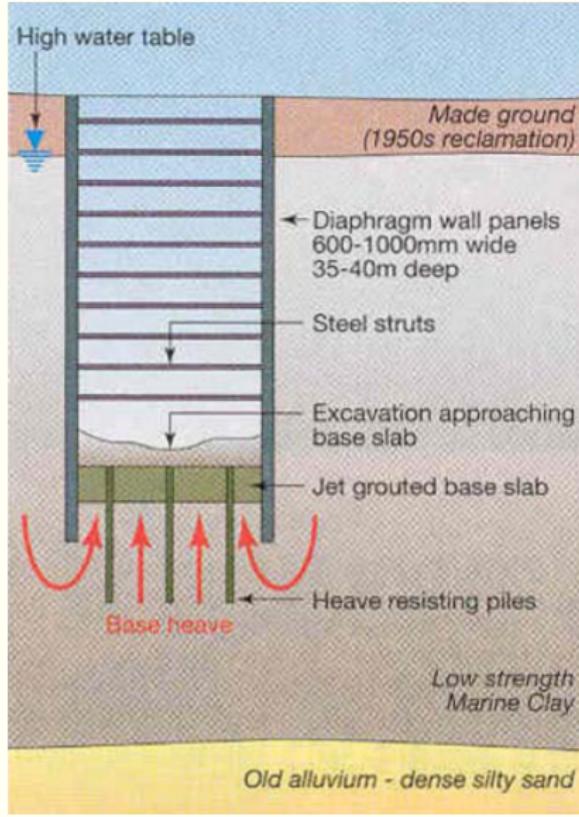
Reasons for collapse

1. Problem with jet grouting at the base of the slab.
2. Struts design - connectors
3. Use of effective stress parameters to do an undrained excavation.

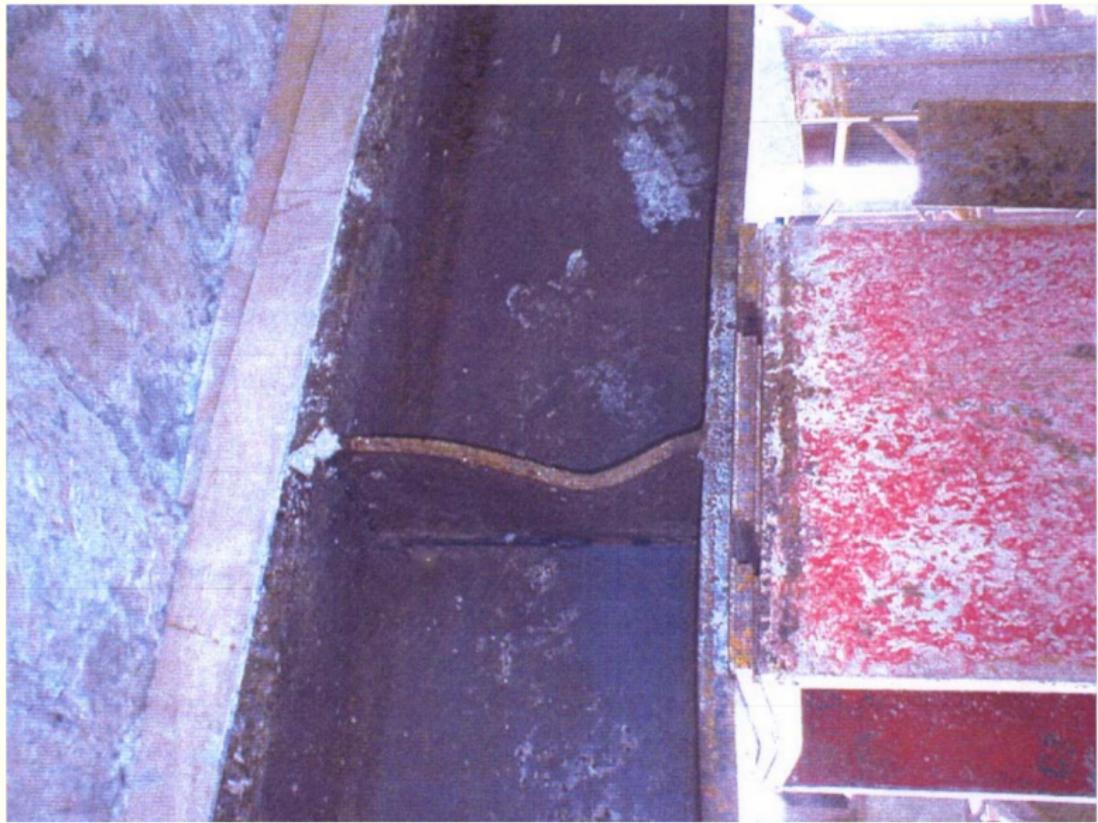
Strut design: Replacing plate-stiffener with C-channel

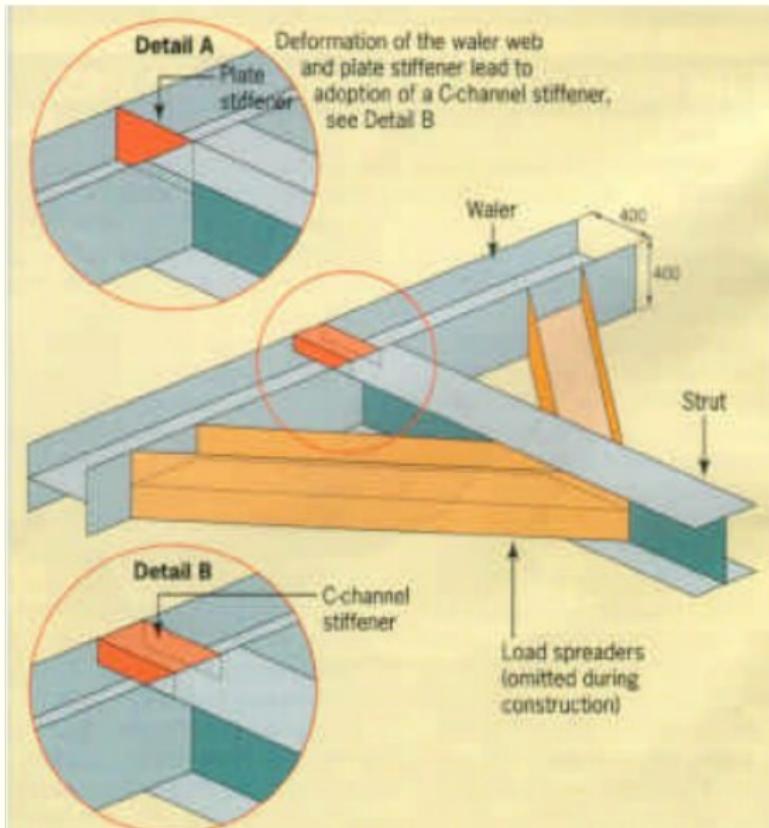
Strut design: Waler connection

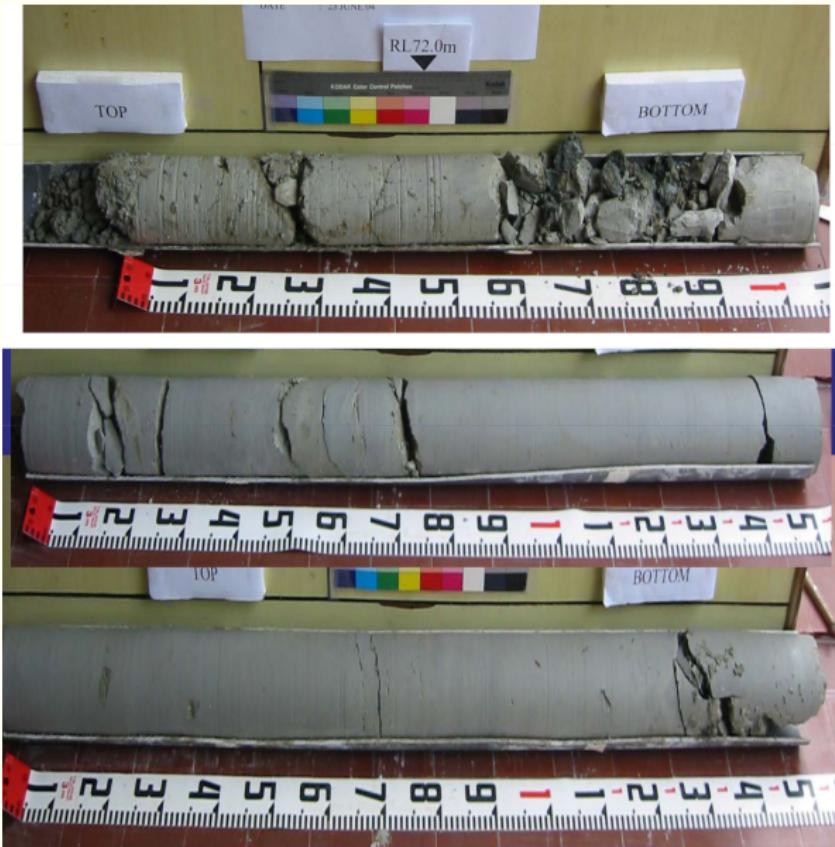
Quality of jet grouting

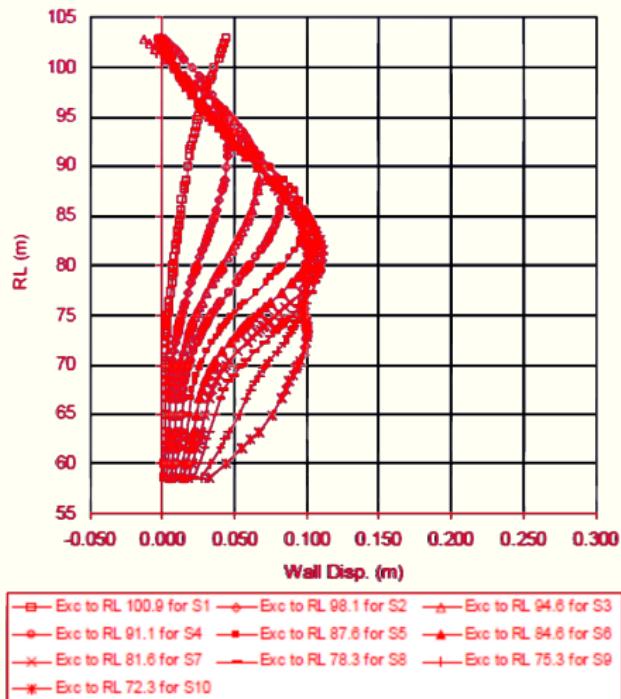
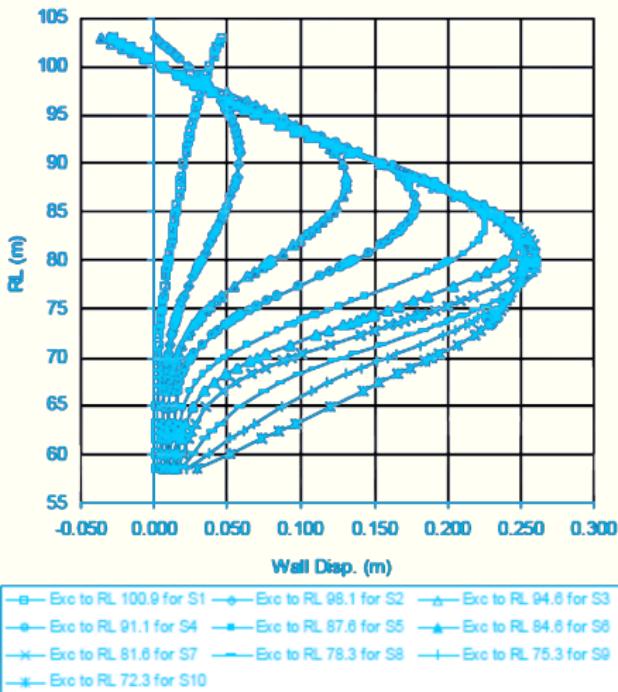
Wall displacements: Effective stress vs Undrained strength

- Method A over-estimates the undrained shear strength of normally and lightly overconsolidated clays
- Its use led to a 50% under-estimate of wall displacements and of bending moments and an under-estimate of the 9 th level strut force of 10%
- The larger than predicted displacements mobilised the capacity of the JGP layers at an earlier stage than predicted

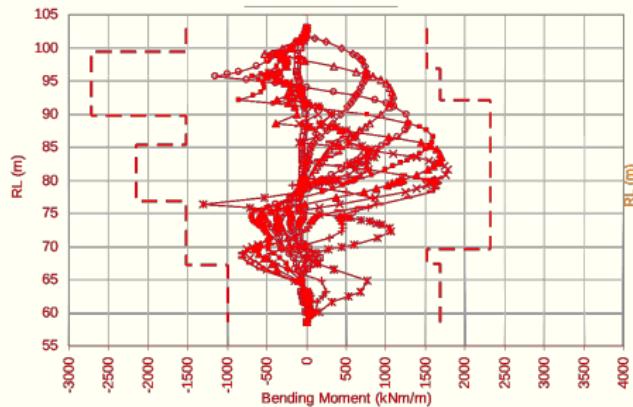
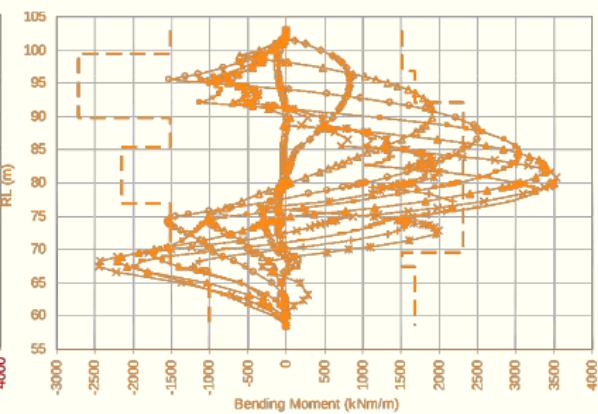
Bending moments: Effective stress vs Undrained strength
