## KLEHOMERIE | Technical Asset Audit (v1.2)

Feb 12, 2026 / Arnaud Zerdab

| Client / Owner Name | | Erithrou Stavrou 20, Tavros 177 | |

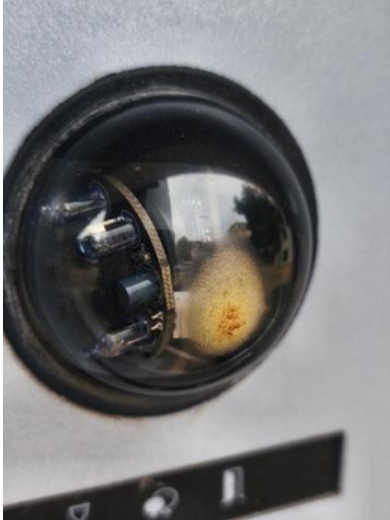
Photo 1

### B-02: Does the Intercom panel look new/functional ?

The camera shutter is burnt

Critical Failure

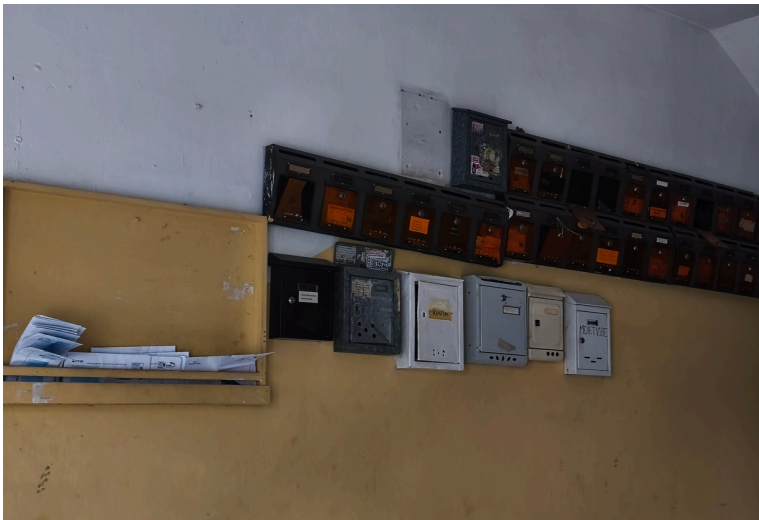
Photo 2

### B-03: Are mailboxes overflowing with junk mail?

Old open mailboxes

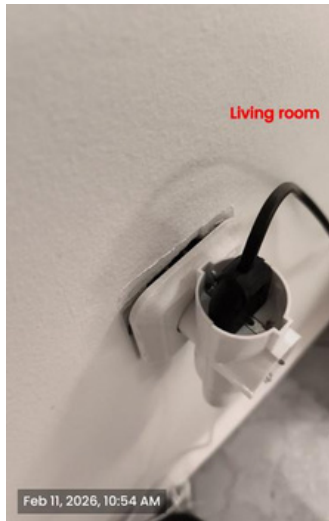
Photo 3

### E-04: Power Sockets (Phase/Earth Loop Test)

Power socket off in living room

Critical Failure

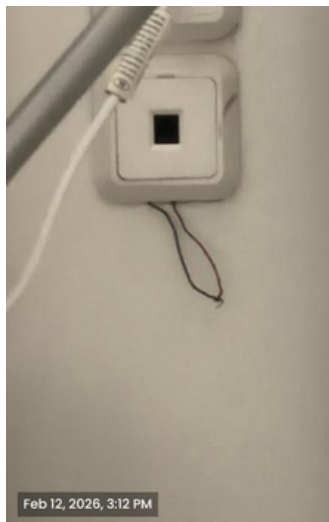
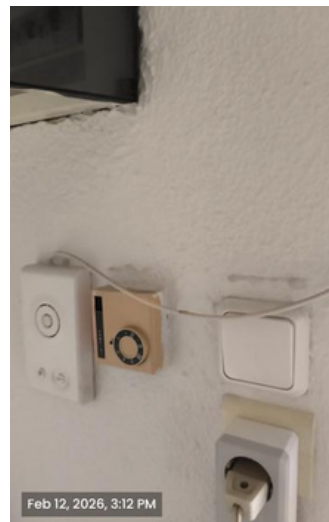
**E-08: Low Voltage Network (Data/Intercom)**

Loose cable intercom

Ethernet slot disconnected

Critical Failure

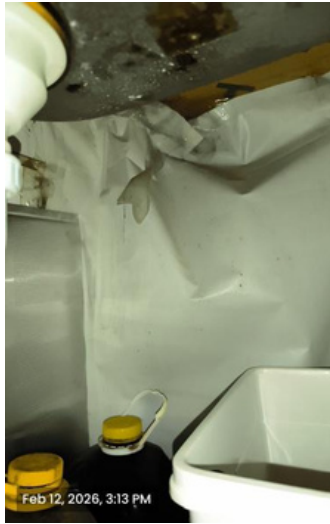
Photo 6

**P-01: Main Stop Valve (General Shut-off)**

Inaccessible Main Shut-off Valve

Critical Failure

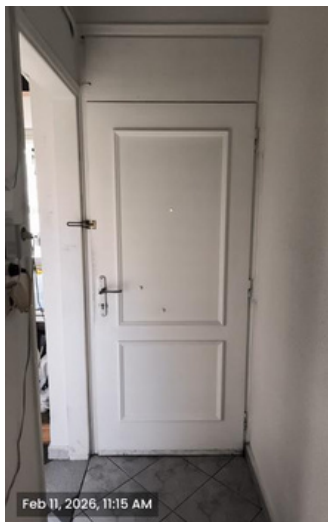
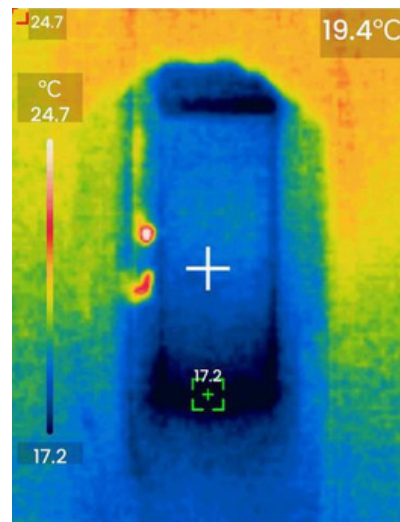
**M-01: Armored Entrance Door (3-Point Lock)**

Critical Failure

Security Risk: Non-armored wooden door (Single-point lock). Energy Risk: Significant thermal bridging detected.

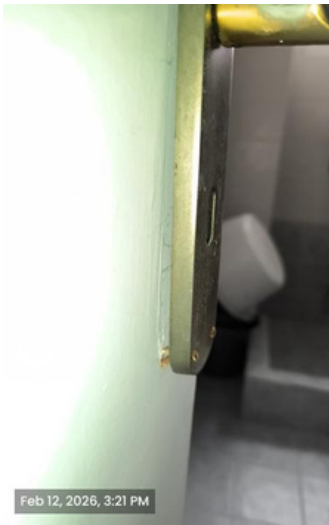
Photo 10

**M-05: Interior Doors (Handles & Hinges)**

Critical Failure

Action Required: Replace all door handles (Corrosion/Mechanical failure)

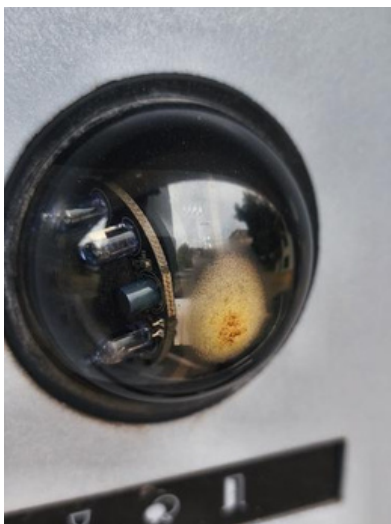
Photo 1

| <b>B-02: Does the Intercom panel look new/functional ?</b> | | Conformed |
| The camera shutter is burnt | | |
| | | Critical Failure |

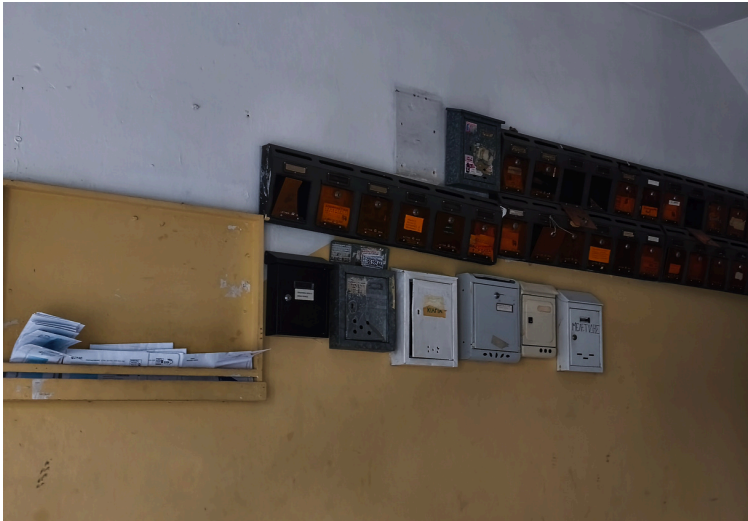
Photo 2

| <b>B-03: Are mailboxes overflowing with junk mail?</b> | | Yes |
| Old open mailboxes | | |

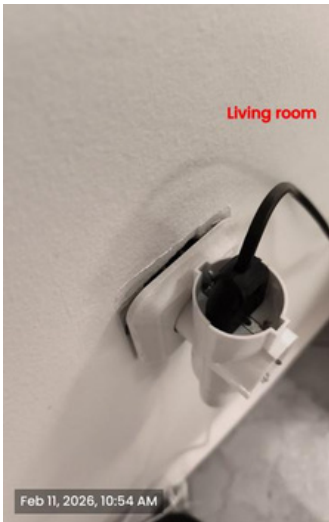
| Photo 3 | | |

| <b>E-04: Power Sockets (Phase/Earth Loop Test)</b> | | Critical Failure |
| Power socket off in living room | | |

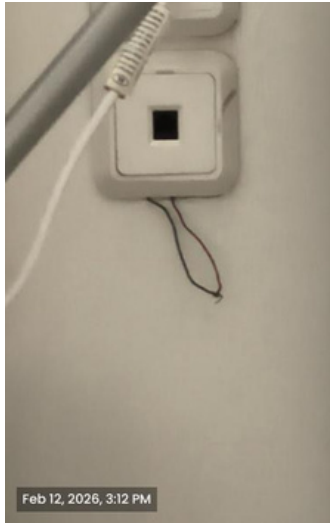
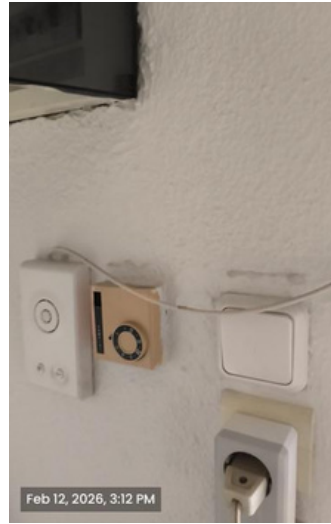
| <b>E-08: Low Voltage Network (Data/Intercom)</b> | | Conformed |
| Loose cable intercom | | |
| Ethernet slot disconnected | | Critical Failure |

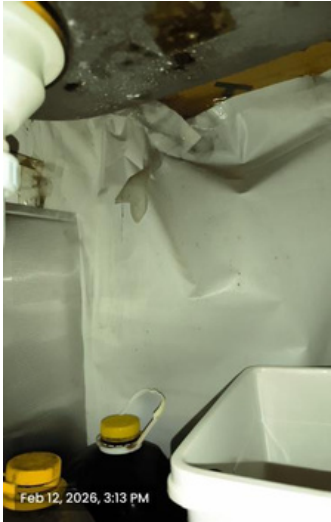
Photo 6

Critical Failure

**P-01: Main Stop Valve (General Shut-off)**

Inaccessible Main Shut-off Valve

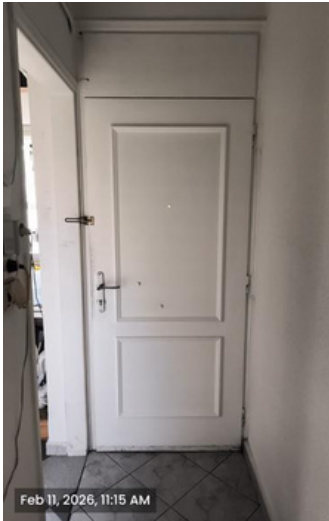
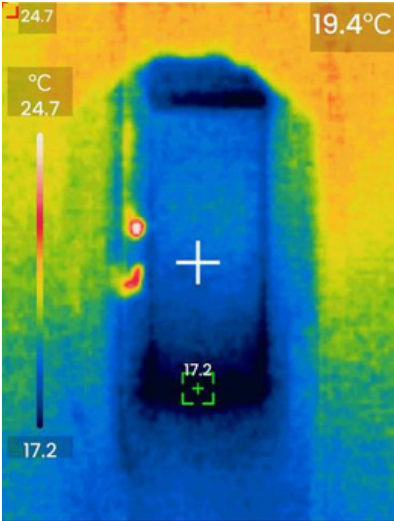
M-01: Armored Entrance Door (3-Point Lock)

Critical Failure

Security Risk: Non-armored wooden door (Single-point lock). Energy Risk: Significant thermal bridging detected.

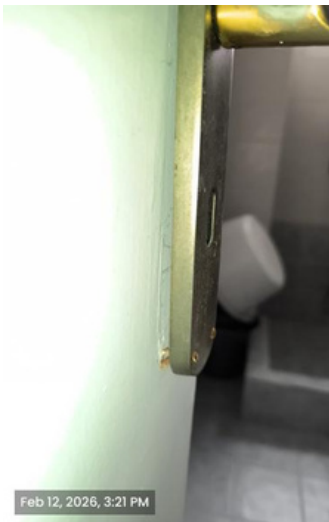
Photo 10

M-05: Interior Doors (Handles & Hinges)

Critical Failure

Action Required: Replace all door handles (Corrosion/Mechanical failure)
