## ATF Fire Research Laboratory

December 27, 2011

SUBJECT: FDS Modeling Analysis  
30 Dowling Circle

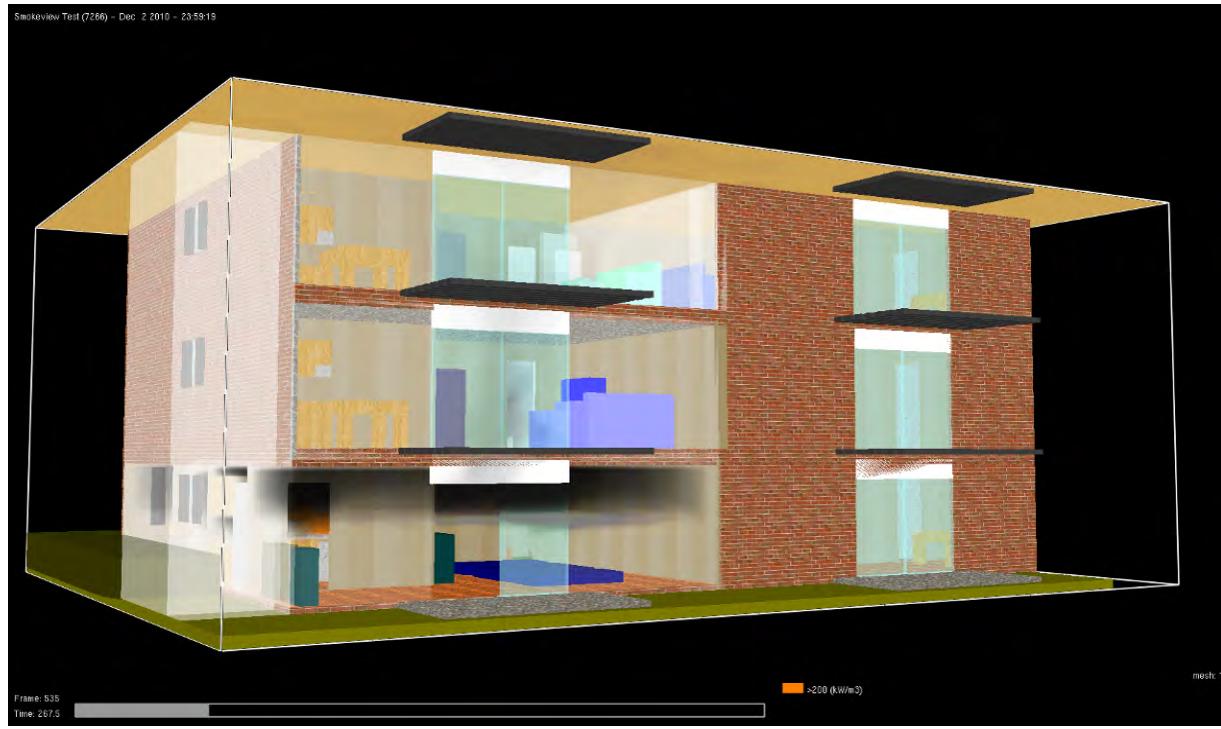
Figure 7. Smokeview frame of the rear of the building indicating the fire origin and smoke spread within the T2 apartment.

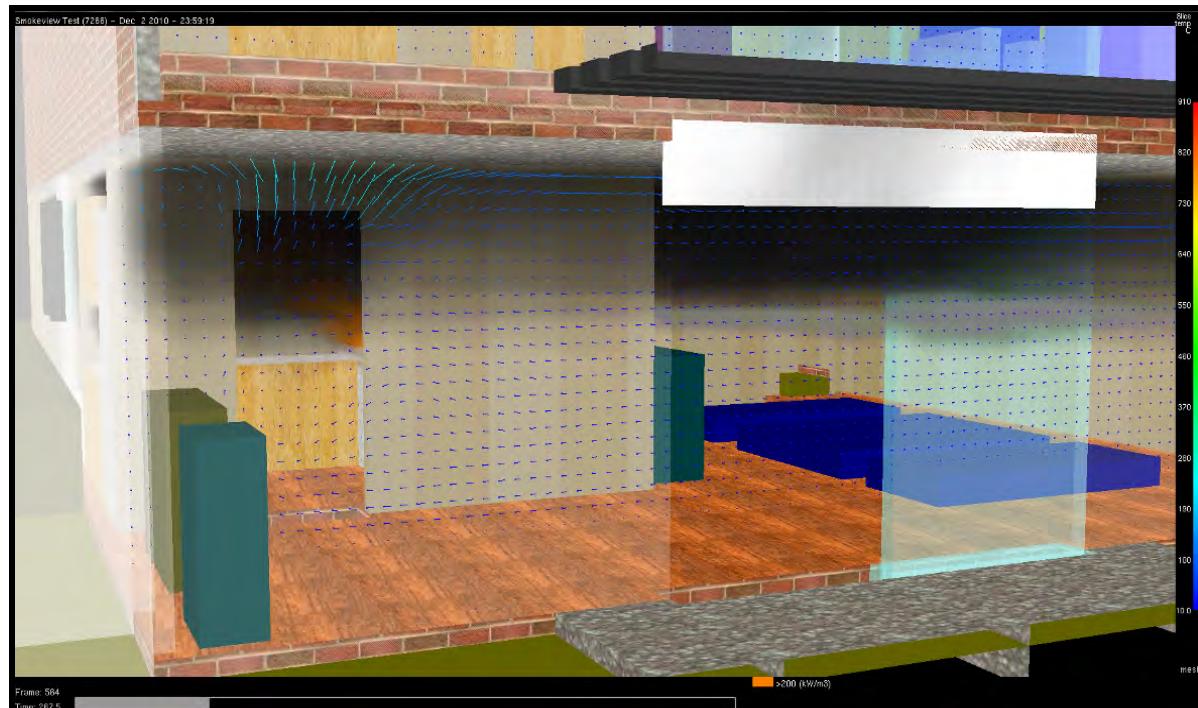
Figure 8. View of smoke flow out of kitchen and open sliding glass door (center of photo) in the rear of apartment T2.

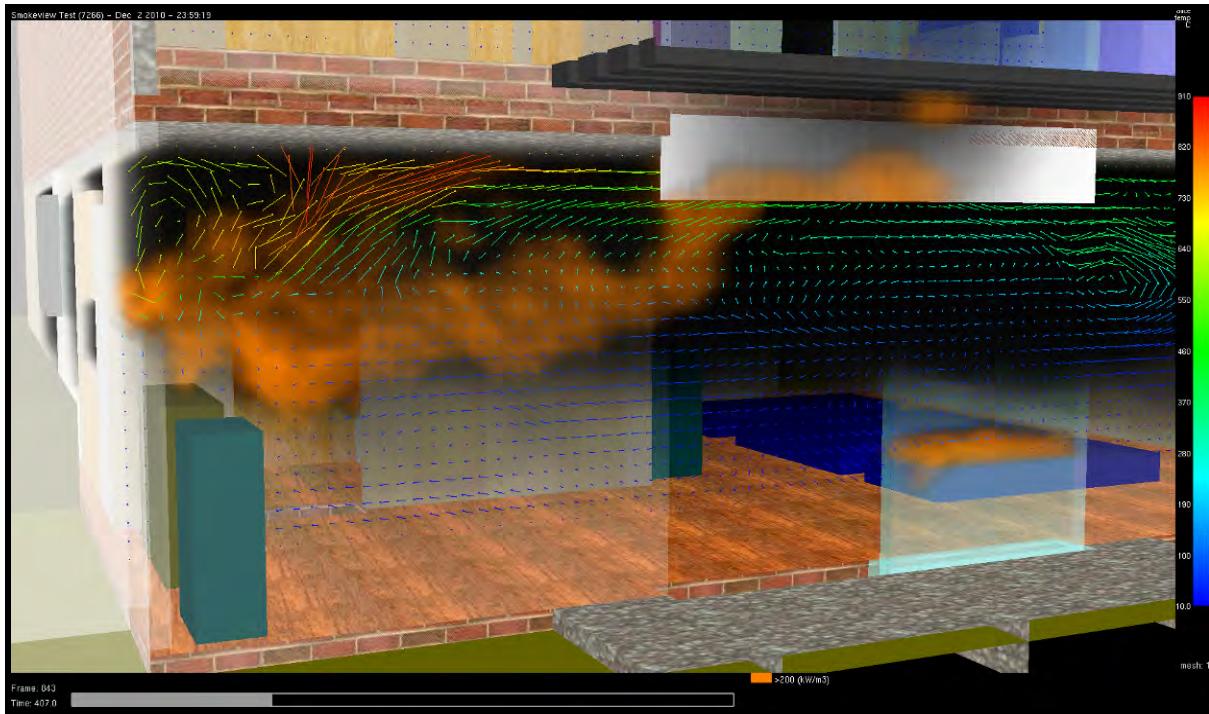
**Figure 9.** Smokeview frame of flashover of the kitchen with flames extending into the living room. Flames also begin to extend out of the rear sliding door and impact the balcony above.

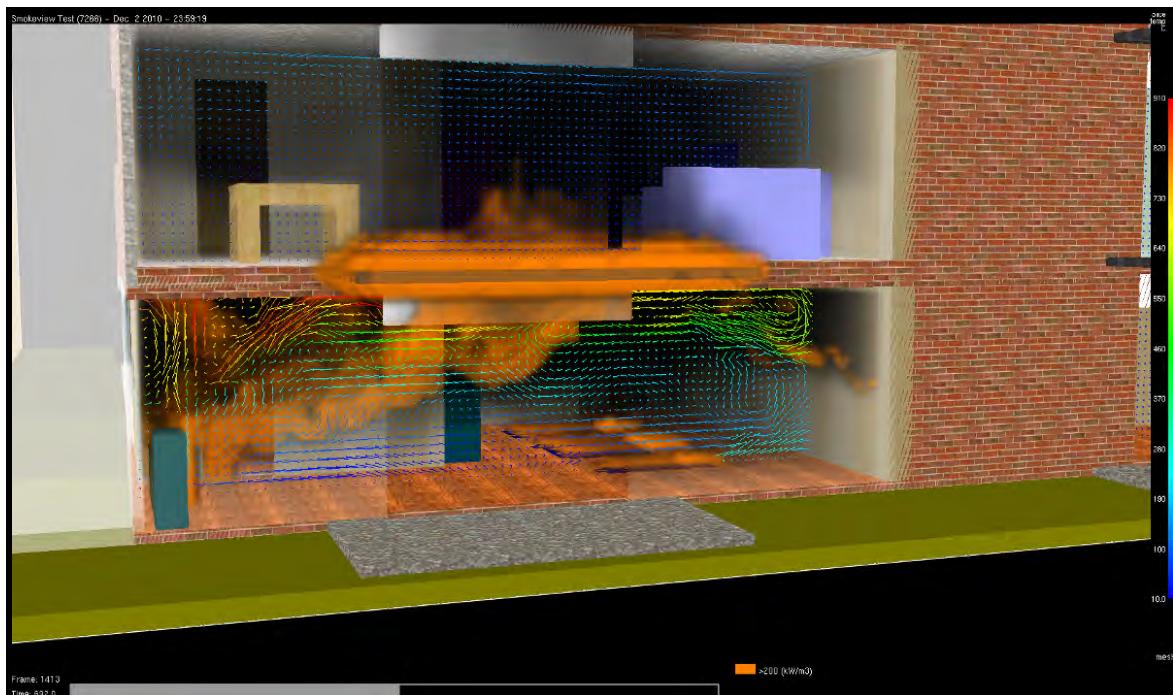
**Figure 10.** Ignition of second level balcony resulting from flame extension from living room.

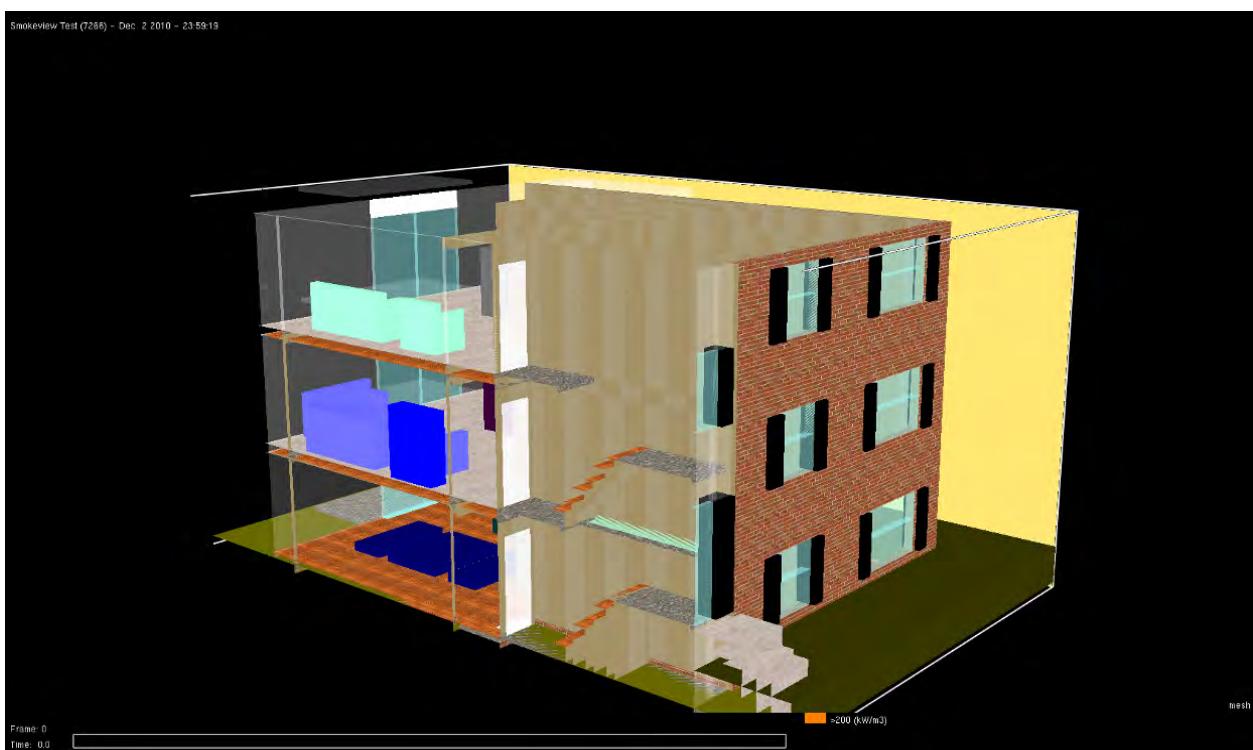
An analysis of the ventilation flow path through the apartment with FDS indicated that a significant unidirectional flow path existed up the stairs with an inlet at the rear terrace sliding door and outlet at the front apartment entrance door leading to the stairwell.

**Figure 11.** Smokeview frame showing section view of stairwell and living room area of all three south side apartments.

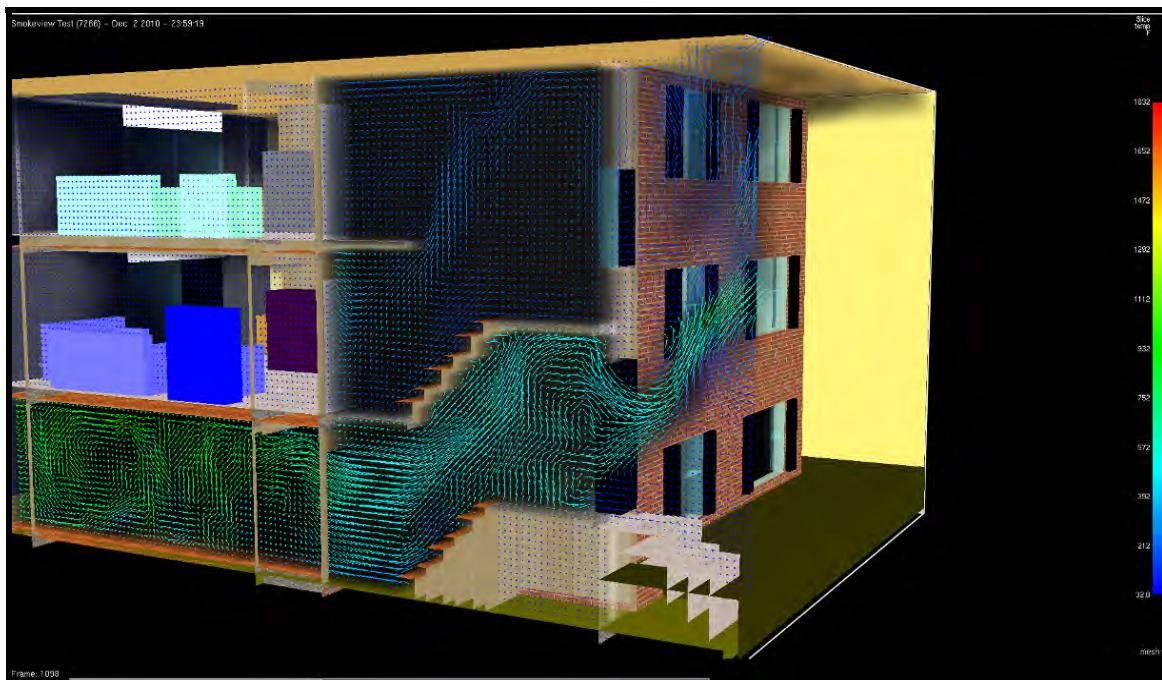
**Figure 12.** Smokeview section frame showing unidirectional flow of approximately 600 Fahrenheit (315 Celsius) gases out of the stairwell entrance door.

This unidirectional flow path up the stairs is difficult to combat and is often experienced during basement fires as crews attempt to descend interior stairs. The model indicates sustained air temperatures in the stairwell of approximately 600 Fahrenheit (315 Celsius) at velocities of approximately 6 mph (2.7 m/s) from floor to ceiling as crews attempted to descend the stairs. This is consistent with statements from firefighting crews, who experienced extremely high heat conditions and indicated periodically seeing flames in the smoke layer flowing up the stairs. The elevated air velocity of the stairwell flow path resulted in a high rate of convective energy transfer to the structural firefighting gear and high perceived temperatures as the firefighters attempted to descend the stairs.

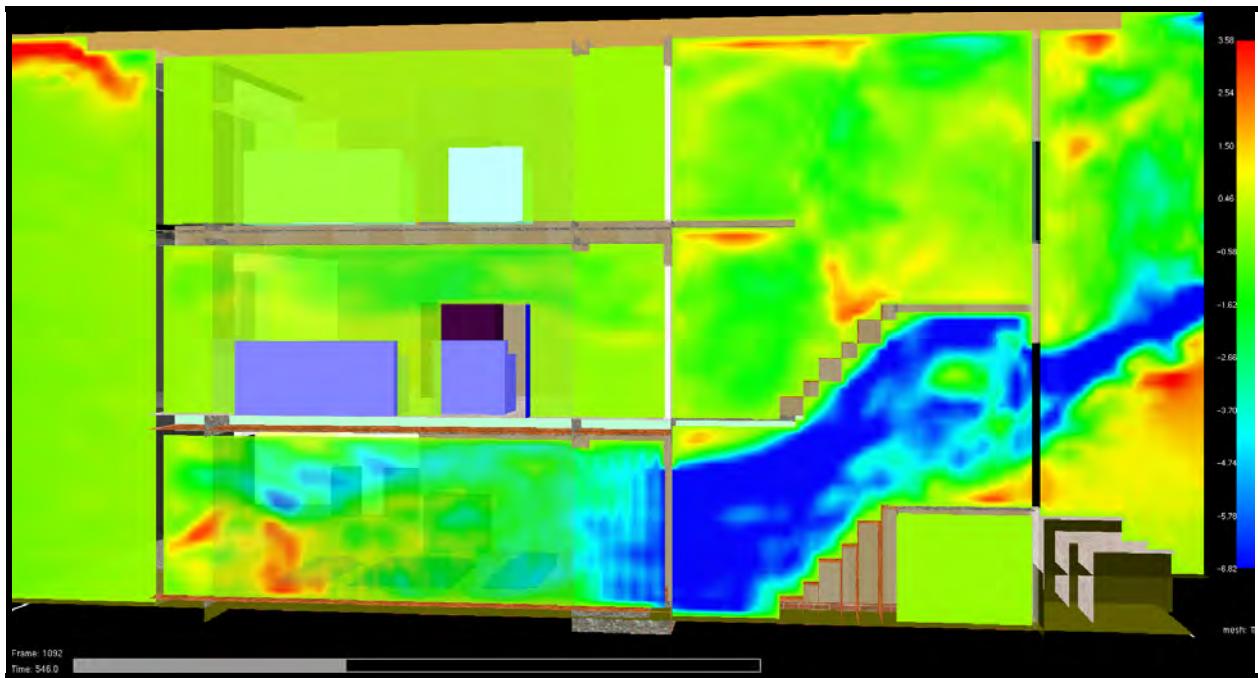
Figure 13. Smokeview frame indicating gas velocity up the stairs of approximately 6 mph (2.7 m/s) from floor to ceiling.

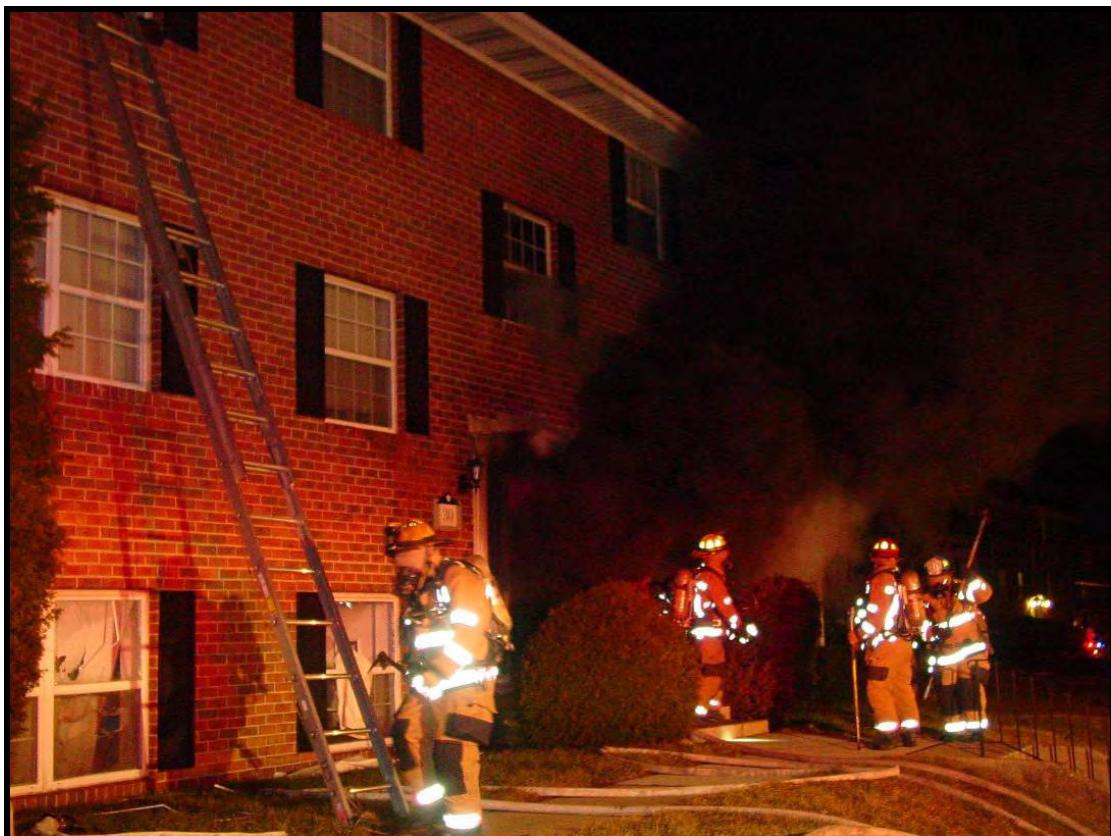
Figure 14. Front photo of unidirectional flow of smoke up stairwell from apartment T2. Note the high volume of smoke from floor to ceiling as the stairwell door serves as the flow path outlet. The

ground ladder in the foreground was used to rescue an occupant on the third floor trapped by heavy smoke in the stairwell.

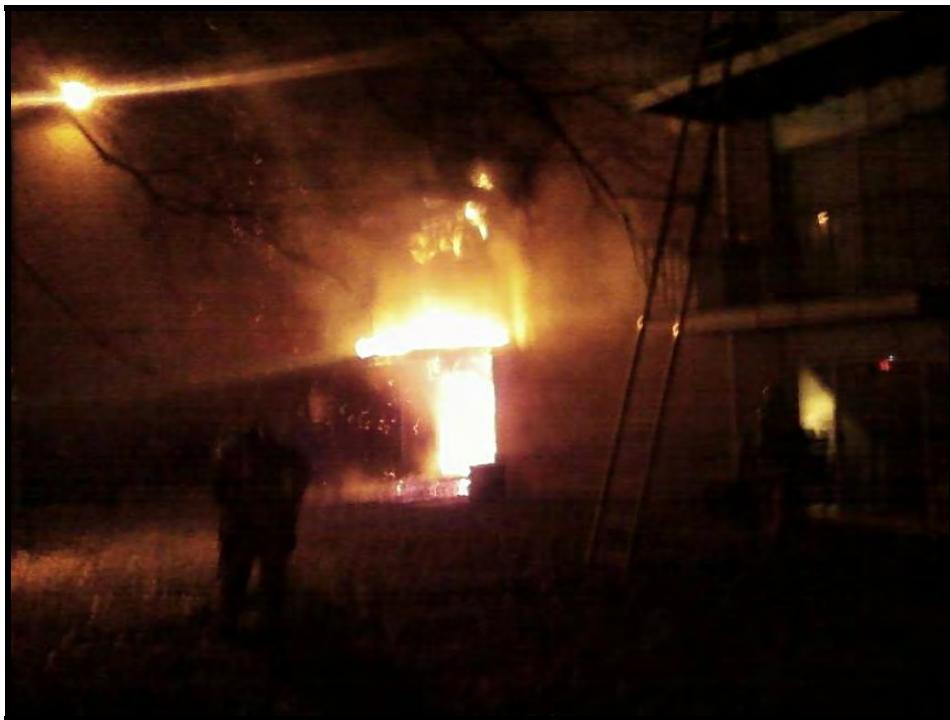
**Figure 15. Photo from rear of flames in apartment T2 and extension to the balcony above. Note the relative minimal volume of smoke as the sliding door serves as the inlet for ventilation into the apartment. The smoke and heat is flowing in from the rear, through the apartment and up the stairs.**

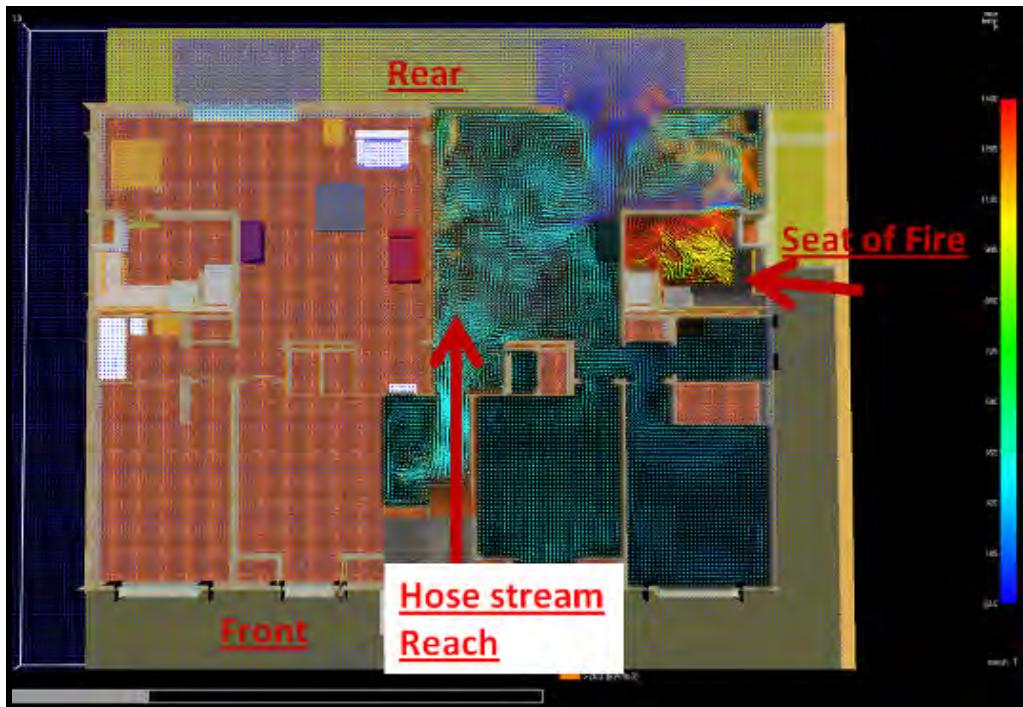
Firefighting crews flowed a hoseline down the stairs to combat the high temperatures; however no significant cooling was noticed by firefighters because the hose stream could not reach the seat of the fully developed fire in the kitchen area. The crews were simply cooling the ventilation flow path without cooling the source of the energy in the apartment. It was not until a hose stream was directed through an exterior window and a portion of the fire was extinguished that gas temperatures and velocities began to decrease, allowing firefighters to make entry to the terrace apartment via the stairs.

Figure 16. Plan view of flow path and temperatures within the apartment. Note the location of the seat of fire and the location of initial hose stream application down the stairs.

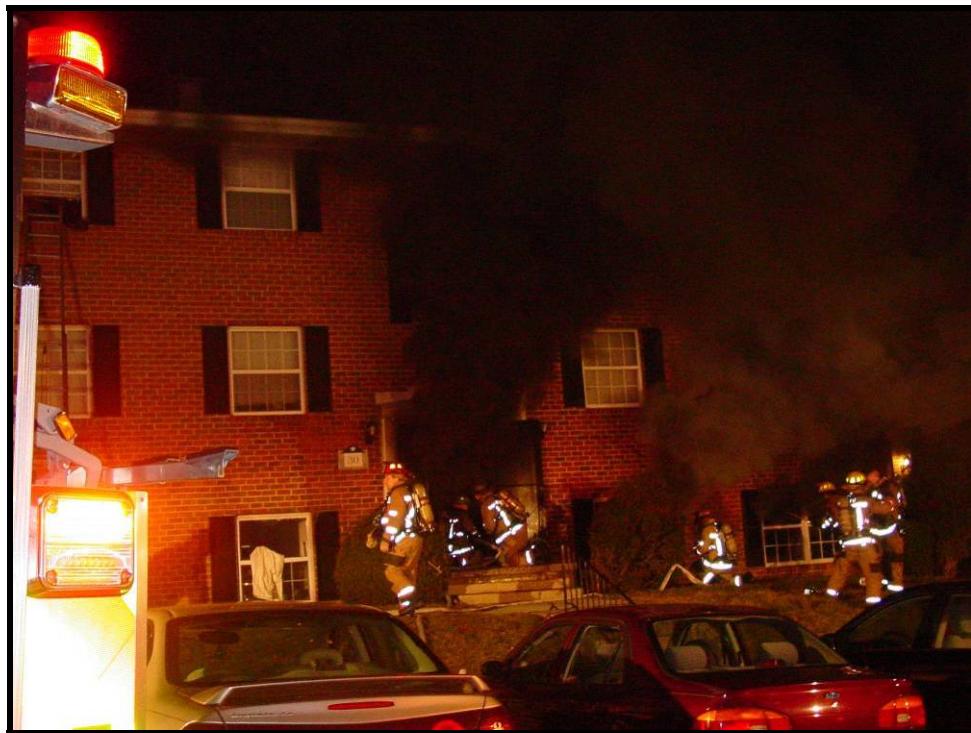
Figure 17. Photograph of hoselines being positioned at the stairwell entrance door and front window. Note the heavy smoke venting from all front openings in apartment T2.

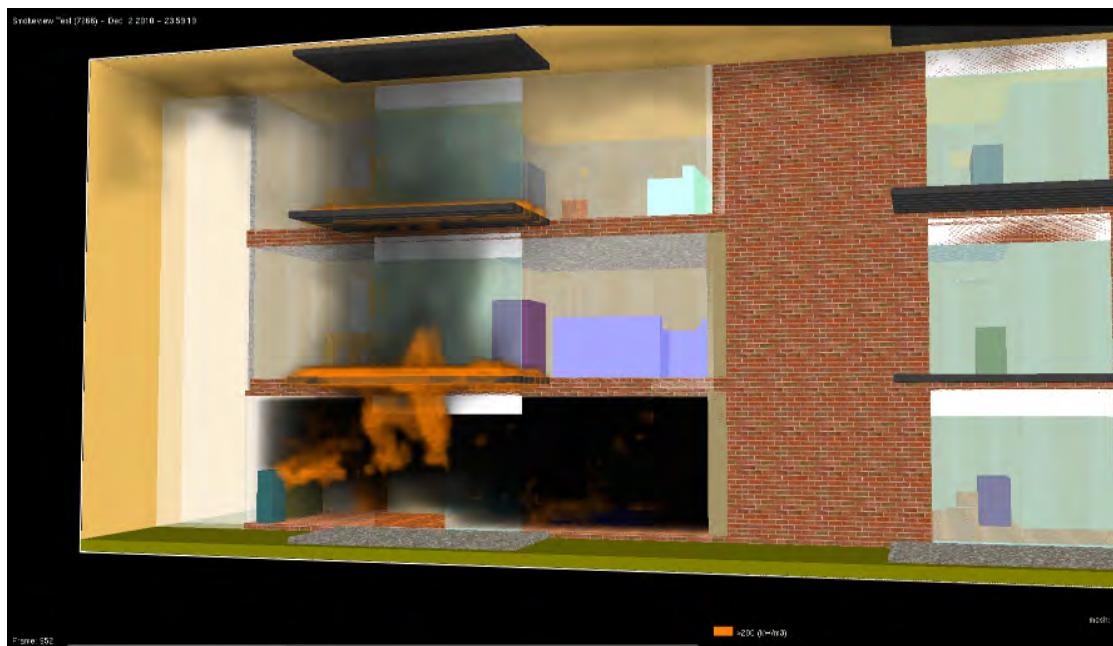
Flames extended upwards from the T2 apartment sliding door and ignited the rear balconies of the second and third level apartments above. Fire on the second floor balcony extended into apartment A2 by failing the sliding glass door and igniting vertical plastic slat curtains that were suspended above. As crews searched within the second floor apartment, they noted seeing the burning curtains on the floor with flames extending to a nearby couch (containing polyurethane foam padding) adjacent to the sliding doorway. The fire continued to grow unsuppressed and spread to a second couch as interior firefighting crews were engaged in rescuing two victims from the living room in the second floor apartment.

**Figure 18. Smokeview frame of the rear of the building with flames extending from T2 and involving both balconies above.**

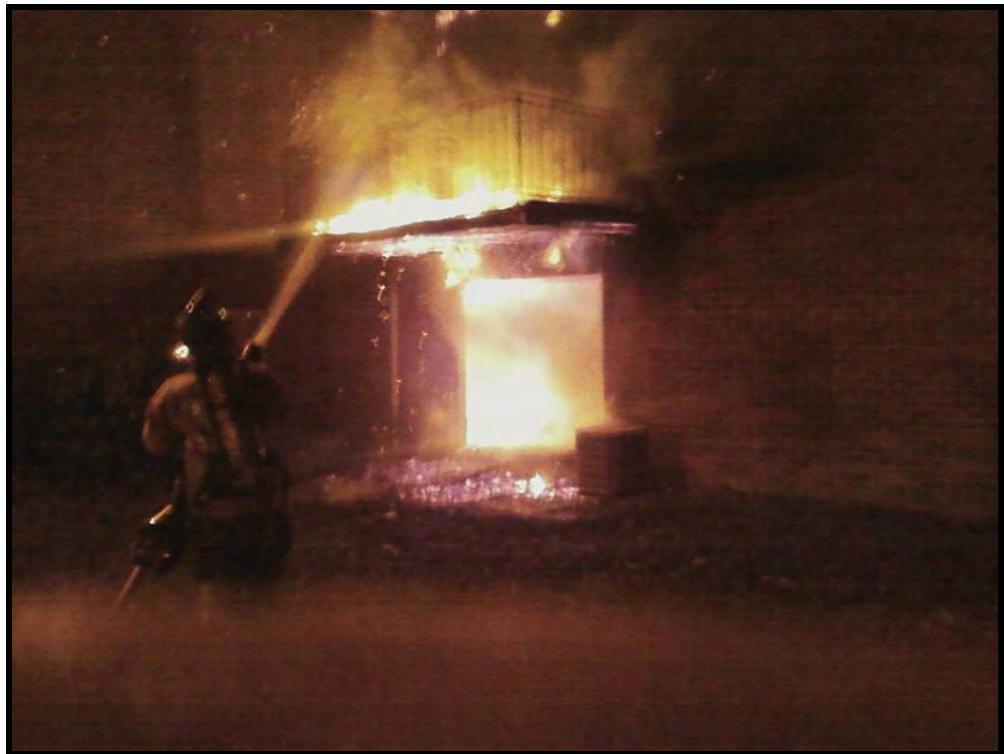
**Figure 19.** Photo of flame extension and suppression efforts at the rear of the structure. Flames caused the second level glass slider to fail and ignite plastic curtains in the doorway located at the top of the photo.

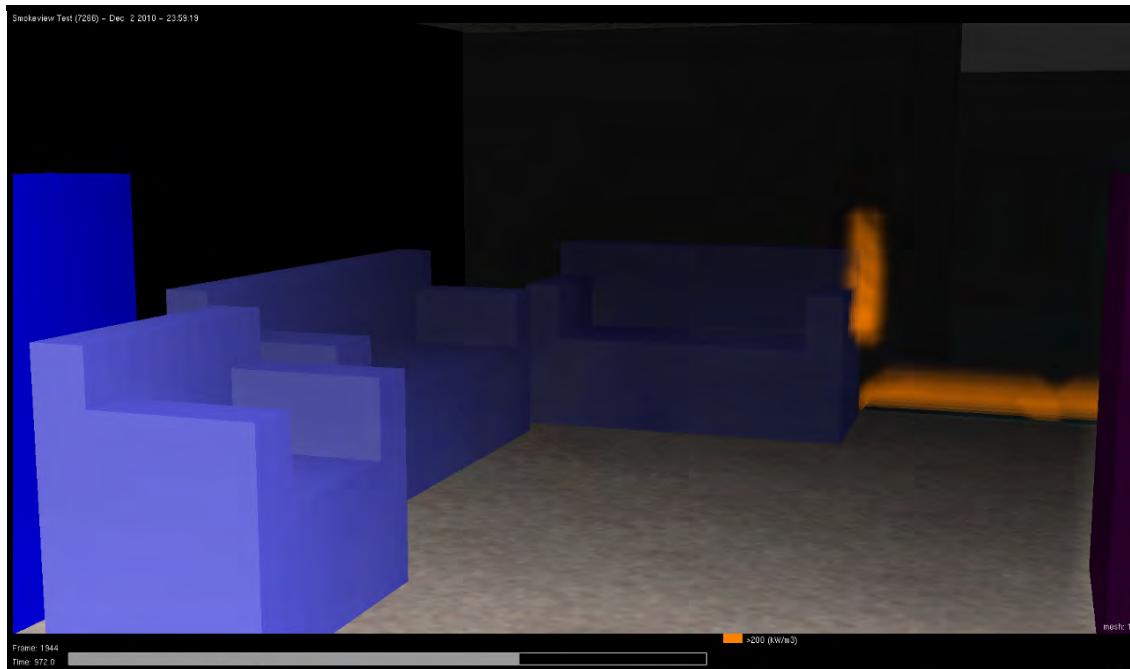
**Figure 20.** Flames extend from plastic curtains in apartment A2 to corner of couch as witnessed by firefighters conducting a search of the second level apartment. Two victims were rescued from the living room.

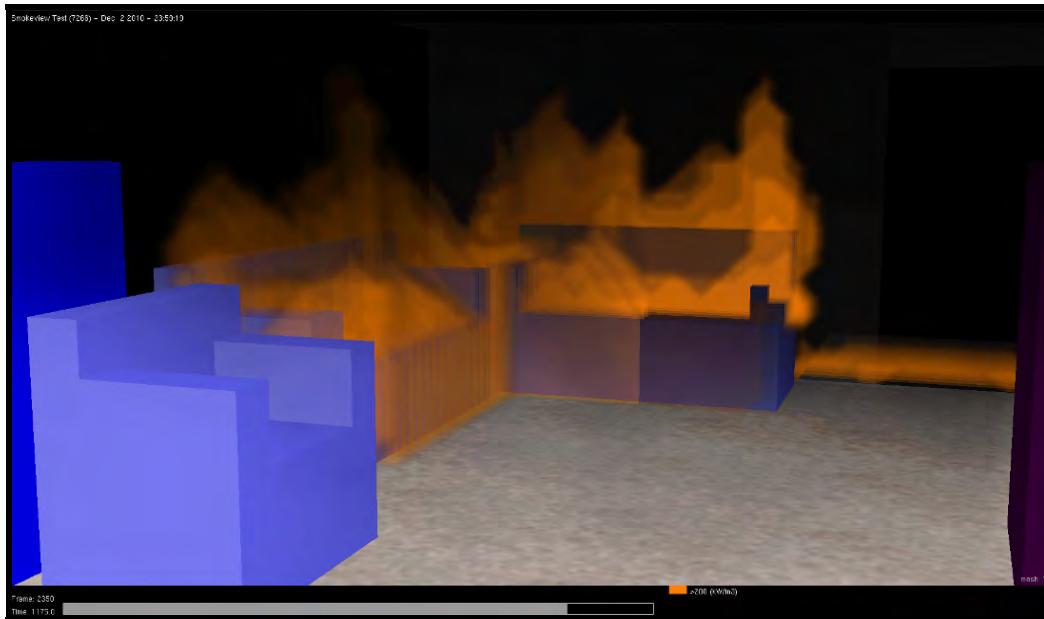
**Figure 21.** As the second victim was located, flames continued to spread across the couches in the living room of A2. The apartment entrance door was opened by additional search crews, allowing sufficient oxygen to support fire growth within the apartment.

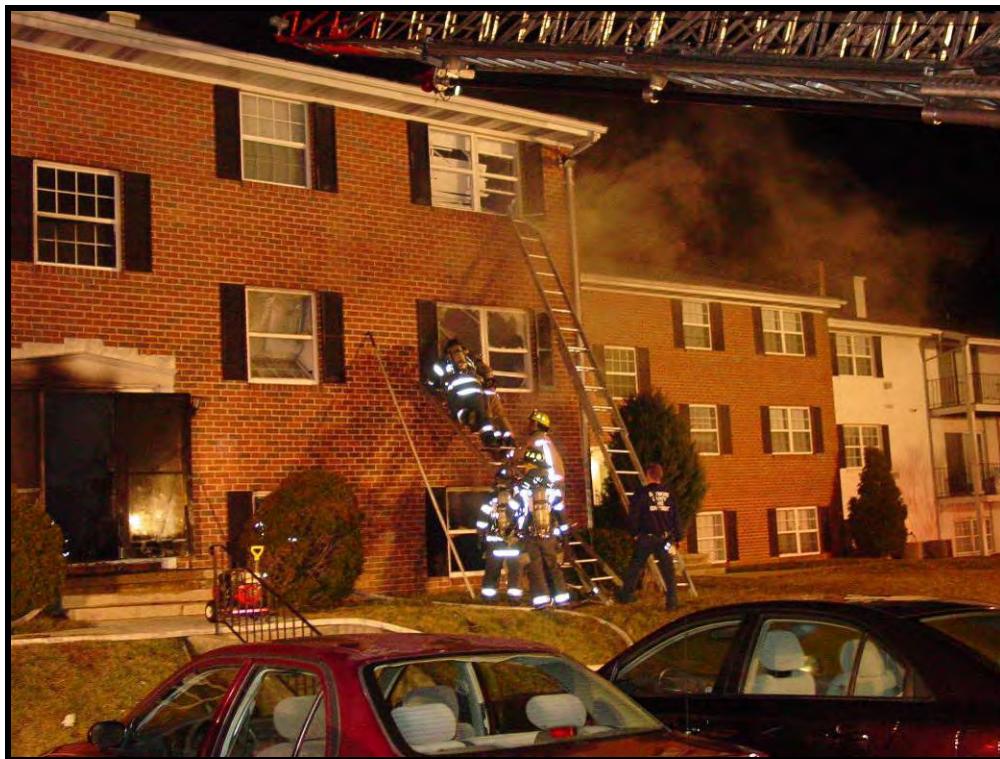
**Figure 22. Photo depicting building smoke and fire conditions around the arrival of Squad 303. Note the lack of heavy smoke or fire in the stairwell or terrace level. There is also no indication of the growing fire in the second (middle) level apartment.**

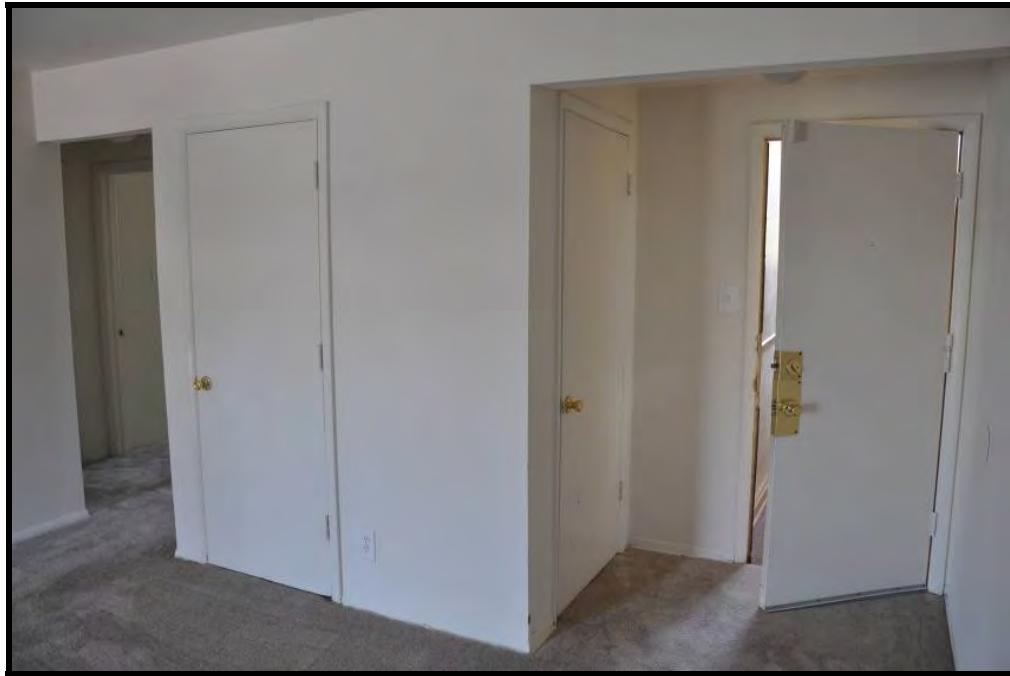
Squad 303's crew proceeded to search two apartments before entering the third floor right side apartment to conduct a search, leaving the entrance door open. It should also be noted that carpeting impacted the bottom of the door and prevented the apartment entrance doors on the second and third levels from closing automatically. The entry doors had to be actively pushed closed to overcome the friction of the carpet.

Figure 23. Exemplar apartment showing apartment entrance door.

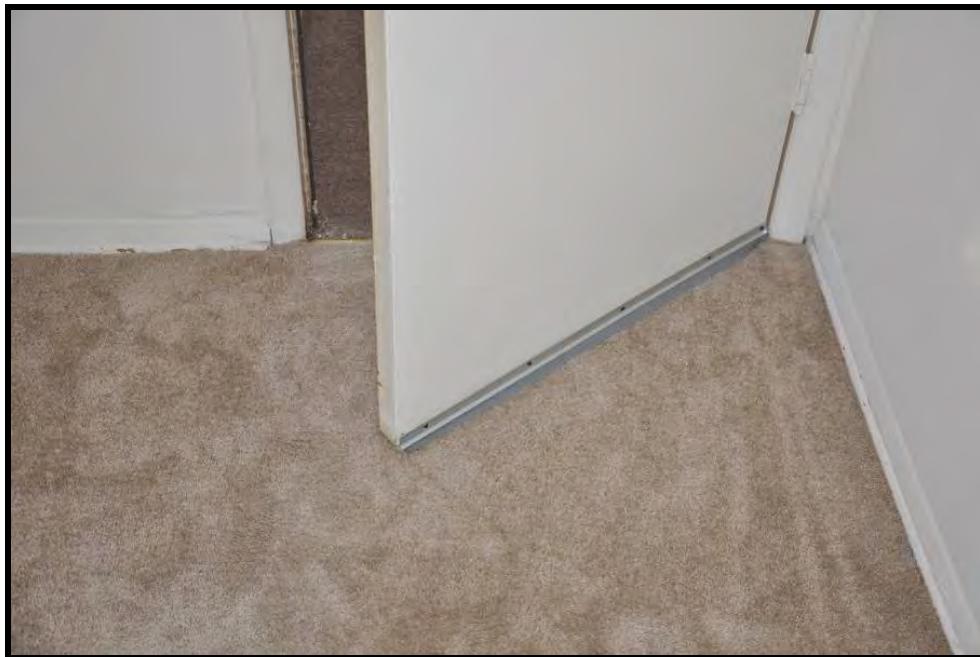
Figure 24. Close view of base of the door impacting the carpet, preventing the door from self closing.

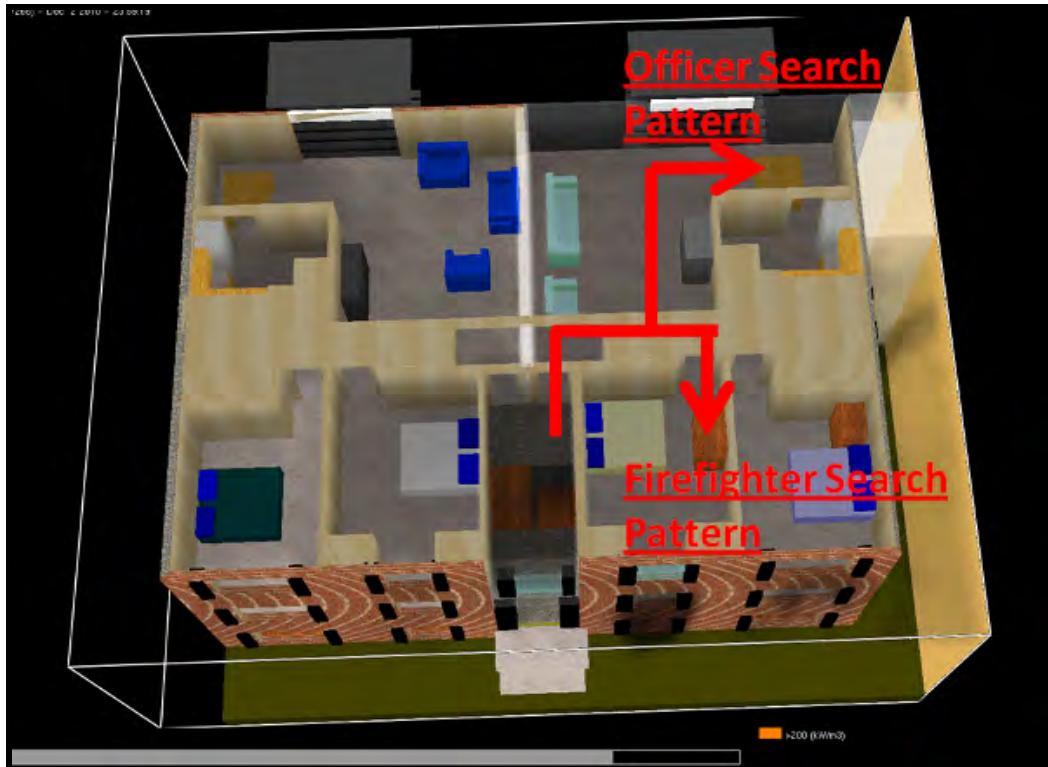
Figure 25. Search pattern of Squad 303's officer and firefighter after they split to conduct a search of the third floor apartment. The officer searched the rear of the apartment while the firefighter searched the bedroom.

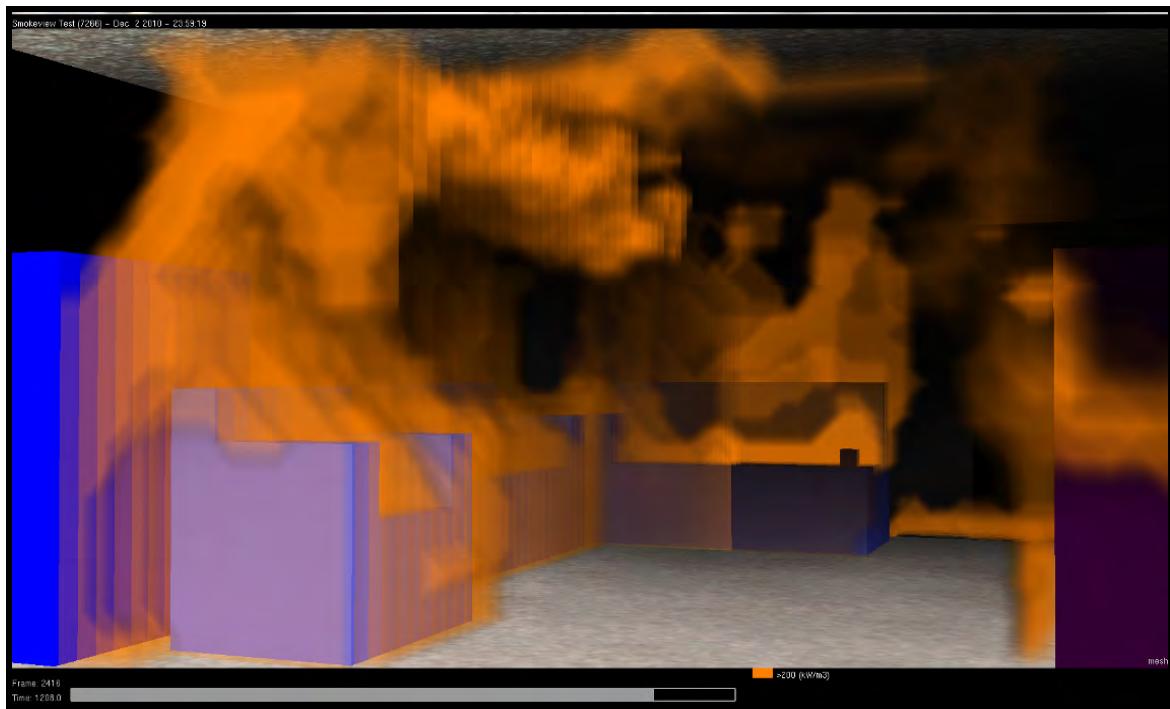
Figure 26. Involvement of the furniture items in the second level apartment that leads to flashover.

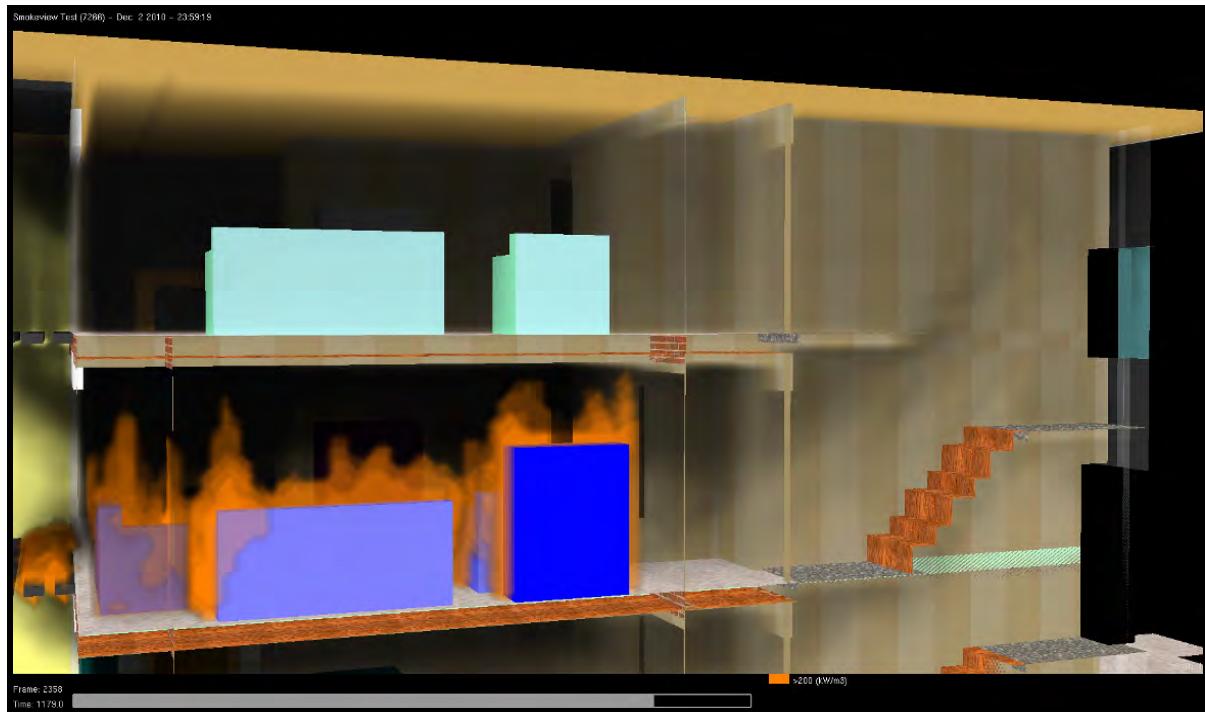
Figure 27. Section view of couches and furniture involved in flame just prior to flashover.

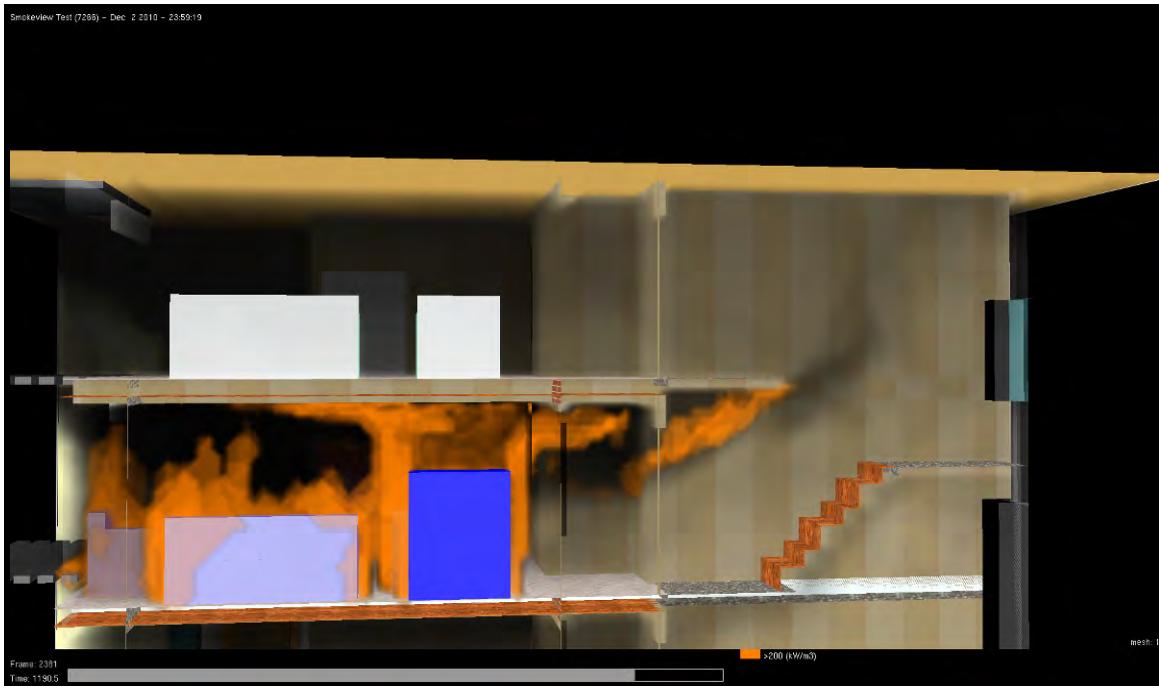
**Figure 28. Rollover from the second level apartment into the stairwell. The second victim was removed from the apartment just as flames began to extend out of the door. Firefighters covered the victim to protect her from the flames, sustaining damage to their gear.**

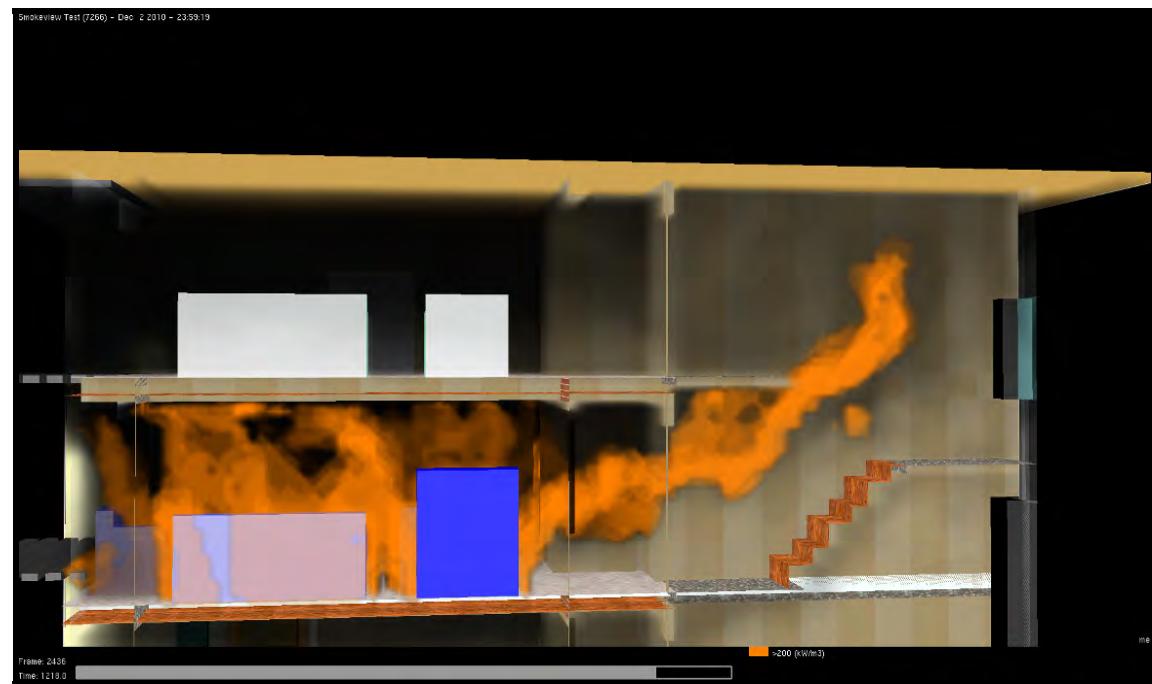
As flames in the second level began to rollover into the apartment entranceway, the smoke layer in the third level quickly dropped to the floor with a rapid increase in temperature. With Squad 303's crew searching above, flames began to extend into the stairwell, supplied by sufficient ventilation flowing through the apartment. This combination of fuel, heat and oxygen rich fresh air resulted in a rapid increase in heat release rate and flashover of the second level apartment followed by full room involvement. The open entrance doors on the second and third levels created a ventilation flow path through the second floor apartment, into the sealed stairwell and up through the third floor apartment directly above. The flames followed this flow path and extended from the second floor, through the stairwell and into the living room area of the third floor apartment. Flashover of the third floor occurred approximately 30 seconds after the second floor experienced flashover.

**Figure 29. Flashover of the second level with flames extending upwards into the sealed stairwell.**

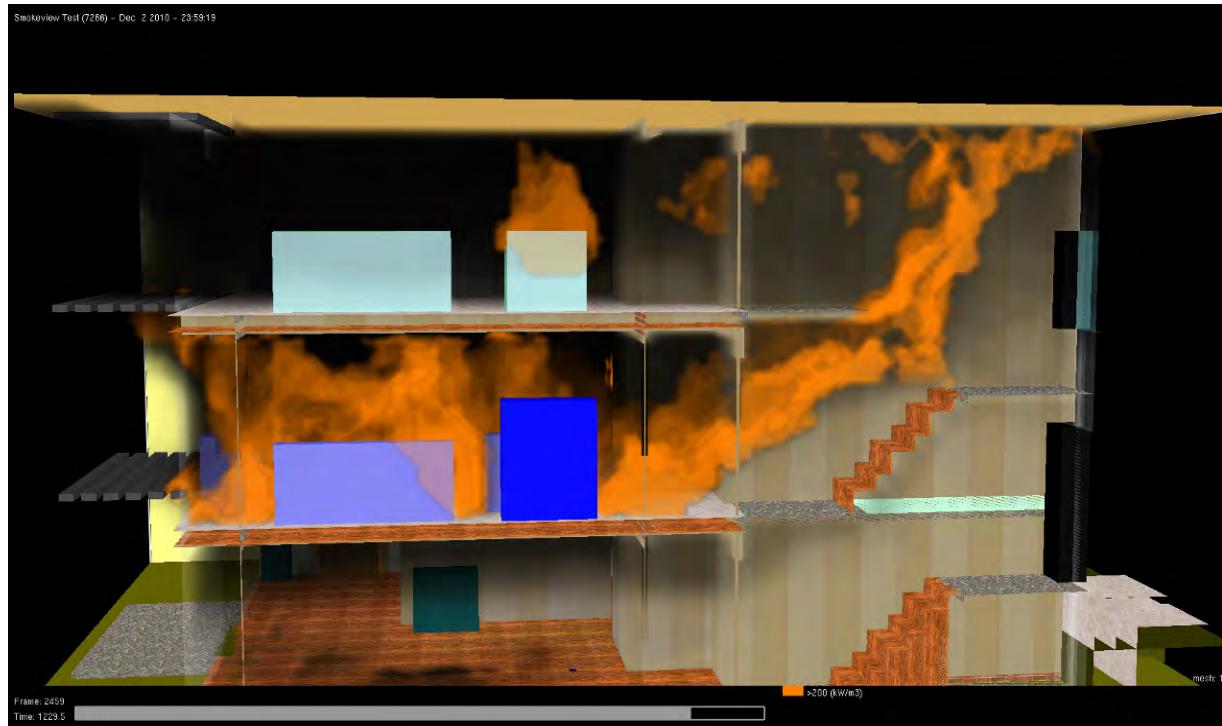
**Figure 30.** Flames followed the ventilation flow path and extend into the third floor apartment, resulting in ignition of the couches just inside the doorway.

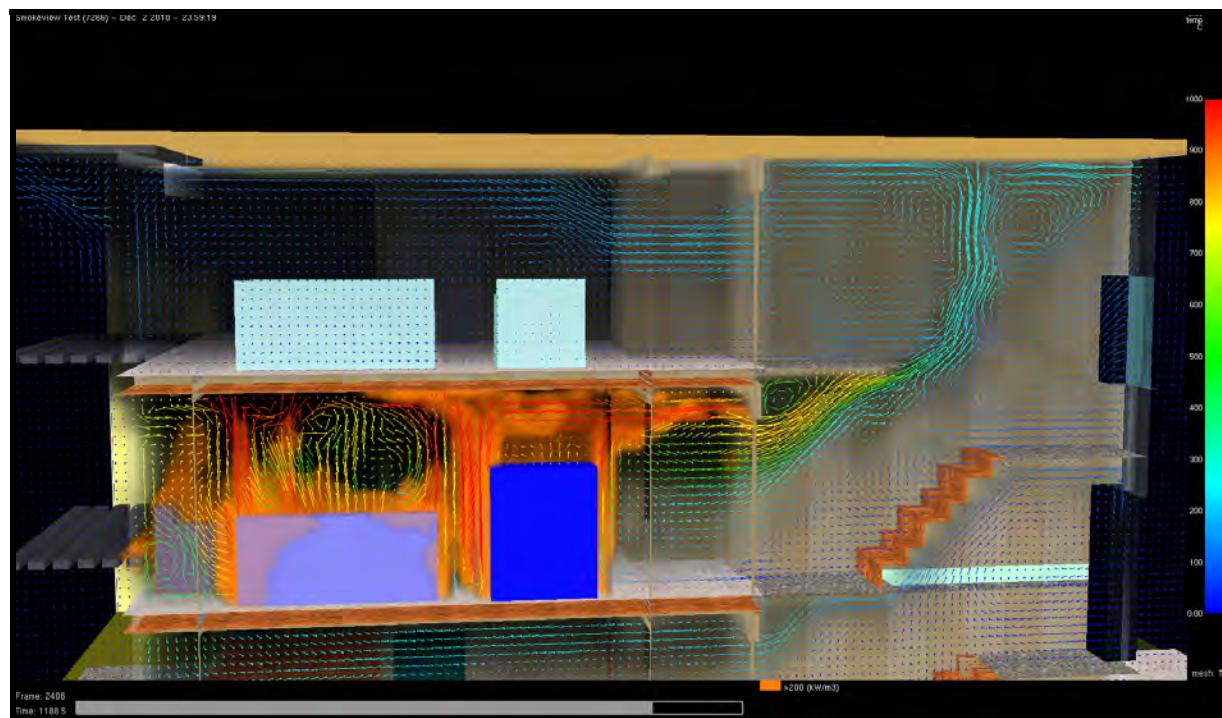
**Figure 31.** Smokeview frame showing temperature, direction and magnitude of ventilation flow path through stairwell at the time of rollover. Note the flow of heat out of the apartment into the stairwell.

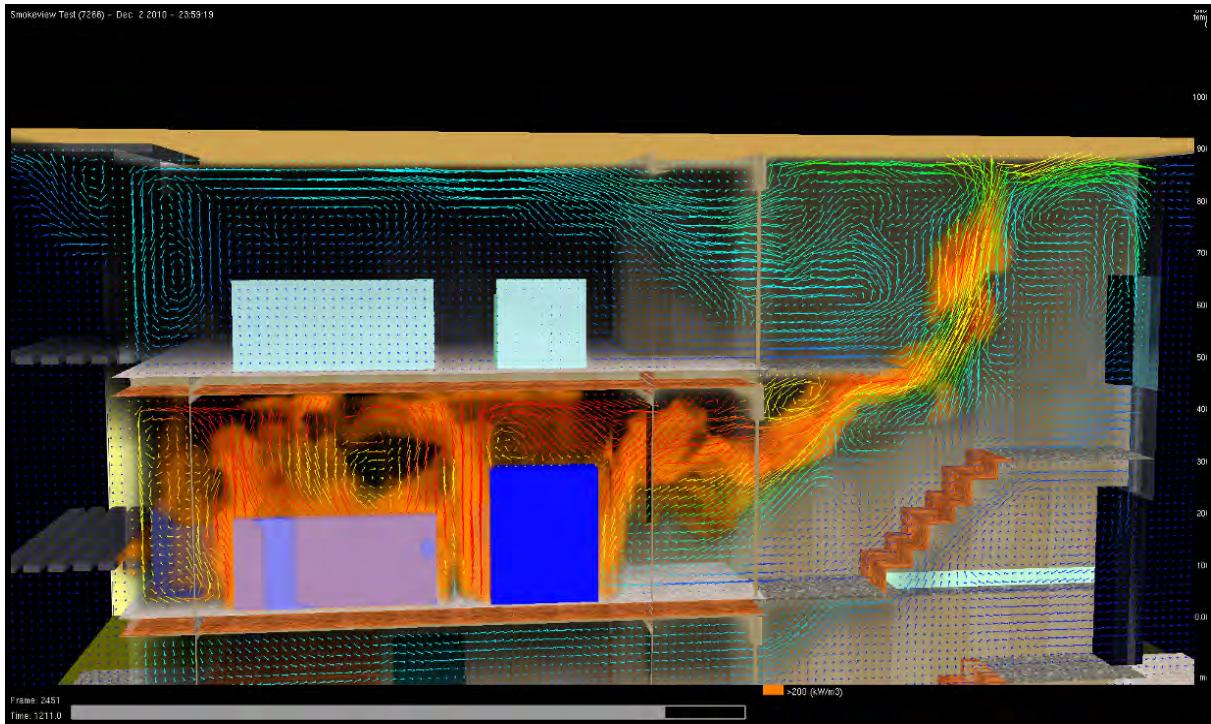
Figure 32. Smokeview frame showing smoke and heat filling the sealed stairwell and flowing into the third level above. Note the flow path from the stairwell into the third floor apartment.
