## ATF Fire Research Laboratory

December 27, 2011

SUBJECT: FDS Modeling Analysis  
30 Dowling Circle

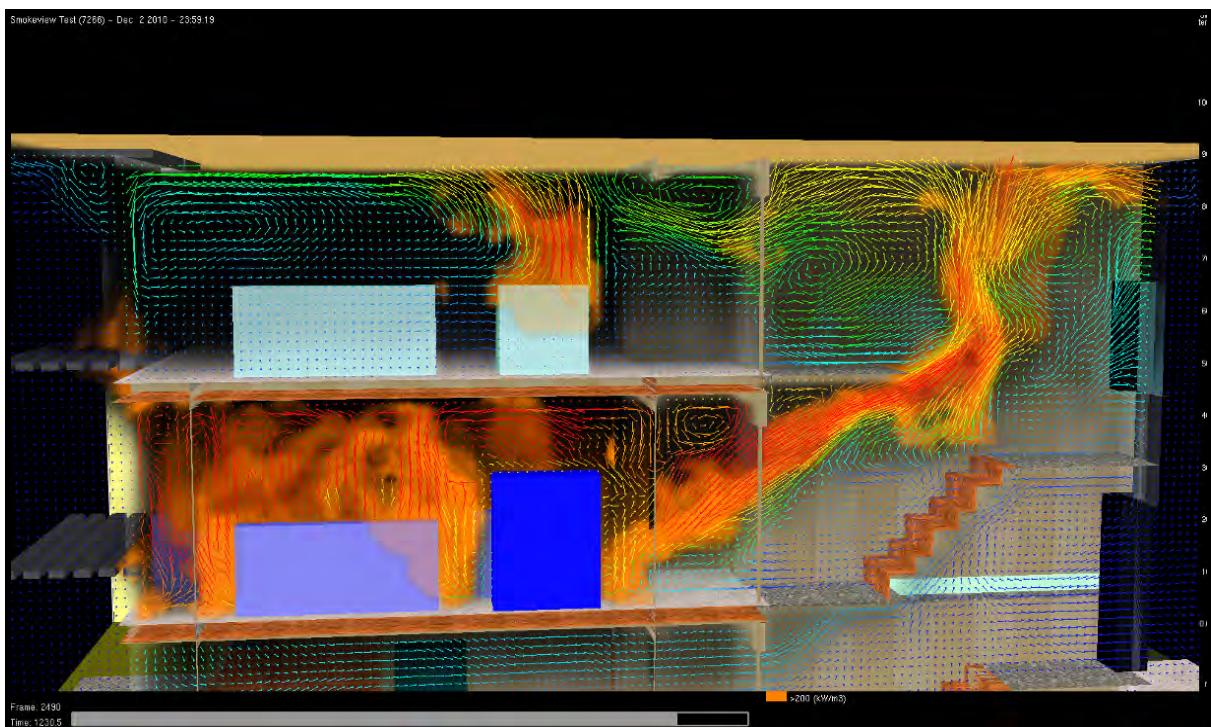
Figure 33. Smokeview frame showing ignition of the couches just inside the third level doorway. The energy from the fully involved second floor apartment flows through the sealed stairwell, directly into the apartment above.

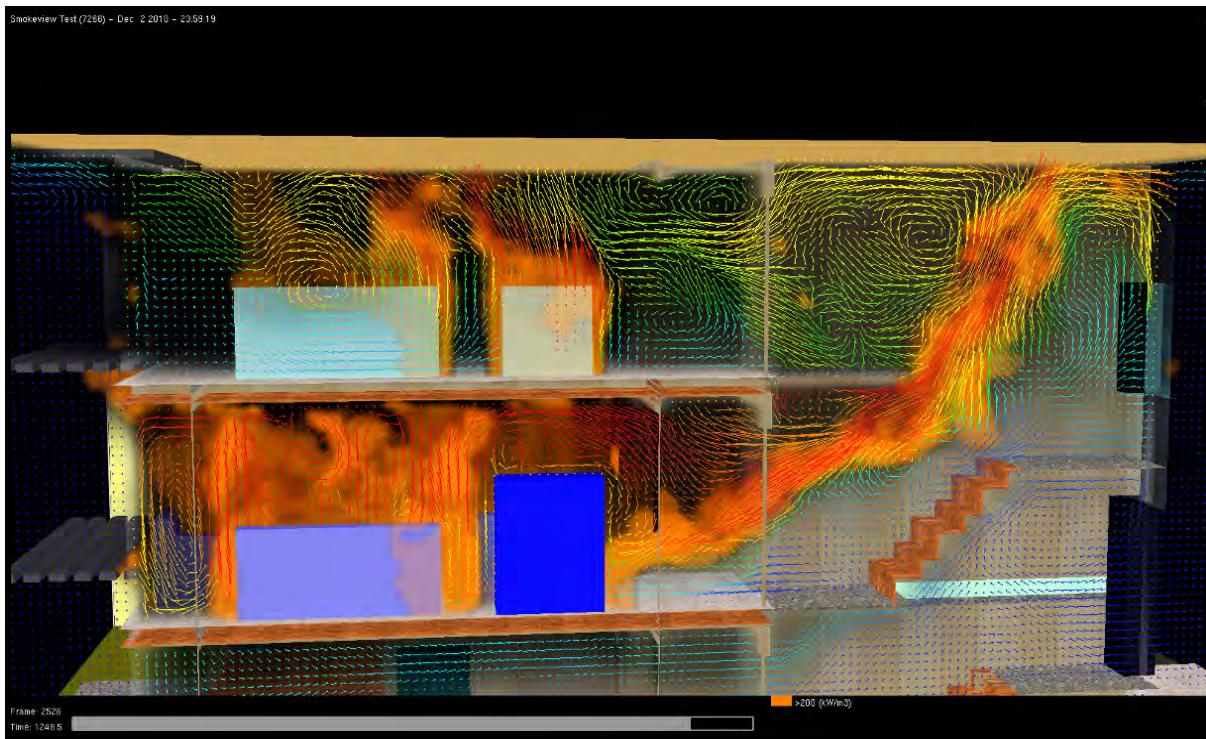
**Figure 34.** Smokeview frame showing fully developed fire on the second level resulting in flashover of the third floor.

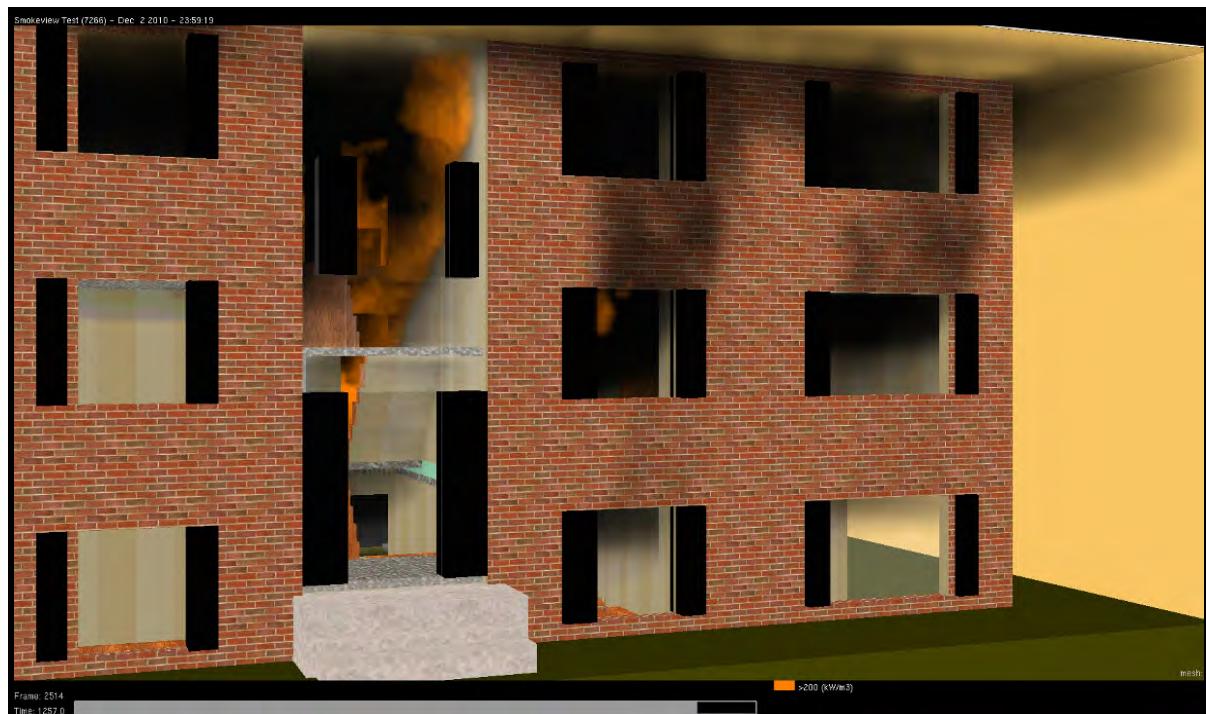
**Figure 35.** A front view of the apartment building from Smokeview of flames extending through the stairwell into the third floor (front stair wall is hidden to show flame extension).

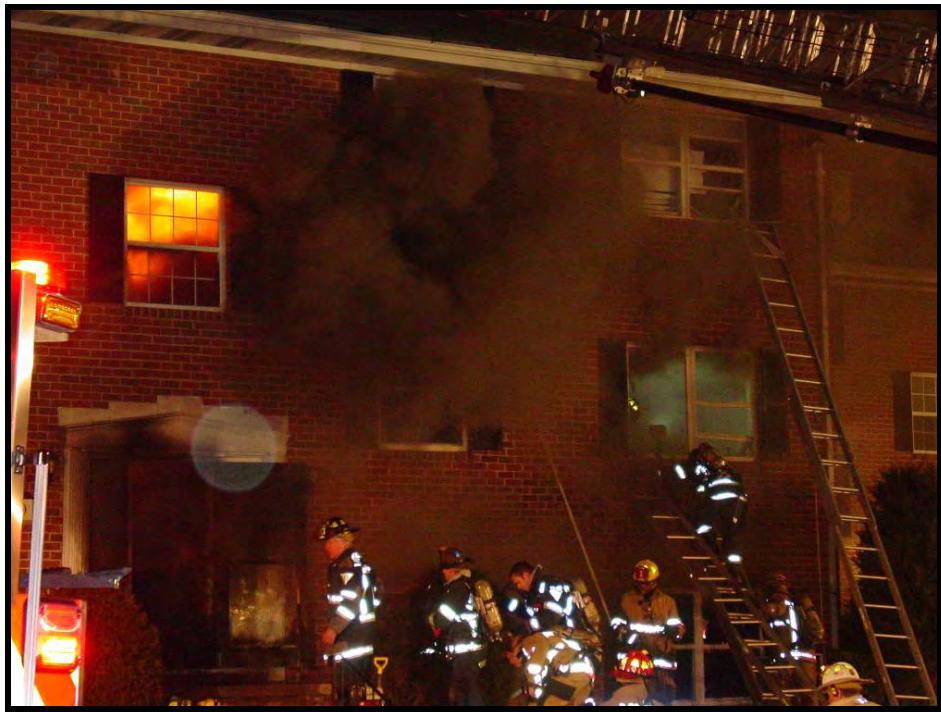
**Figure 36.** Photo showing flame extension into hallway as the second floor apartment reaches flashover. Note the heavy smoke and fire conditions that now exist in the stairwell as compared to when Squad 303 originally made entry.

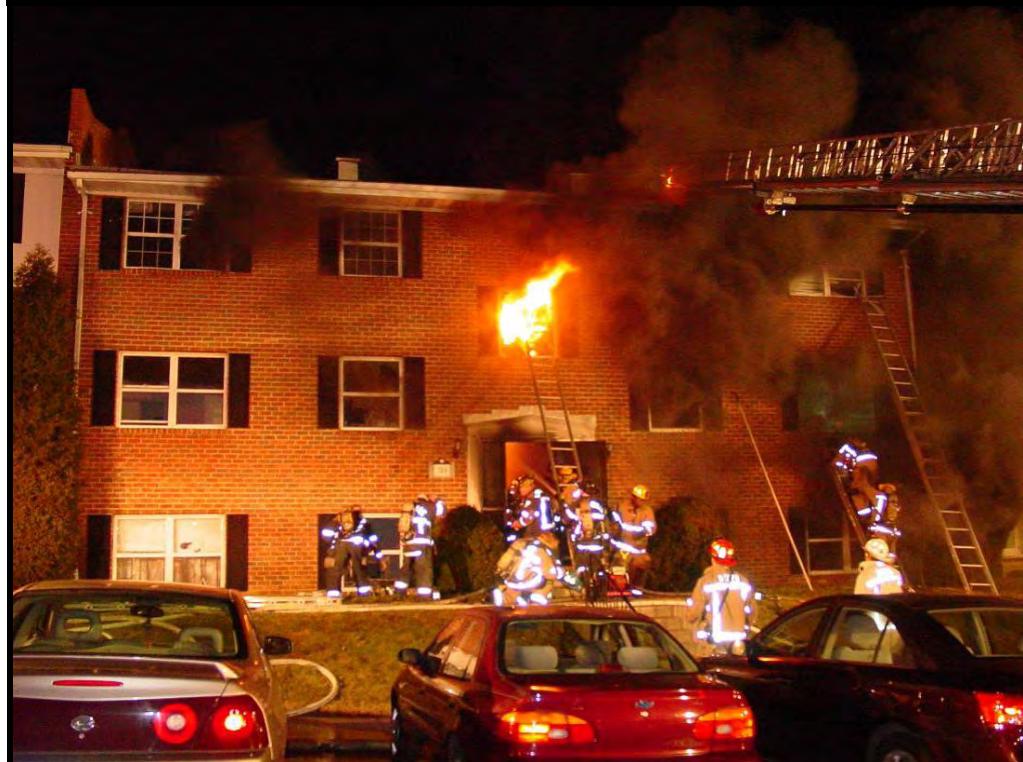
**Figure 37.** Photo showing flame extension through the stairwell to the third level. The stairwell window is broken by a ladder just after flames extend to the third floor. Evacuation tones are sounded just before this photo.

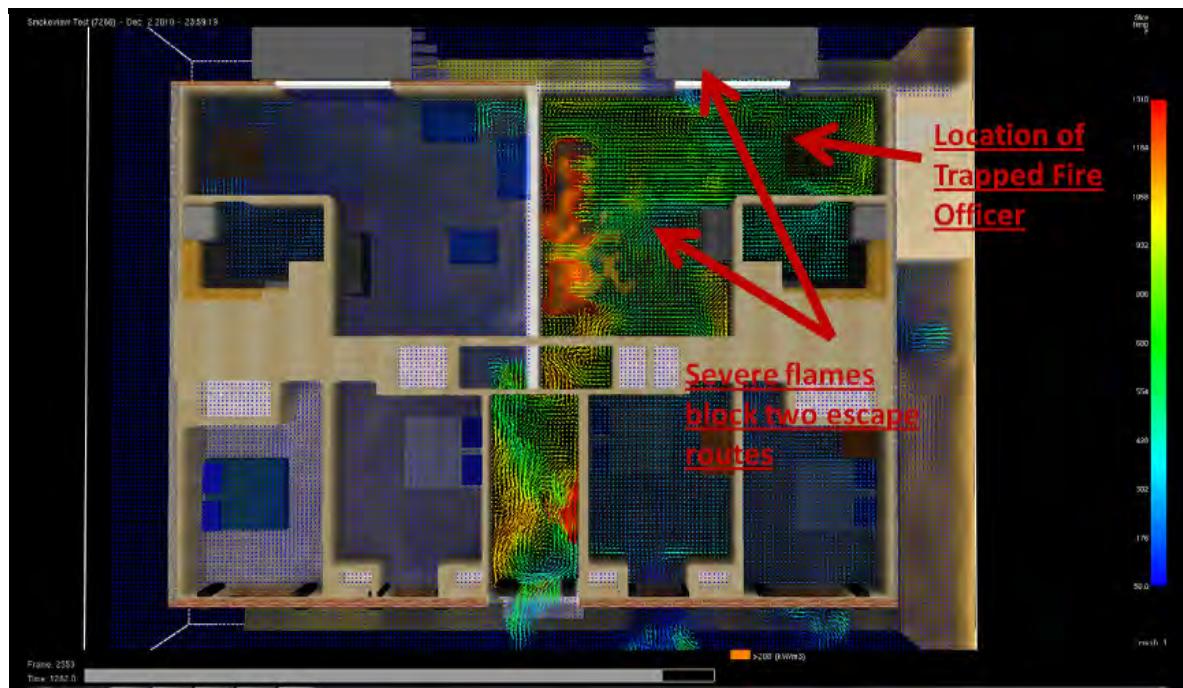
Squad 303 officer's means of egress through the apartment entrance door was also blocked by the flames in the living room and stairwell. There were no windows located in the rear of the apartment. The only means of escape was the balcony slider, however the entire balcony was engulfed in flames from the fully involved apartment below.

Figure 38. Plan view showing location of trapped fire officer and potential escape routes through structure, both of which are block by flames.

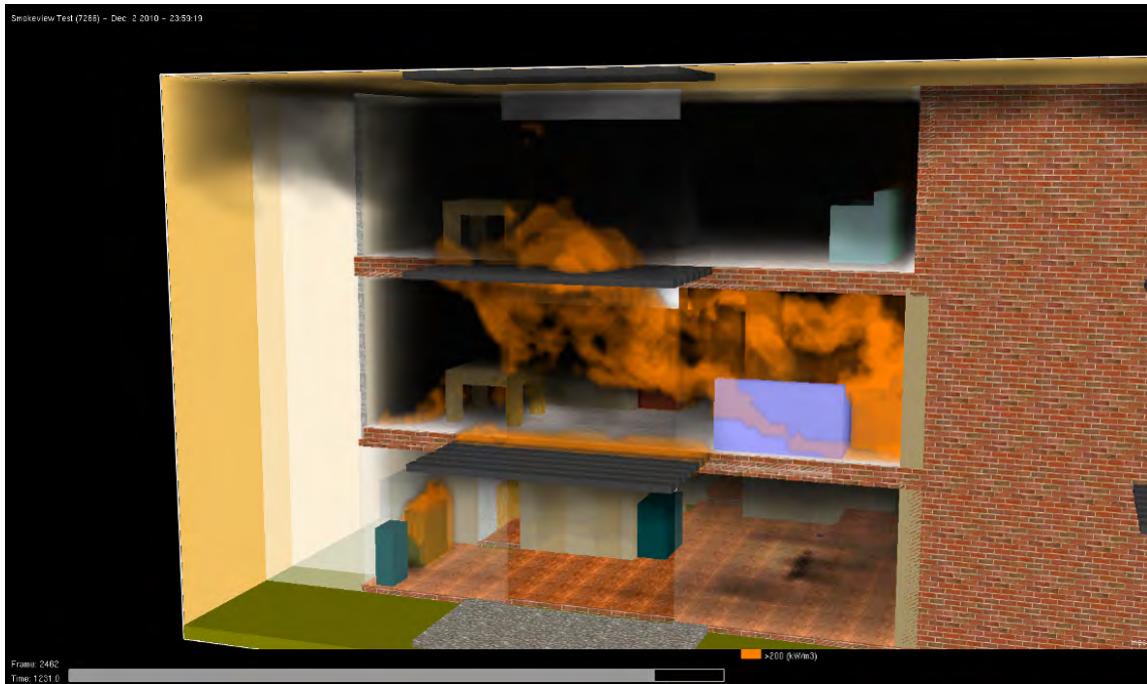
**Figure 39. Smokeview frame showing flames blocking potential egress through the third floor balcony as seen from the rear of the building.**

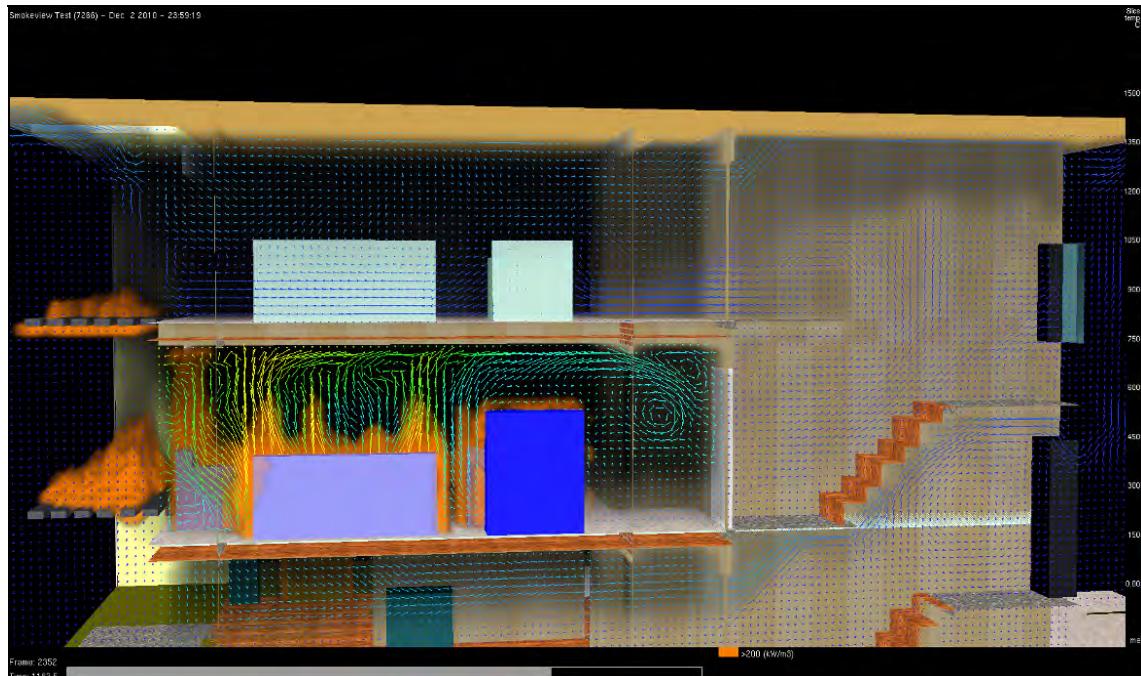
The first alternative modeling run featured the exact same fire scenario, except the second (middle) level apartment door was closed after the last victim was removed from that apartment. The apartment entry doors from the stairwell were fire-rated doors constructed of solid wood. As soon as the door is shut, the ventilation flow path through the apartment and up the stairwell is blocked.

Figure 40. Shutting the second level apartment door blocks the flow path and flame extension into the stairwell.

The model indicates that closing the second level apartment door prevents the flow of smoke, heat and other products of combustion from entering the stairwell, thus preventing flashover of the stairwell and the third level. As long as the second floor entry door remains shut, the model indicated that the conditions within the stairwell and third floor remain tenable for firefighters, even with the third floor apartment door open.

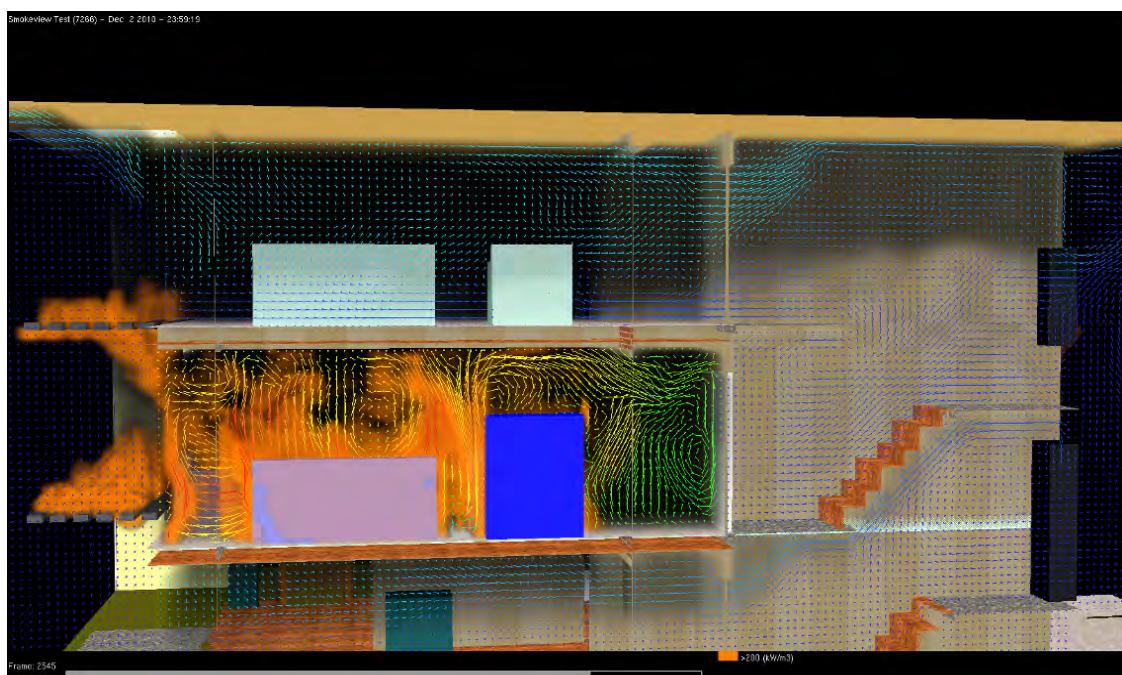
Figure 41. Even with the third floor apartment door left open, the model indicates that the stairwell and third floor remain tenable for firefighters. Flames eventually extend from the third floor balcony into the apartment, however the escape routes through the stairwell and the front apartment windows are accessible.

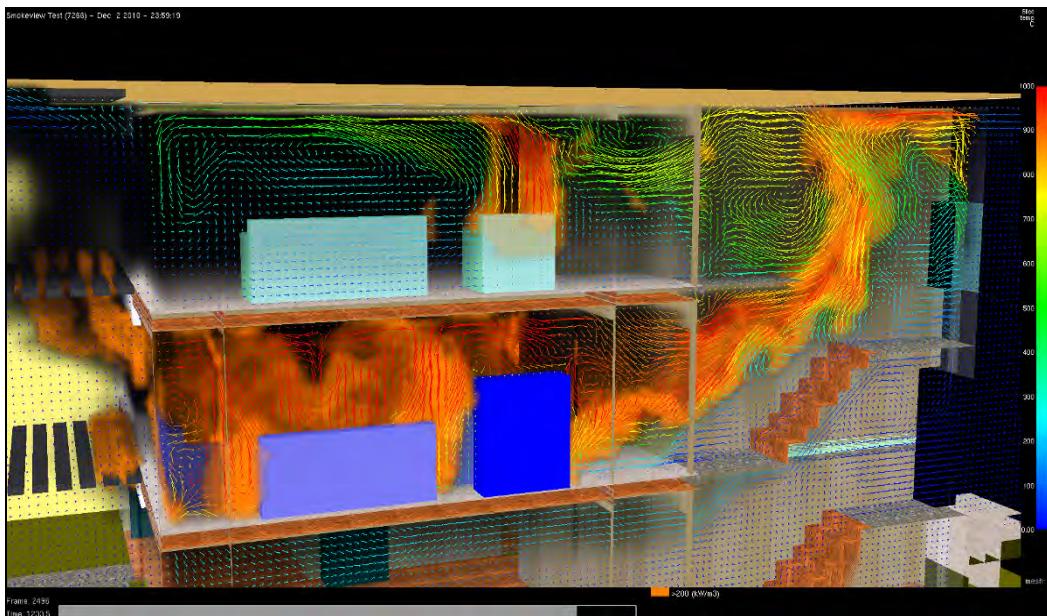
**Figure 42. Smokeview frame from the actual model with both apartment doors open for comparison purposes. The ventilation flow through the apartments results in an increased burning rate within both the second and third levels, as well as the stairwell.**

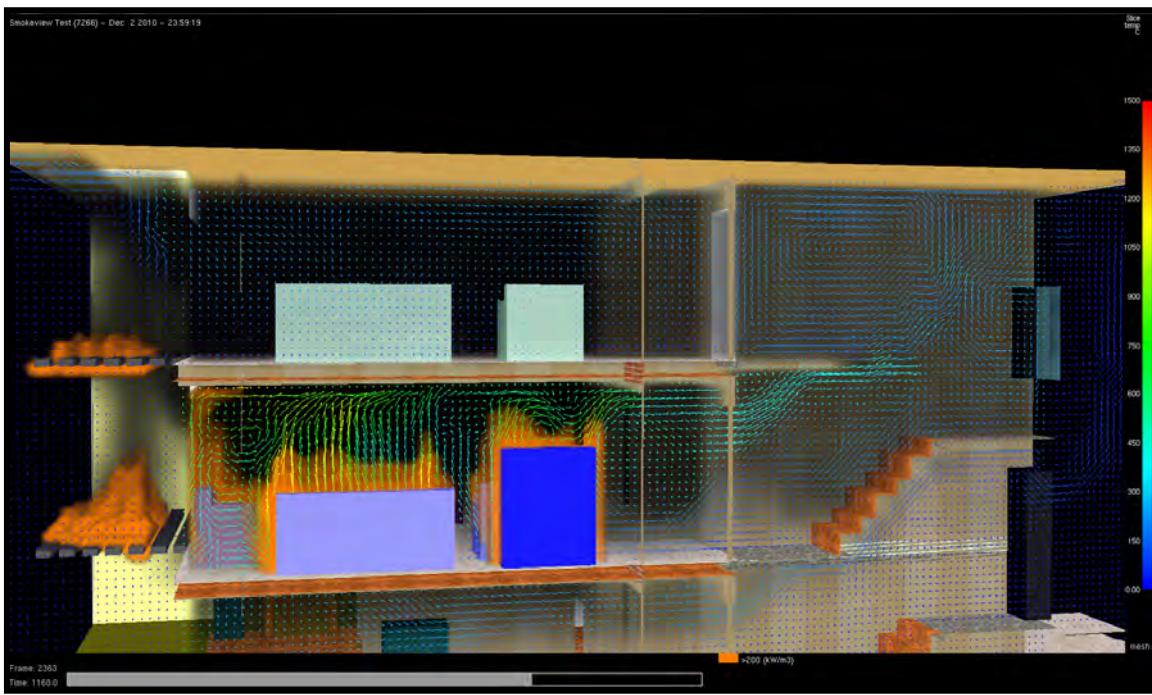
A second alternative modeling scenario was conducted where the third level entrance door was closed after crews made entry to search the apartment. The same fire conditions from the actual model were used. When the door remained closed, the outlet of the ventilation flow path was blocked at the top of the stairs. Without a complete flow path, there wasn't sufficient oxygen flowing through the second floor apartment to support extended burning in the stairwell. Consequently after flashover of the second floor, the flames in the stairwell only exist momentarily before consuming all available oxygen and becoming ventilation limited. The fire model indicated that temperatures within the third floor apartment stayed tenable for firefighters, even with a fully developed fire on the second floor and flames in the stairwell. Flames would eventually extend up the rear balcony to the third level, however they would not block egress through the living room and front windows of the apartment. By closing the apartment door on the third floor and blocking the outlet for fire gases emanating from the second floor apartment, the third floor apartment remains tenable for firefighting crews and the temperatures only briefly spike in the stairwell before the fire becomes ventilation limited.

**Figure 43.** Smokeview frame showing closed third floor apartment door preventing fire gases from entering the apartment.

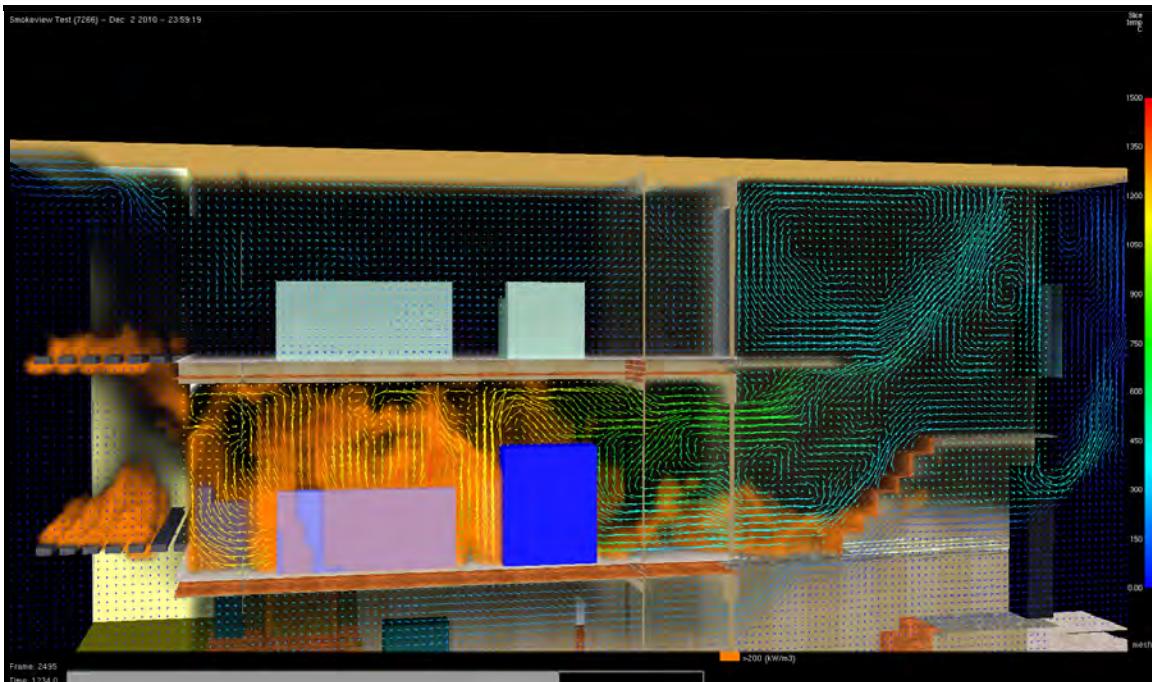
**Figure 44.** Blocking the outlet of the flow path decreases the burning rate within the second floor apartment and stairwell. The stairwell becomes oxygen limited and doesn't support sustained flaming combustion by the third floor apartment door at the top of the stairs.

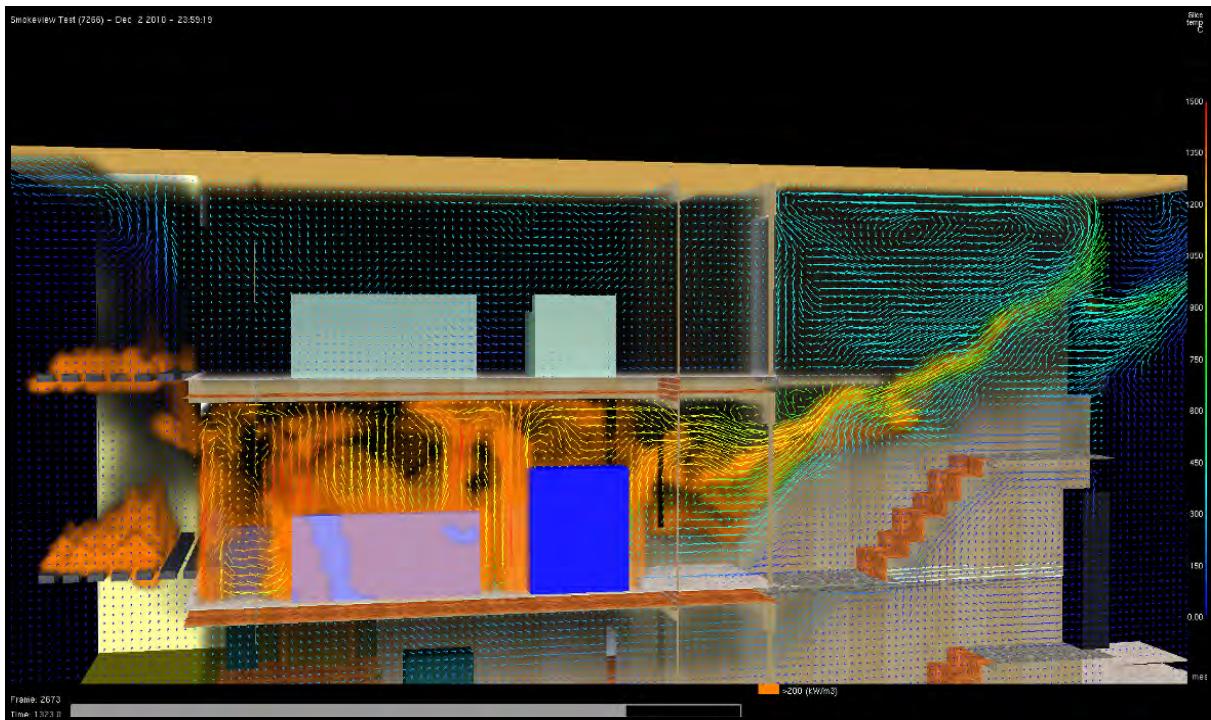
Figure 45. Even with the front stairwell window vented, the upper volume of the stairwell near the third level apartment entry doors remains oxygen limited and flames do not extend to the third level apartments via the stairs.

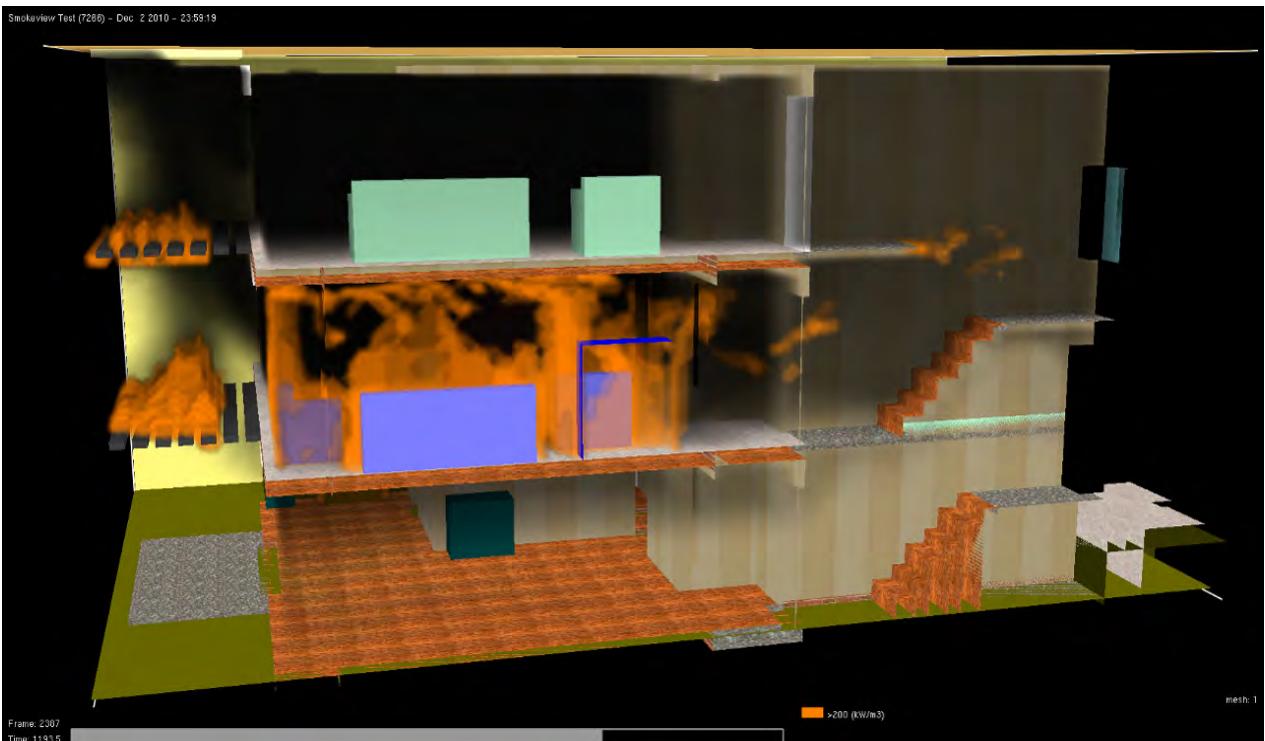
Figure 46. Smokeview frame showing oxygen limited conditions within the stairwell and relatively little flaming combustion as compared to the actual modeling scenario with both doors open.

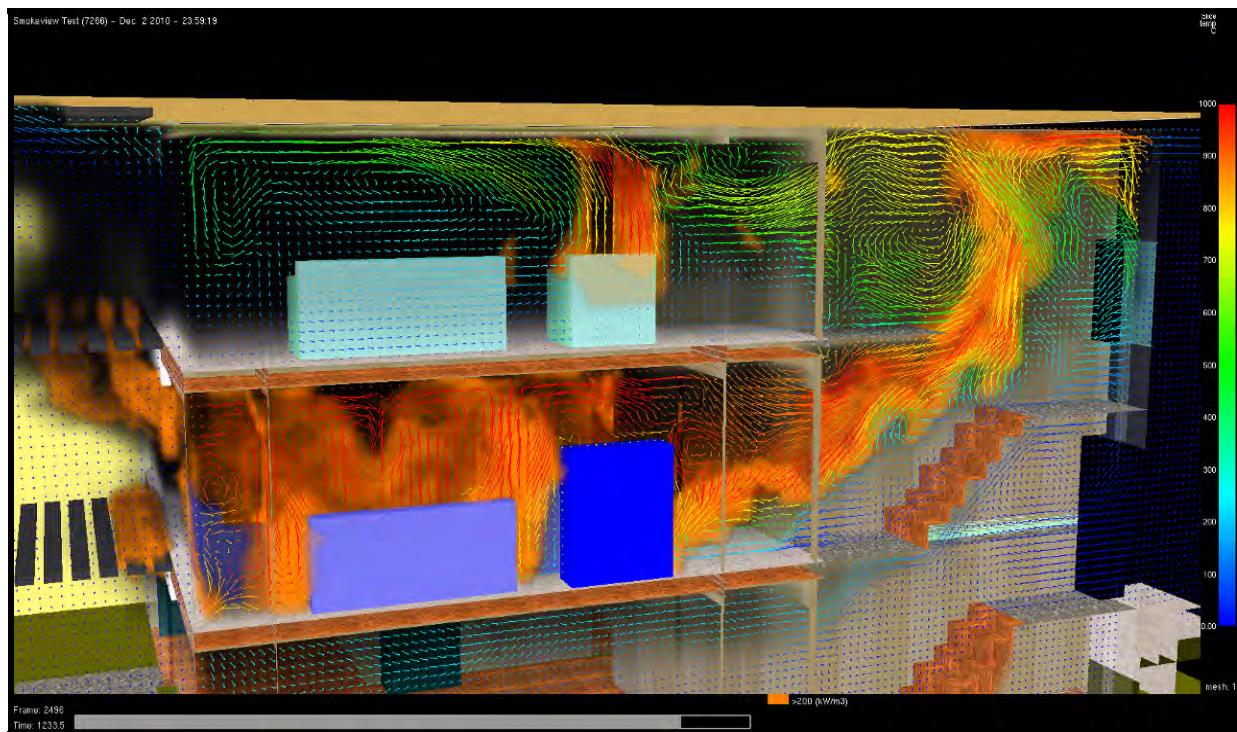
**Figure 47. Smokeview frame of actual modeling scenario for comparison purposes. Note the increased burning rate as compared to the ventilation limited conditions within the stairwell with the third floor apartment door shut.**

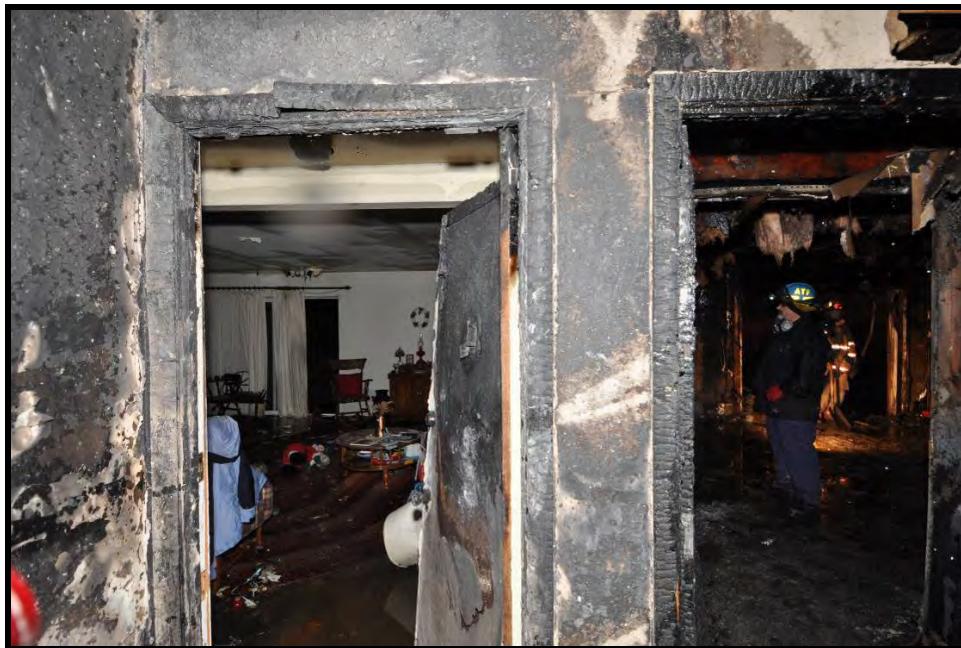
Figure 48. Terrace level stairwell landing looking into T1 (left) and T2 (right) apartments.

The impact of compartmentation on fire and smoke spread is evident by examining the post-fire damage throughout the structure. While other factors contributed to the relative fire damage, including fire department overhaul and relative apartment configuration, analyzing the damage to the building and the position of the apartment entry doors provides insight on the benefits of compartmentation. By closing apartment unit entrance doors and interior hollow core doors, one can slow or even block the ventilation flow path through the structure, thus significantly reducing the rate of fire spread. The photos below represent the post-fire damage in all six apartments within the fire building. Four of the six apartment entry doors were open for the majority of the fire and the relative difference in damage is clearly evident.

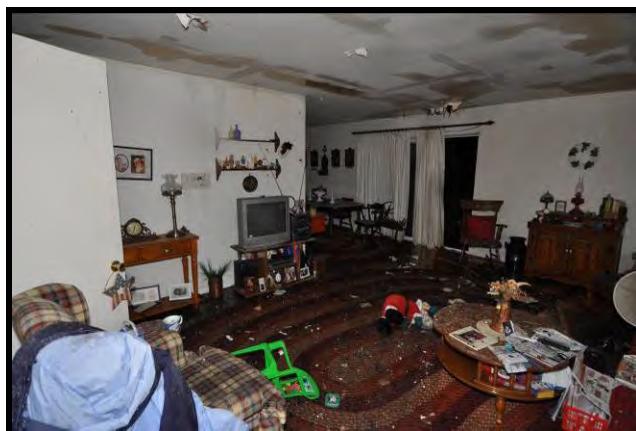
Figure 49. Damage to apartment T1. Door was closed for majority of the fire.

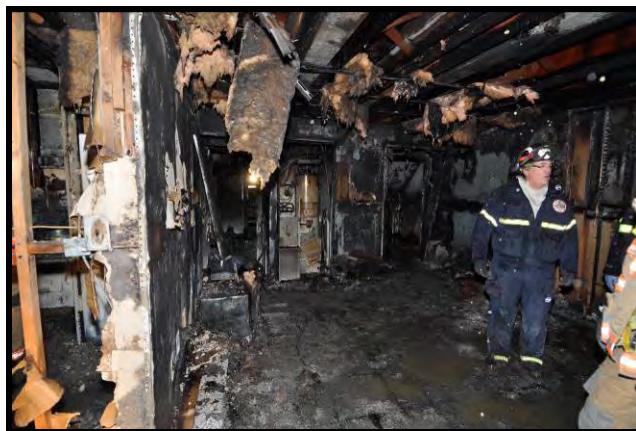
Figure 50. Damage to apartment T2 (post overhaul). Door was opened by occupant after discovering the fire.

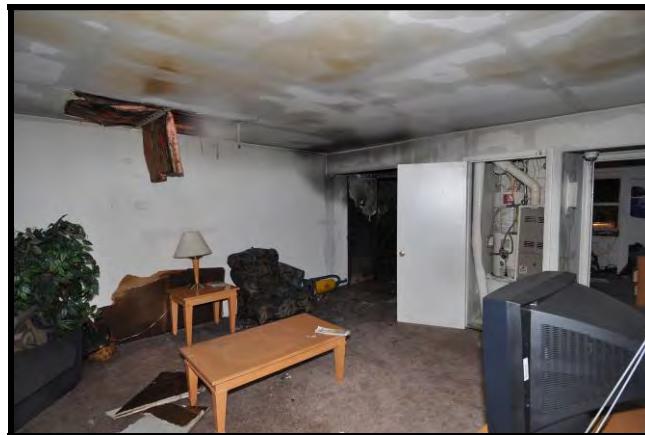
**Figure 52.** Photo of damage to apartment A1. Door was closed for majority of fire.

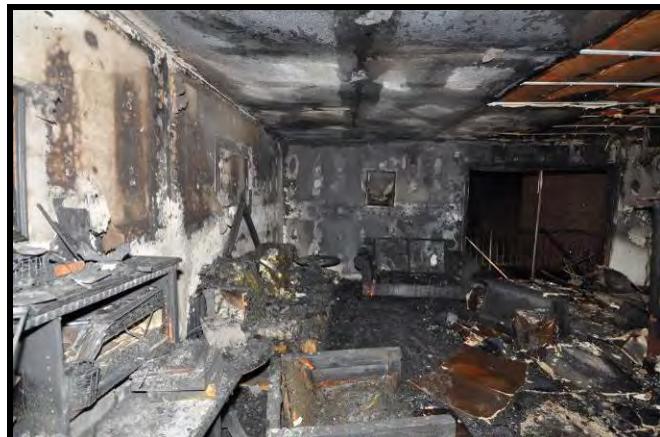
**Figure 53.** Photo of damage to apartment A2. Door was left opened by search crews.

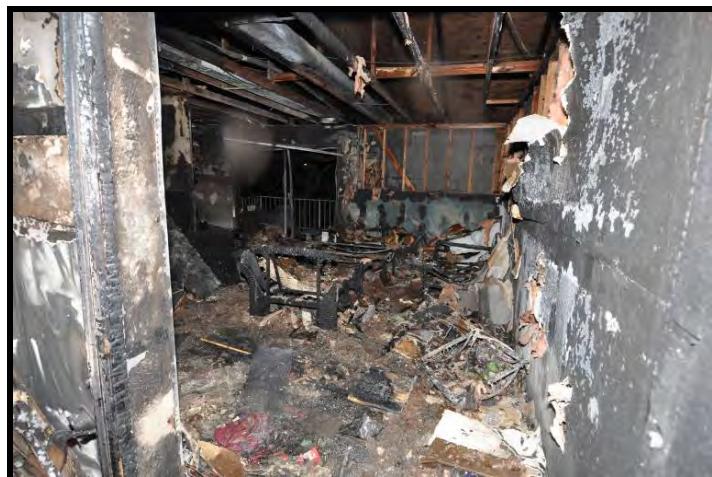
**Figure 55.** Damage to apartment B1 (post overhaul). Door was left opened by search crews.

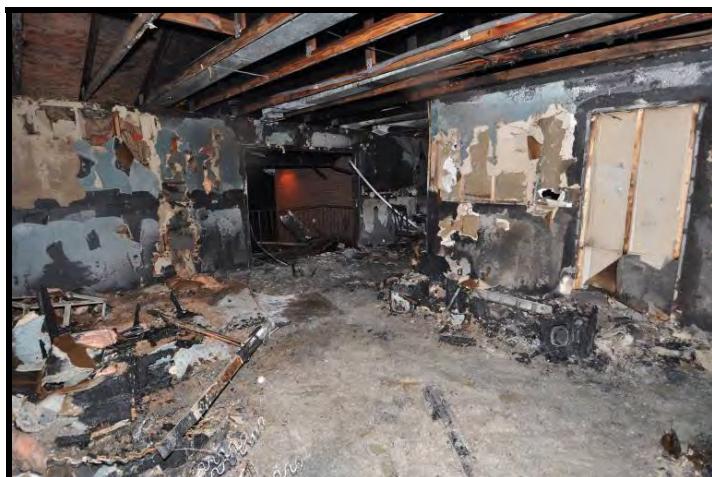
**Figure 56.** Damage to apartment B2 (post overhaul). Door was left opened by search crews.

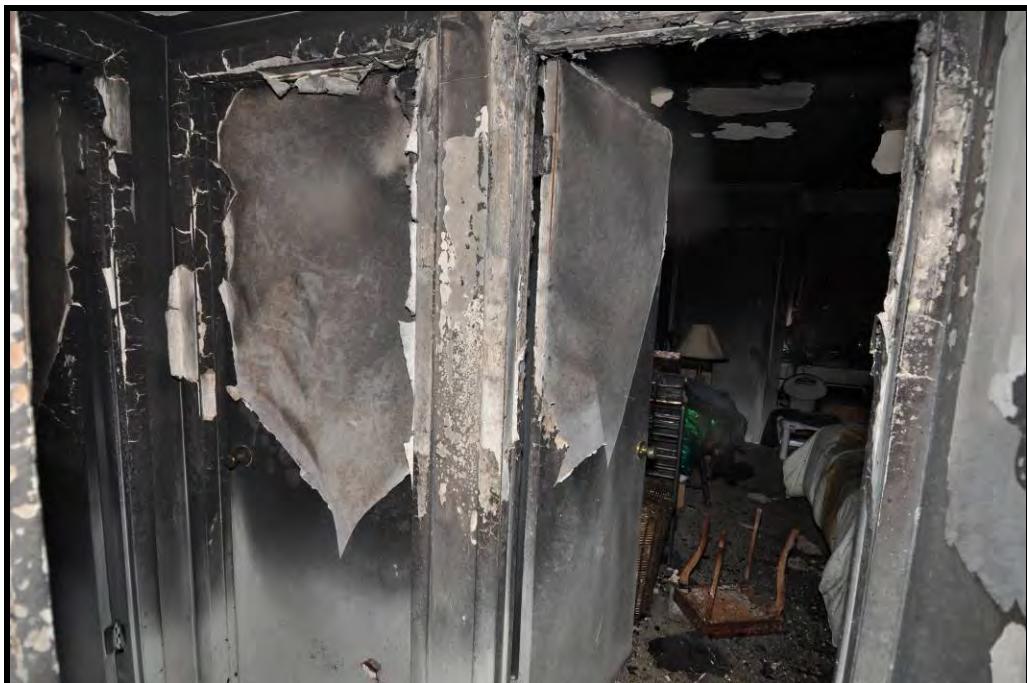
**Figure 57.** The left side hollow core door in this photo was shut by search crews after removing a victim from the living room to the bedroom. The living room reached flashover a short time later.

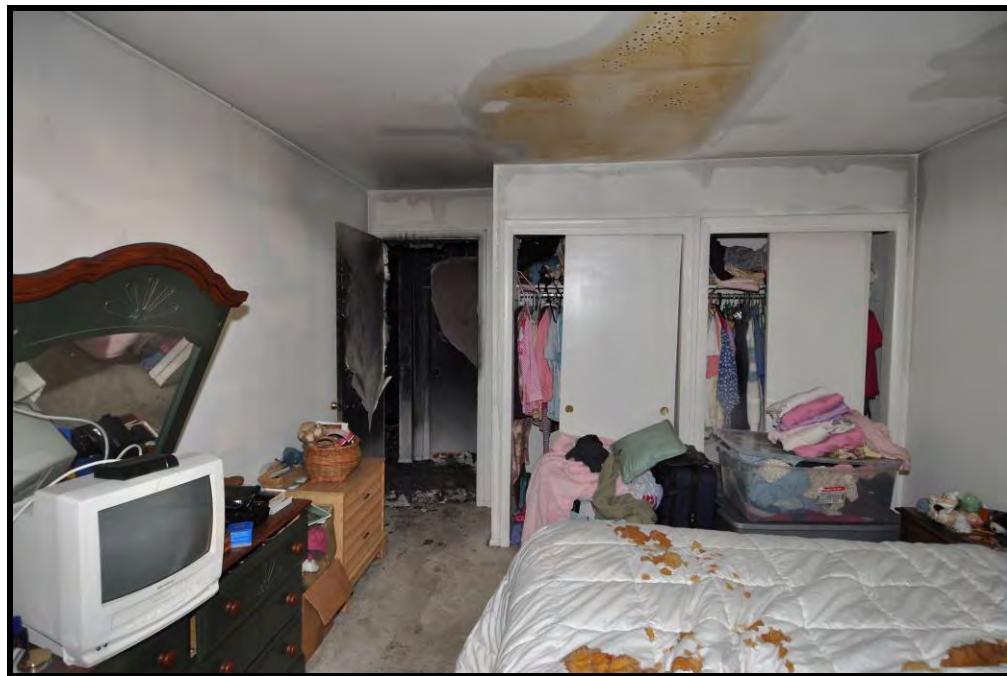
Figure 58. Photo of the bedroom on the other side of the hollow core where the victim was removed. Note the lack of smoke and fire damage, despite a fully developed fire on the other side of the door.

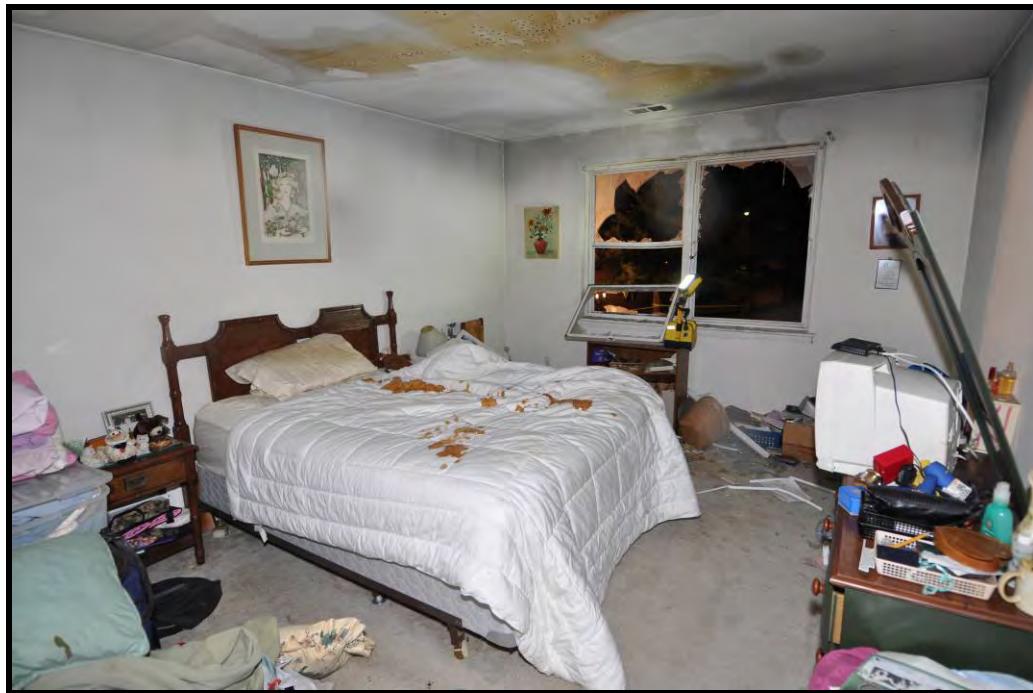
Figure 59. A second photo of same bedroom showing the VES window where the search crew entered and exited the apartment. Taking the time to shut the hollow core door blocked the ventilation flow path through the front window, thus isolating the crew and victim from the severe smoke and fire conditions in the hallway and living room.

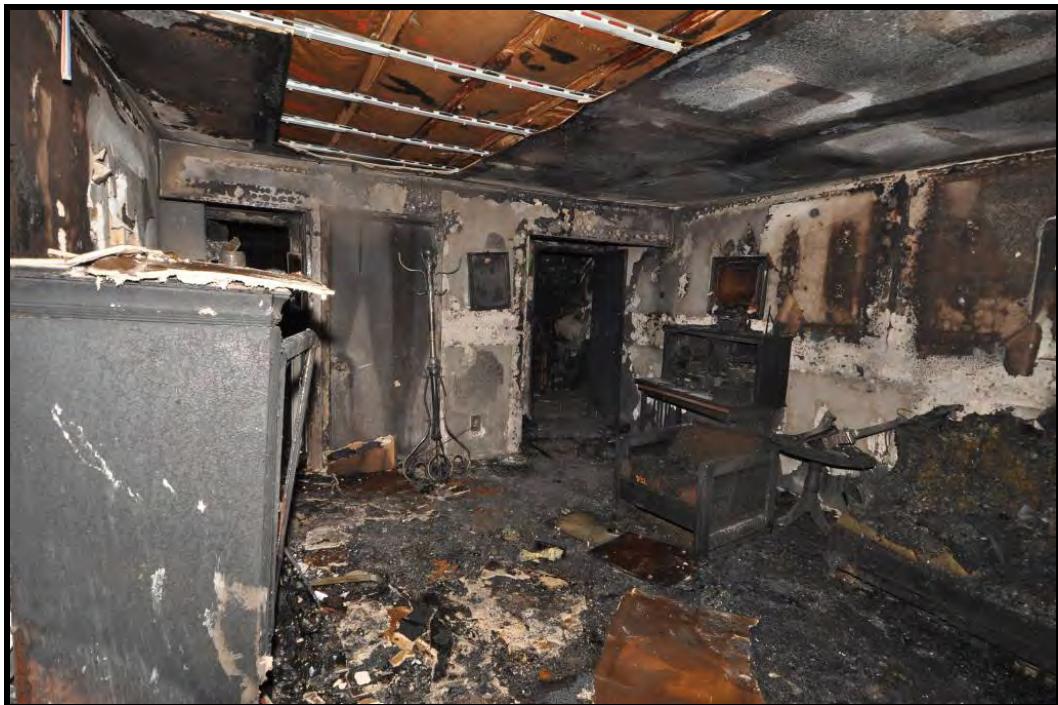
**Figure 60. Photo of living room that experienced flashover in apartment A2. The hollow core bedroom door is located in the small hallway at the upper left of this photo.**
