Adam St. John: Ventilation Flow Paths and Fire Growth

MODELING ANALYSIS

1. Analysis of Fire Development in the Terrace Level

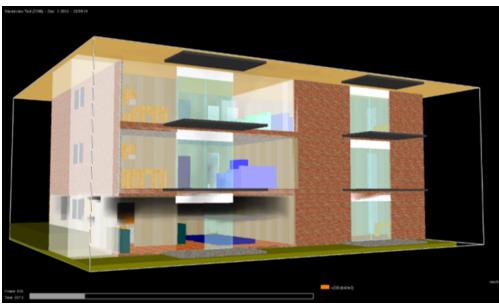
Figure 2. A Smokeview frame of the rear of the building indicating the fire origin and smoke spread within the T2 apartment.

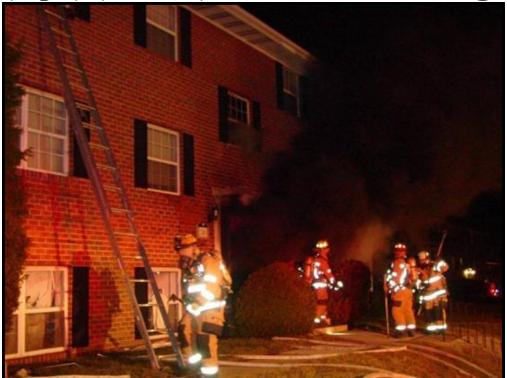
Photo 1. The front of the structure shows the unidirectional flow of smoke up the stairwell from apartment T2. Note the high volume of smoke from floor to ceiling as the stairwell door serves as the flow path outlet. The ground ladder in the foreground was used to rescue an occupant on the third floor who was trapped by heavy smoke in the stairwell.

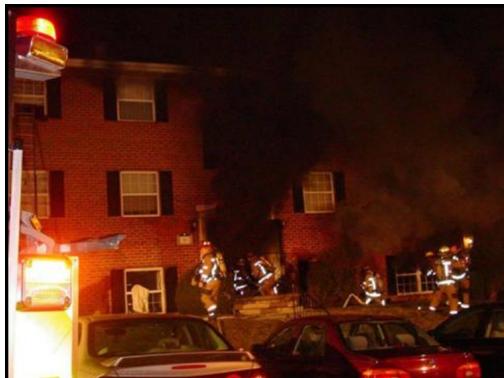
Photo 3. Hoselines are being positioned at the stairwell entrance door and the front window. Note the heavy smoke venting from all front openings in apartment T2.

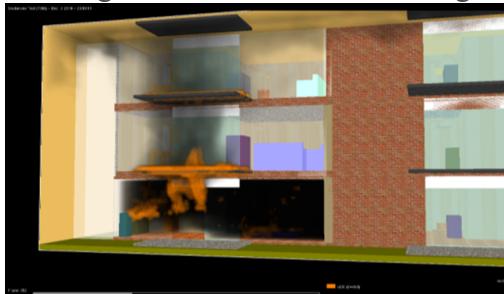
Figure 10. A Smokeview frame of the rear of the building with flames extending from T2 and involving both balconies above.

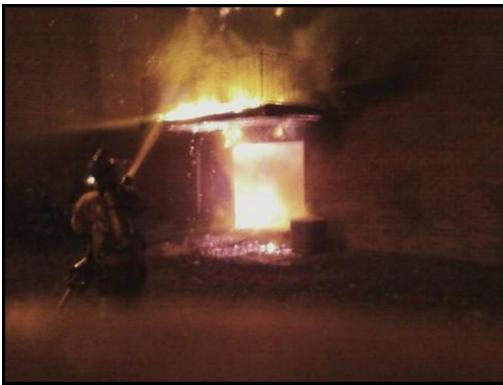
Photo 4. Flame extension and suppression efforts at the rear of the structure. Flames caused the second-level glass slider to fail and ignite plastic curtains in the doorway (top of the photo).

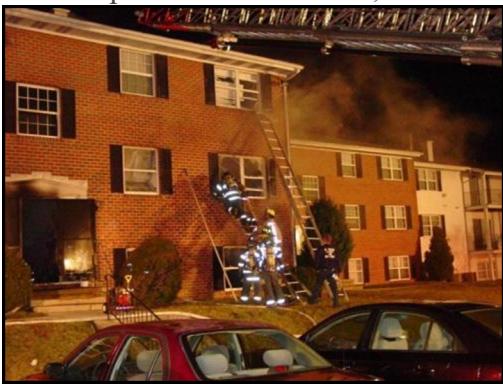
Photo 5. Building smoke and fire conditions around the arrival of Squad 303. Note the lack of heavy smoke or fire in the stairwell or on the terrace level. There is also no indication of the growing fire in the second (middle) level apartment.

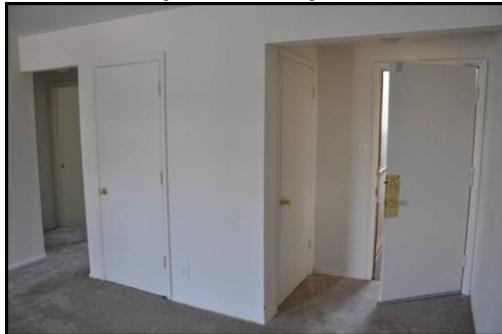
Squad 303's crew proceeded to search two apartments before entering the third-floor, right-side apartment to conduct a search, leaving the entrance door open. It should also be noted that carpeting impacted the bottom of the door and prevented the apartment entrance doors on the second and third levels from closing automatically. The entry doors had to be actively pushed closed to overcome the friction of the carpet.

Figure 13. Exemplar apartment showing the apartment entrance door.

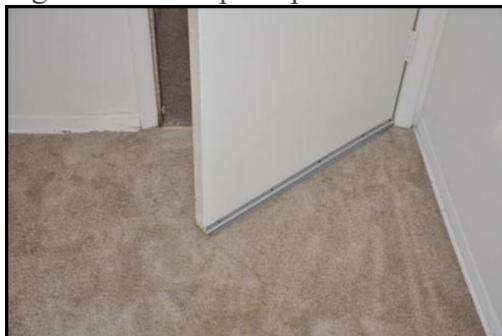
Figure 14. A close view of the base of the door impacting the carpet, preventing the door from self-closing. When Squad 303's crew of two firefighters entered the third-level apartment (B2), smoke was banked about halfway down the walls with moderate visibility. The crew could clearly see the floor of the apartment without the need to crawl below the smoke layer to search. Squad 303's crew was unaware of the flames spreading across the two couches in the second-floor apartment below them. The crew split to search the apartment faster, with one firefighter searching the front bedrooms and the officer searching the kitchen and the living room.

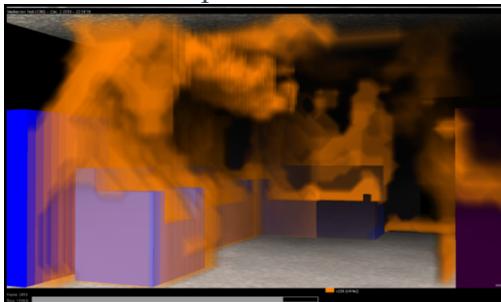
Figure 16. Involvement of the furniture items in the second-level apartment led to flashover.

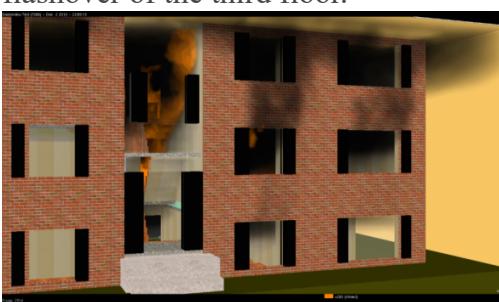
Figure 25. A front view of the apartment building, from Smokeview, of flames extending through the stairwell into the third floor (front stair wall is hidden to show flame extension).

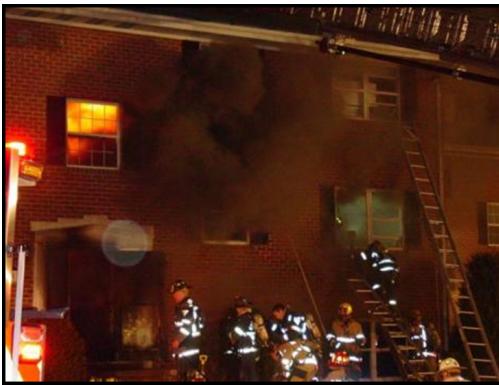
Photo 6. Flame extension into the hallway as the second-floor apartment reaches flashover. Note the heavy smoke and fire conditions that now exist in the stairwell as compared to when Squad 303 originally made entry.

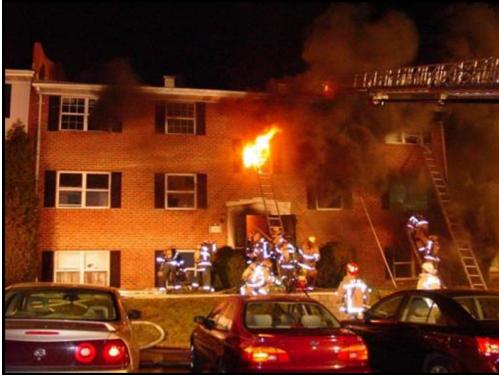
Photo 7. Flame extension through the stairwell to the third level. The stairwell window is broken by a ladder just after flames extend to the third floor. Evacuation tones were sounded just before this photo. Command sounded the building evacuation tones as flames extended into the hallway and up to the third-level apartment. Two couches just inside the entrance door on the third level ignited, blocking the primary means of egress for both firefighters from Squad 303.

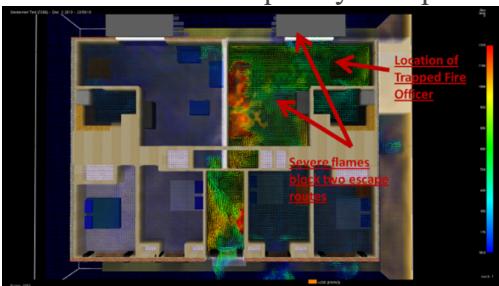
Squad 303 officer's means of egress through the apartment entrance door was also blocked by the flames in the living room and stairwell. There were no windows in the rear of the apartment. The only means of escape was the balcony slider; however, the entire balcony was engulfed in flames from the fully involved apartment below.

Figure 26. The location of the trapped fire officer and potential escape routes through the structure, both of which are blocked by flames.

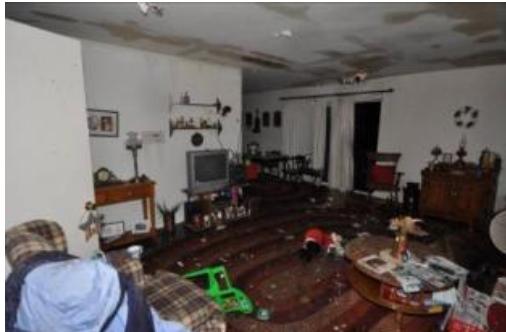
Photo 9. Damage to apartment T1. The door was closed for the majority of the fire.

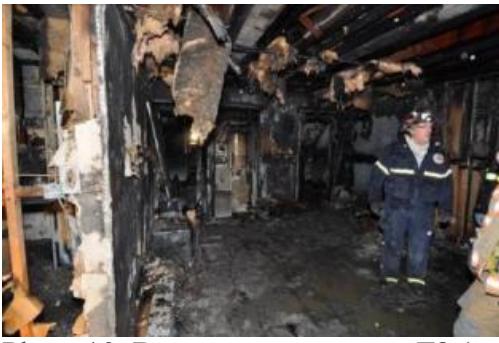
Photo 10. Damage to apartment T2 (post overhaul). The door was opened by the occupant after discovering the fire.

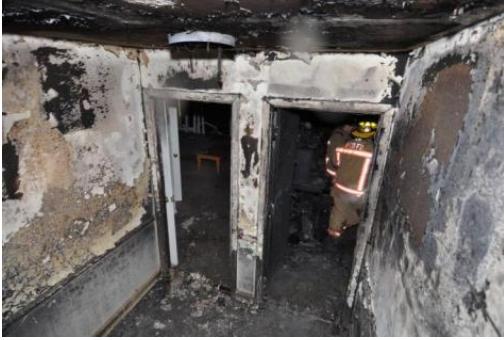
Photo 11. The second-floor stairwell landing and apartments A1 (left) and A2 (right).

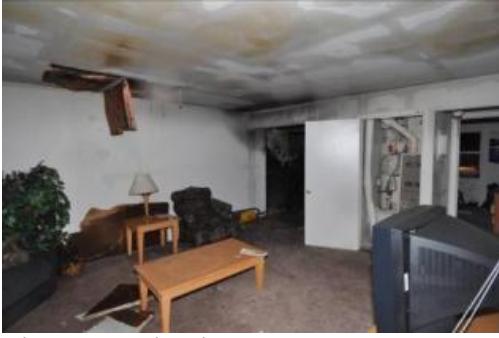
Photo 12. The damage to apartment A1. The door was closed for the majority of the fire.

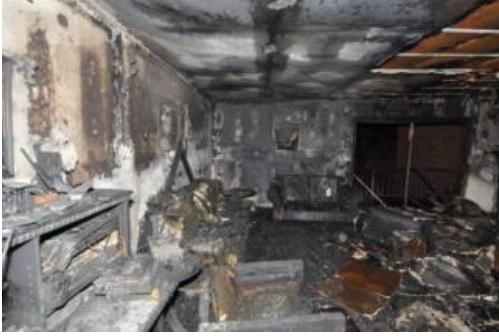
Photo 13. The damage to apartment A2. The door was left open by search crews.

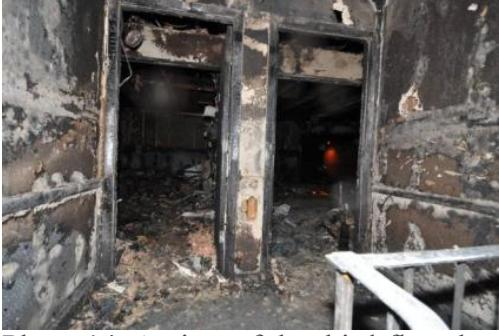
Photo 14. A view of the third-floor landing looking in at apartments B1 (left) and B2 (right).

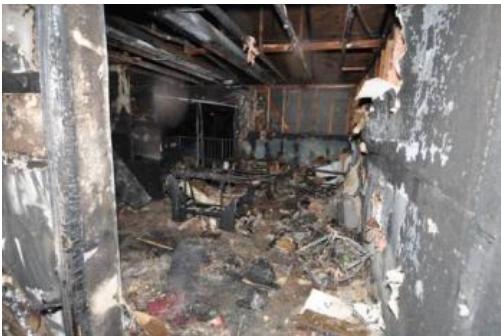
Photo 15. Damage to apartment B1 (post overhaul). The door was left open by search crews.

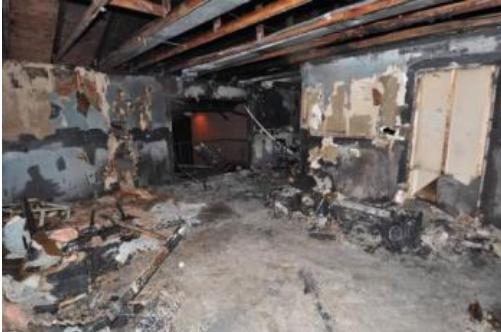
Photo 16. The damage to apartment B2 (post overhaul). The door was left open by search crews. Using doors to compartmentalize and limit fire and smoke spread in a structure is not limited to fire-rated entrance doors. Interior hollow core doors also offer considerable protection for compartmentation purposes. A search crew used the Vent-Enter-Search (VES) technique through a front window used a hollow core bedroom door to isolate themselves from the developing fire in the living room of apartment A2. As the crews removed the second victim from the living room to the bedroom, they shut the bedroom hollow core door behind them. The living room soon experienced flashover followed by full room involvement; however, the bedroom remained isolated from the heat and smoke for the duration of the fire. The photos below illustrate this effective use of compartmentation to protect firefighters during a search.

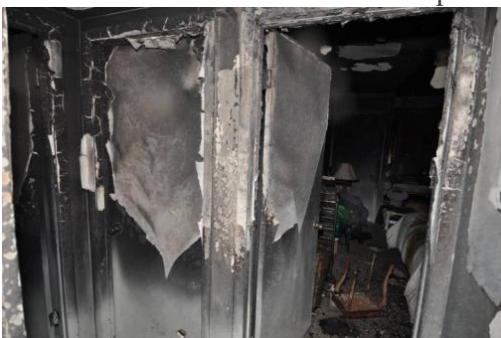
Photo 17. The left side hollow core door in this photo was shut by search crews after removing a victim from the living room to the bedroom. The living room reached flashover a short time later.

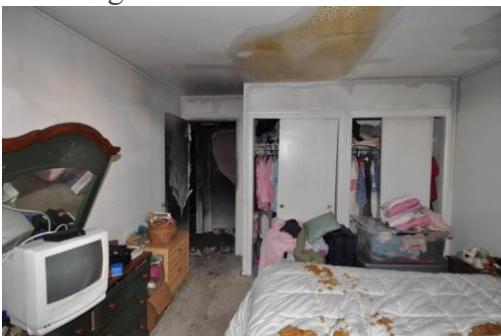
Photo 18. The bedroom on the other side of the hollow core door from which the victim was removed. Note the lack of smoke and fire damage despite a fully developed fire on the other side of the door.

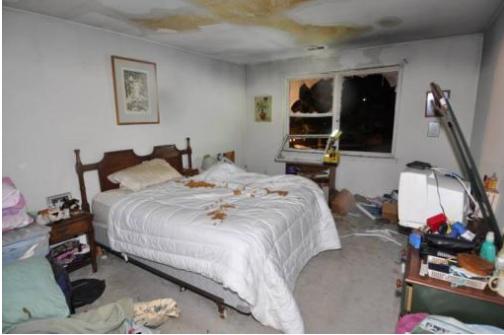
Photo 19. The same bedroom above showing the VES window where the search crew entered and exited the apartment. Taking the time to shut the hollow core door blocked the ventilation flow path through the front window, thus isolating the crew and victim from the severe smoke and fire conditions in the hallway and living room.

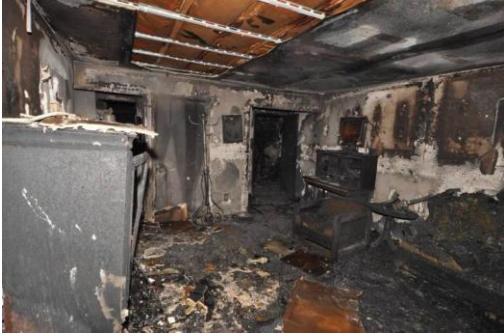
Photo 20. The living room that experienced flashover in apartment A2. The hollow core bedroom door is in the small hallway at the upper left of this photo.
