Warren City Parks

Action Plan

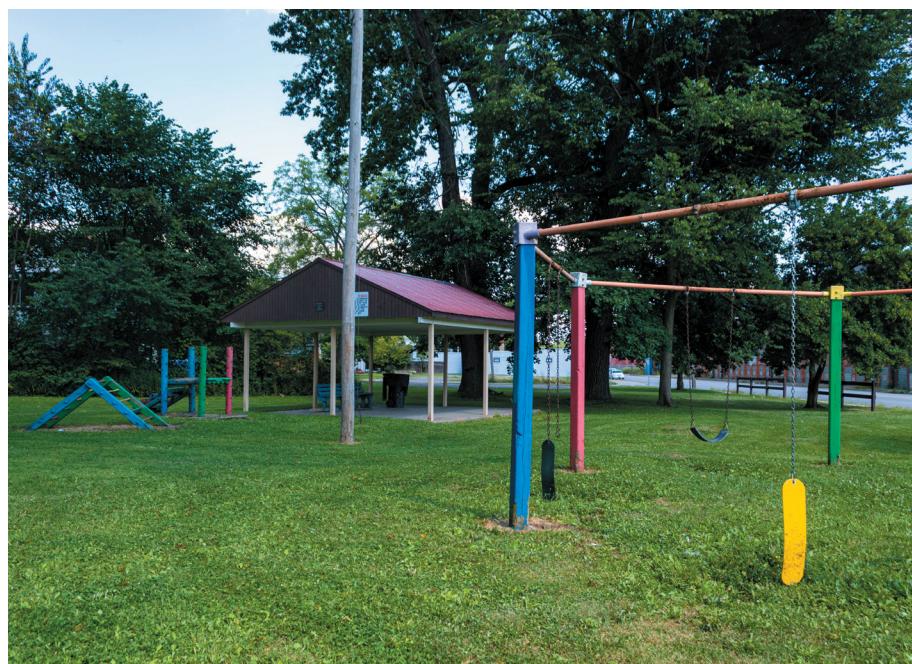
Image 3.3 AmVets Park Photo
AmVets Park pavilion and park infrastructure.

Park Conditions: Most of the equipment at the park is in need of repair or replaced. There is no signage along the walk to the park and it lacks a designated entrance.

- Repair the fence along West Market
- Replace the 2 degraded benches in the pavilion
- Tree maintenance as needed for public safety in high use areas of the park to be guided in part by the Tree Inventory Summary Report, located in the appendix
- Develop a maintenance plan for park
- Improve wayfinding signage to the parks
- Install ADA compliant crosswalks to access the park
- Continue to engage with the groups or organizations who use the park for organized physical activity, including them on any future infrastructure improvement planning
- Evaluate and improve existing playground areas in accordance with National Recreation and Parks Association (NRPA) safe surface standards

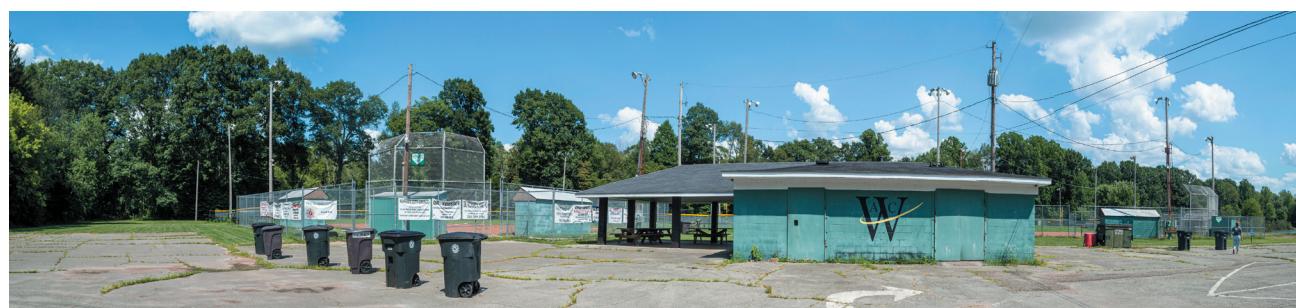
Image 3.7 Burbank Park Photo

Park Conditions: Wayfinding signage exists on Tod Ave NW and Elm Hill Drive. There is one entrance/exit to the park with signs identifying video monitoring at the park, though overall the park lacks adequate signage. The bleachers and dugouts are in fair to poor condition. The play equipment is located about 100 yards from the parking lot within the greenspace close to the pond. The majority of the park lies in the floodway of the Mahoning River, and as such causes regular flooding of the park.

Panoramic view of organized sport infrastructure at Burbank Park.

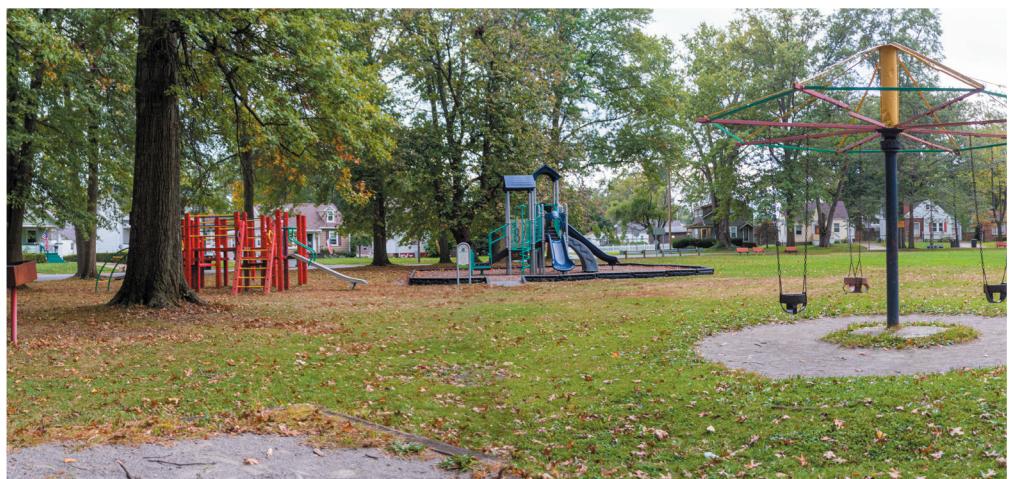
Park Features: The park lacks signage for direction or physical activity programming, bike or walking paths to or within the park, and bike parking. The climbing equipment needs repaired and painted.

Image 3.12 Circle Park Both photos to the right on pages 26 and 27 depict Circle Park and its play equipment and seating.

- Improve and repair sidewalk access to the park for pedestrian safety
- Repair, replace or remove drinking fountains
- Replace, repair, and add additional lighting to all recreational areas
- Update and/or install bike racks
- Greening and beautification of entrances and intersections near park
- Incorporate recycling stations
- Replace, repair, or remove grills, picnic tables, and benches throughout the park
- Install, replace, or repair seating at recreational areas
- Install pet waste stations

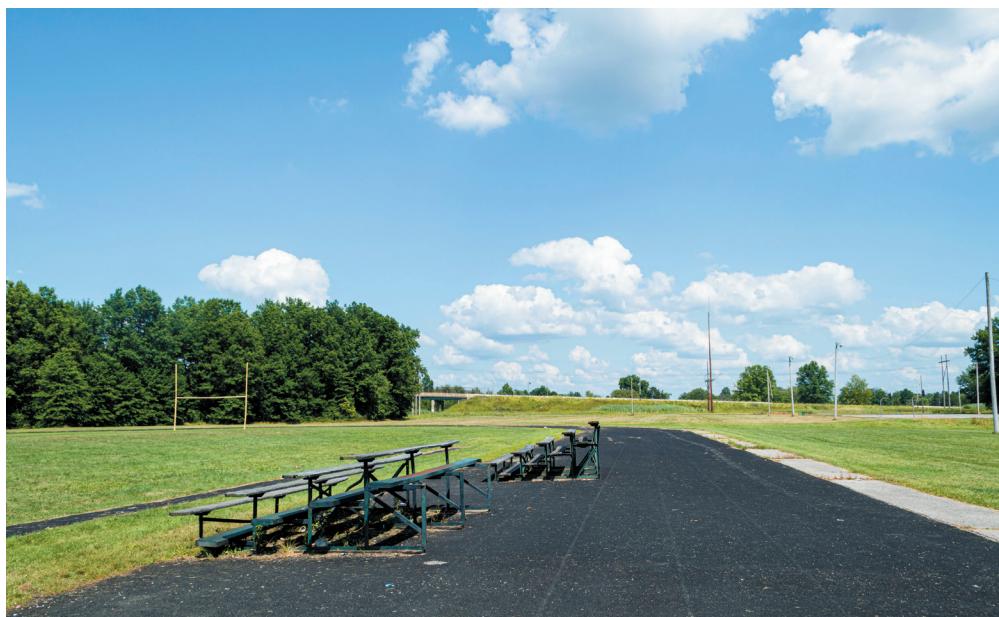
Park Features: The football field and track around the field are well maintained and in good condition. There is no bike rack and no working drinking fountain. Concession and bathrooms are usually locked. The parking lot is in poor condition.

*Image 3.15 Deemer Park
Pictured to the right are the bleachers, track, and football field located at Deemer Park.*

Considering the isolated location and low usage of Deemer Park for residents overall, before adopting any other initiatives the city should work directly with residents and stakeholders, specifically the Warren Little Raiders, to evaluate all land use options for the site including disposition or alternative usage.

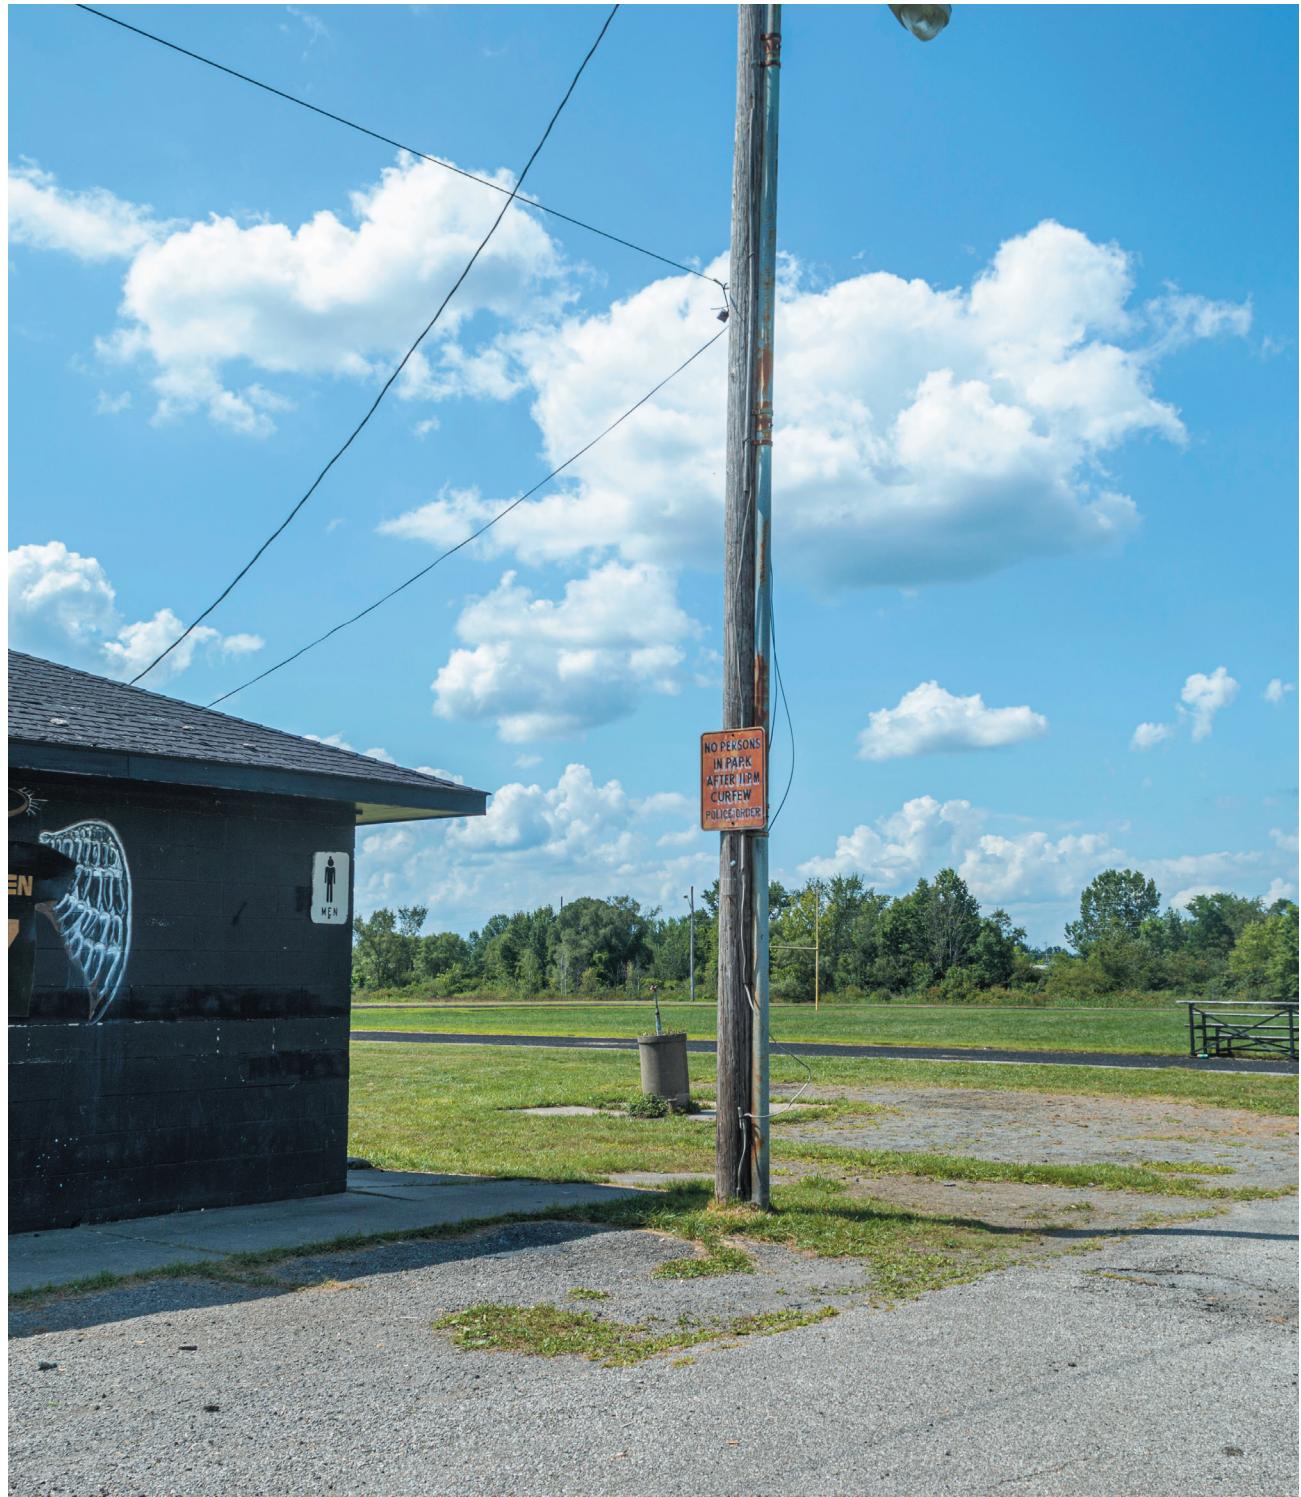
Image 3.16 Deemer Park Photograph
Pictured is the concession stand at Deemer Park.

Park Conditions: The basketball and tennis courts are in fair condition. However, there are no basketball or tennis nets on site. The pavilion, concession stand, and parking lot all need significant maintenance and updates. High weeds are present at the entrance to the park and around the sign. The two drinking fountains are not operating. There are no operational bathrooms on site.

- Repair as needed and open the restrooms for use during park hours (or otherwise decommission the restrooms)
- List the park on the City of Warren website

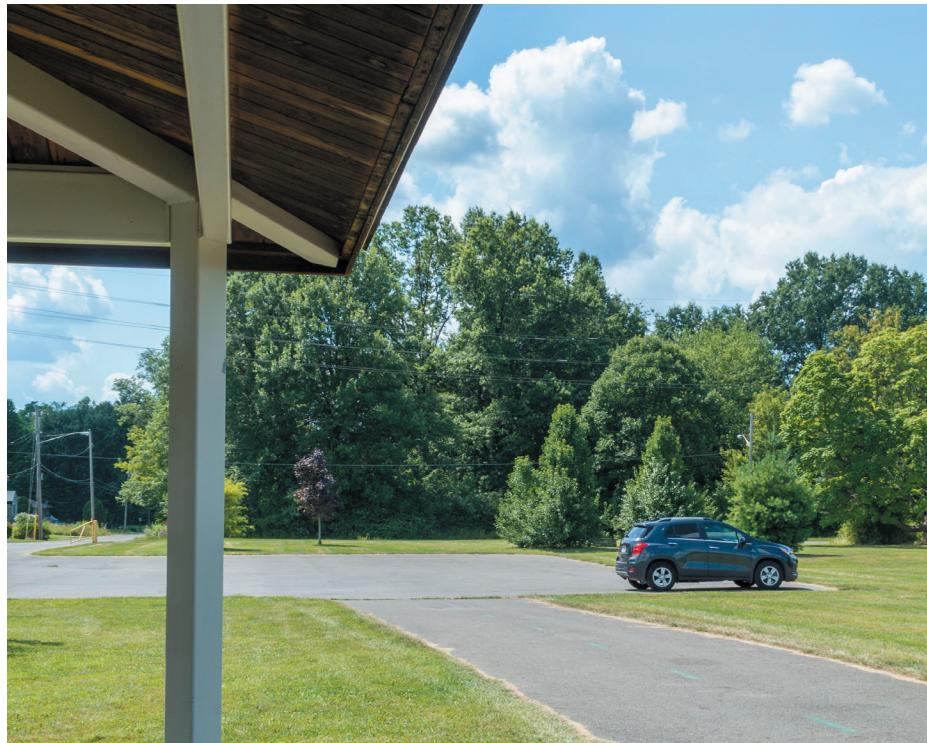
Photo 3.20 North End Park
Pictured is the parking lot from the pavilion located at North End Park.

Park Conditions: The park is in overall good condition. Standing water is an ongoing issue. The park experiences limited vandalism.

- Develop a stormwater management plan to alleviate flooding in the park
- Continue outreach and engagement with bike community for active use and promotion of the trailhead and bike path
- Improve and repair sidewalk access to the park for pedestrian safety
- Repair, replace or remove drinking fountains
- Replace, repair, and add additional lighting to all recreational areas
- Update and/or install bike racks
- Greening and beautification of entrances and intersections near park
- Incorporate recycling stations
- Replace, repair, or remove grills, picnic tables, and benches throughout the park
- Install, replace, or repair seating at recreational areas
- Install pet waste stations

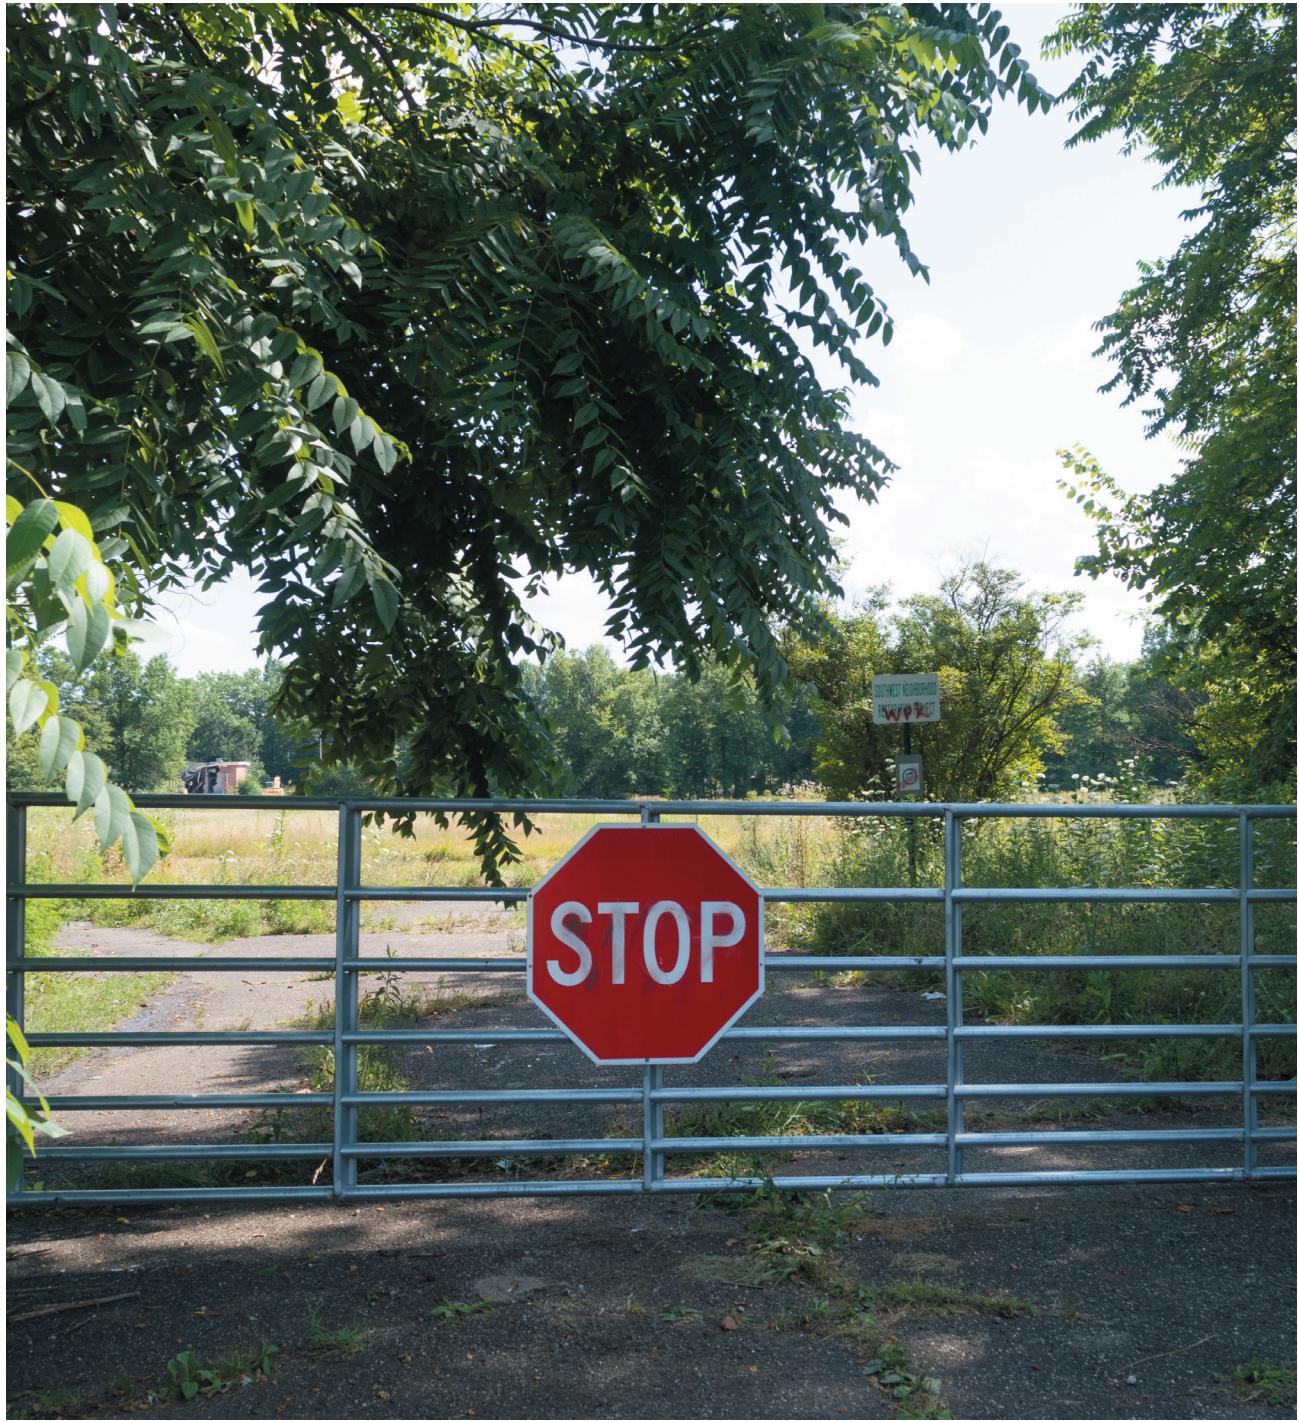
Image3.37 Southwest Park
Gate that is kept locked and blocks access to the park.

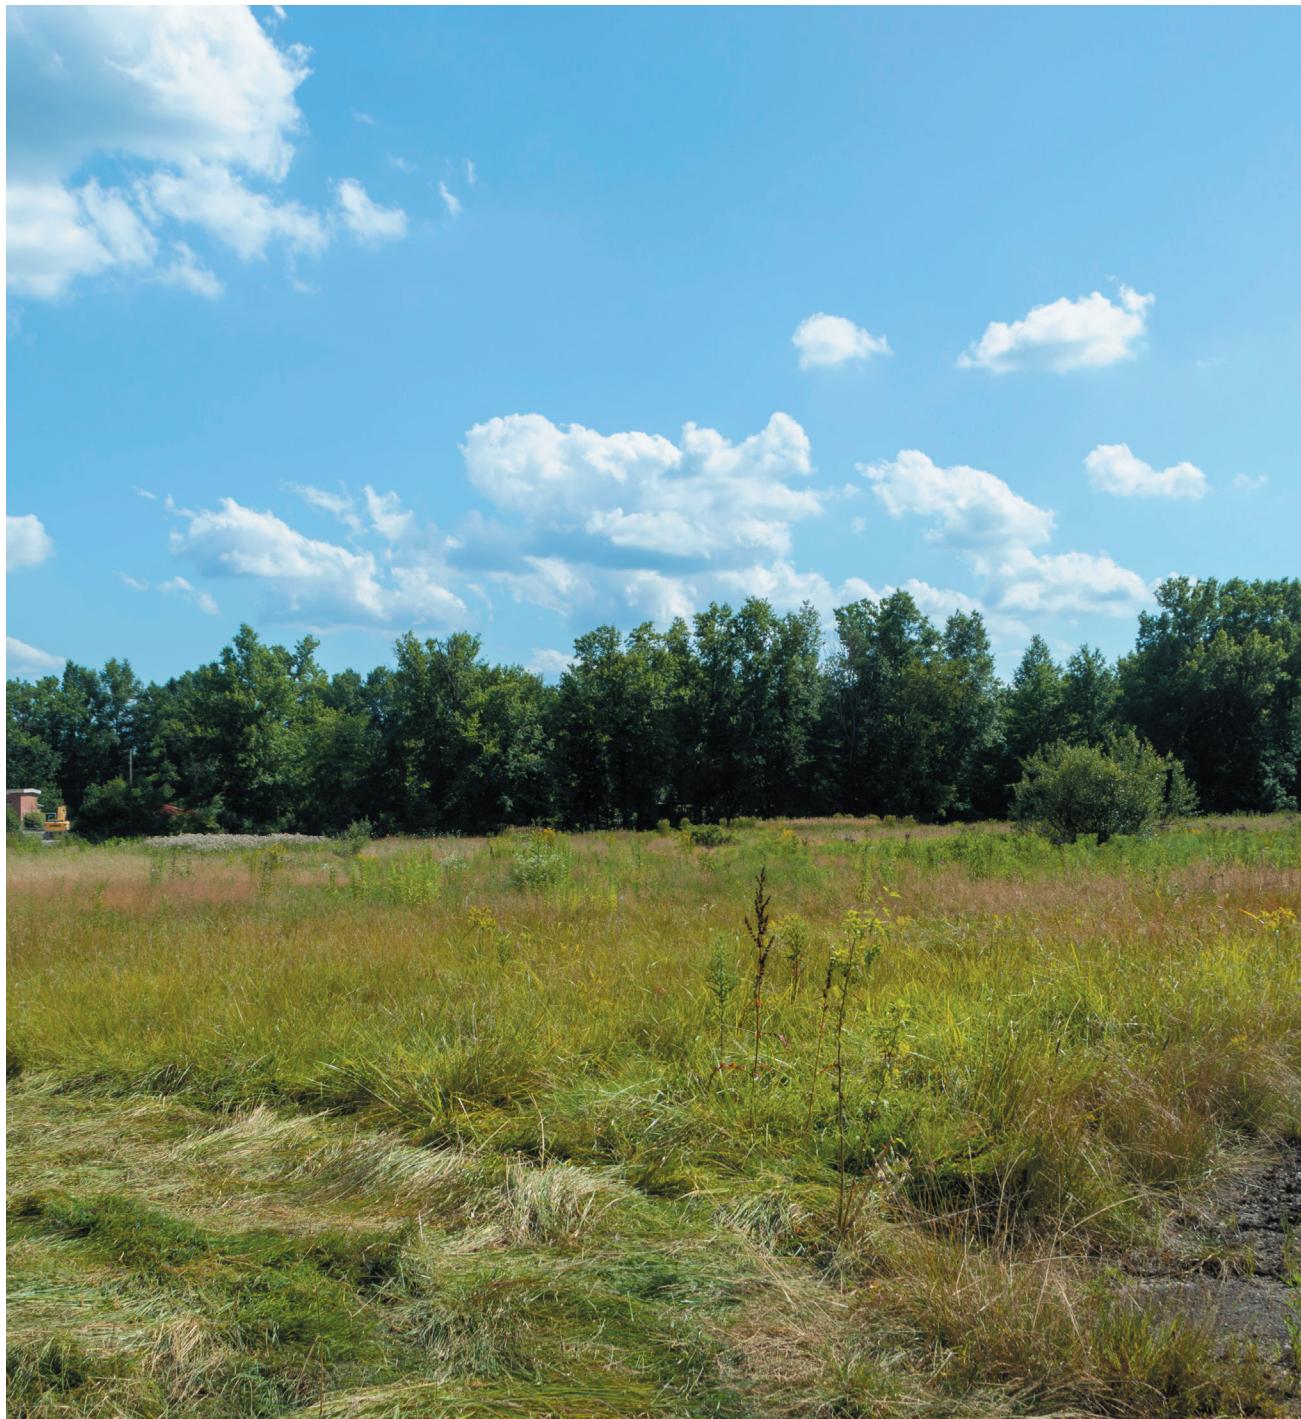
Image 3.38 Southwest Park

Park Appearance: Most of the park is isolated and hidden from street view. The park has not had regular use for many years. The park has litter, tall grass and broken playground equipment.

View of Southwest Park from the area that would be designated for parking.

- Update existing parking areas
- Improve and repair sidewalk access to the park for pedestrian safety
- Repair, replace or remove drinking fountains
- Replace, repair, and add additional lighting to all recreational areas
- Update and/or install bike racks
- Greening and beautification of entrances and intersections near park
- Incorporate recycling stations
- Replace, repair, or remove grills, picnic tables, and benches throughout the park
- Install, replace, or repair seating at recreational areas
- Install pet waste stations
