INSPECTION REPORT

Rainbow Villas

3/1/2026

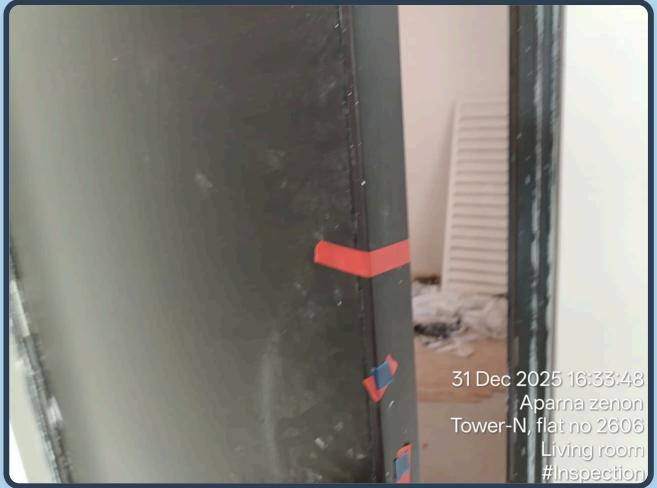
S. NO.	ISSUE	PICTURE
1	Moment/Play observed after closing the shutter

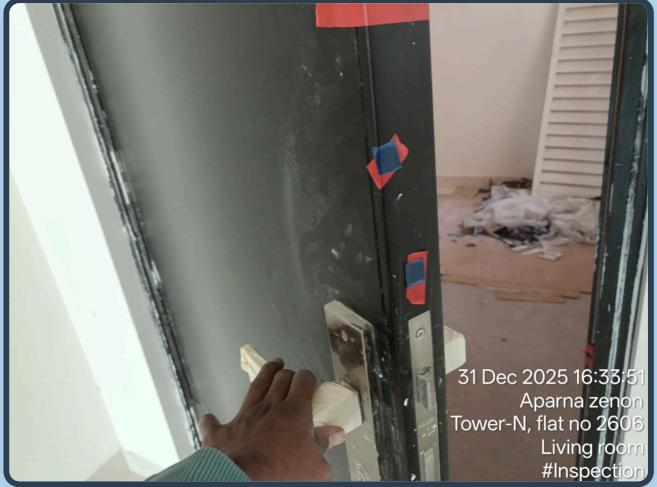
<p>31 Dec 2025 16:33:48 Aparna zenon Tower-N, flat no 2606 Living room #Inspection</p>
2	Crack observed on shutter

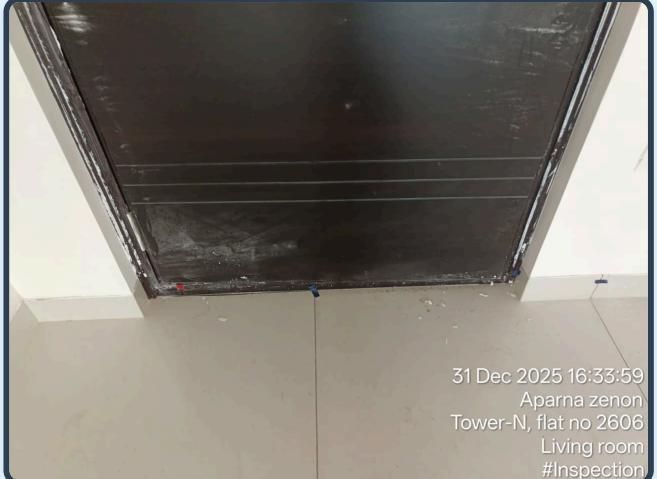
S. NO.	ISSUE	PICTURE
3	Sealant application not done properly

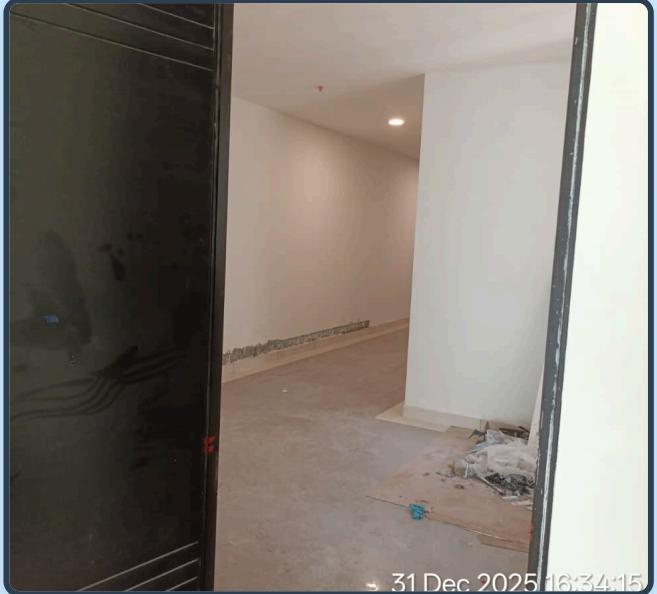
<p>31 Dec 2025 16:33:59 Aparna zenon Tower-N, flat no 2606 Living room #Inspection</p>
4	Rubber gasket is not fixed

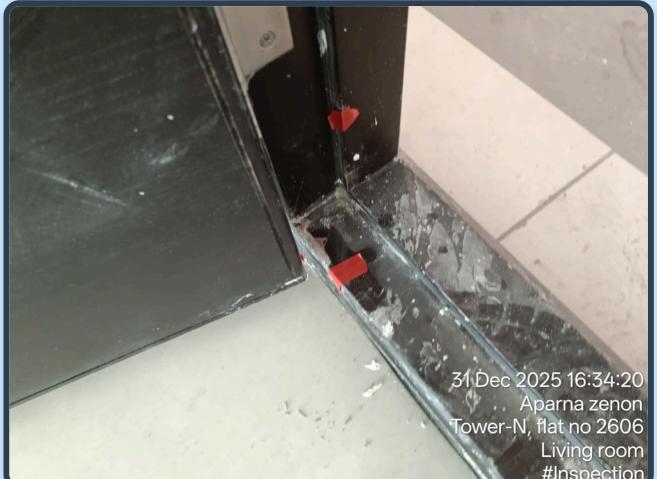
<p>31 Dec 2025 16:34:15</p>
5	Edge damages observed on door frame

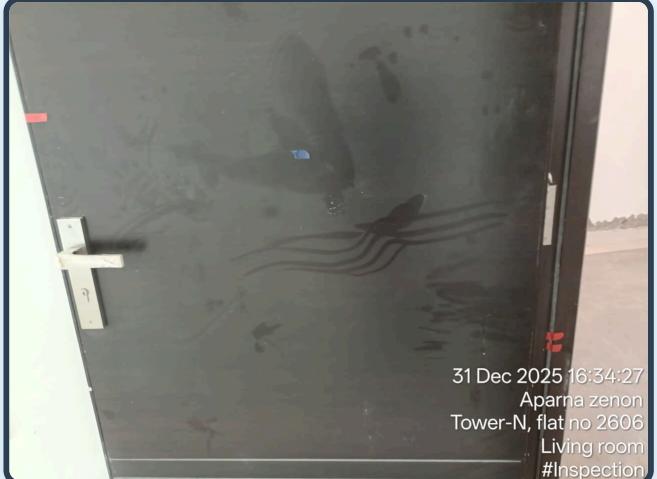
S. NO.	ISSUE	PICTURE
6	Polishing not done properly on shutter and door frame

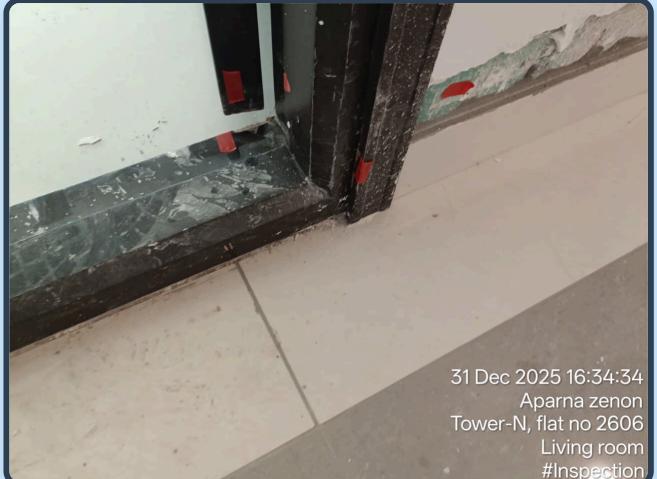
<p>31 Dec 2025 16:34:27 Aparna zenon Tower-N, flat no 2606 Living room #Inspection</p>
7	Edge damages observed on beading

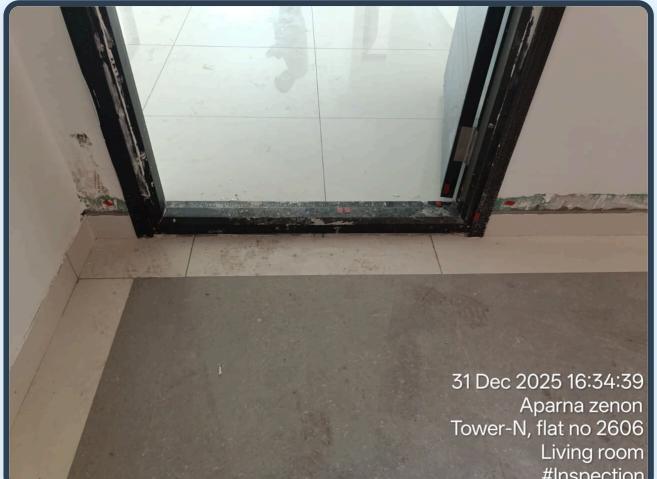
<p>31 Dec 2025 16:34:34 Aparna zenon Tower-N, flat no 2606 Living room #Inspection</p>
8	Putty finishing work are pending

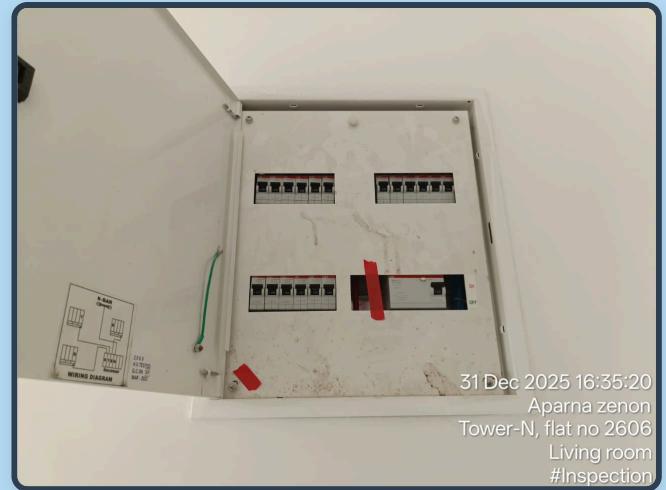
12

MCB cover plate is not fixed in proper alignment

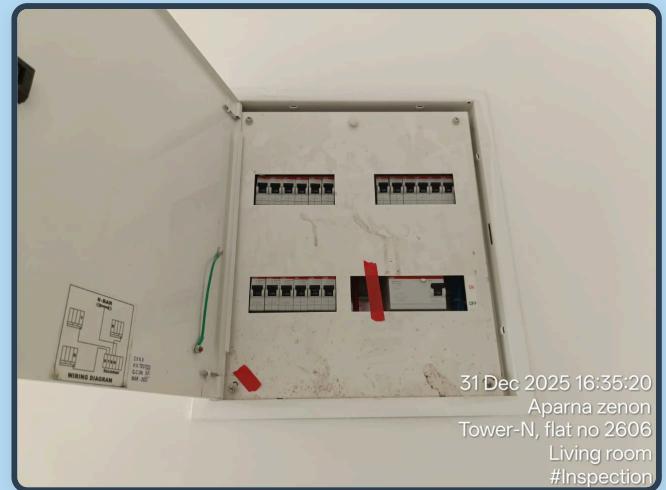
13

Screws are missing

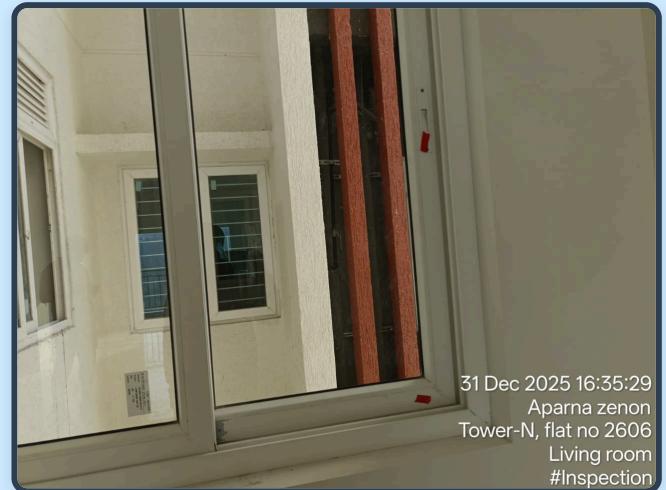
14

Noise observed while operating the slide

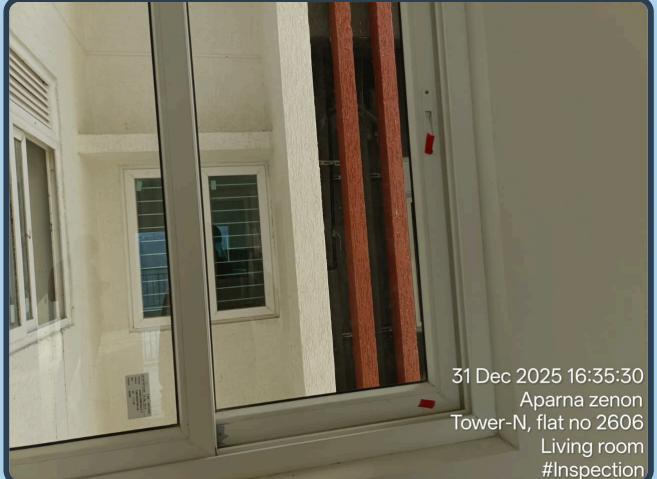
S. NO.	ISSUE	PICTURE
15	Window lockset is not functioning properly

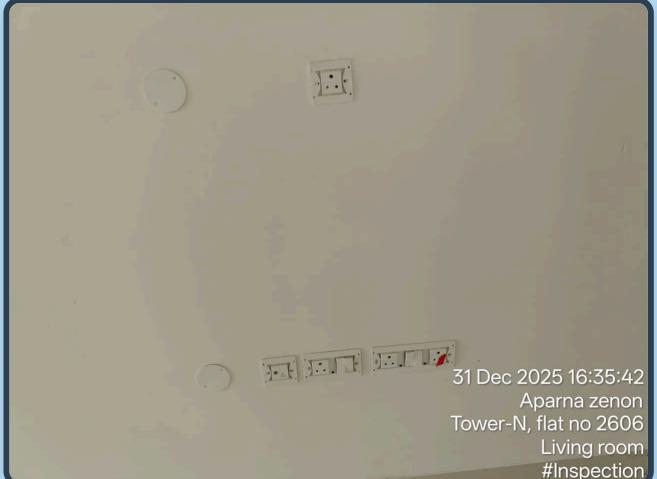
<p>31 Dec 2025 16:35:30 Aparna zenon Tower-N, flat no 2606 Living room #Inspection</p>
16	RCB tester display shows a connection between the earthing and live conductors, indication incorrect socket wiring

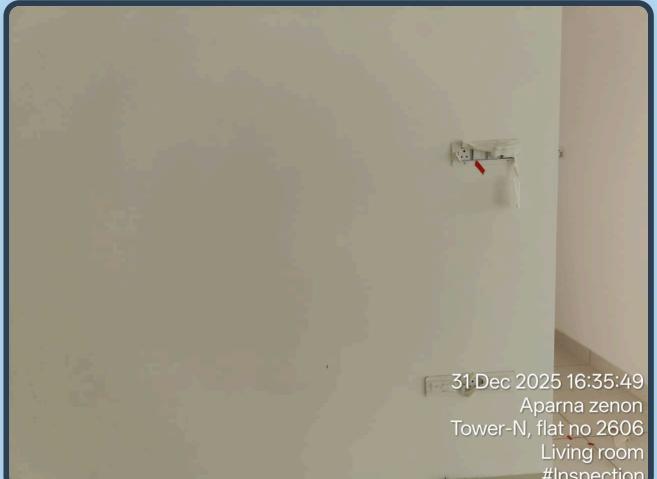
<p>31 Dec 2025 16:35:42 Aparna zenon Tower-N, flat no 2606 Living room #Inspection</p>
17	Cover plates are not fixed

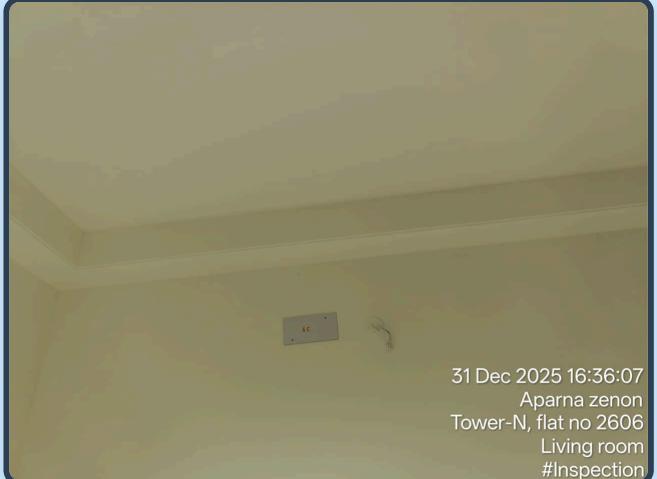
S. NO.	ISSUE	PICTURE
18	Joint air cracks observed on cornish board

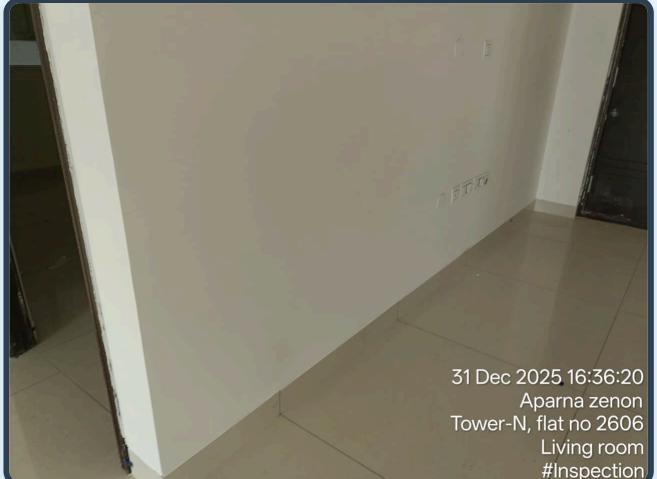
<p>31 Dec 2025 16:36:07 Aparna zenon Tower-N, flat no 2606 Living room #Inspection</p>
19	Paint surface finishing not done properly on wall

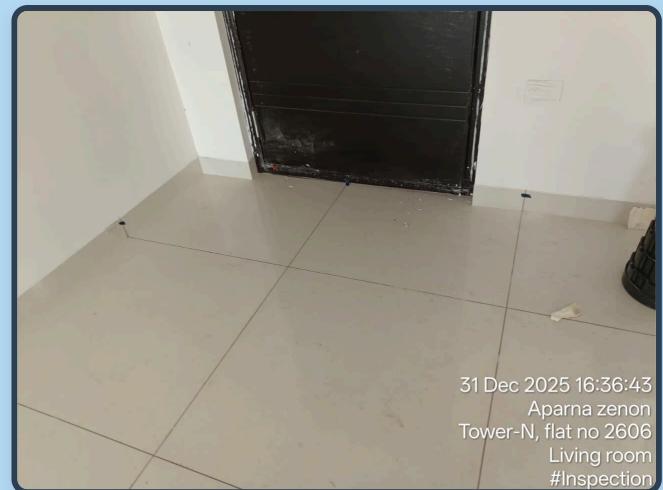
21

Gap observed between skirting
tiles

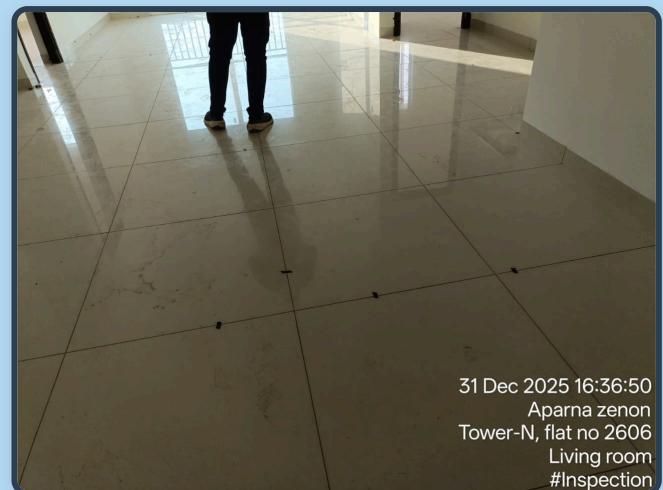
22

Grouting gaps observed between
floor tiles

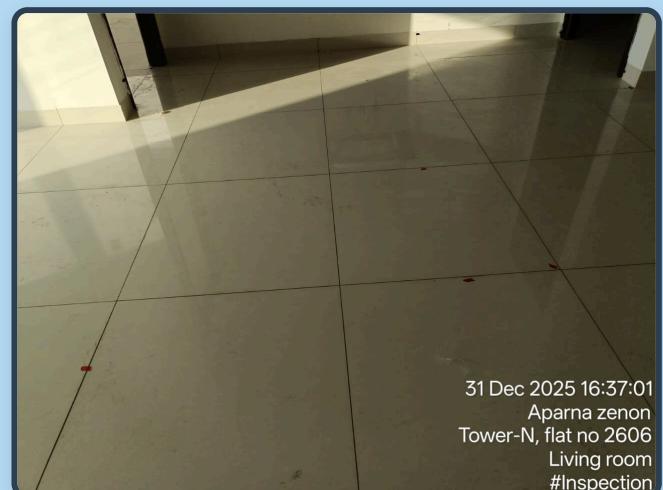
23

offset observed between floor
tiles

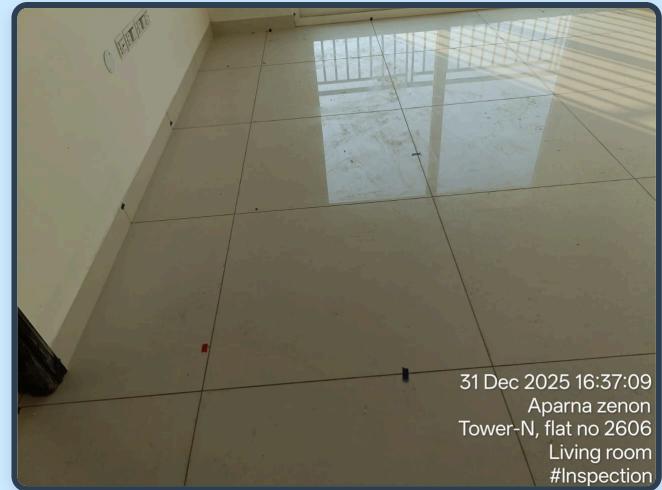
24

Grouting gaps observed between floor tiles

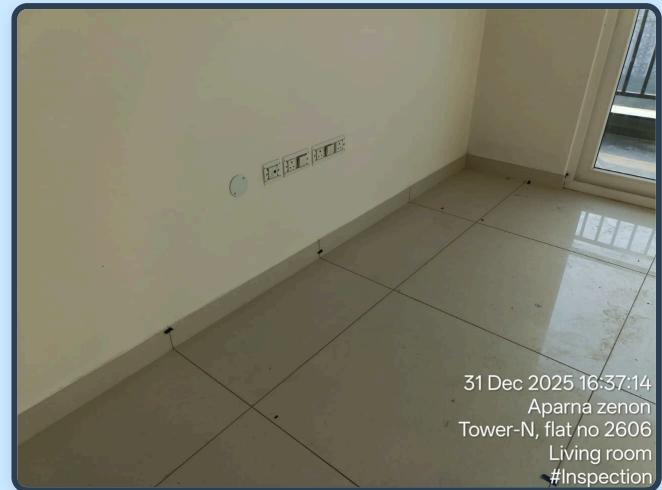
25

Chipoff observed on floor issues

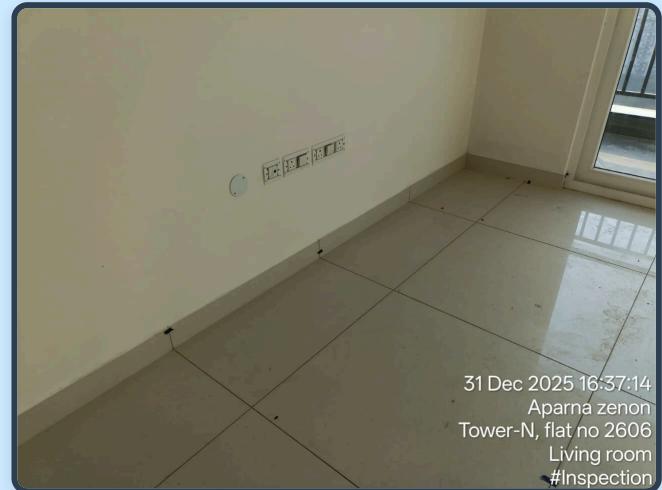
26

Grouting gaps observed between skirting tiles

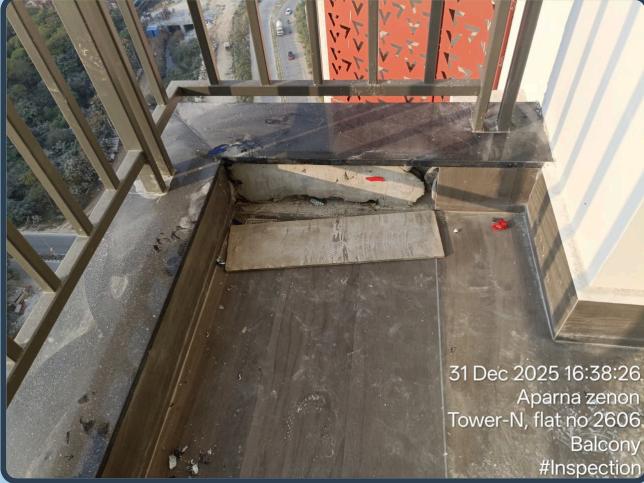
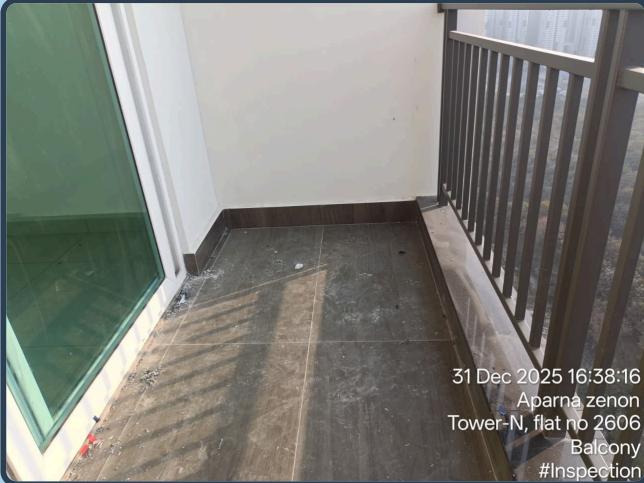
S. NO.	ISSUE	PICTURE
1	Skirting tile is not fixed

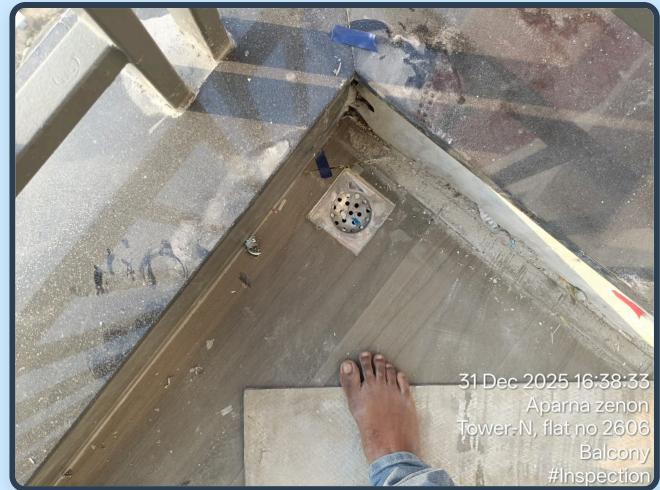
2

Grouting gaps observed between skirting tiles

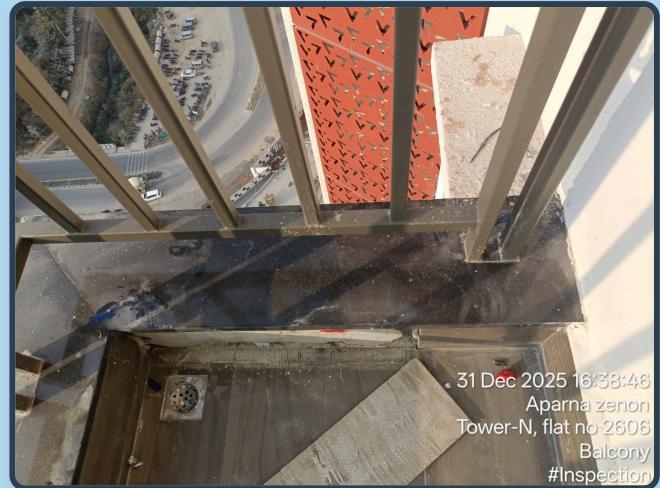
3

Gaps observed between granite stone

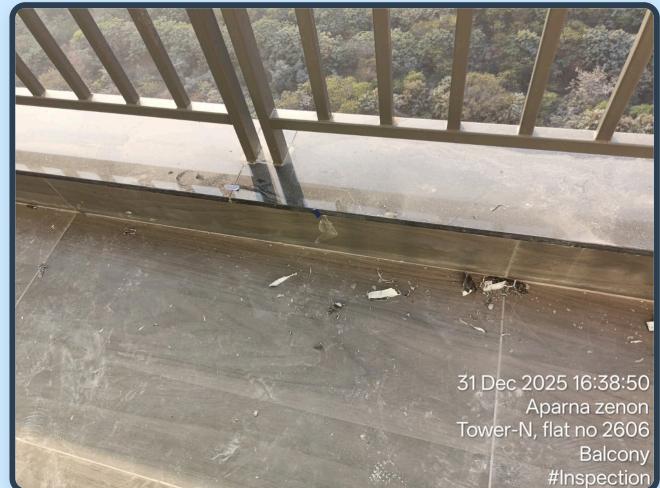
4

Gaps observed between granite stone and skirting tiles

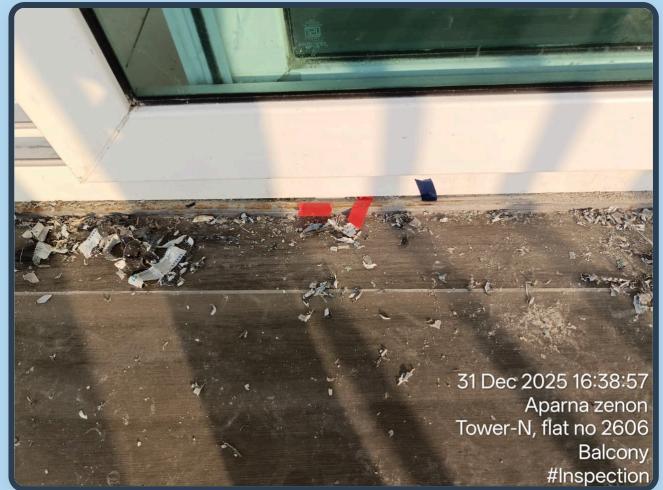
5

Sealant application not done
properly

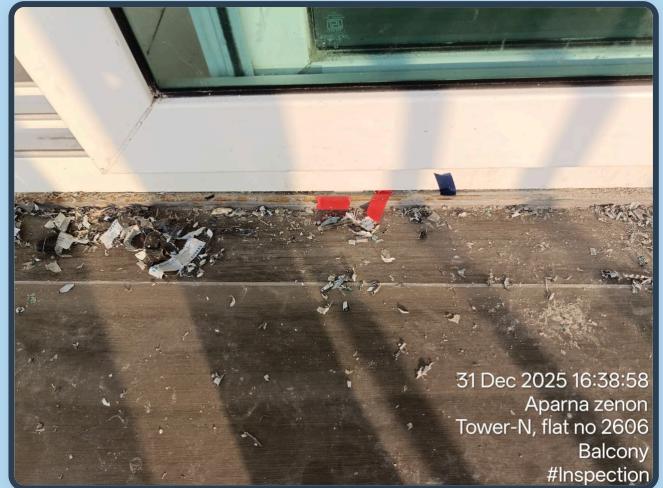
6

Rust observed on strip

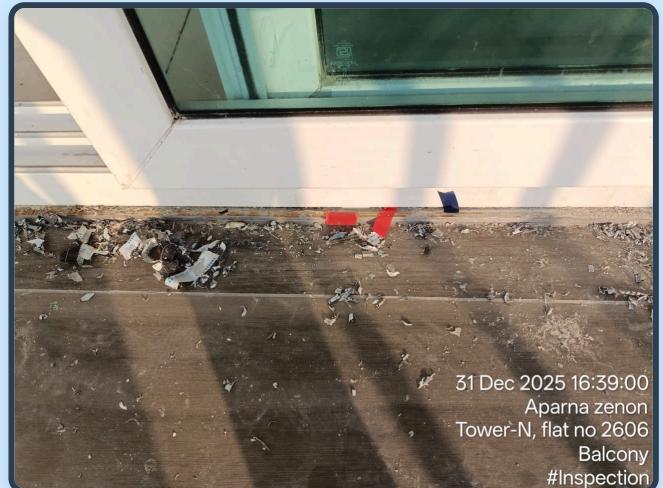
7

Strip is not aligned properly with
the level of the flooring tiles

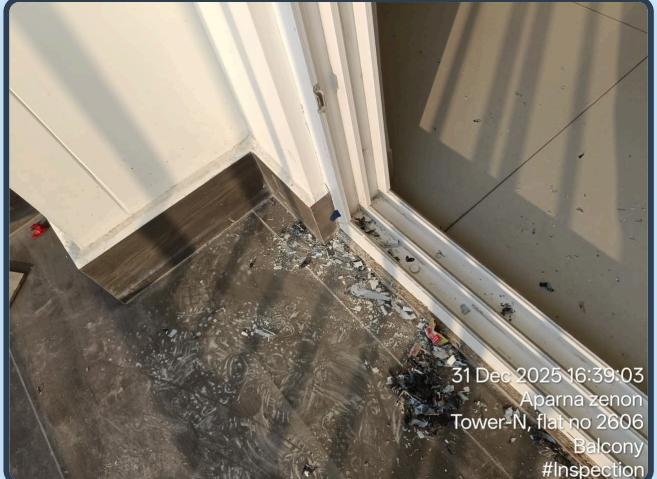
S. NO.	ISSUE	PICTURE
8	Sealant application not done properly

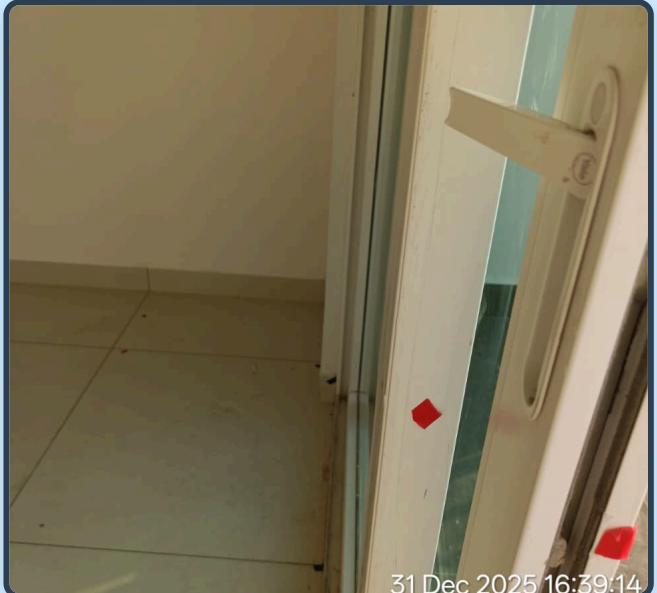
<p>31 Dec 2025 16:39:11 Aparna zenon Tower-N, flat no 2606 Balcony #Inspection</p>
11	Scratch observed on interlock

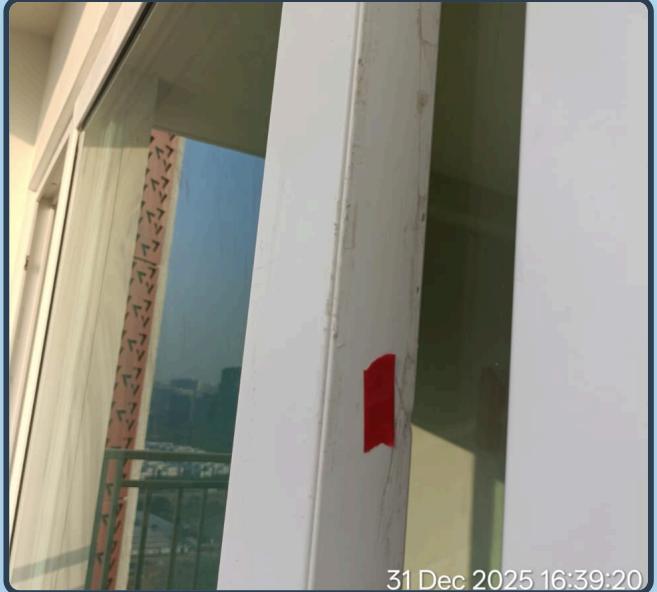
S. NO.	ISSUE	PICTURE
12	Dent and scratches observed on the interlock

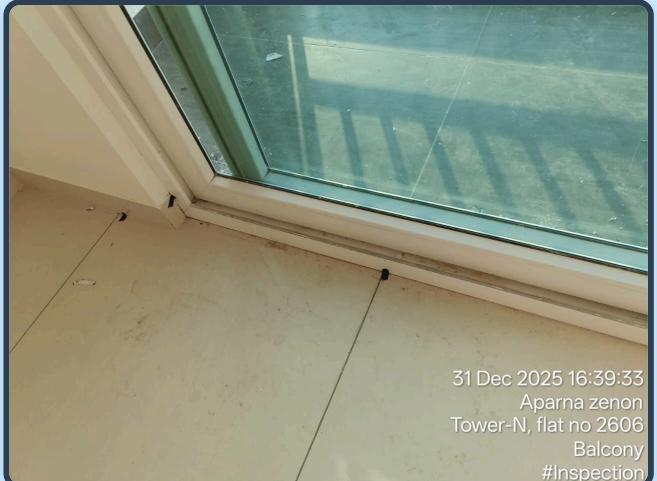
31 Dec 2025 16:39:29 Aparna zenon Tower-N, flat no 2606 Balcony #Inspection
14	Sealany application not done properly	<i>No Image</i>
15	Sealant application not done properly

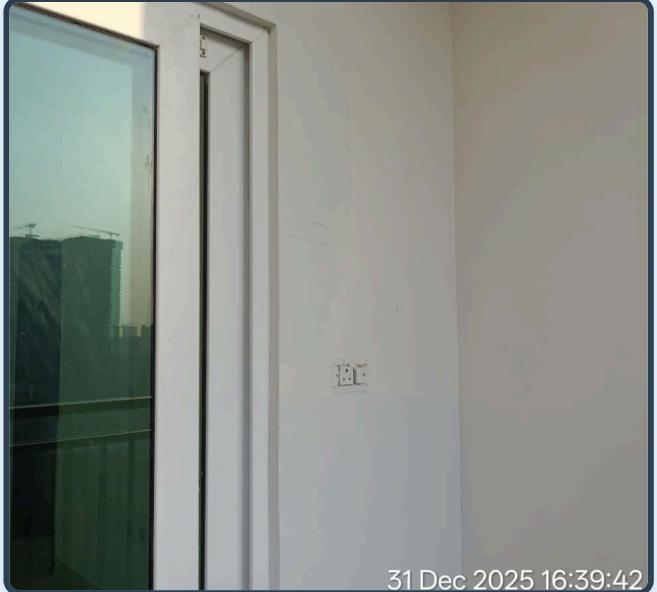
S. NO.	ISSUE	PICTURE
16	Paint Surface finishing not done properly on wall

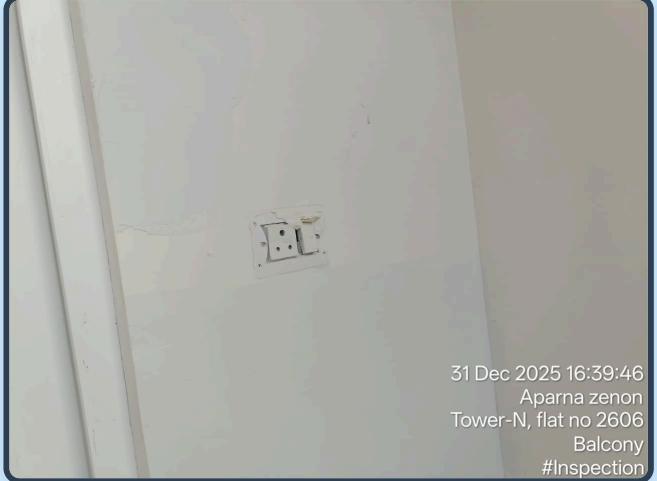
31 Dec 2025 16:39:42
17	Cover plate is not fixed

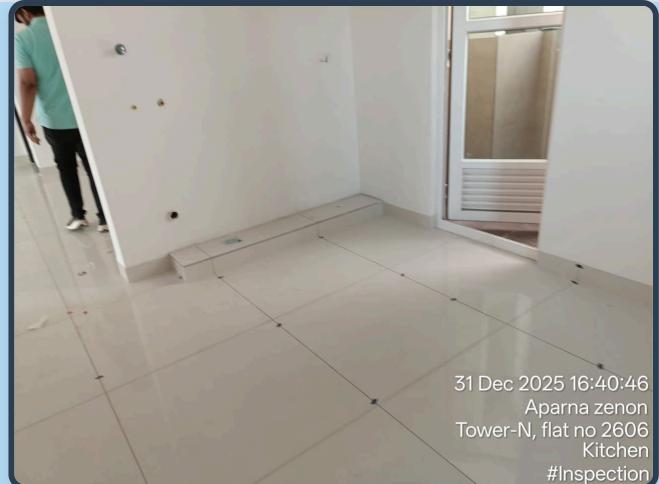
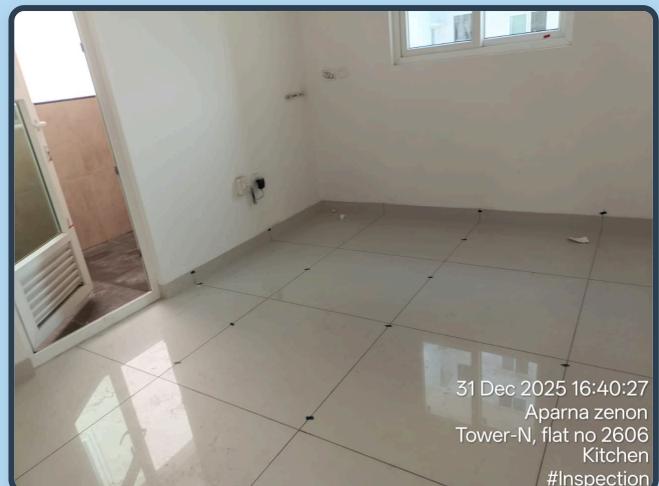
2

Window lockset is not fixed

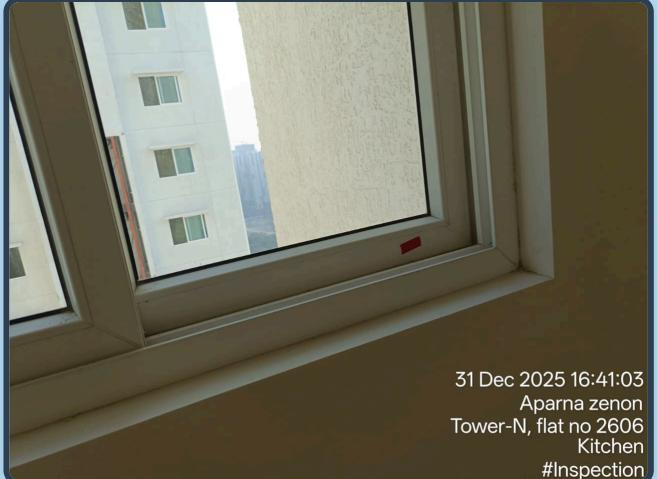
S. NO.	ISSUE	PICTURE
3	Nosie observed while operating the slide

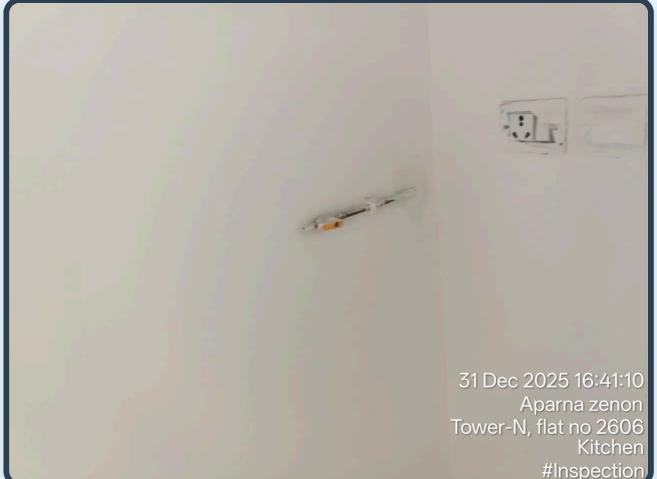
<p>31 Dec 2025 16:41:03 Aparna zenon Tower-N, flat no 2606 Kitchen #Inspection</p>
4	Paint stains on the wall

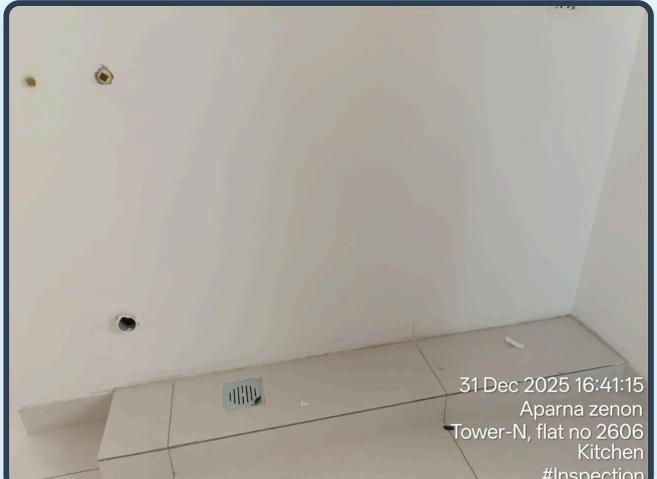
<p>31 Dec 2025 16:41:10 Aparna zenon Tower-N, flat no 2606 Kitchen #Inspection</p>
5	Paint surface finishing not done properly on wall

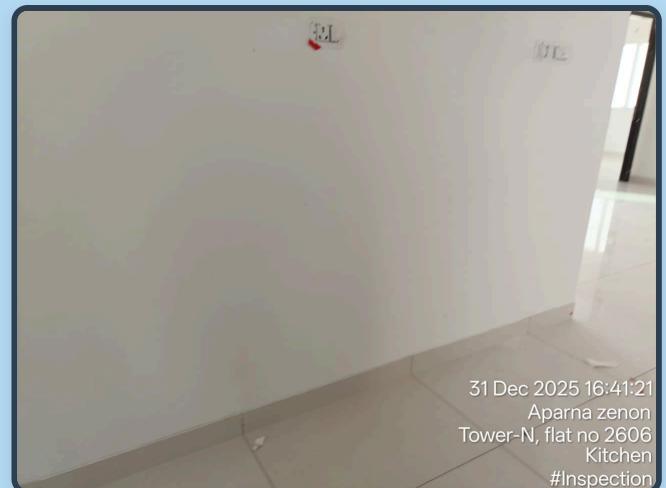
6

Cover plate is not fixed

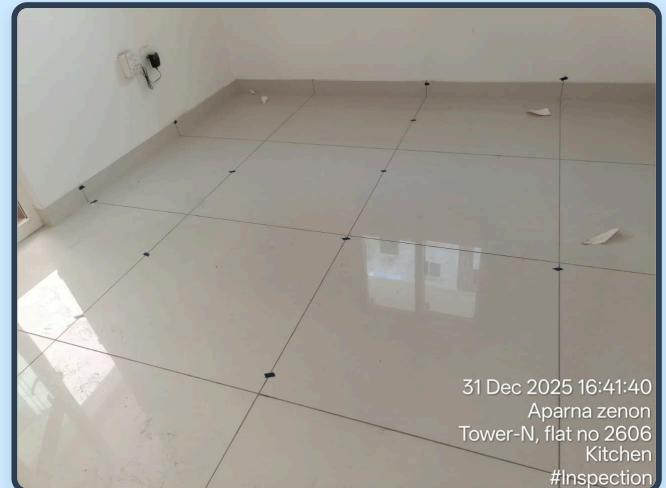
7

Grouting gaps observed between
floor tiles

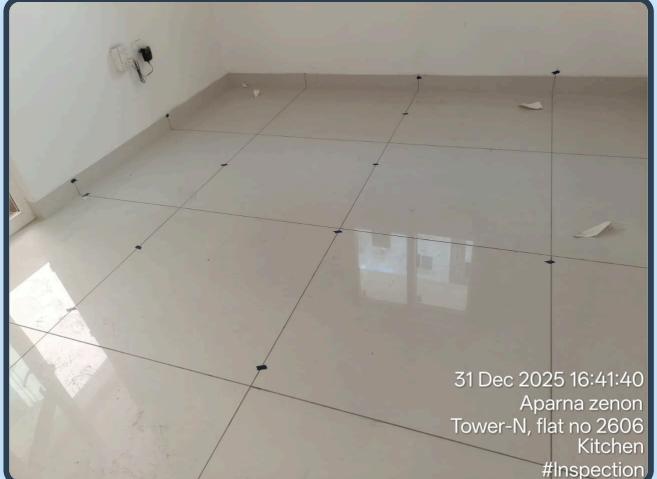
S. NO.	ISSUE	PICTURE
8	Gap observed on above skirting tiles

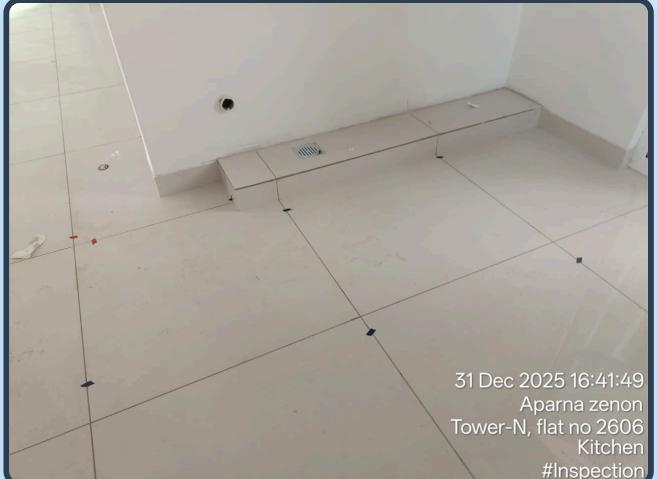
<p>31 Dec 2025 16:41:40 Aparna zenon Tower-N, flat no 2606 Kitchen #Inspection</p>
9	Grouping gaps observed between floor tiles

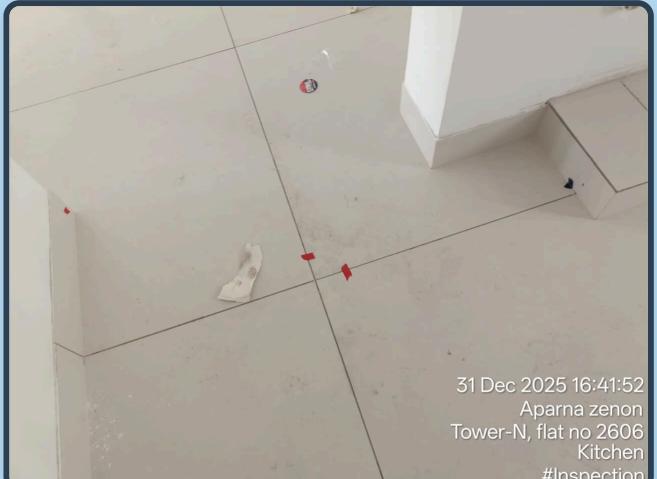
<p>31 Dec 2025 16:41:49 Aparna zenon Tower-N, flat no 2606 Kitchen #Inspection</p>
10	Offset observed on tiles

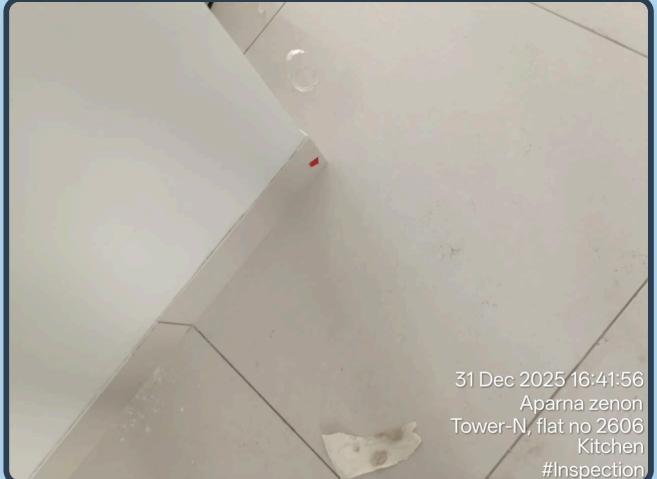
S. NO.	ISSUE	PICTURE
11	Edge Damages observed on the skirting tiles

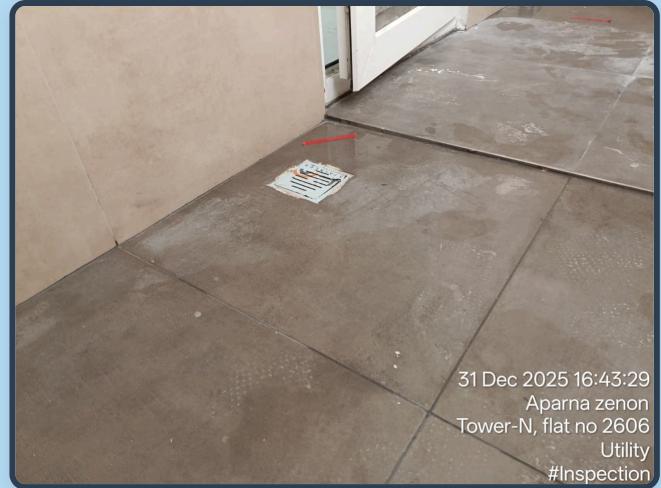
3

Inadeqaute slopw issue observed
on floor tiles

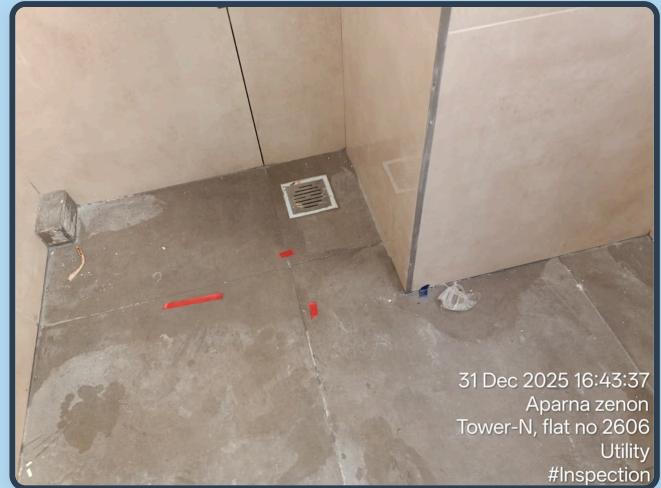
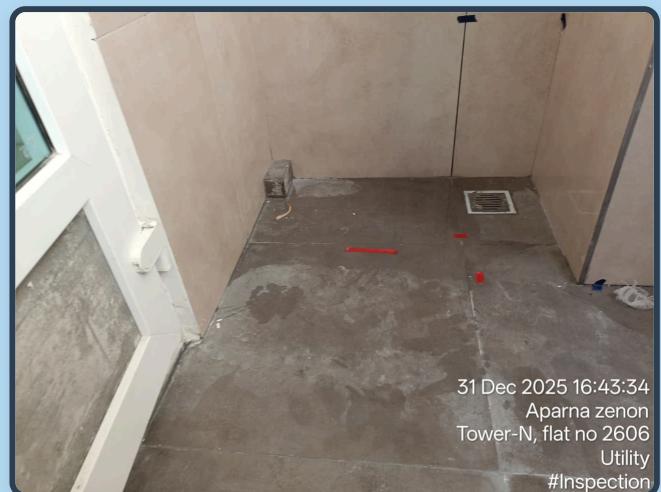
4

chipoff observed on floor tile

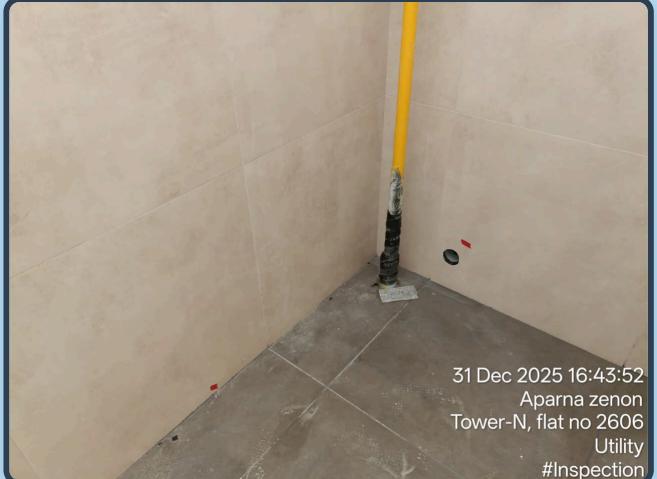
S. NO.	ISSUE	PICTURE
8	Chipoff observed on the wall tile

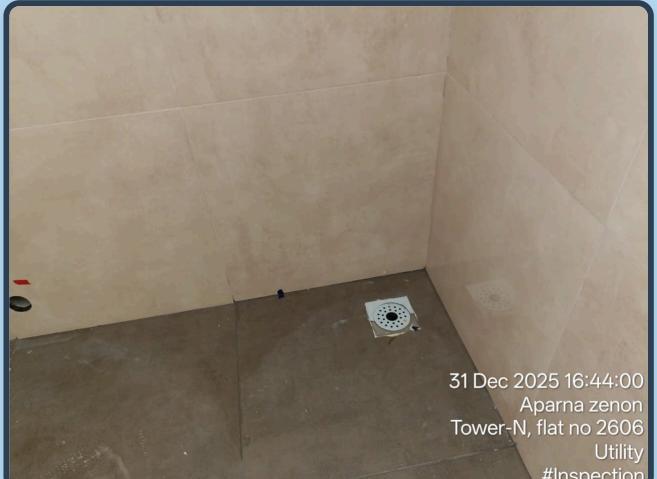
<p>31 Dec 2025 16:43:58 Aparna zenon Tower-N, flat no 2606 Utility #Inspection</p>
10	Grouting gaps observed between wall tiles and floor tiles

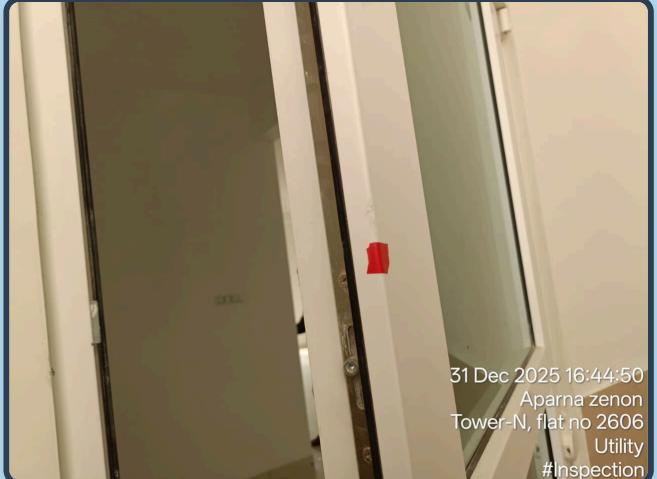
S. NO.	ISSUE	PICTURE
17	Dent observed on the slide

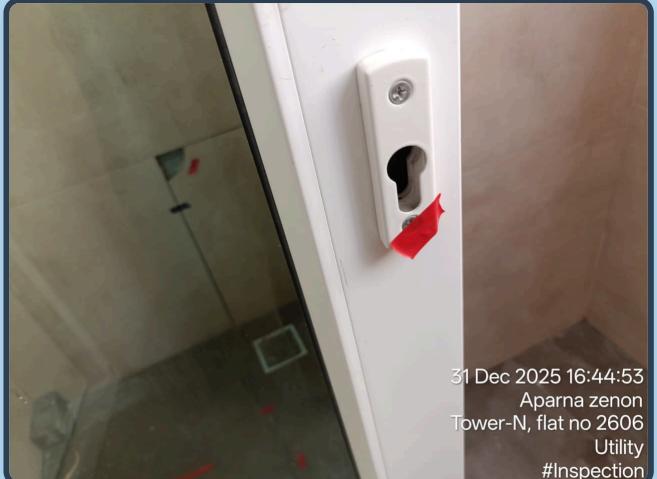
<p>31 Dec 2025 16:44:50 Aparna zenon Tower-N, flat no 2606 Utility #Inspection</p>
18	Lockset is not fixed

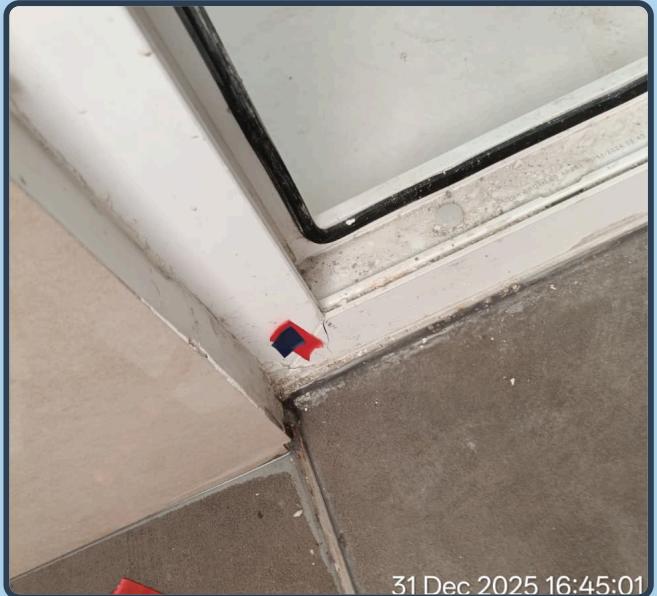
<p>31 Dec 2025 16:44:53 Aparna zenon Tower-N, flat no 2606 Utility #Inspection</p>
19	Cracks observed on the frame

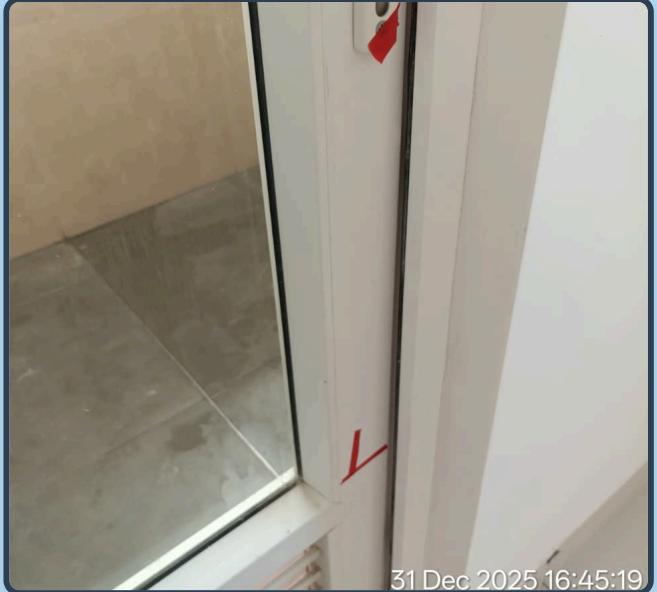
S. NO.	ISSUE	PICTURE
20	Lockset is not aligned properly with the striker plate, and gaps are visible at the bottom

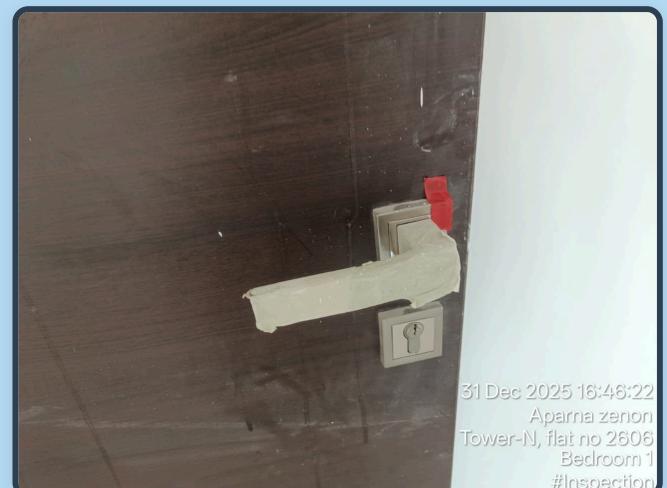
2

Handle fitting are loose

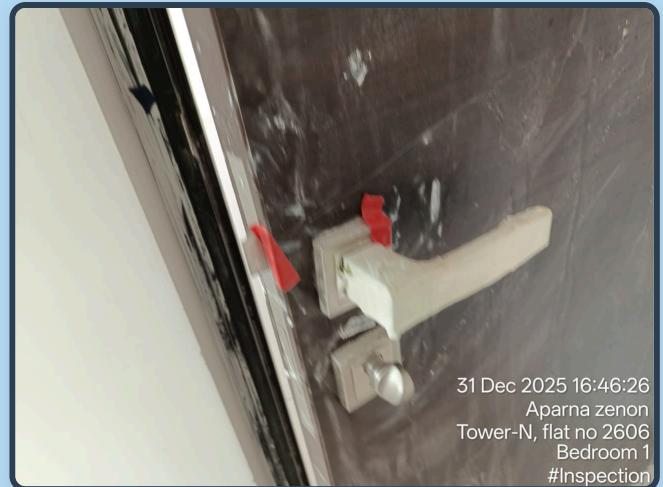
3

Auto lockset is hitting the door frame during operation

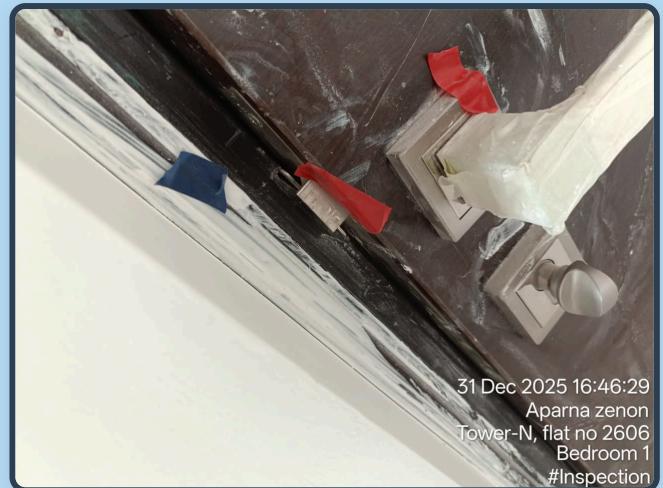
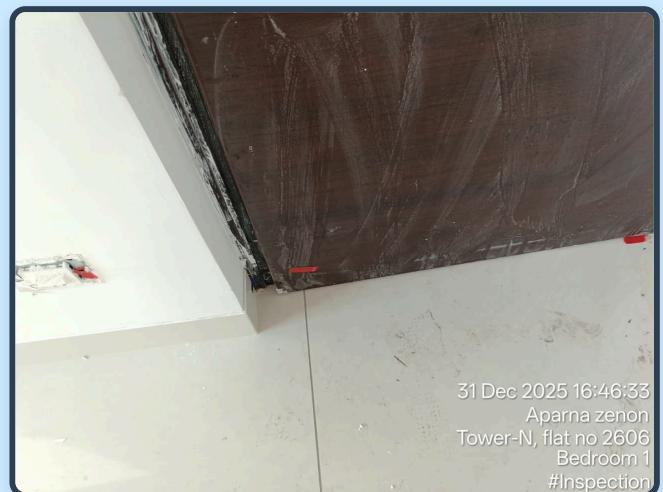
4

Stopper is not fixed

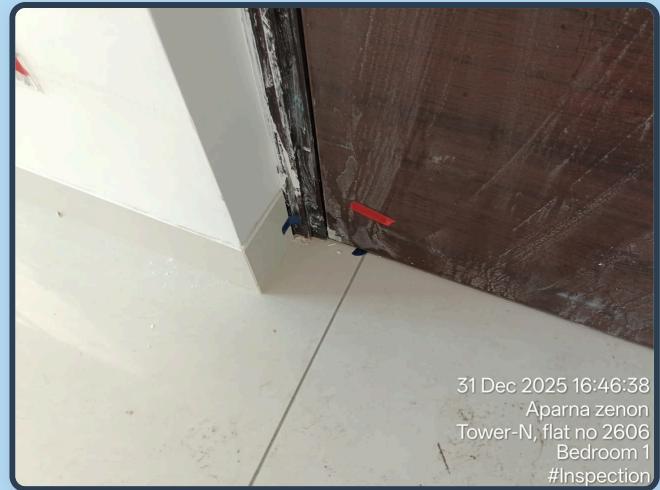
5

Sealant application is not done
properly

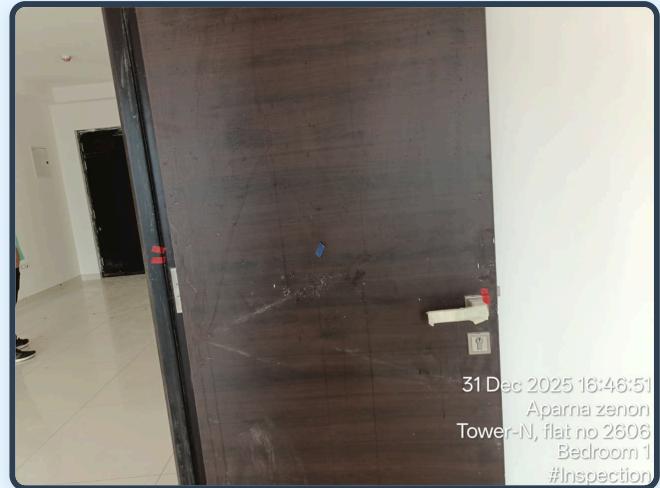
6

Polishing not done properly on
shutter and door frame

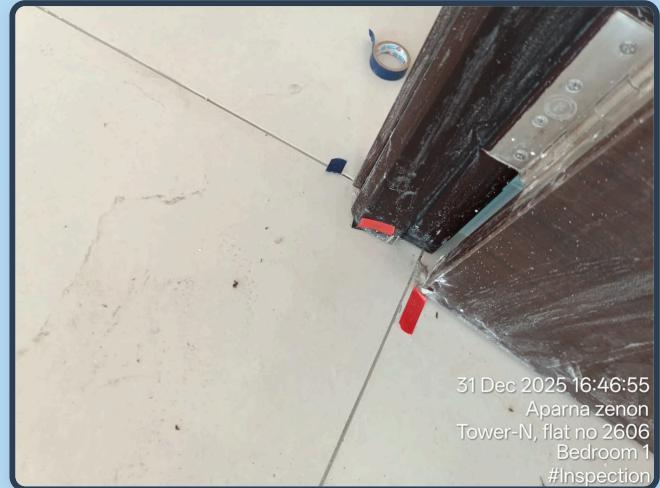
7

Edge damages observed on the
door frame

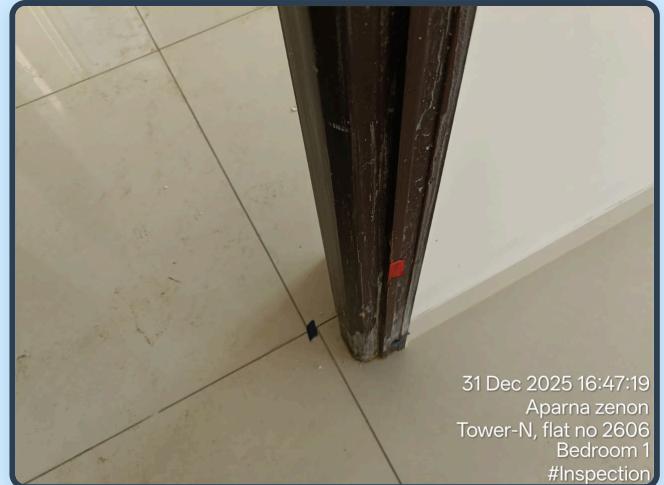
11

Dents observed on beading

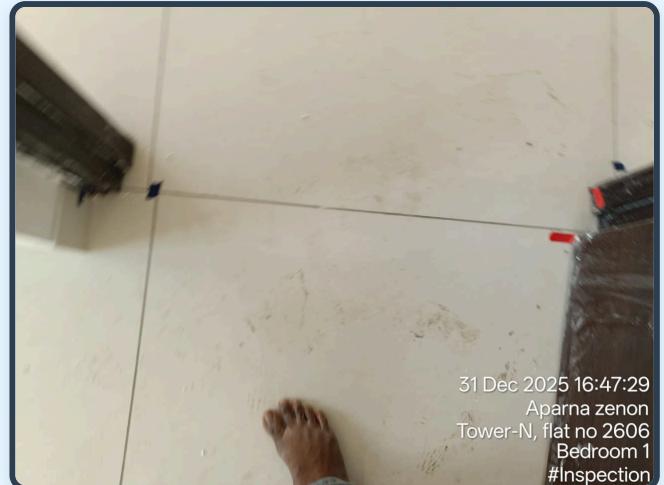
12

Chipoff observed on the floor tile

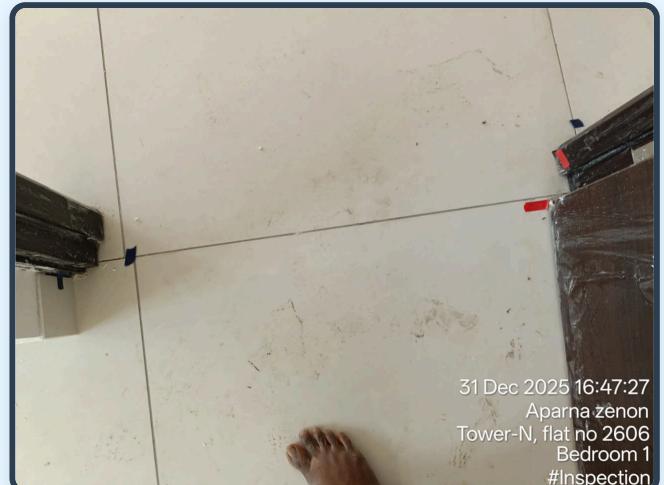
13

Grouting gaps observed between
floor tiles

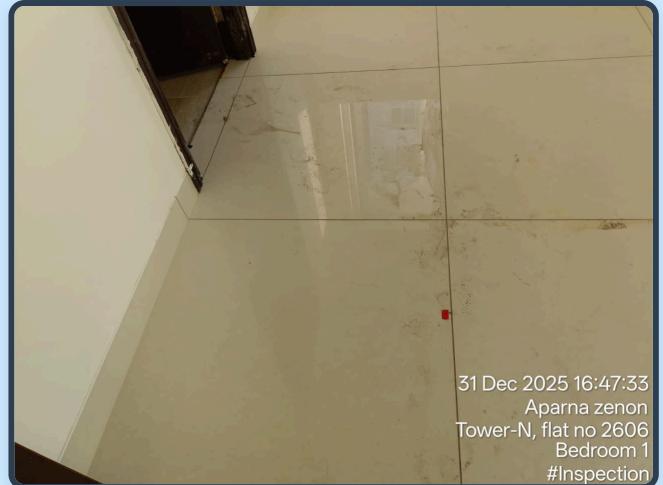
14

Chipoff observed on floor tile
