INSPECTION REPORT

Rainbow Villas

3/1/2026

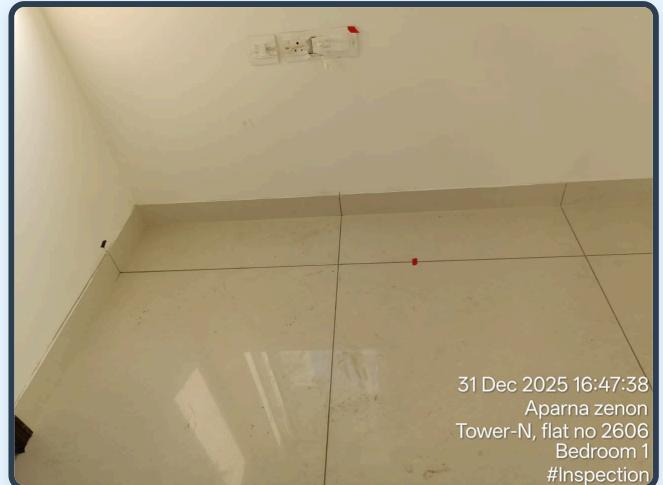
15

Offset observed on floor tile

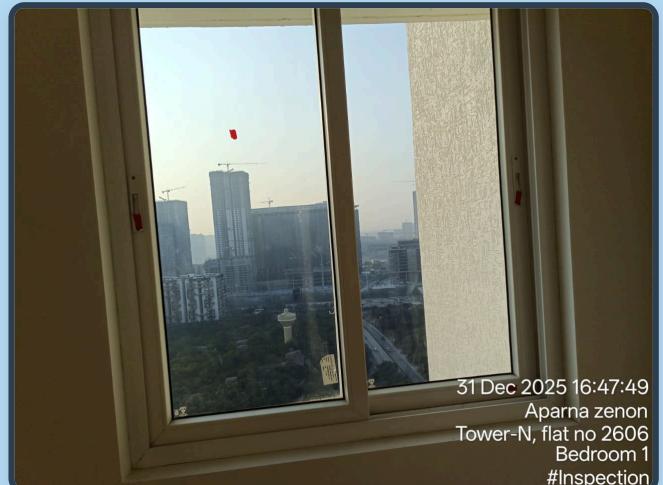
16

Window lockset is not functioning
properly

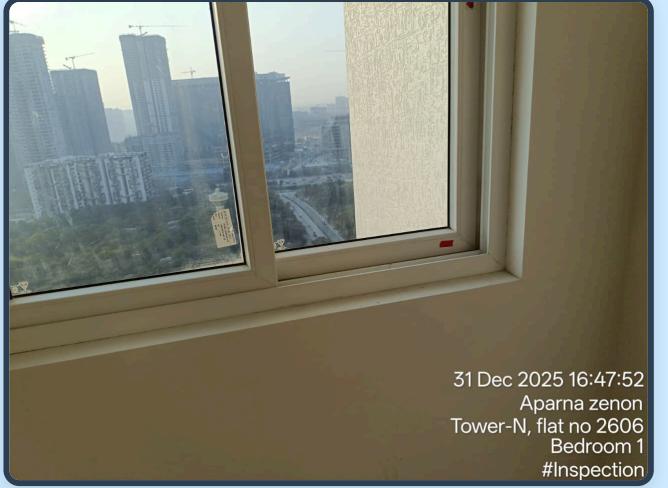
S. NO.	ISSUE	PICTURE
17	Noise observed while operating the slide

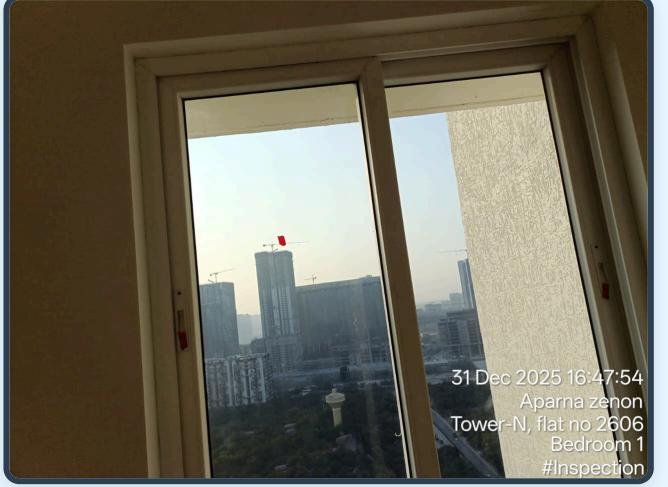
<p>31 Dec 2025 16:47:52 Aparna zenon Tower-N, flat no 2606 Bedroom 1 #Inspection</p>
18	Scratch observed on the glass

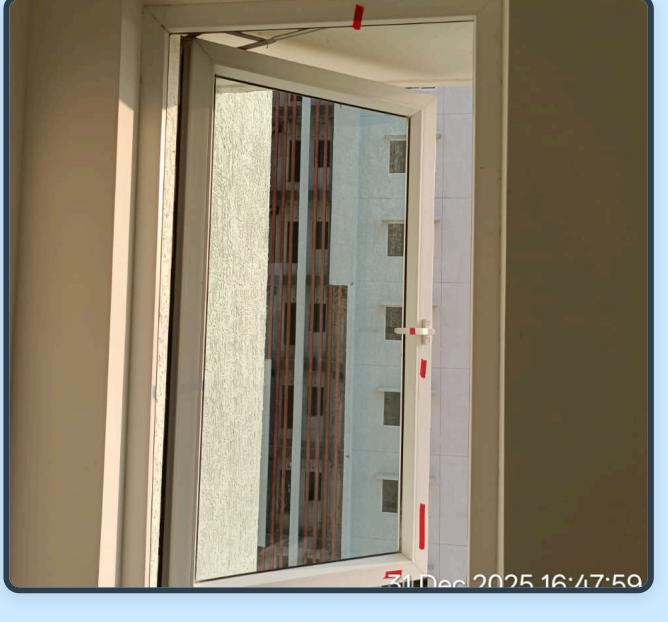
<p>31 Dec 2025 16:47:54 Aparna zenon Tower-N, flat no 2606 Bedroom 1 #Inspection</p>
19	Screw caps are missing

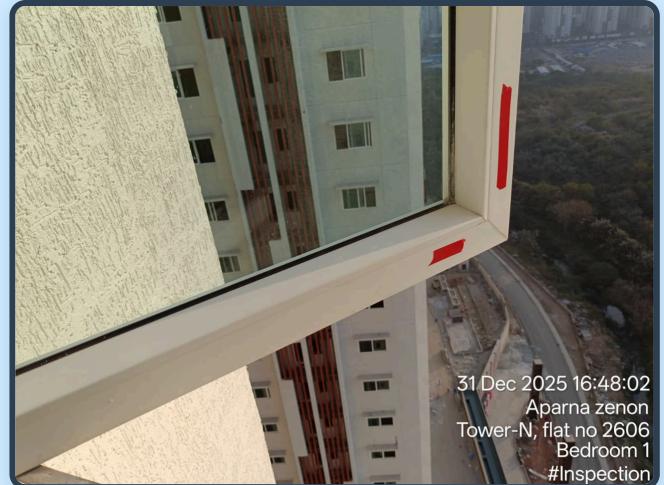
20

Noise observed while operating
the shutter

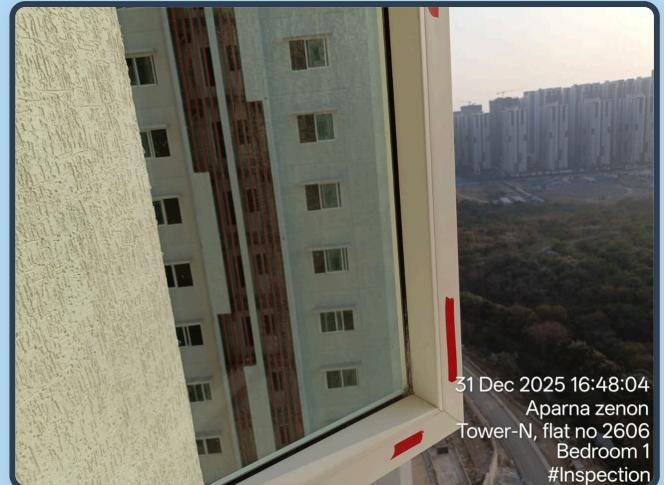
21

Shutter struck the striker during
operation

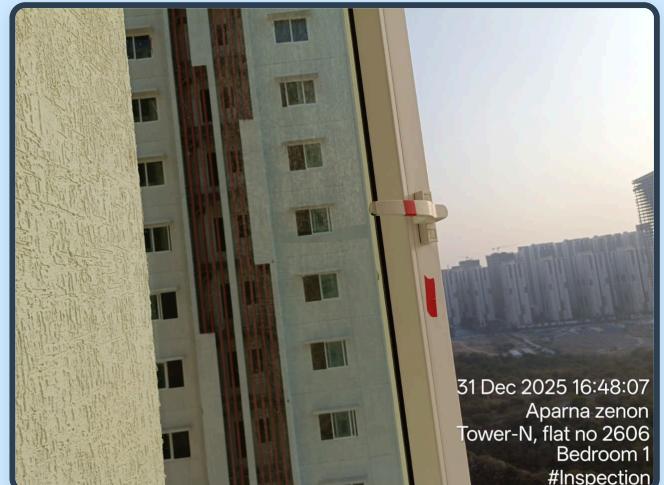
22

Shutter and handle is hard to
operate

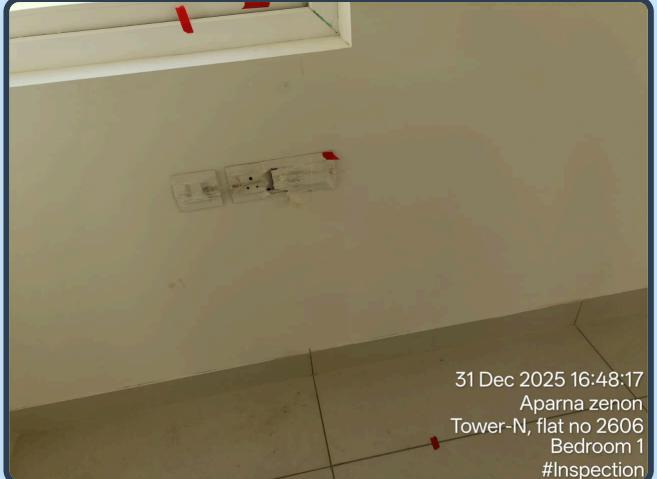
S. NO.	ISSUE	PICTURE
23	Cover Plates are not fixed

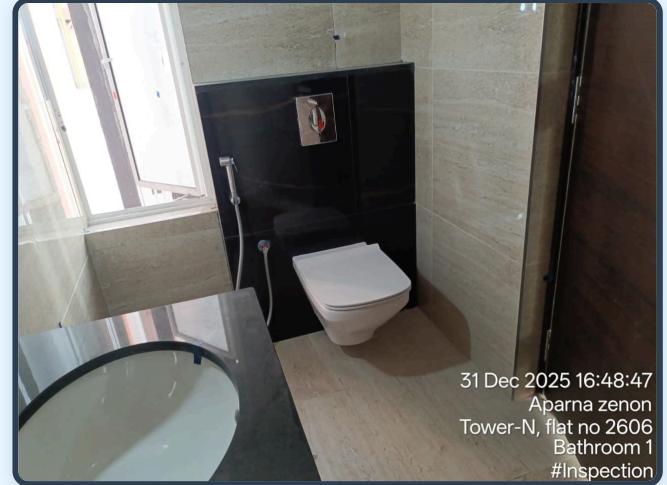
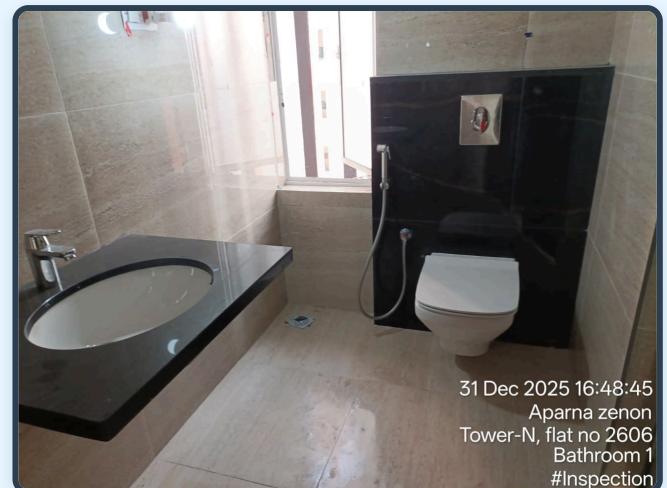
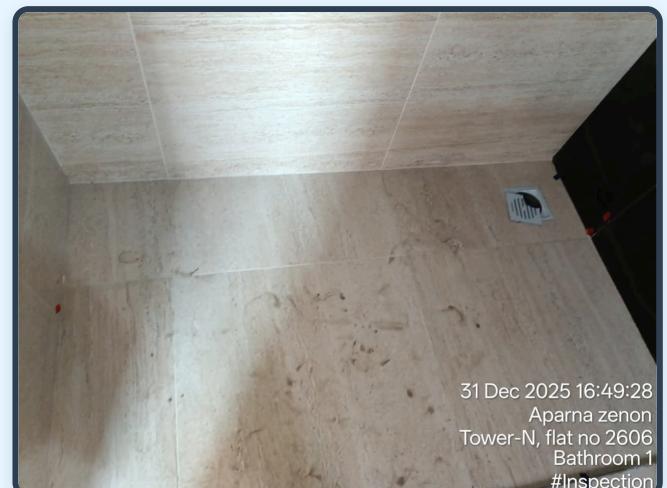
2

Chipoff observed on wall tiles

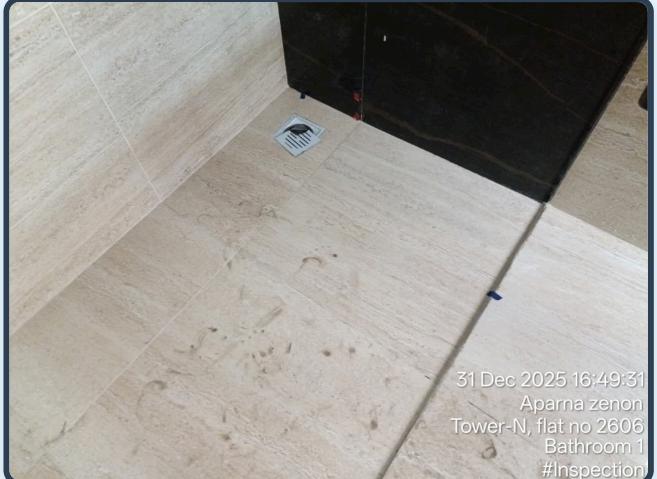
S. NO.	ISSUE	PICTURE
3	Grouting gaps observed between tiles

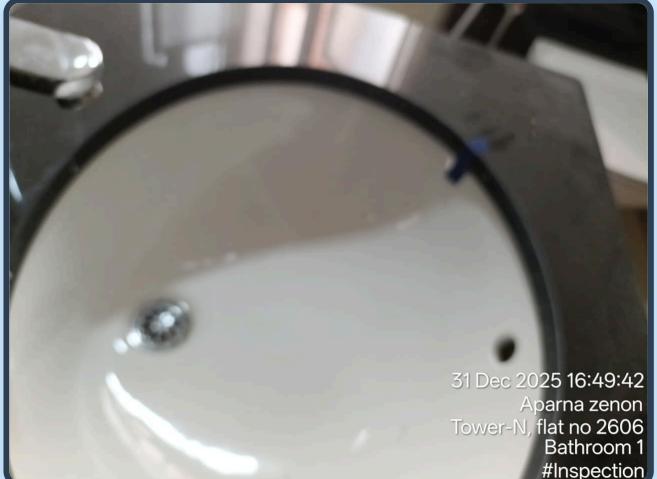
<p>31 Dec 2025 16:49:31 Aparna zenon Tower-N, flat no 2606 Bathroom 1 #Inspection</p>
4	Gap observed between granite stone and wash basin

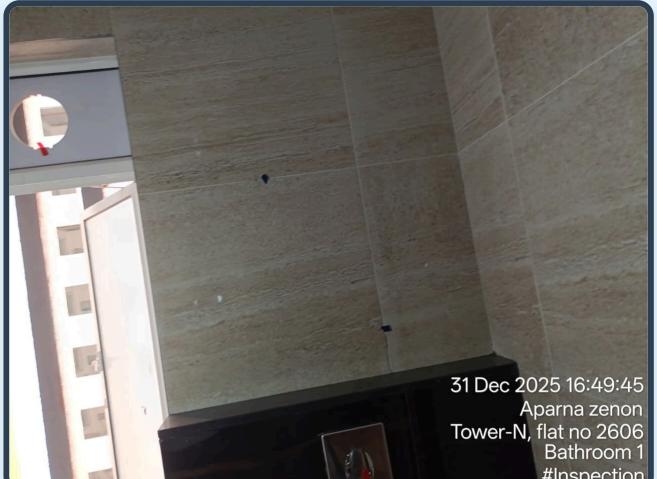
<p>31 Dec 2025 16:49:42 Aparna zenon Tower-N, flat no 2606 Bathroom 1 #Inspection</p>
5	Grouting gaps observed between wall tiles

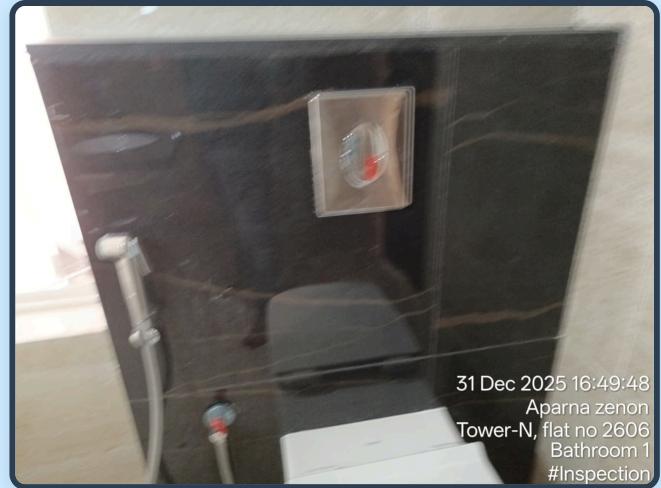
6

No water supply in flush

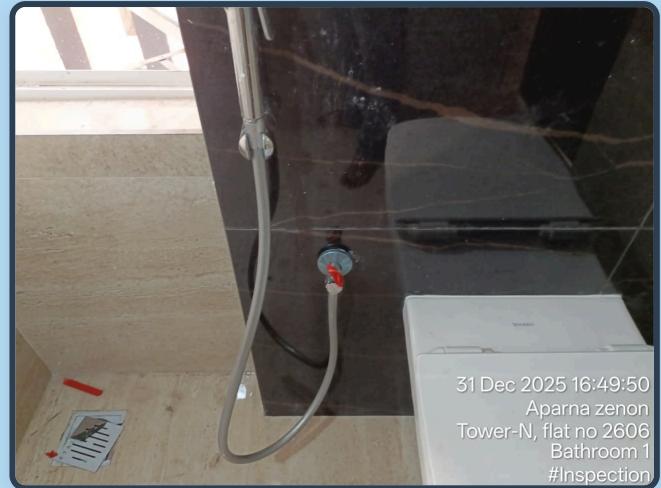
7

Leakage observed at angle cock

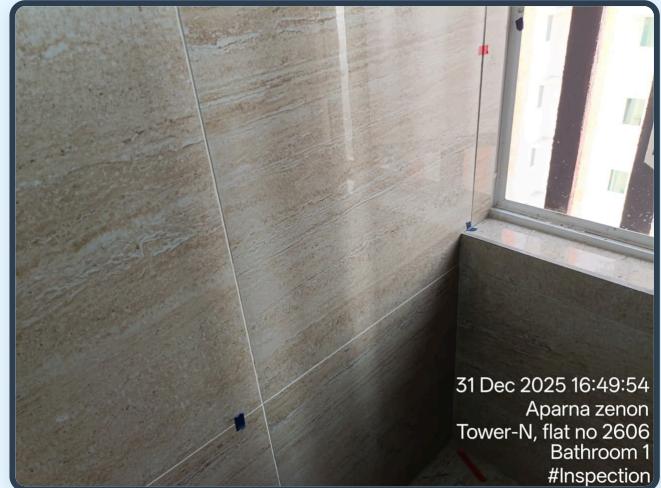
8

Grouting gaps observed between
wall tiles

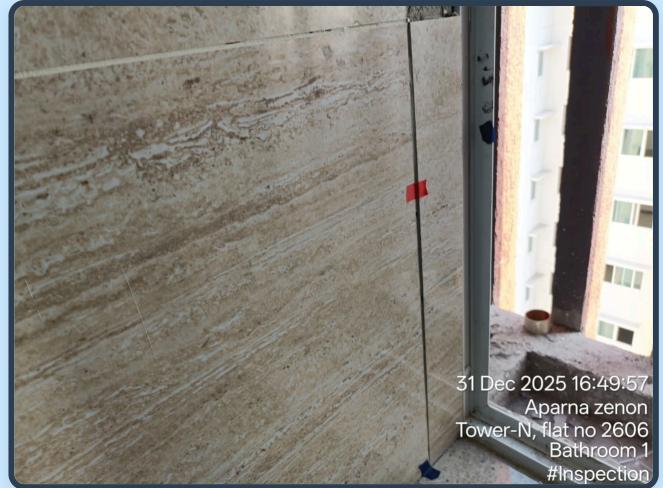
9

Offset observed on the wall tile

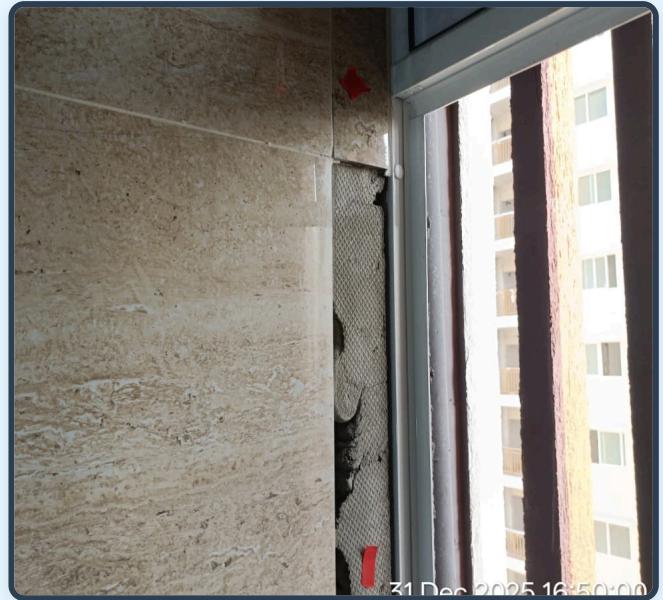
10

Wall tile is not fixed

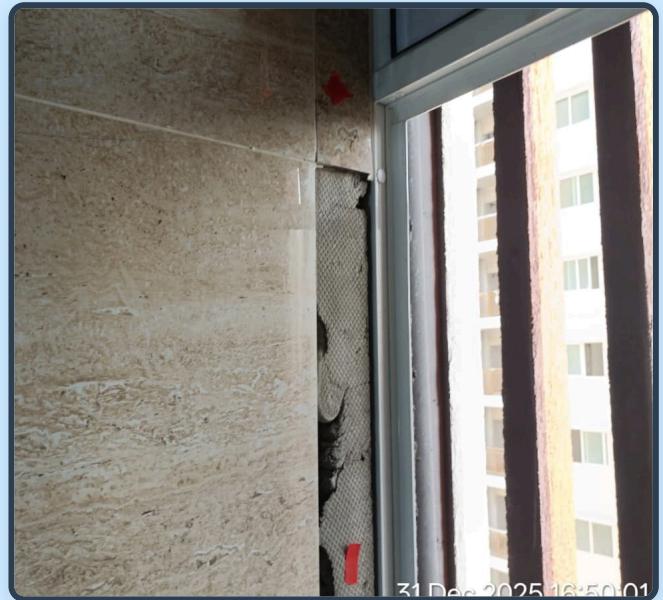
11

hollow tile observed on wall tile

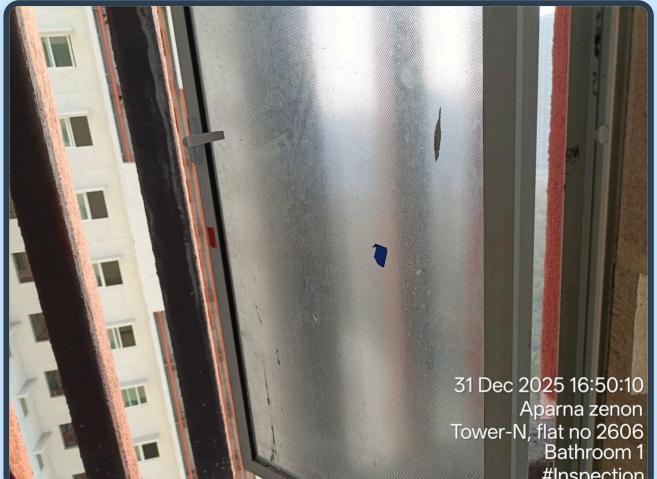
<p>31 Dec 2025 16:50:09 Aparna zenon Tower-N, flat no 2606 Bathroom 1 #Inspection</p>
14	Ventilator shutter is hard to operate

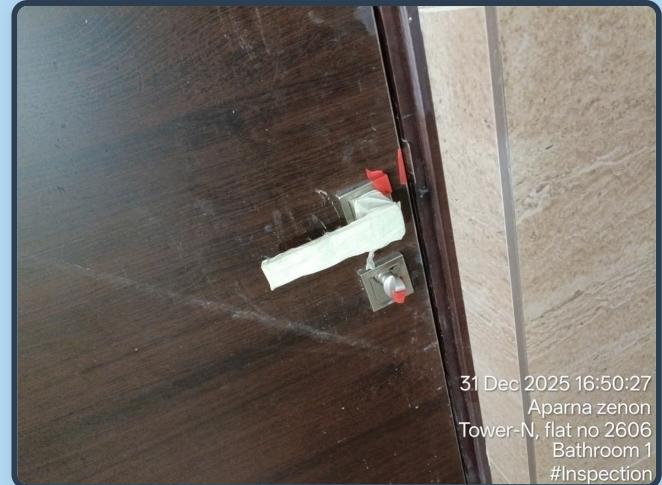
15

Handle fittings are loose

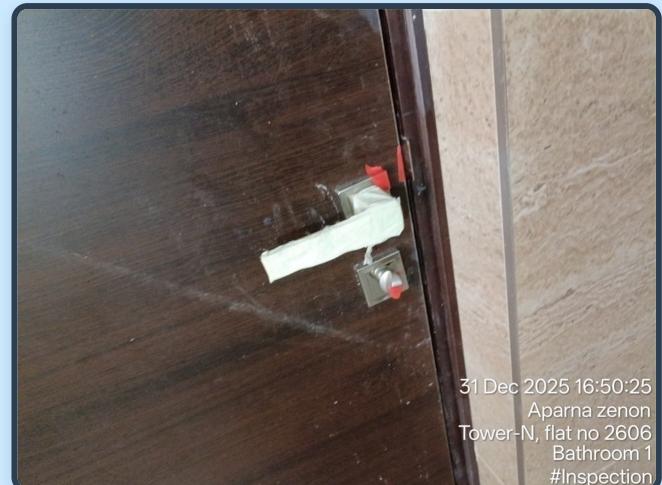
16

Knob is hard to operate

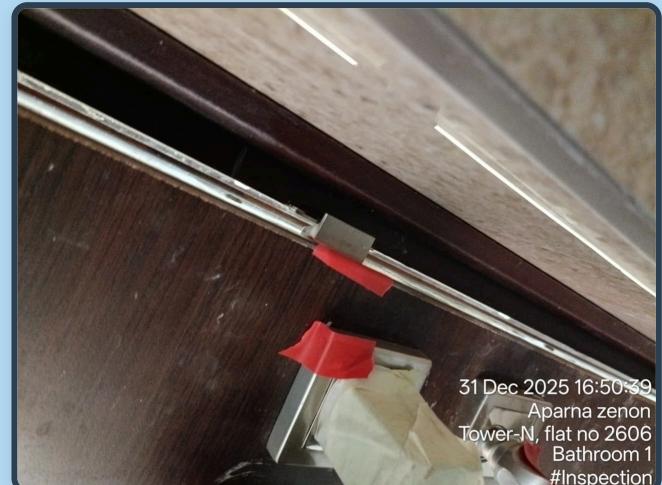
17

Auto Lockset is hitting the door frame during operation

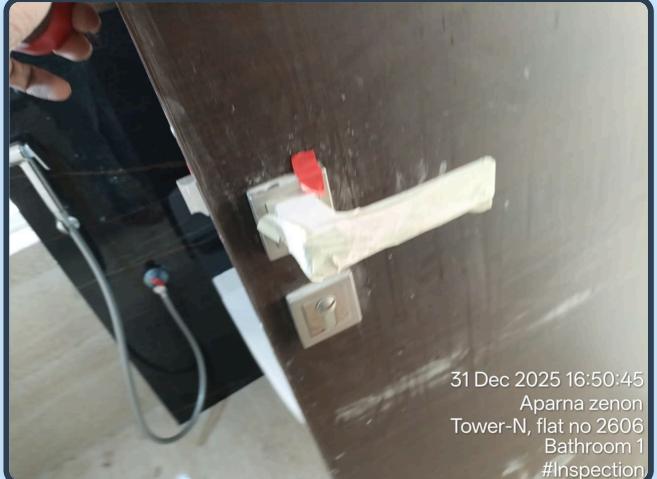
S. NO.	ISSUE	PICTURE
18	Handle fittings are loose

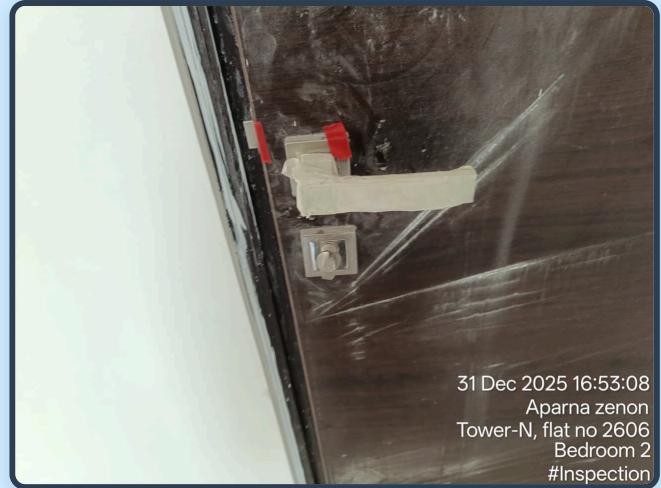
6

Handle fittings are loose

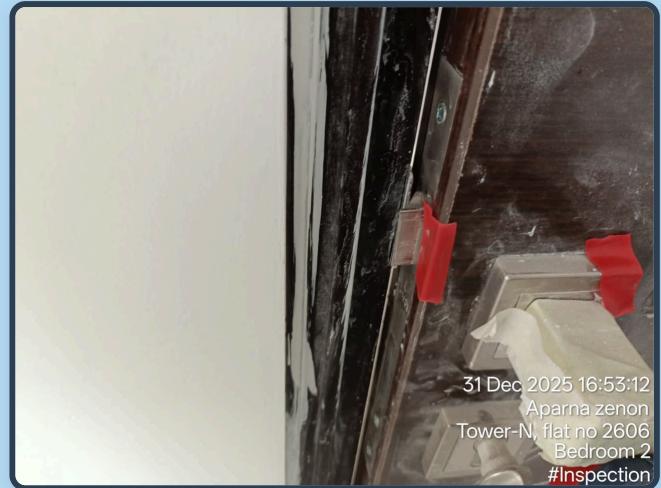
7

The Auto lockset is hitting the door frame during operation

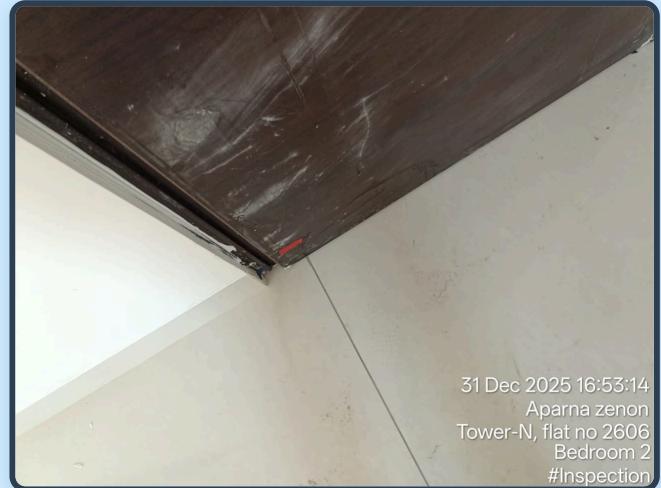
8

Stopper is not fixed

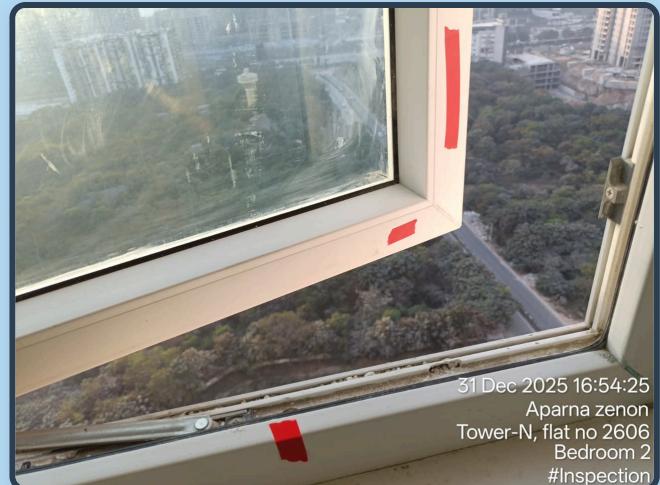
15

Noise observed while operating
the shutter

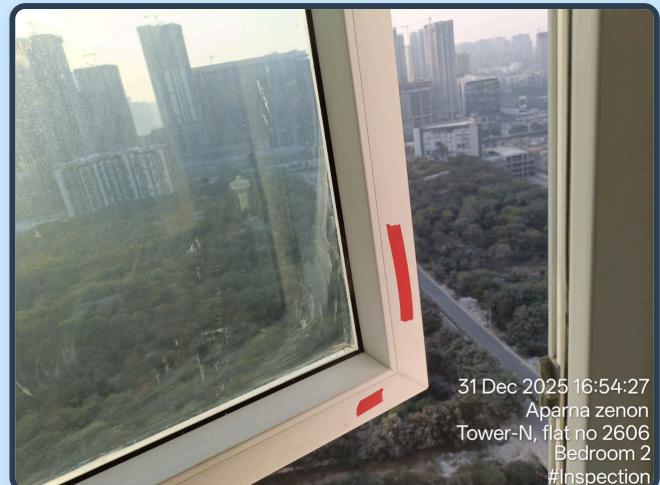
16

Shutter struck the striker during
operation

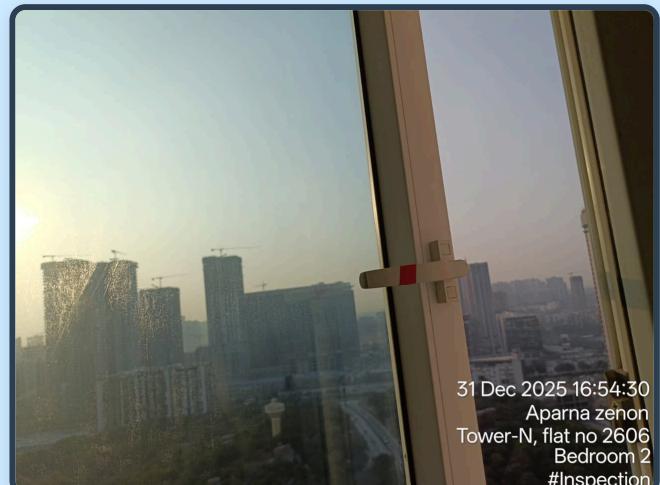
17

Handle is hard to operate

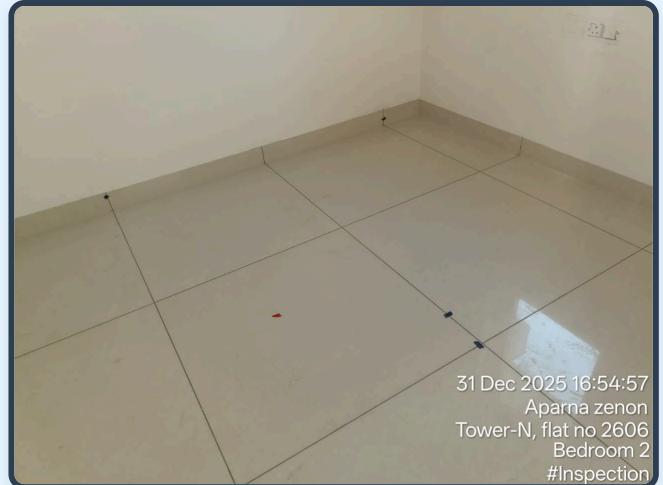
21

chipoff observed on floor tile

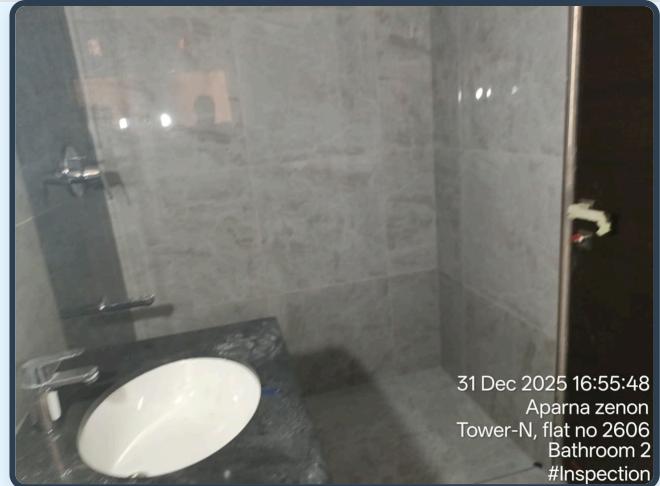
2

Gap observed between granite
stone and wash basin

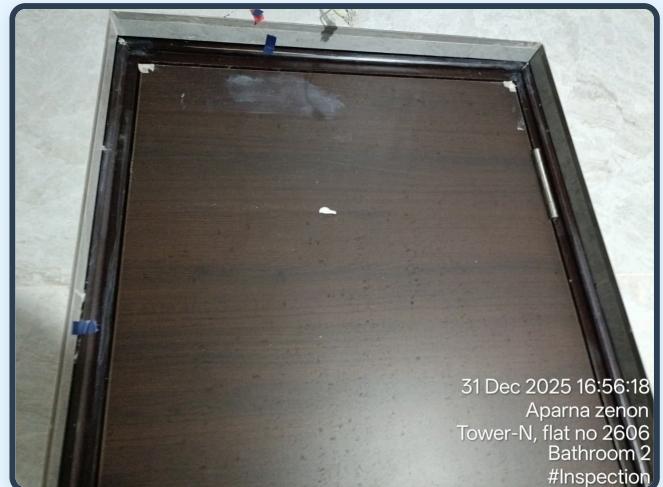
4

Sealant application is not done
properly

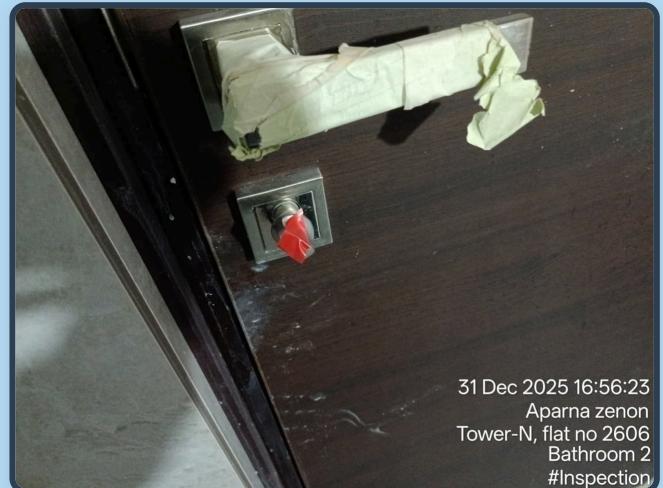
5

Knob is hard to handle

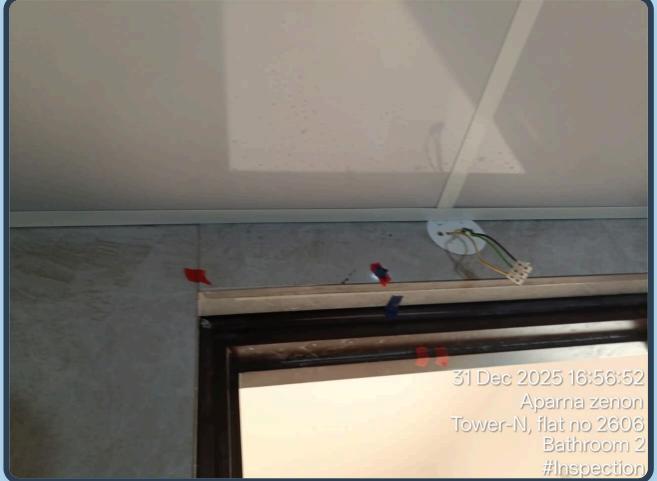
<small>31 Dec 2025 16:56:44</small>
10	Crack observed on wall tile

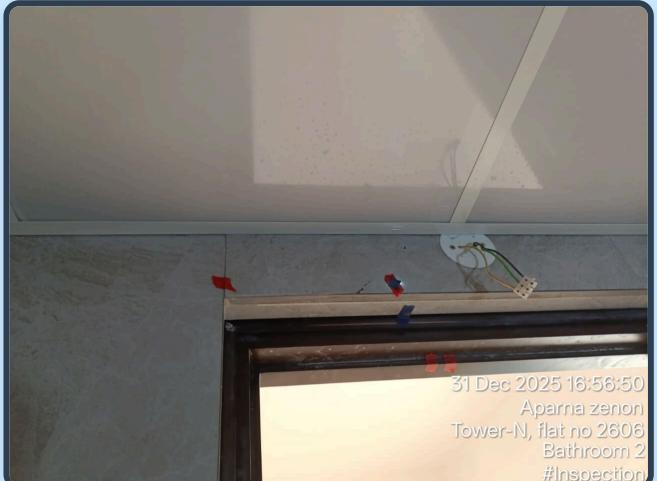
<small>31 Dec 2025 16:56:52 Aparna zenon Tower-N, flat no 2606 Bathroom 2 #Inspection</small>
11	Offset observed on the wall tiles

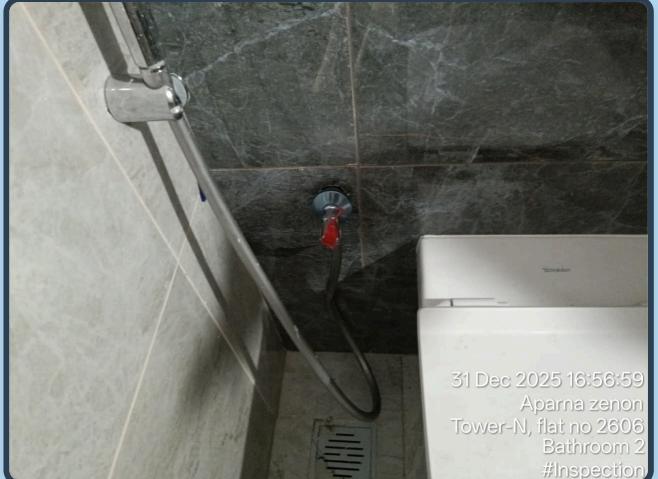
S. NO.	ISSUE	PICTURE
12	Leakage observed at the angle cock

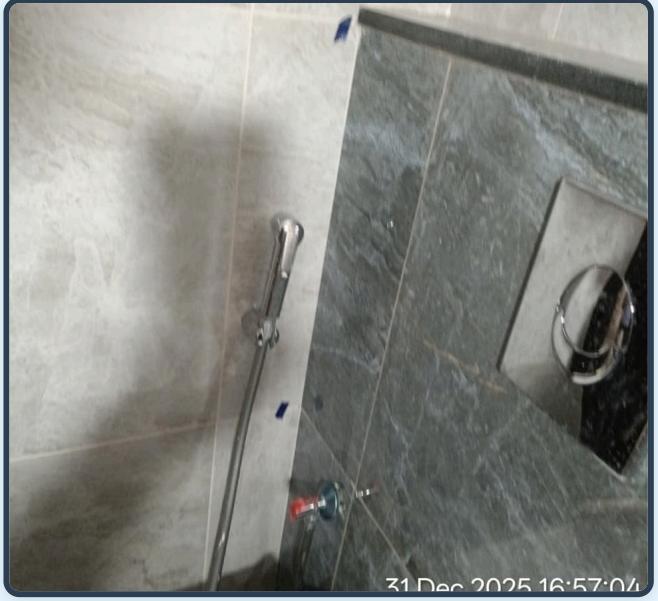
<p>31 Dec 2025 16:56:59 Aparna zenon Tower-N, flat no 2606 Bathroom 2 #Inspection</p>
13	Grouting gaps observed between wall tiles

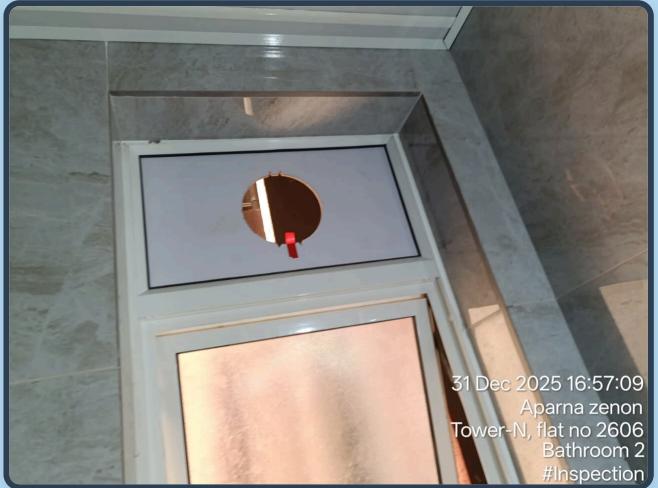
<p>31 Dec 2025 16:57:04</p>
14	Exhaust fans are not fixed in all bathrooms

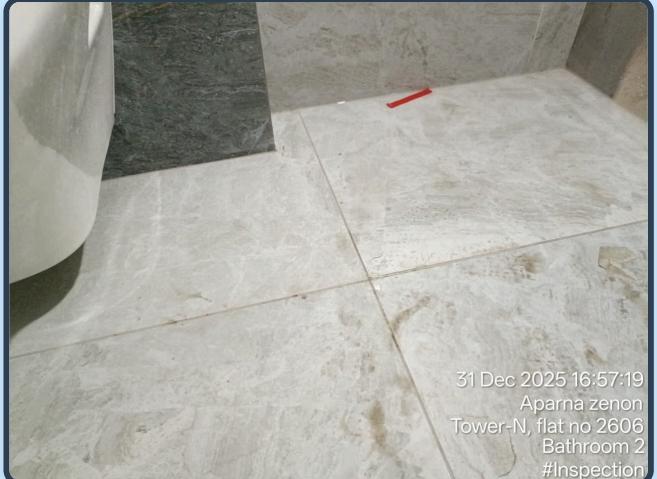
S. NO.	ISSUE	PICTURE
15	Inadequate slope issue observed on floor tiles

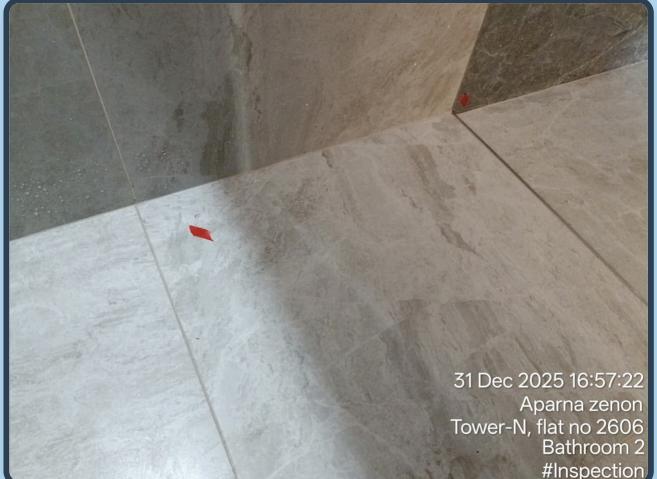
<p>31 Dec 2025 16:57:19 Aparna zenon Tower-N, flat no 2606 Bathroom 2 #Inspection</p>
16	Chipoff observed on tile

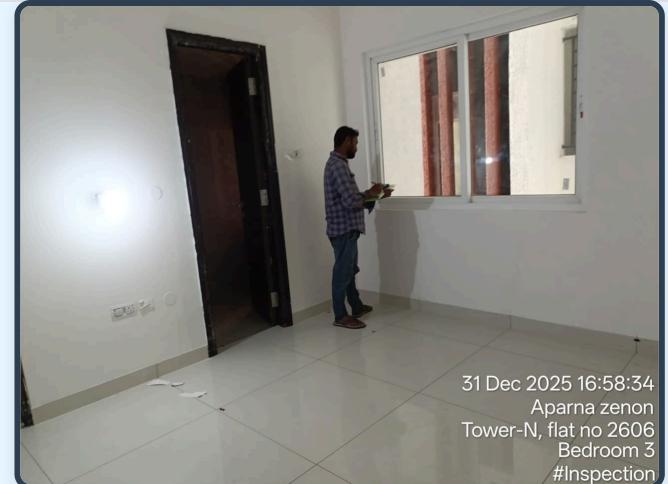
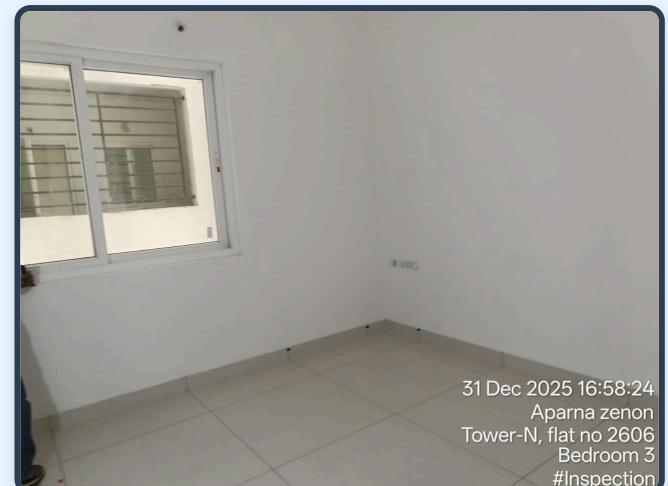
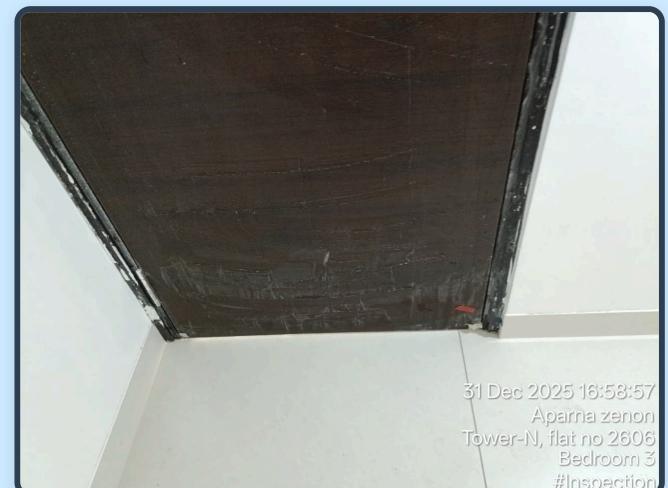
2

Stopper is not fixed

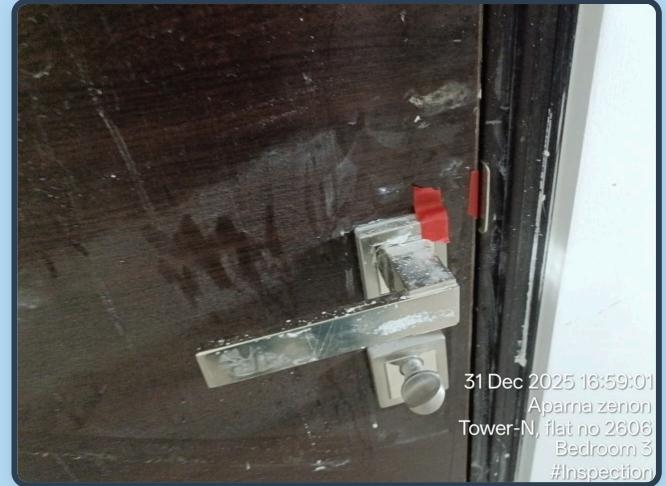
3

Handle fittings are loose

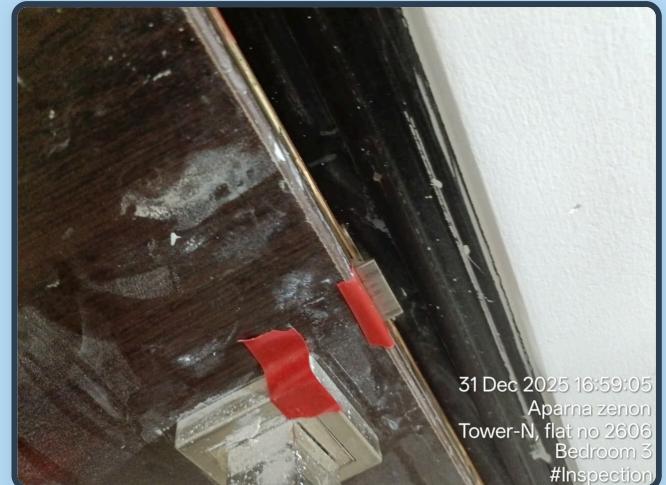
4

Auto lockset is hitting the door frame during operation

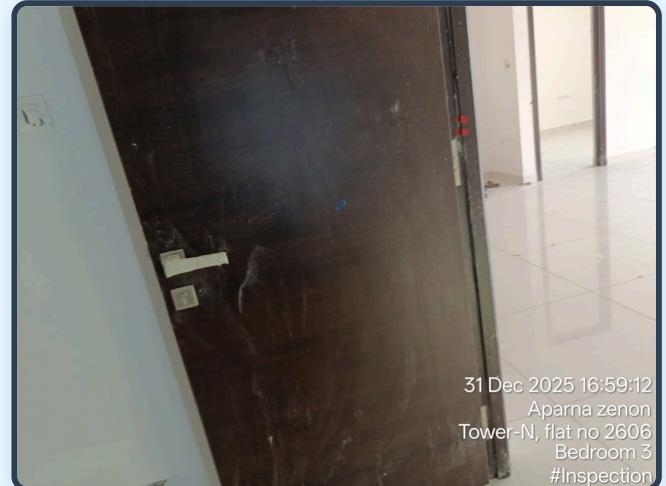
5

Polishing not done properly on shutter and door frame

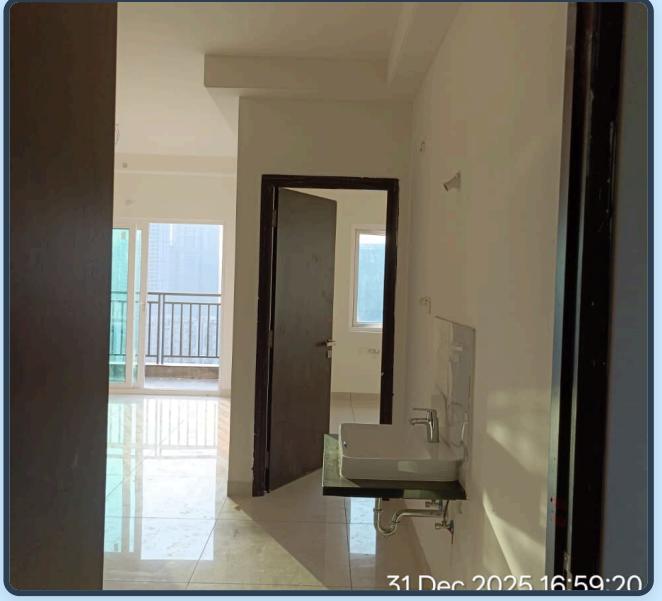
S. NO.	ISSUE	PICTURE
6	Rubber gasket is not fixed

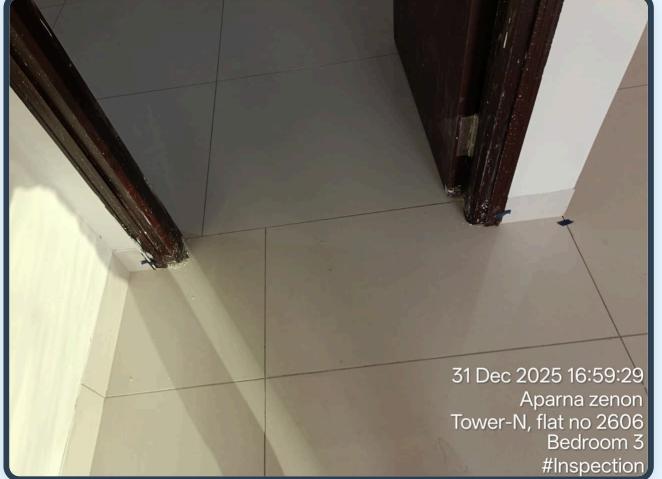
<small>31 Dec 2025 16:59:20</small>
7	Sealant application not done properly

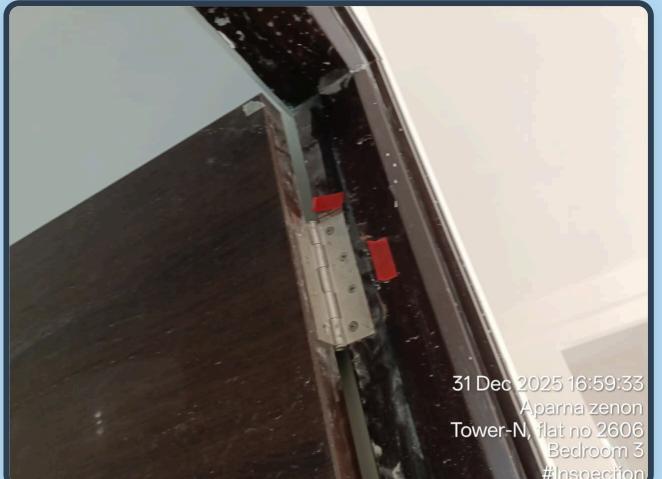
<small>31 Dec 2025 16:59:29 Aparna zenon Tower-N, flat no 2606 Bedroom 3 #Inspection</small>
8	Chipoff observed on door frame

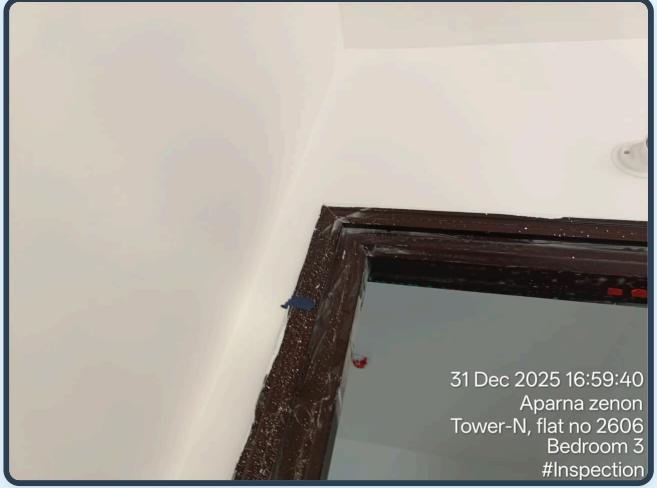
S. NO.	ISSUE	PICTURE
9	Sealant application not done properly

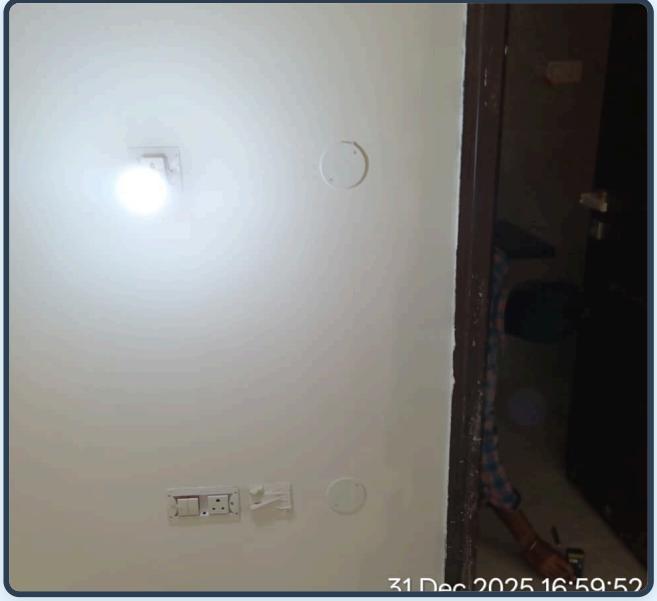
<p>31 Dec 2025 16:59:40 Aparna zenon Tower-N, flat no 2606 Bedroom 3 #Inspection</p>
10	Paint surface finishing not done properly on wall

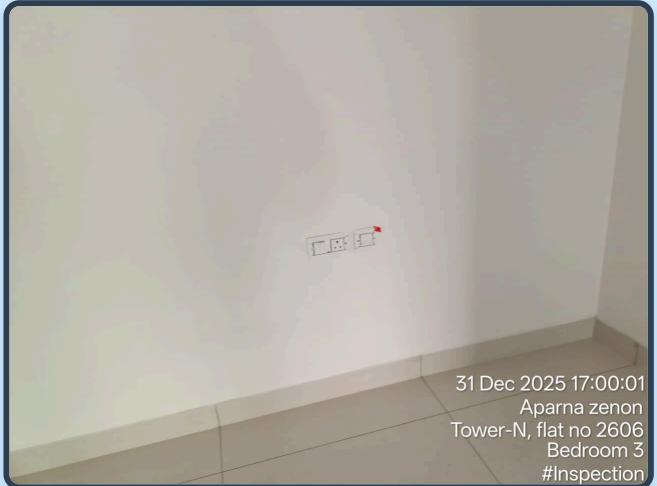
<p>31 Dec 2025 16:59:52</p>
11	Cover plates are not fixed

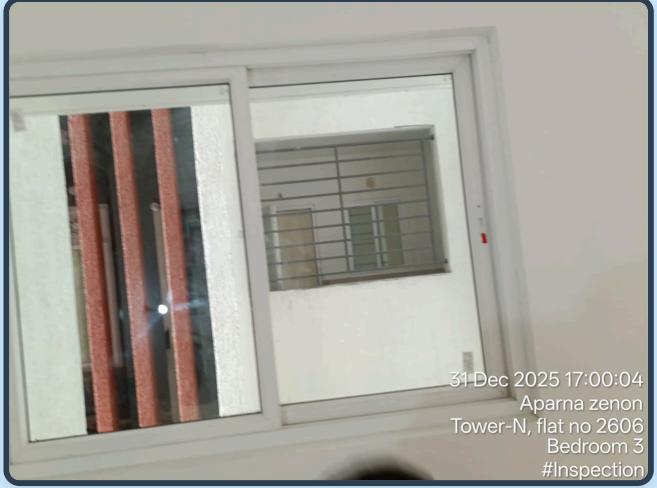
S. NO.	ISSUE	PICTURE
12	Window lockset is not functioning properly

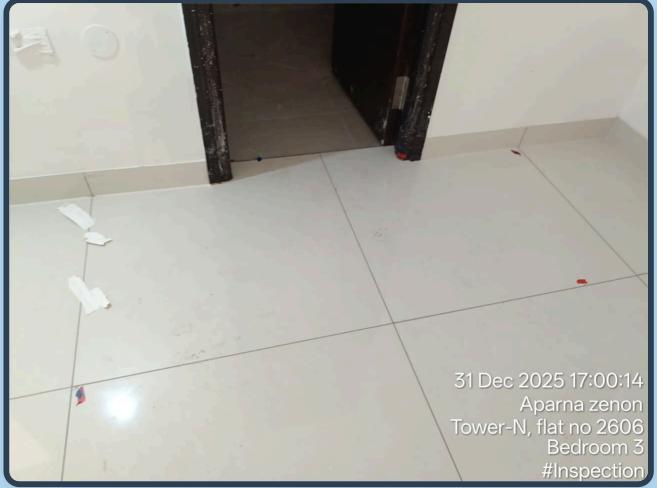
<p>31 Dec 2025 17:00:04 Aparna zenon Tower-N, flat no 2606 Bedroom 3 #Inspection</p>
13	chipoff observed on floor tile

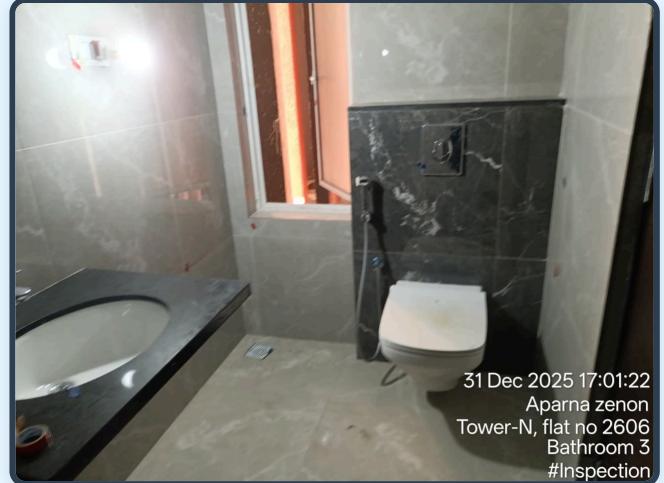
2

Gap observed between granite
stone and wash basin

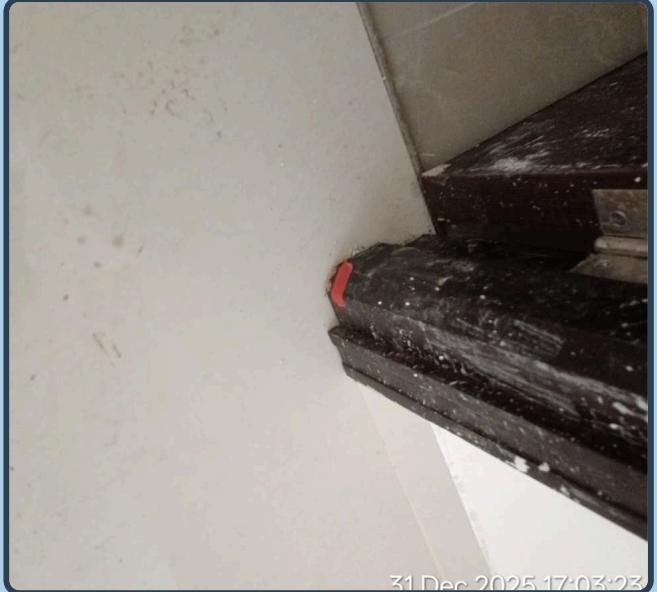
S. NO.	ISSUE	PICTURE
3	Edge damages observed on door

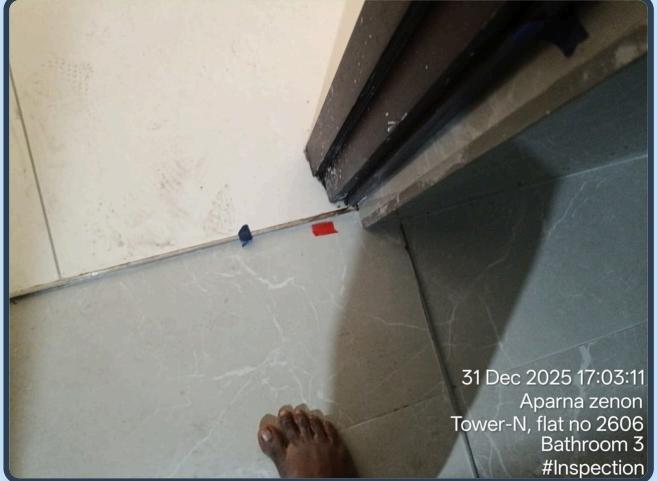
31 Dec 2025 17:03:23
4	Grouting gaps observed between floor tiles

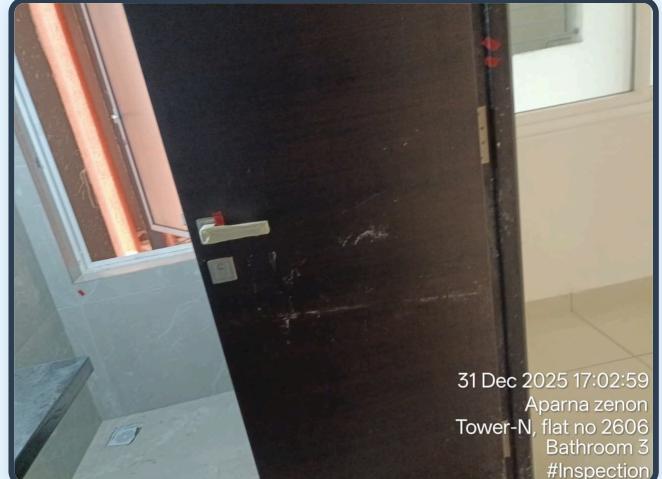
<p>31 Dec 2025 17:02:51 Aparna zenon Tower-N, flat no 2606 Bathroom 3 #Inspection</p>
7	Polishing not done properly on shutter and door frame

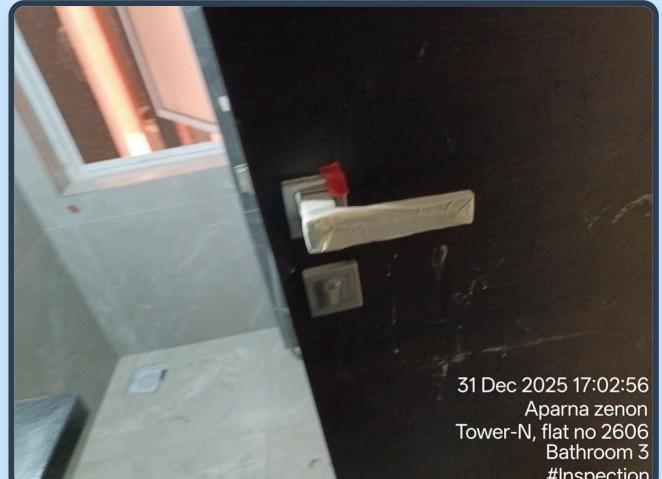
<p>31 Dec 2025 17:02:59 Aparna zenon Tower-N, flat no 2606 Bathroom 3 #Inspection</p>
8	Handle fittings are loose

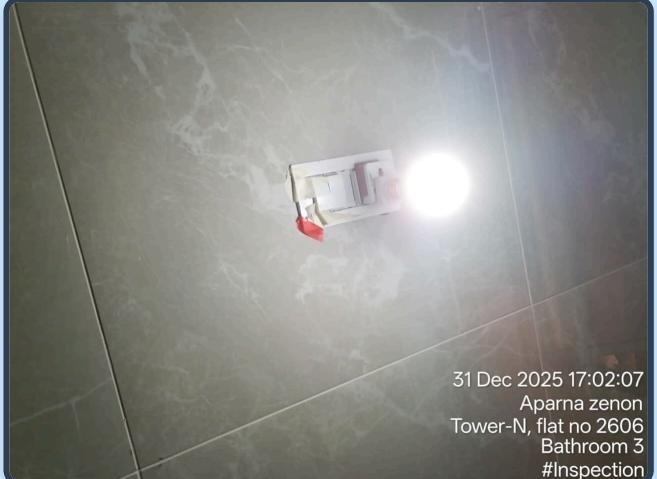
S. NO.	ISSUE	PICTURE
9	Cover plate is not fixed

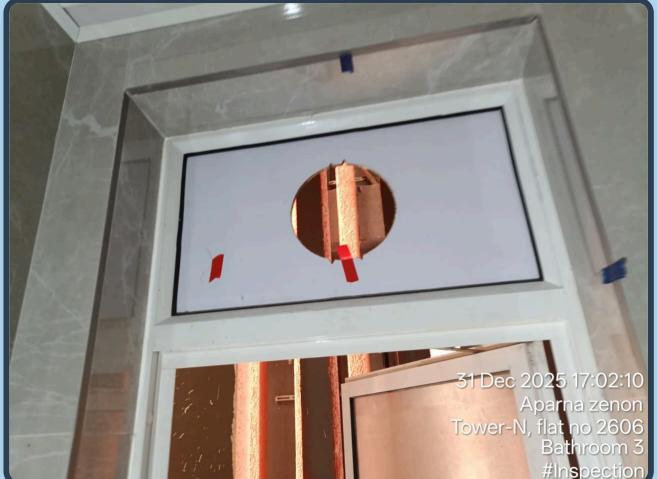
<p>31 Dec 2025 17:02:07 Aparna zenon Tower-N, flat no 2606 Bathroom 3 #Inspection</p>
10	Damage observed on board

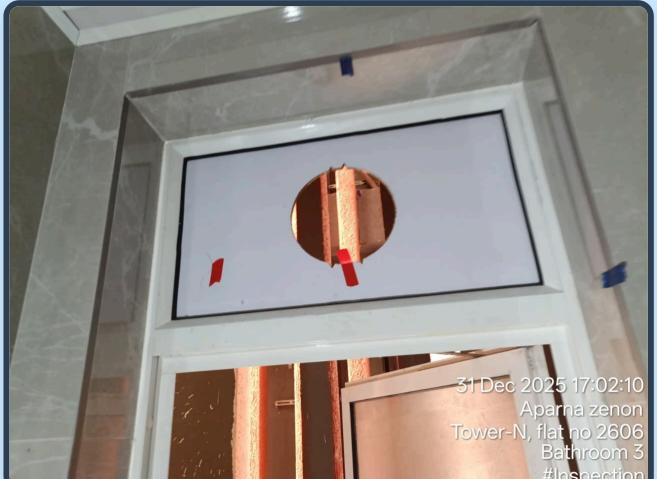
<p>31 Dec 2025 17:02:10 Aparna zenon Tower-N, flat no 2606 Bathroom 3 #Inspection</p>
11	Exhaust fans are not fixed at all
