# INSPECTION REPORT

**Rainbow Villas**

**3/1/2026**

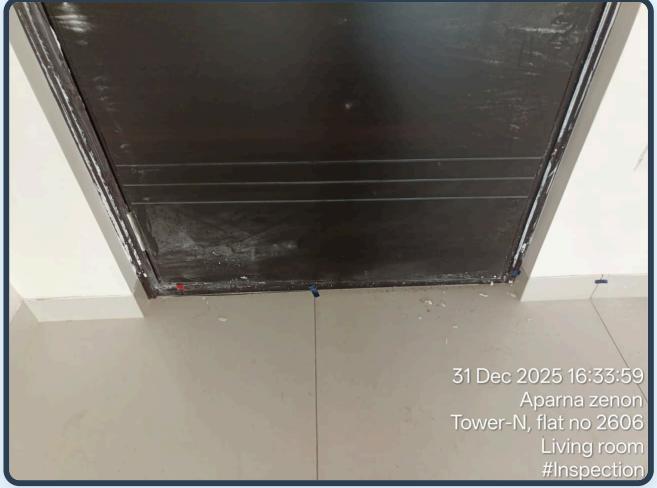
S. NO.	ISSUE	PICTURE
3	Sealant application not done properly

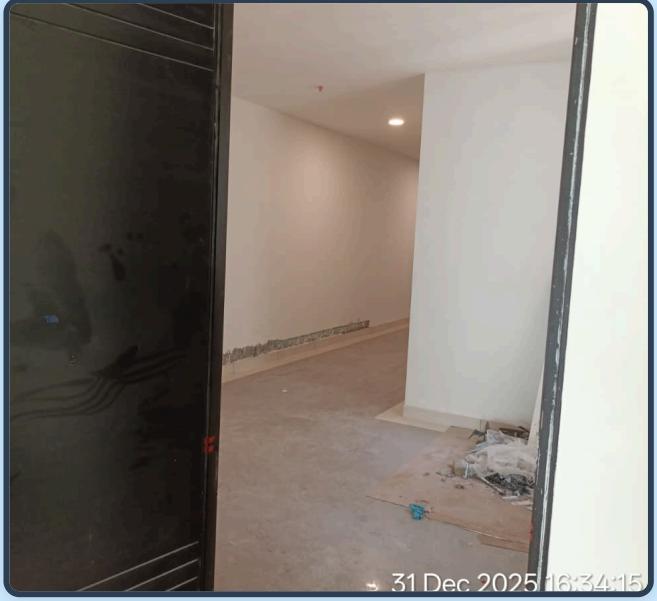
<p>31 Dec 2025 16:33:59 Aparna zenon Tower-N, flat no 2606 Living room #Inspection</p>
4	Rubber gasket is not fixed

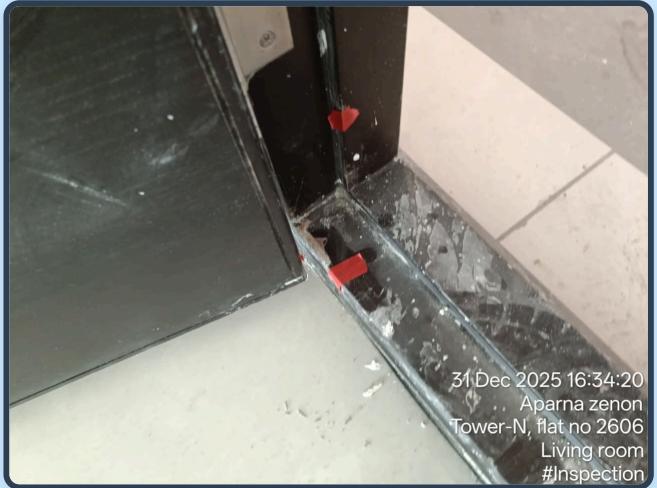
<p>31 Dec 2025 16:34:15</p>
5	Edge damages observed on door frame

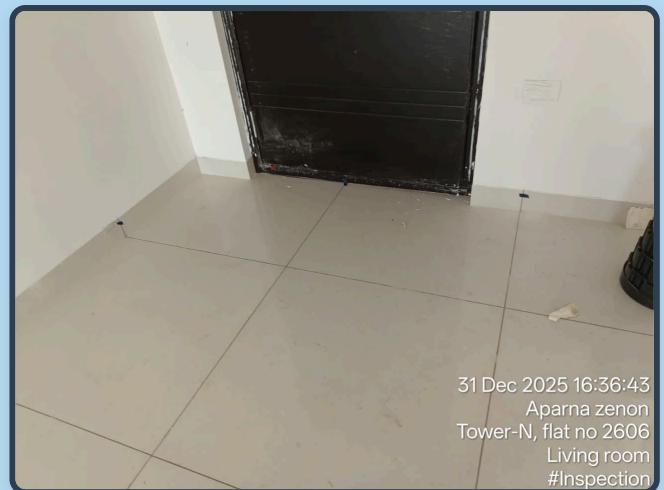
21

Gap observed between skirting  
tiles

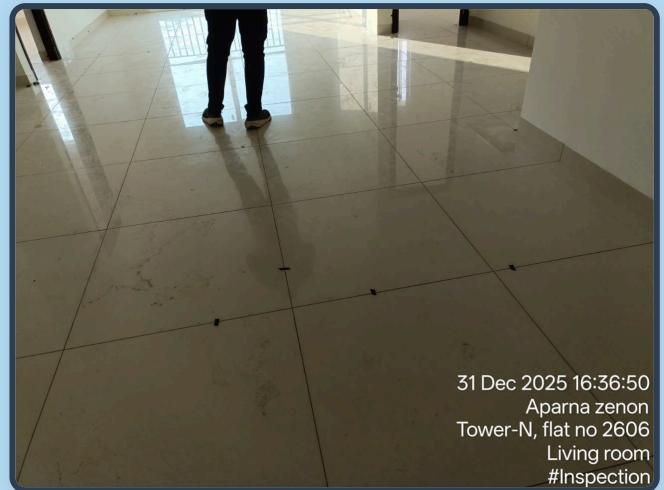
22

Grouting gaps observed between  
floor tiles

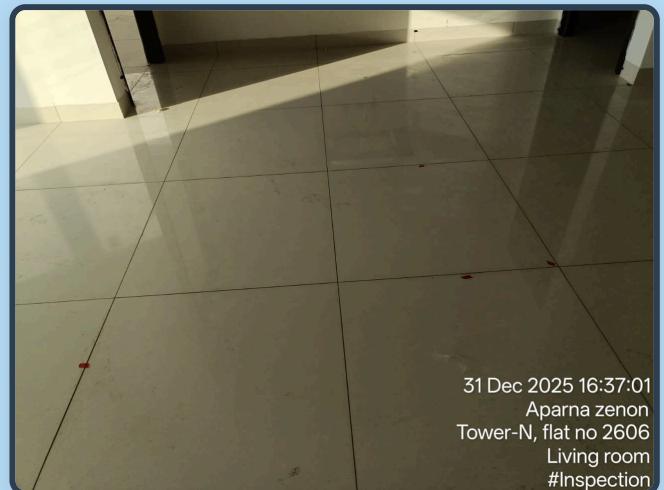
23

offset observed between floor  
tiles

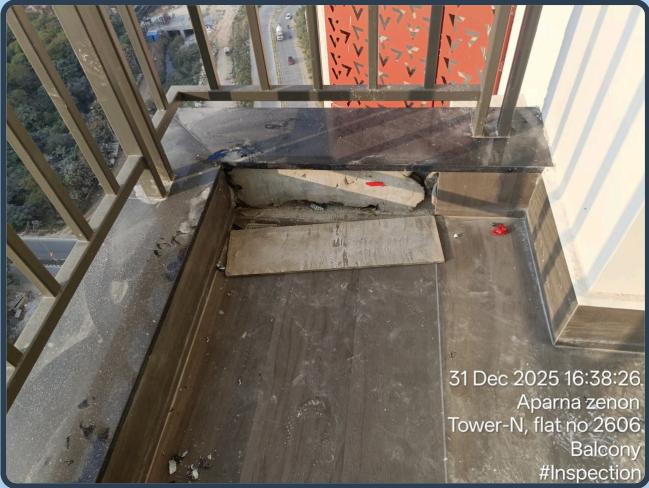
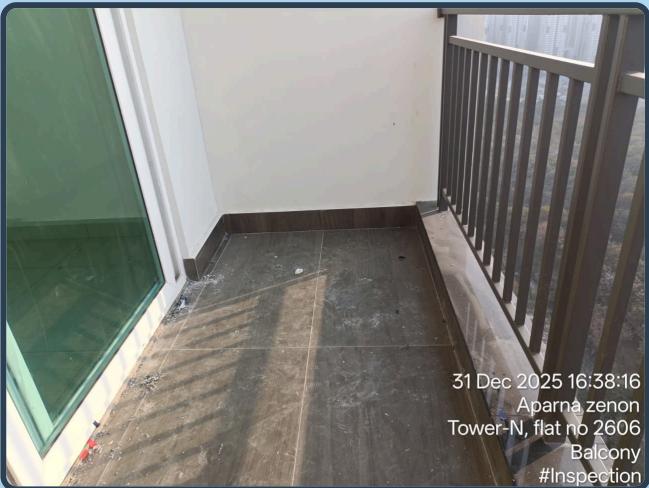
S. NO.	ISSUE	PICTURE
1	Skirting tile is not fixed

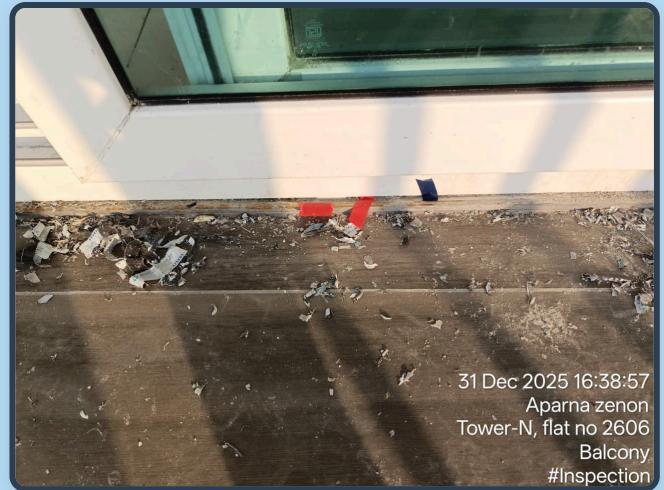
5

Sealant application not done  
properly

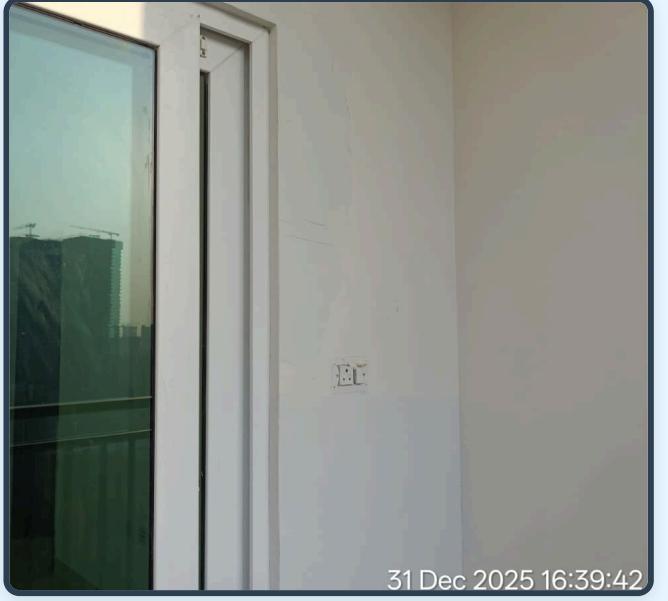
S. NO.	ISSUE	PICTURE
16	Paint Surface finishing not done properly on wall

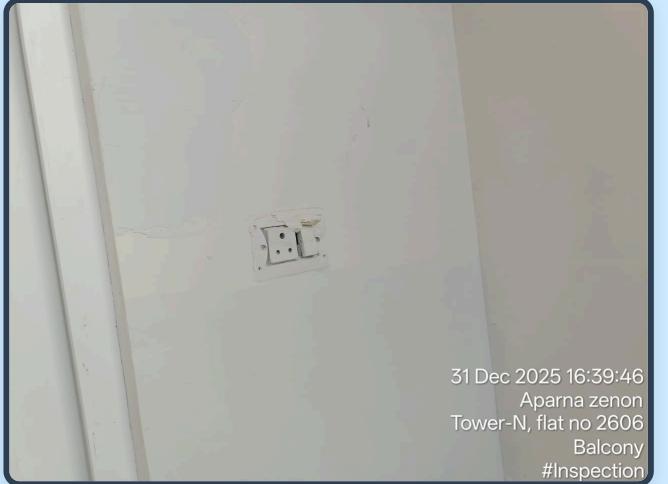
31 Dec 2025 16:39:42
17	Cover plate is not fixed

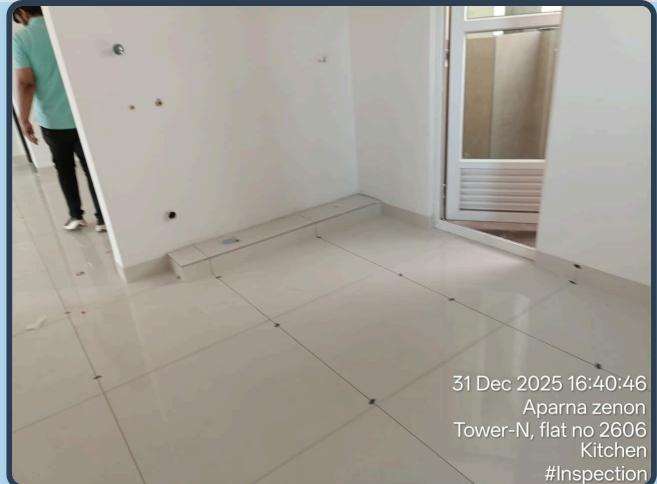
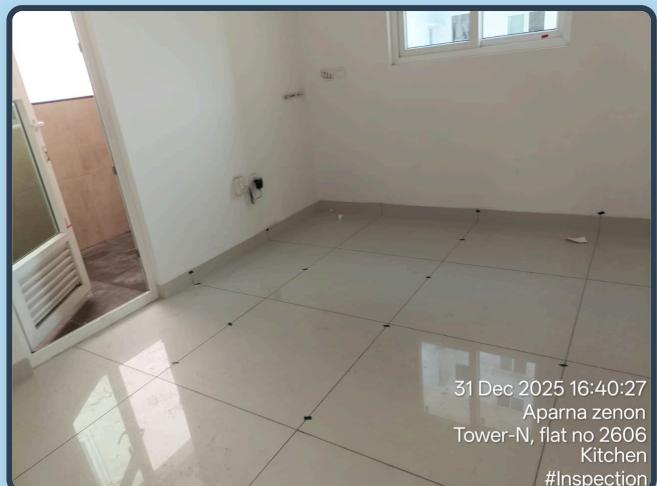
2

Window lockset is not fixed

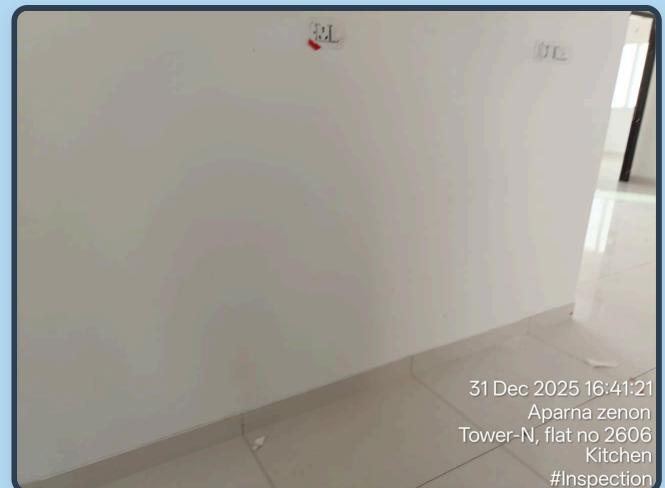
6

Cover plate is not fixed

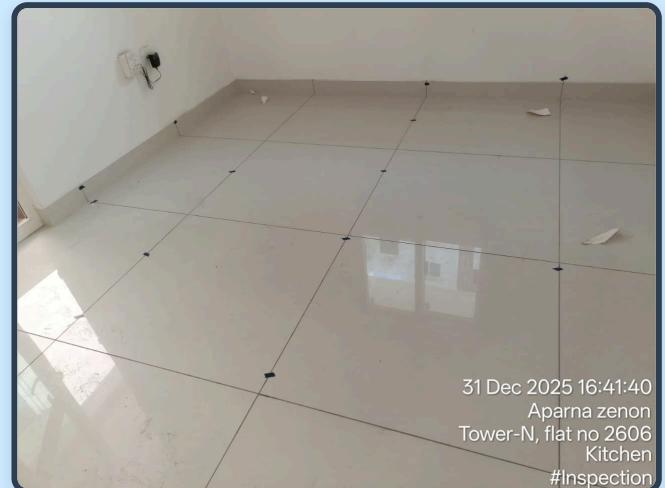
7

Grouting gaps observed between  
floor tiles

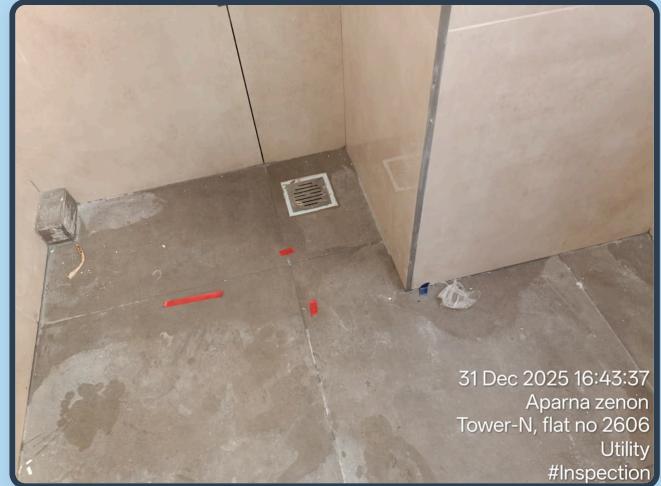
4

chipoff observed on floor tile

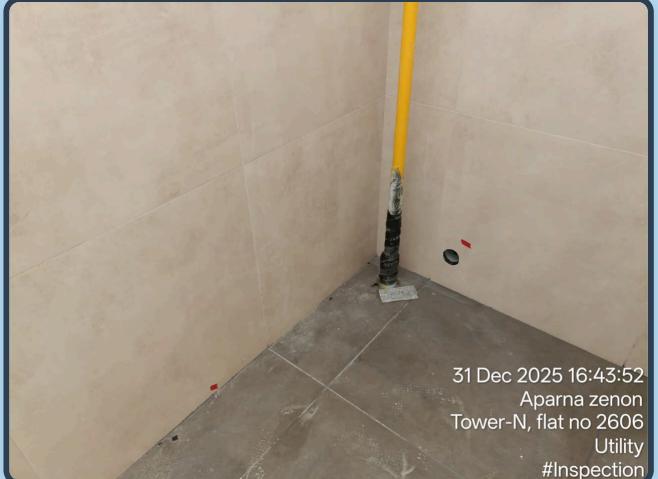
S. NO.	ISSUE	PICTURE
8	Chipoff observed on the wall tile

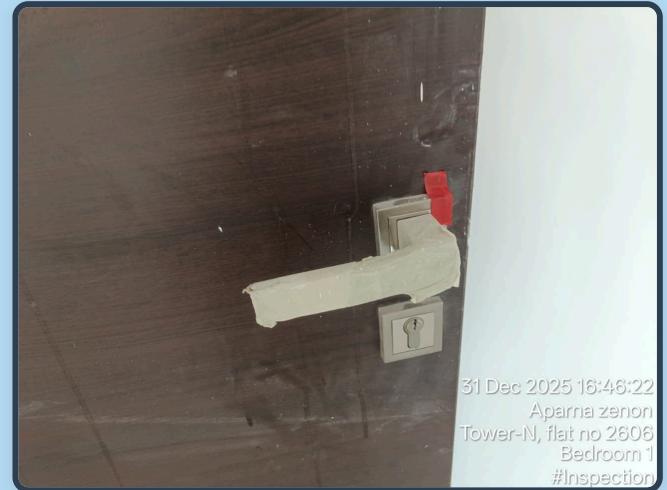
2

Handle fitting are loose

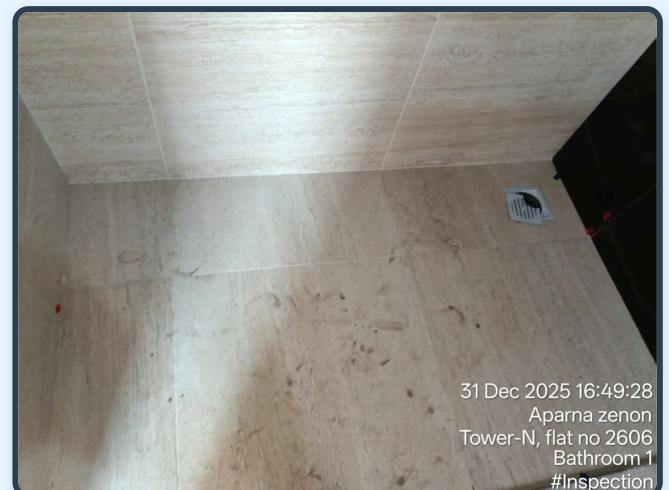
2  
Chipoff observed on wall tiles

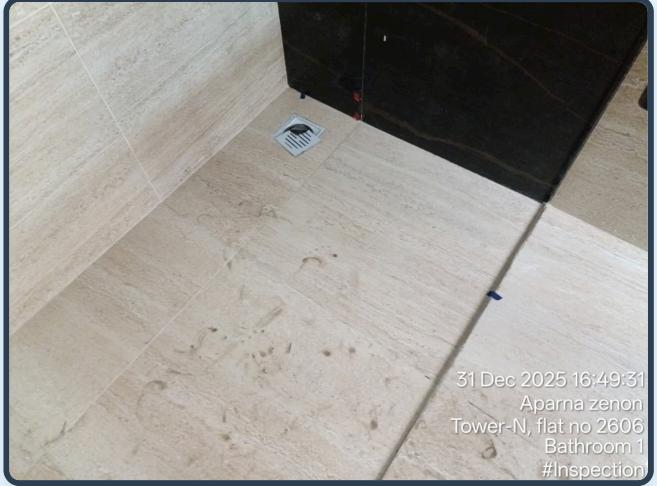
S. NO.	ISSUE	PICTURE
3	Grouting gaps observed between tiles

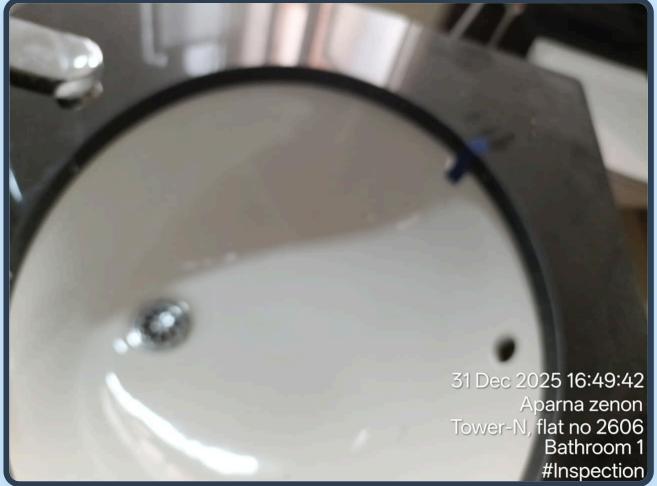
<p>31 Dec 2025 16:49:31 Aparna zenon Tower-N, flat no 2606 Bathroom 1 #Inspection</p>
4	Gap observed between granite stone and wash basin

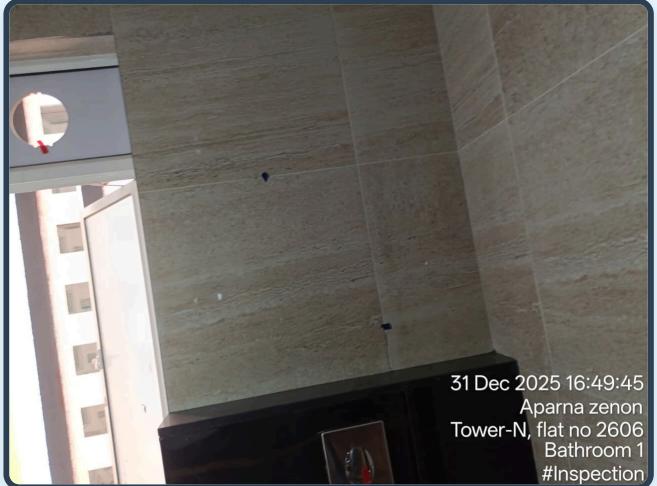
<p>31 Dec 2025 16:49:42 Aparna zenon Tower-N, flat no 2606 Bathroom 1 #Inspection</p>
5	Grouting gaps observed between wall tiles

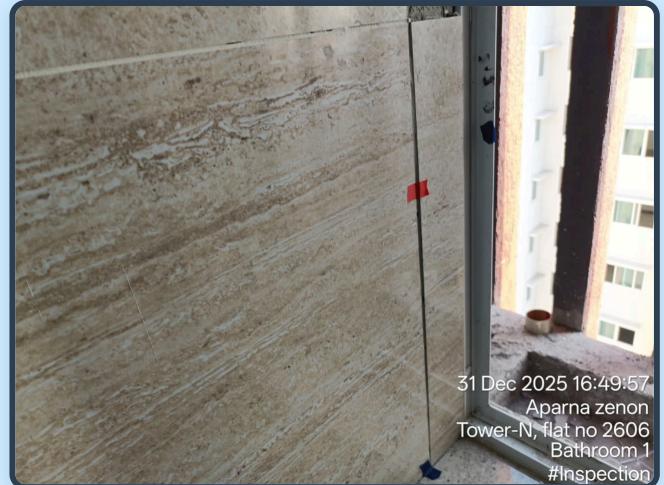
9

Offset observed on the wall tile

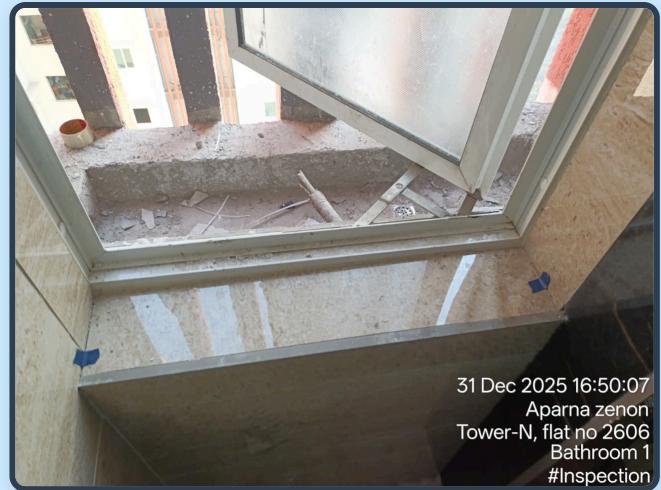
12

Grouting gaps observed between wall tiles

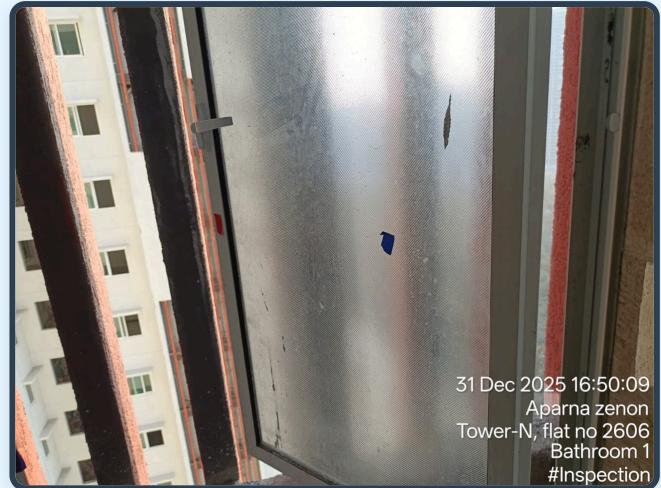
13

Paint stains observed on the glass

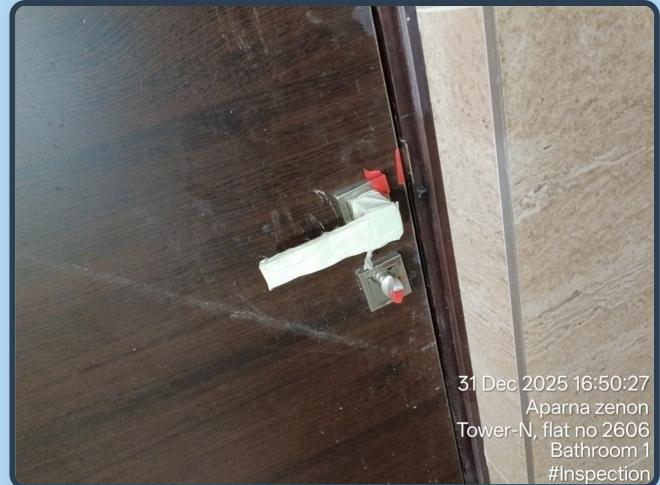
15

Handle fittings are loose

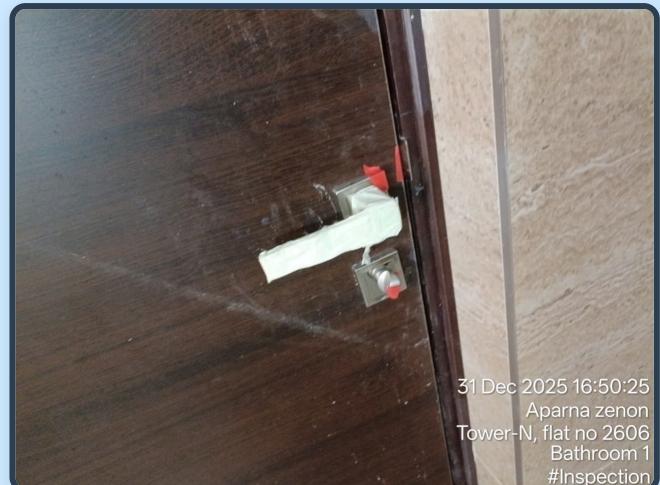
16

Knob is hard to operate

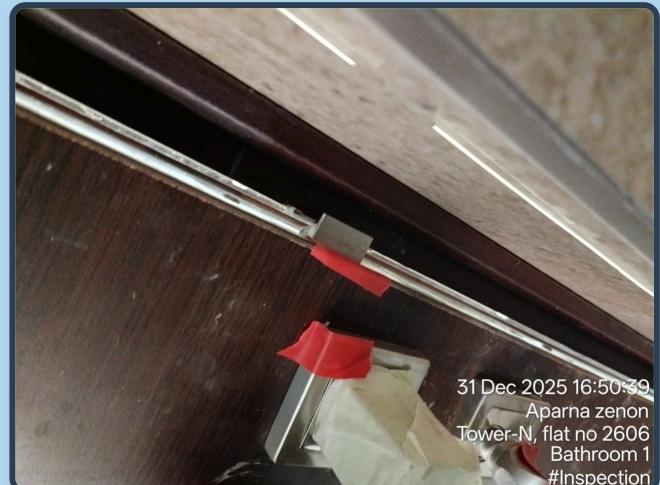
17

Auto Lockset is hitting the door frame during operation

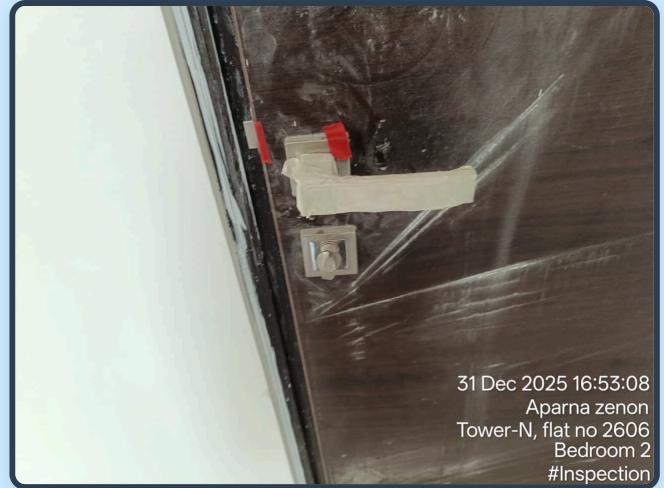
6

Handle fittings are loose

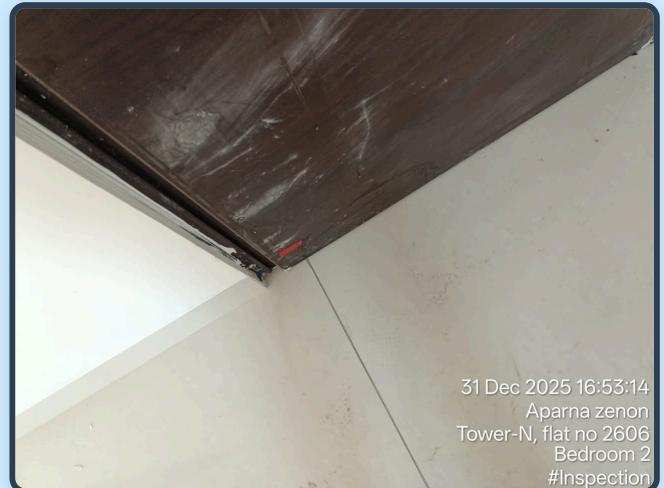
8

Stopper is not fixed

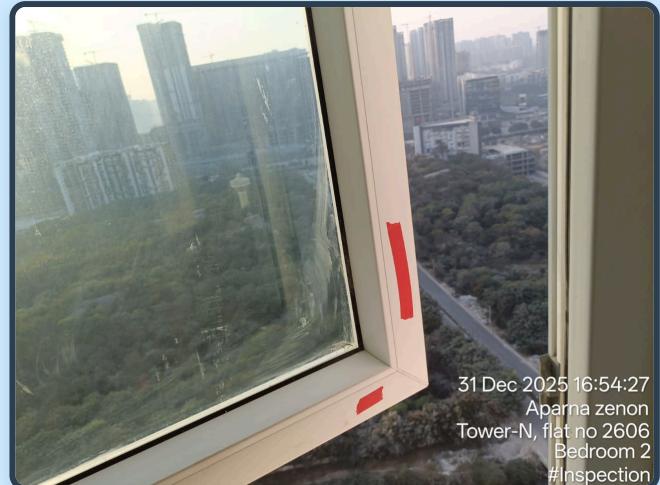
16

Shutter struck the striker during  
operation

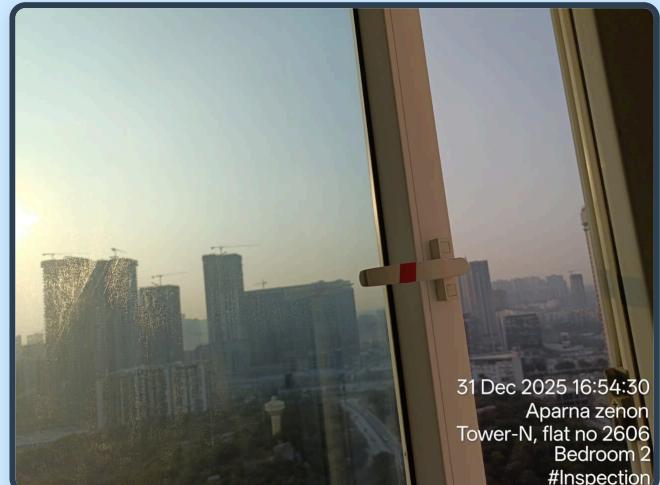
17

Handle is hard to operate

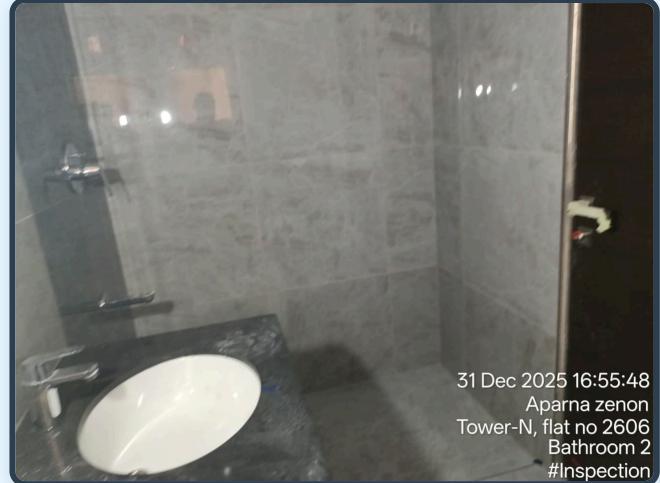
2

Gap observed between granite  
stone and wash basin

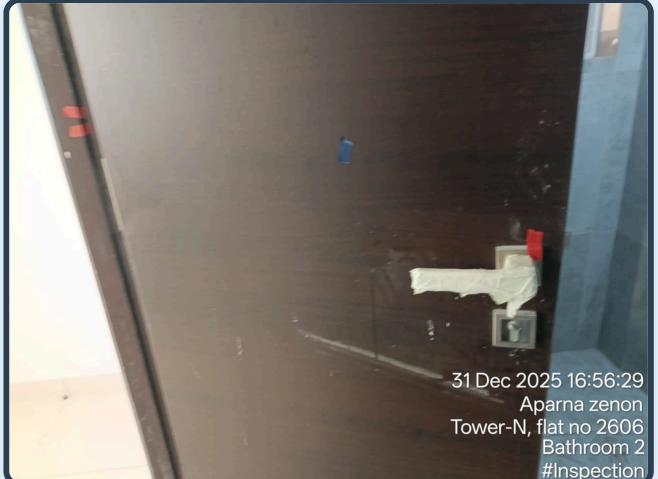
<p>31 Dec 2025 16:56:27  Aparna zenon  Tower-N, flat no 2606  Bathroom 2  #Inspection</p>
7	Polishing not done properly on shutter and door frame

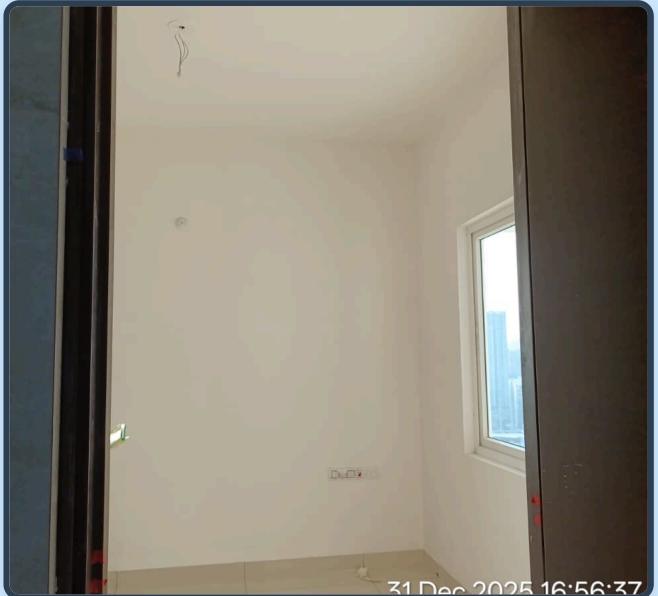
<p>31 Dec 2025 16:56:29  Aparna zenon  Tower-N, flat no 2606  Bathroom 2  #Inspection</p>
8	Rubber gasket is not fixed

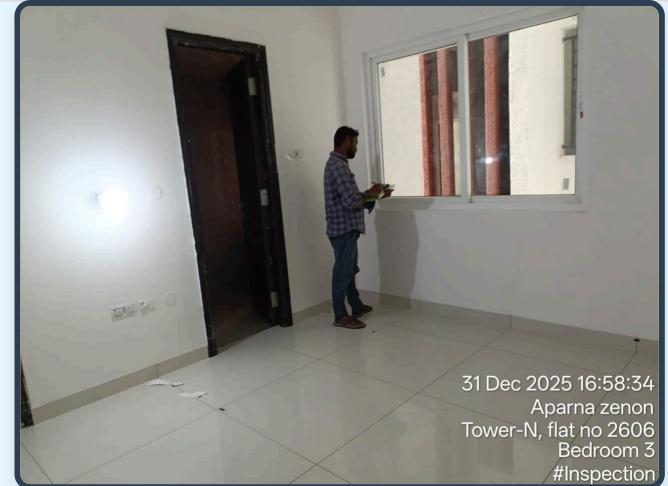
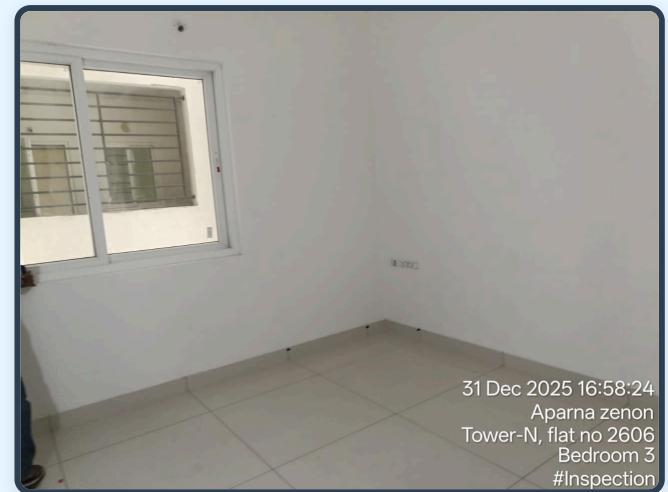
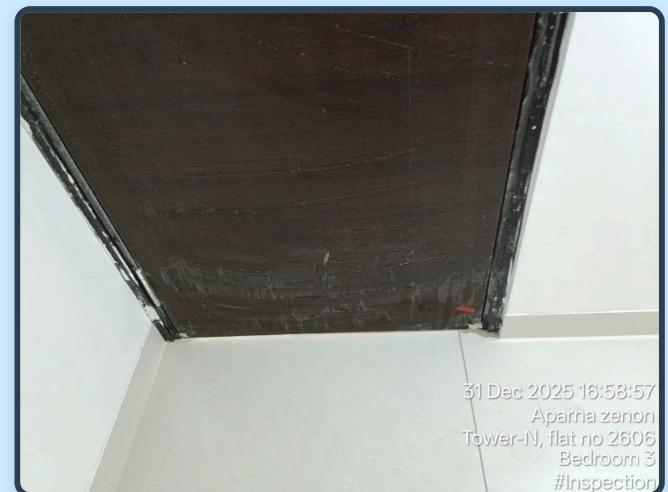
2

Stopper is not fixed

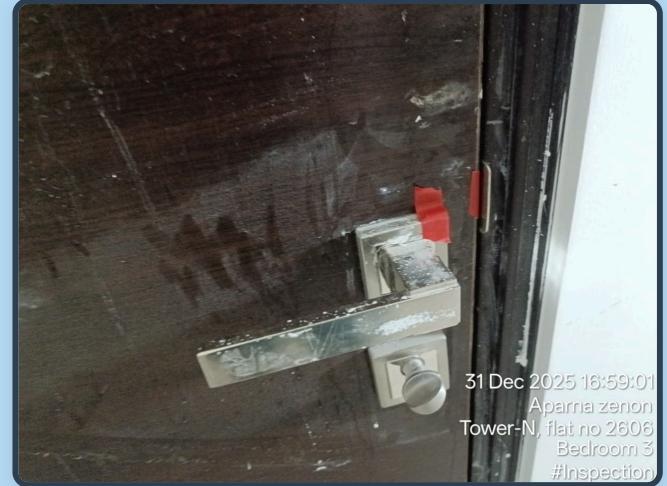
3

Handle fittings are loose

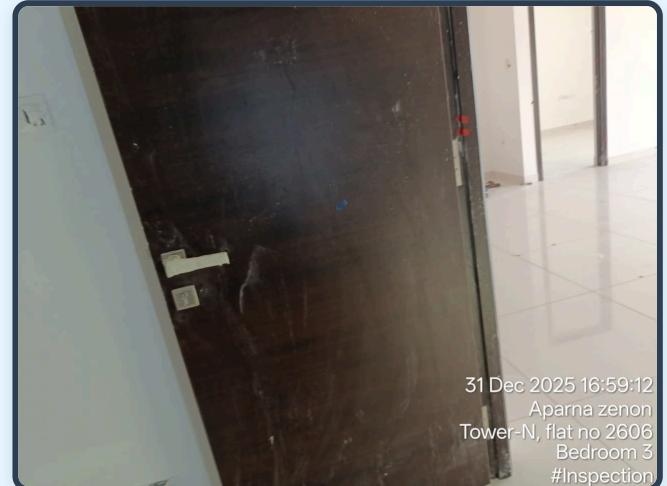
5

Polishing not done properly on shutter and door frame

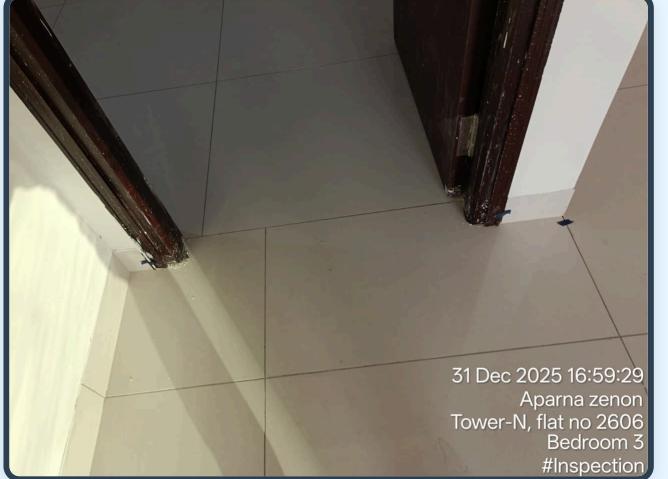
<small>31 Dec 2025 16:59:20</small>
7	Sealant application not done properly

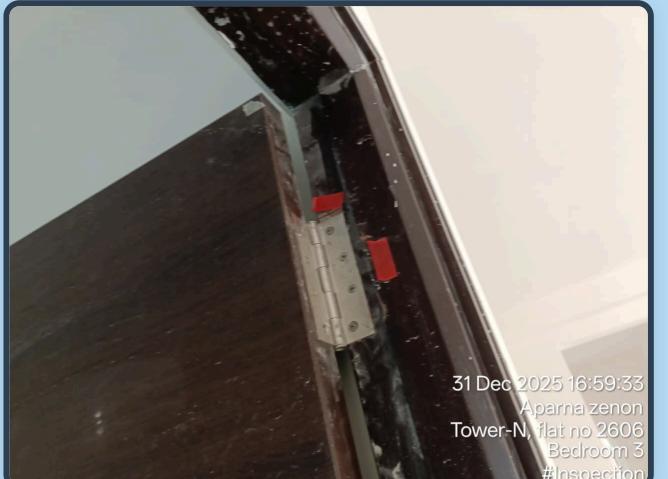
<small>31 Dec 2025 16:59:29 Aparna zenon Tower-N, flat no 2606 Bedroom 3 #Inspection</small>
8	Chipoff observed on door frame

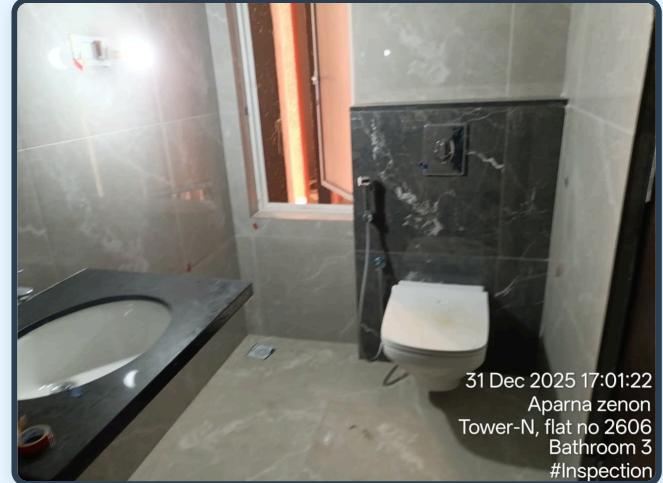
2

Gap observed between granite  
stone and wash basin

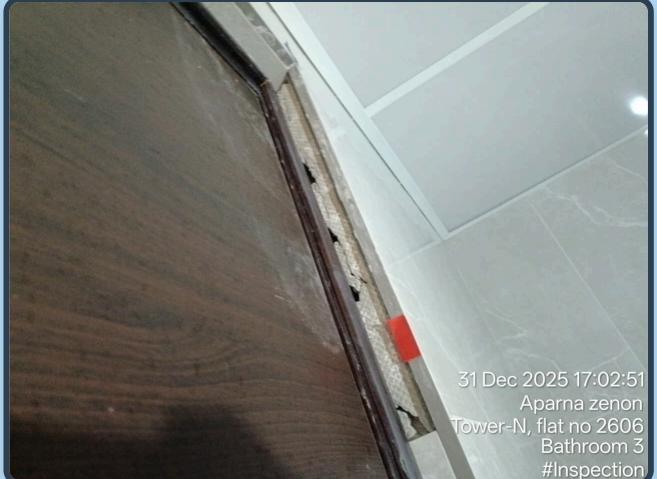
S. NO.	ISSUE	PICTURE
6	Wall tile is not fixed

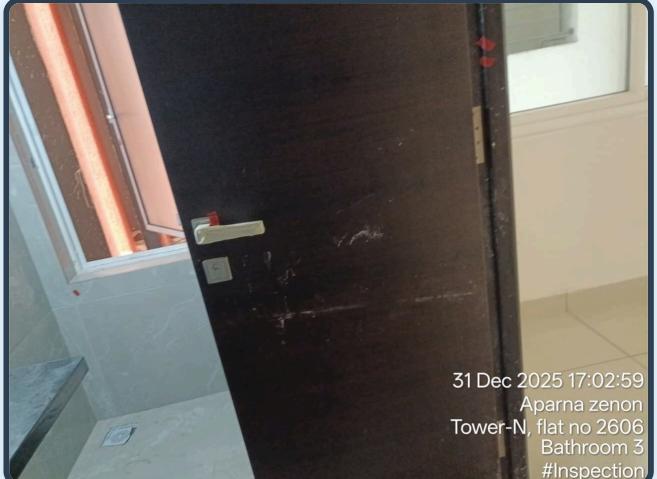
<p>31 Dec 2025 17:02:51  Aparna zenon  Tower-N, flat no 2606  Bathroom 3  #Inspection</p>
7	Polishing not done properly on shutter and door frame

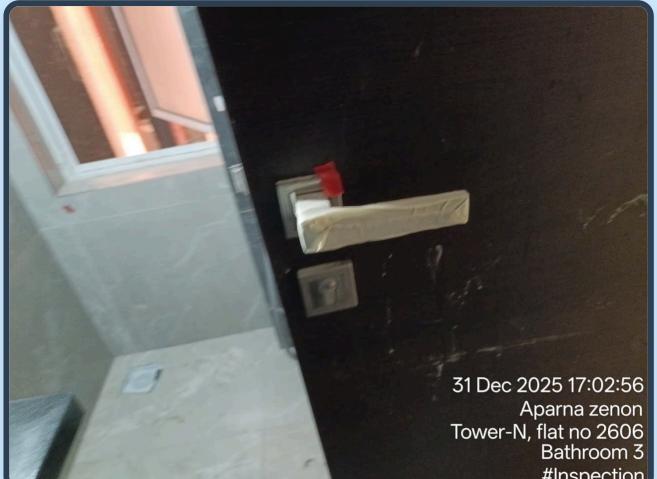
<p>31 Dec 2025 17:02:59  Aparna zenon  Tower-N, flat no 2606  Bathroom 3  #Inspection</p>
8	Handle fittings are loose
