BMW Airhead Oil Filter Canister Displacement: Service Practice, Load Paths, and the \$2,000 O-Ring Myth

Custom Konrad

January 10, 2026

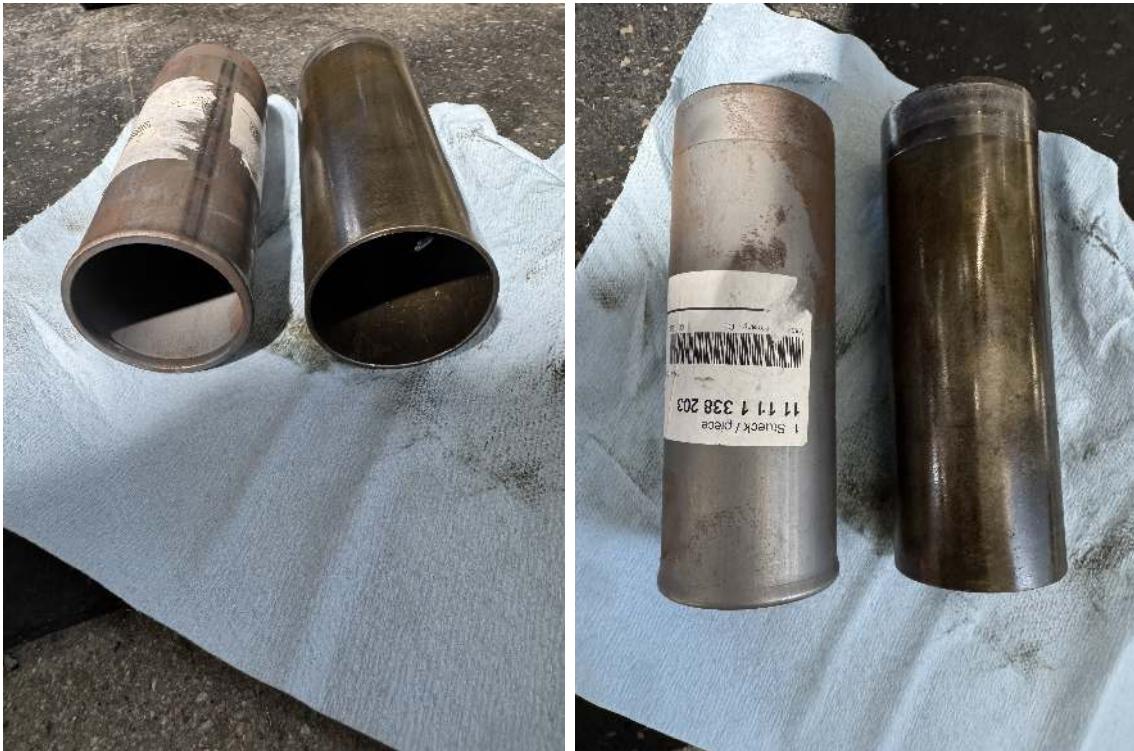
Figure 3: Replacement canister mouth geometry and comparison. The formed mouth exhibits an initial outward flare, followed by inward rolling and final axial flattening, producing a broad, stiff sealing land for the O-ring and optional shims. Side-by-side comparison illustrates the mouth geometry and BMW part number presentation on the replacement canister.
