BMW Airhead Oil Filter Canister Displacement: Service Practice, Load Paths, and the \$2,000 O-Ring Myth

Custom Konrad

January 11, 2026

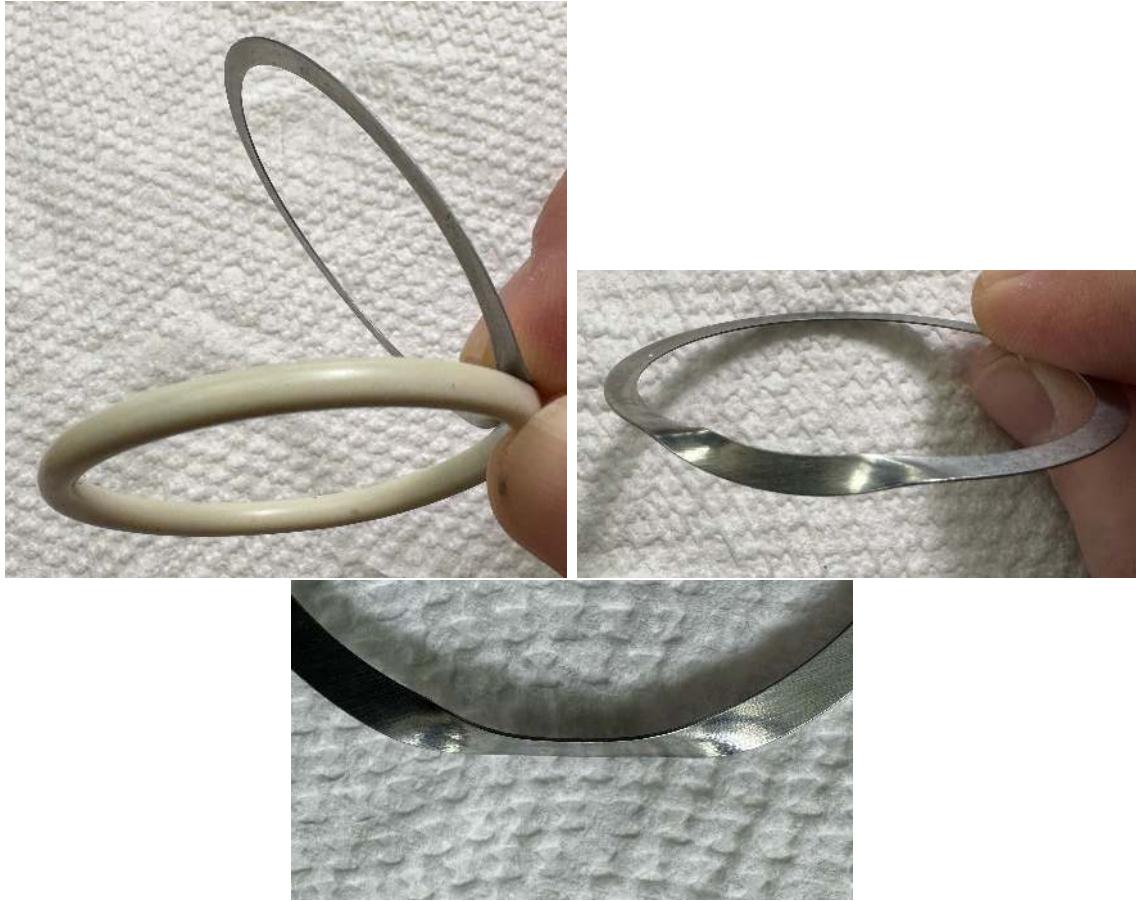
The O-ring visible in Fig. 1 appears nominal and is included primarily for reference. Its mechanical role is indirect but decisive: once local support at the canister mouth was compromised, the O-ring—effectively incompressible in volume—continued to transmit its axial preload into the seal stack. With the load path constrained by the surrounding geometry, this preload was redistributed into the unsupported portion of the shim, producing smooth local plastic bending without requiring global overload or gross misalignment. In this condition, the O-ring transitions from a compliant sealing element to an effective load-transmitting medium.

Figure 1: O-ring and shim condition as found. The shim shows smooth, continuous plastic curvature in the region rendered unsupported by radial displacement of the canister mouth. The O-ring appears nominal in the images and is included for reference; its contribution to the observed deformation arises from load redistribution under geometric constraint rather than from visible material distortion.

Under these altered support conditions, the O-ring continues to transmit its preload into the seal stack, as quantified above. Because the shim is no longer uniformly supported, this force is applied over a reduced and asymmetric area, causing the unsupported portion of the shim to plastically deform and translate axially. The resulting axial motion drives the elastomer laterally into the annular gap between the canister and the crankcase face, producing the observed external oil leak.

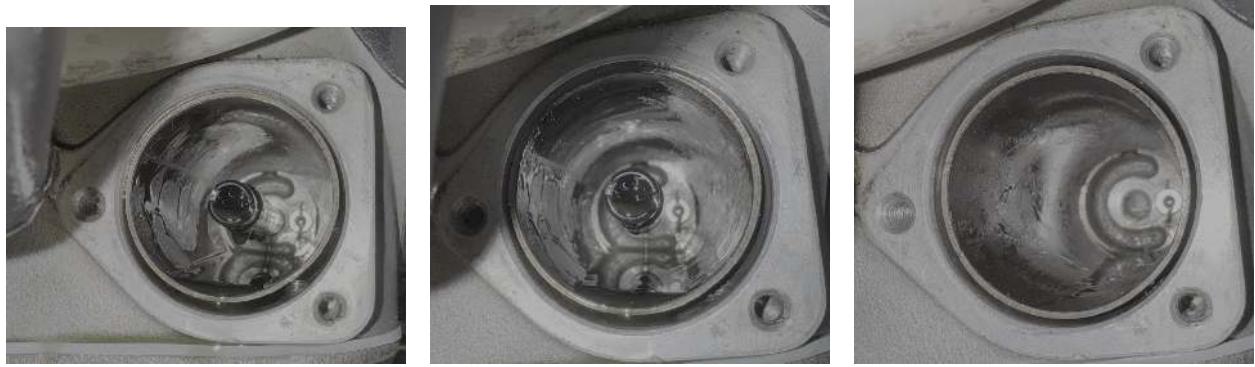
Further inspection identified radial interference between the oil filter canister and an overlong oil pan fastener located beneath the canister mouth. During installation, slight resistance

was felt while tightening this fastener. This resistance was initially interpreted as normal thread engagement but is more consistently explained as the onset of lateral contact between the fastener tip and the thin-wall steel canister, introducing an unintended radial jacking load.

The mechanical response of the canister to this interference is documented in Fig. 2(a–c). After removal of the fastener, partial elastic spring-back was observed, but the canister did not fully re-center on its own. Deliberate mechanical re-centering at the mouth was required to restore alignment, indicating that the dominant response was rigid-body motion rather than purely elastic deformation.

(a) Localized deformation identified
 (b) Fastener removed as first corrective action
 (c) Canister mechanically re-centered by controlled levering

Figure 2: Canister displacement and recovery sequence, demonstrating dominant rigid-body motion about the distal press-fit region. (a) Localized deformation at the canister mouth caused by unintended radial jacking. Note the bolt protrusion visible in the lower-right quadrant (near the 5 o'clock position). (b) After fastener removal, partial elastic spring-back occurs, but full self-centering does not occur without an applied corrective moment. (c) Deliberate mechanical re-centering at the mouth restores nominal alignment of the canister relative to the crankcase bore. The central PIPE was removed at this stage to provide clearance for controlled levering without interference.

The immediate mechanical issue was resolved by re-centering the canister, a field-normal repair consistent with long-standing independent service practice. Nominal alignment was restored, and the system could have been reassembled and returned to service, as illustrated in Fig. 2. In many cases, this outcome would represent a reasonable and sufficient repair.

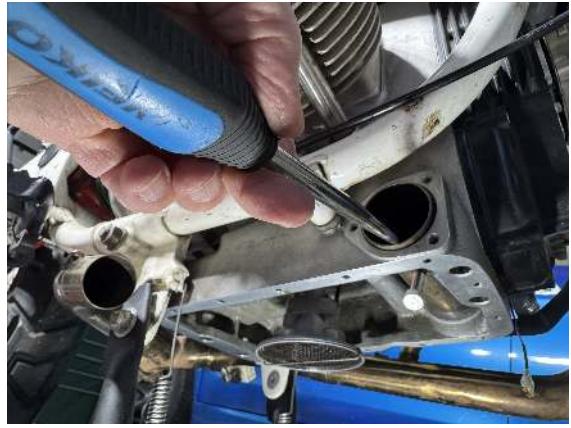
(b) Counter-torque applied to maintain axial alignment and prevent bore damage.

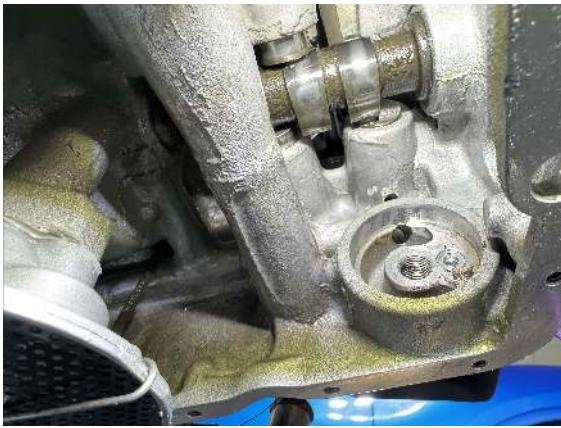
(c) Canister removed after controlled tapping sequence.

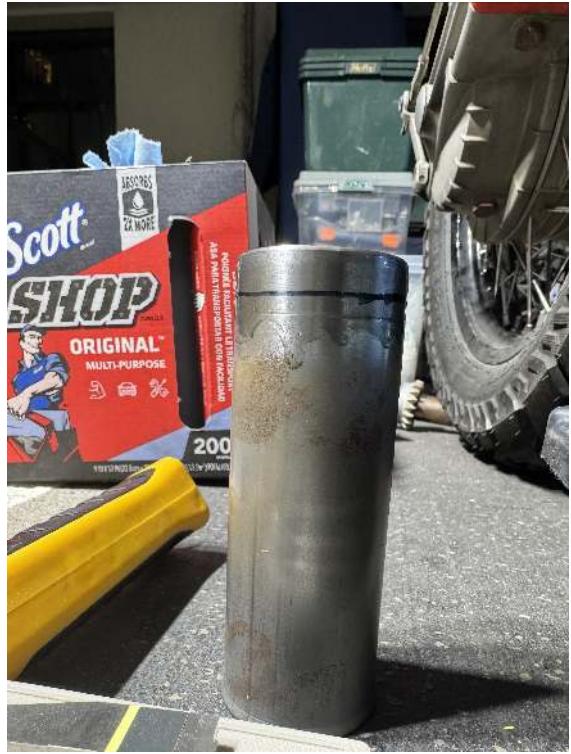
(d) Replacement canister distal end cleaned and lightly oiled prior to insertion. Note the traced insertion depth check line.
