BMW Airhead Oil Filter Canister Displacement: Service Practice, Load Paths, and the \$2,000 O-Ring Myth

Custom Konrad

January 11, 2026

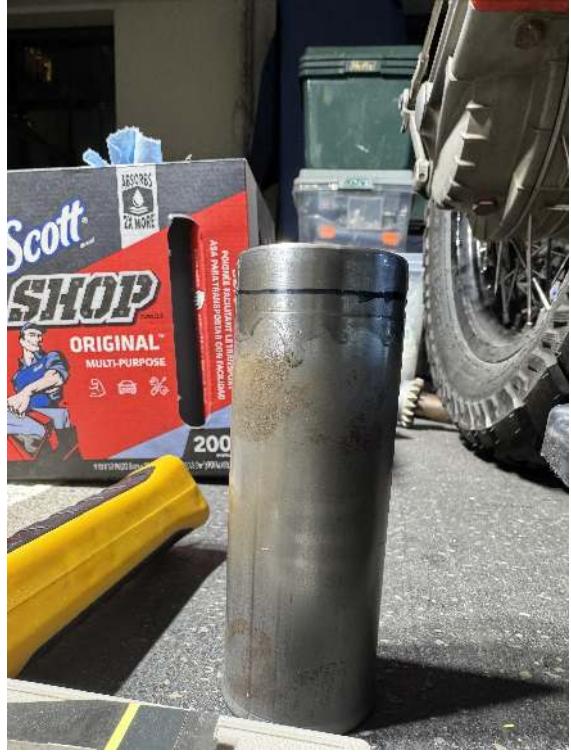
(d) Replacement canister distal end cleaned and lightly oiled prior to insertion. Note the traced insertion depth check line.

Prior to insertion, the distal end of the replacement canister was cleaned with gray Scotch-Brite to remove light surface oxidation and condition the surface for uniform contact during seating. The contact region was then lightly lubricated with engine oil to reduce insertion friction and mitigate the risk of galling.
