# BMW Airhead Oil Filter Canister Displacement: Service Practice, Load Paths, and the \$2,000 O-Ring Myth

*Custom Konrad*

January 11, 2026

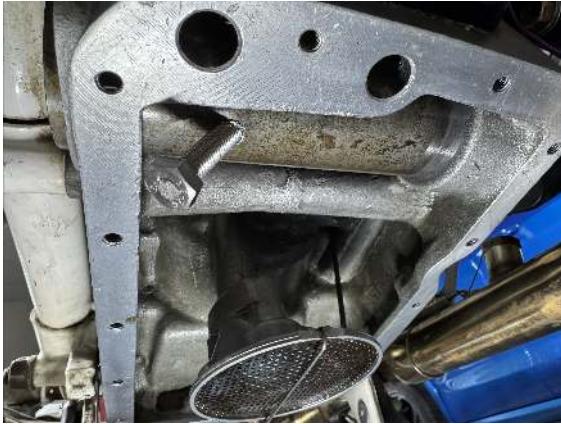
(a) Localized wall deformation during drive-out tapping. The bolt contact reaction at the canister wall was effectively radial prior to tapping. Plastic deformation and bolt rotation within the thin sheet are unavoidable.

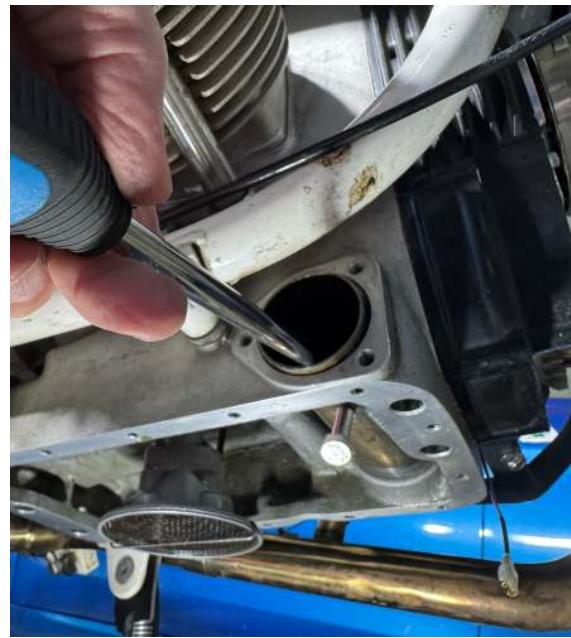
(b) Counter-torque applied to maintain axial alignment and prevent bore damage.

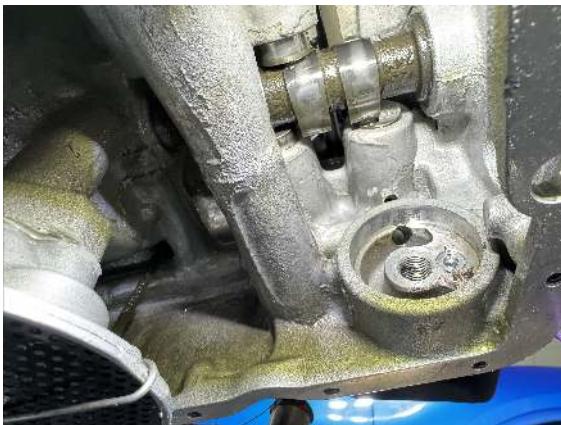
(c) Canister removed after controlled tapping se-

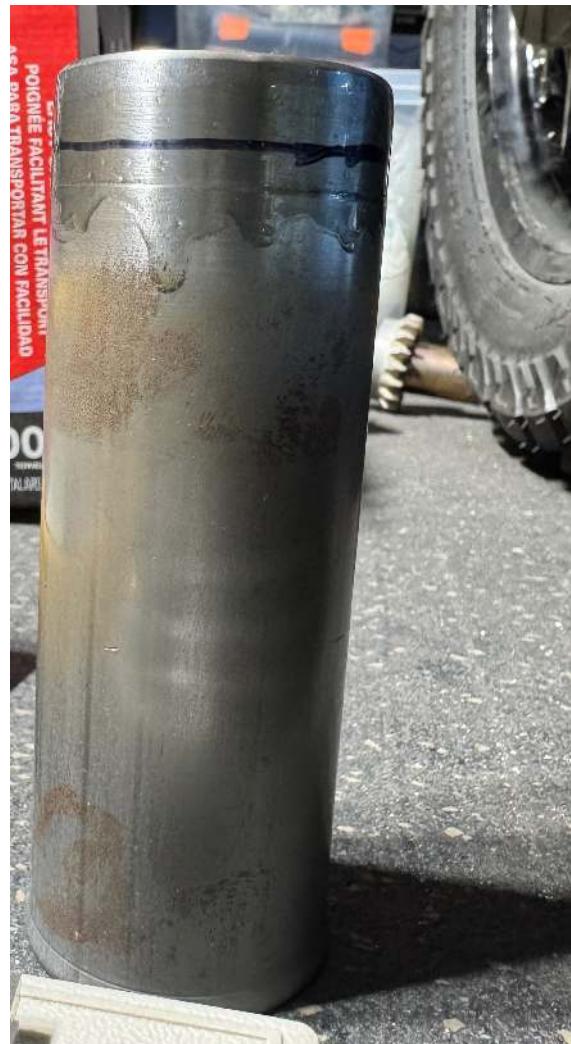
(d) Replacement canister distal end cleaned and

Prior to insertion, the distal end of the replacement canister was cleaned with gray Scotch-Brite to remove light surface oxidation and condition the surface for uniform contact during seating. The contact region was then lightly lubricated with engine oil to reduce insertion friction and mitigate the risk of galling.
