BMW Airhead Oil Filter Canister Displacement: Service Practice, Load Paths, and the \$2,000 O-Ring Myth

Custom Konrad

January 11, 2026

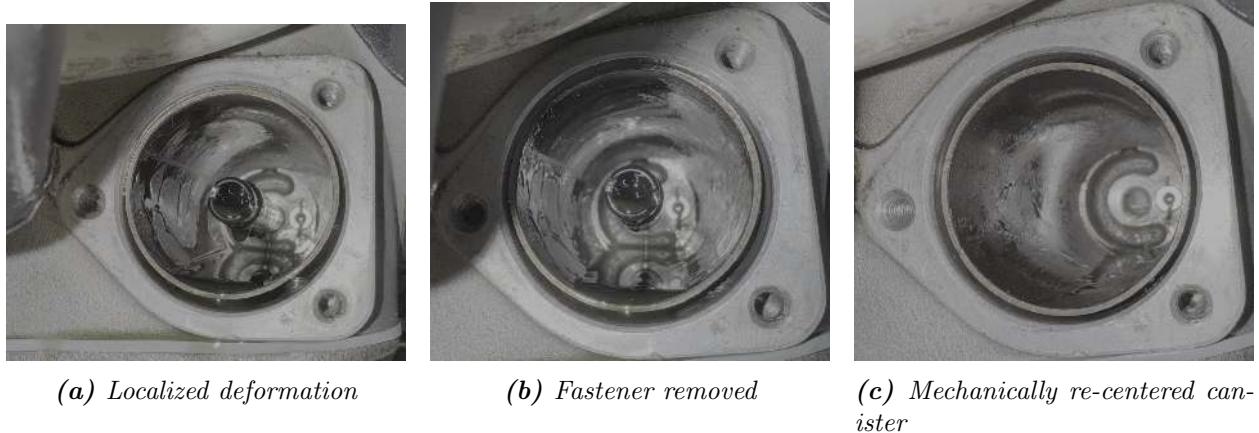
The mechanical response of the canister to this interference is documented in Fig. 2(a-c). After removal of the fastener, partial elastic spring-back was observed, but the canister did

not fully re-center on its own. Deliberate mechanical re-centering at the mouth was required to restore alignment, indicating that the dominant response was rigid-body motion rather than purely elastic deformation.

Figure 2: Canister displacement and recovery sequence, demonstrating dominant rigid-body motion about the distal press-fit region. (a) Localized deformation at the canister mouth caused by unintended radial jacking. Note the bolt protrusion visible in the lower-right quadrant (near the 5 o'clock position). (b) After fastener removal, partial elastic spring-back occurs, but full self-centering does not occur without an applied corrective moment. (c) Deliberate mechanical re-centering at the mouth restores nominal alignment. The central PIPE was removed at this stage to provide clearance for controlled levering without interference.

The immediate mechanical issue was resolved by re-centering the canister, a field-normal repair consistent with long-standing independent service practice. Nominal alignment was restored, and the system could have been reassembled and returned to service, as illustrated in Fig. 2. In many cases, this outcome would represent a reasonable and sufficient repair.

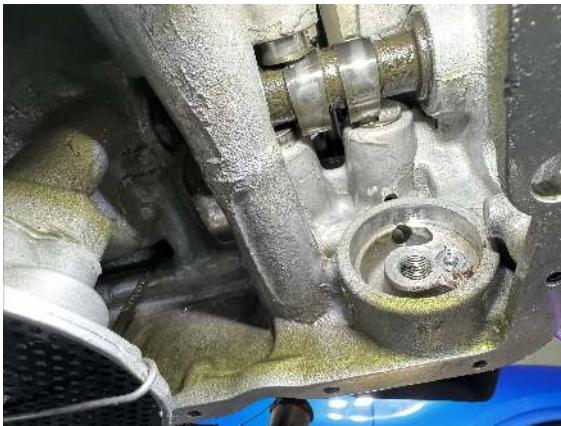
(c) Canister removed after controlled tapping sequence.

5. Completion and inspection. Once released, remove the canister by hand. Carefully remove all chip containment measures and clean the cavity thoroughly. Inspect the bore for scoring, raised material, or damage before proceeding with installation.

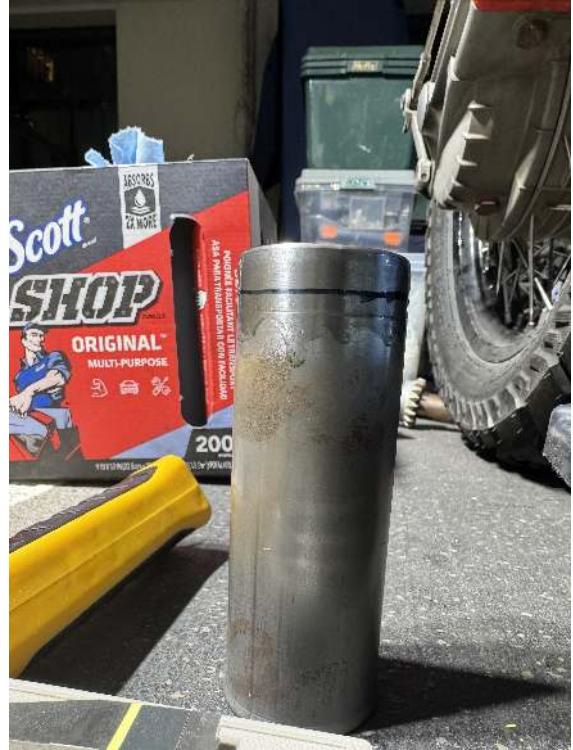
(d) Replacement canister distal end cleaned and lightly oiled prior to insertion. Note the traced insertion depth check line.

Prior to insertion, the distal end of the replacement canister was cleaned with gray Scotch-Brite to remove light surface oxidation and condition the surface for uniform contact during seating. The contact region was then lightly lubricated with engine oil to reduce insertion friction and mitigate the risk of galling.

- Final depth control was achieved through direct measurement by transferring the wear mark from the original canister onto the replacement canister (Fig. 3d), and tapping the replacement canister into the bore until this reference mark was reached (Fig. 3g). This approach leverages the confirmed axial equivalence of the original and replacement canisters, with any residual variation accommodated using external shims.
