BMW Airhead Oil Filter Canister Displacement: Service Practice, Load Paths, and the \$2,000 O-Ring Myth

Custom Konrad

January 13, 2026

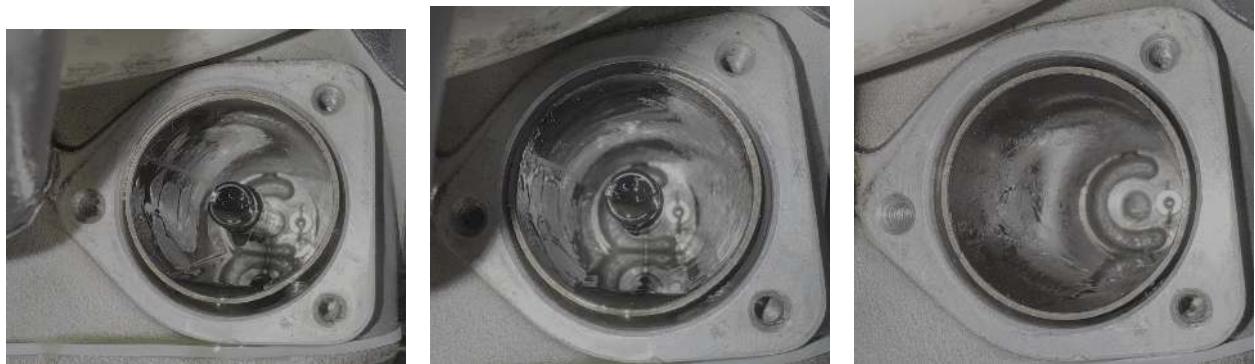
Further inspection identified radial interference between the oil filter canister and an overlong oil pan fastener located beneath the canister mouth. During installation, slight resistance was felt while tightening this fastener. This resistance was initially interpreted as normal thread engagement but is more consistently explained as the onset of lateral contact between the fastener tip and the thin-wall steel canister, introducing an unintended radial jacking load.

The mechanical response of the canister to this interference is documented in Fig. 2(a–c). After removal of the fastener, partial elastic spring-back was observed, but the canister did not fully re-center on its own. Deliberate mechanical re-centering at the mouth was required

(a) Localized deformation identified
 (b) Fastener removed as first corrective action
 (c) Canister mechanically re-centered by controlled levering

Figure 2: Canister displacement and recovery sequence, demonstrating dominant rigid-body motion about the distal press-fit region. (a) Localized deformation at the canister mouth caused by unintended radial jacking. Note the bolt protrusion visible in the lower-right quadrant (near the 5 o'clock position). (b) After fastener removal, partial elastic spring-back occurs, but full self-centering does not occur without an applied corrective moment. (c) Deliberate mechanical re-centering at the mouth restores nominal alignment of the canister relative to the crankcase bore. The central PIPE was removed at this stage to provide clearance for controlled levering without interference.
