BMW Airhead Oil Filter Canister Displacement: Service Practice, Load Paths, and the \$2,000 O-Ring Myth

Custom Konrad

January 11, 2026

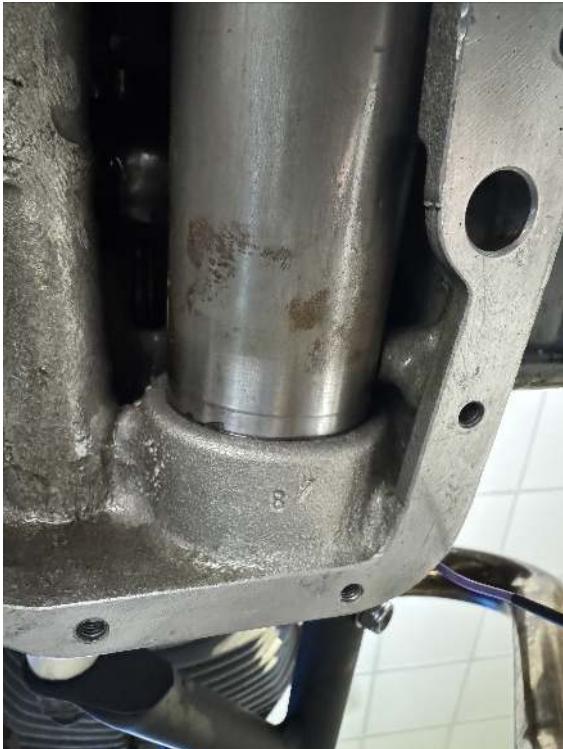
(g) Final installed position relative to the reference depth mark.

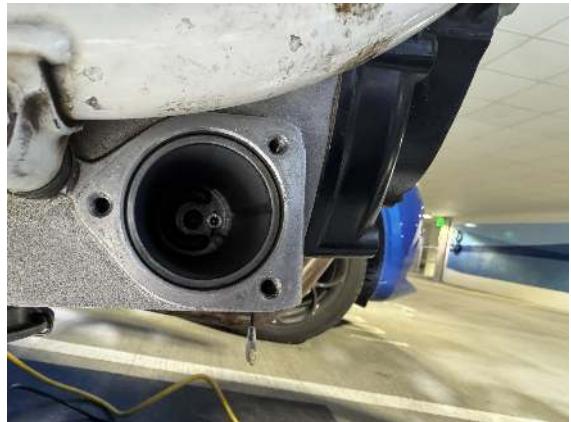
At no point during the installation was corrective re-centering required, and no evidence of asymmetric resistance or elastic spring-back was observed after seating. These observations are consistent with a clean, undistorted bore and with the mechanically more forgiving mouth geometry of the later-style canister.

(h) View into installed canister showing improved concentricity and self-centering.
