BMW Airhead Oil Filter Canister Displacement: Service Practice, Load Paths, and the \$2,000 O-Ring Myth

Custom Konrad

January 12, 2026

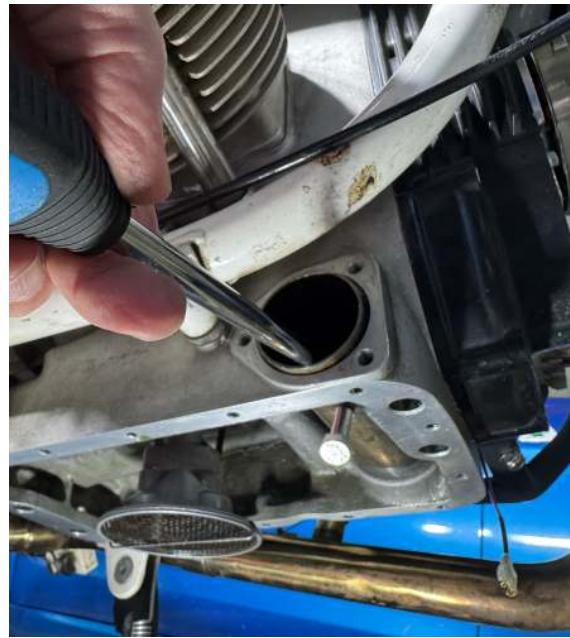
(b) Counter-torque applied to maintain axial alignment and prevent bore damage.

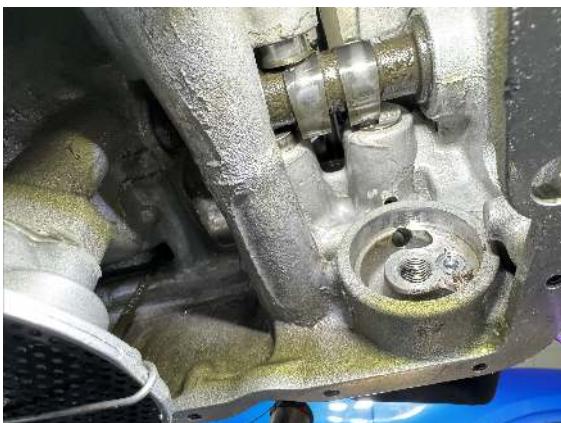
(c) Canister removed after controlled tapping sequence.

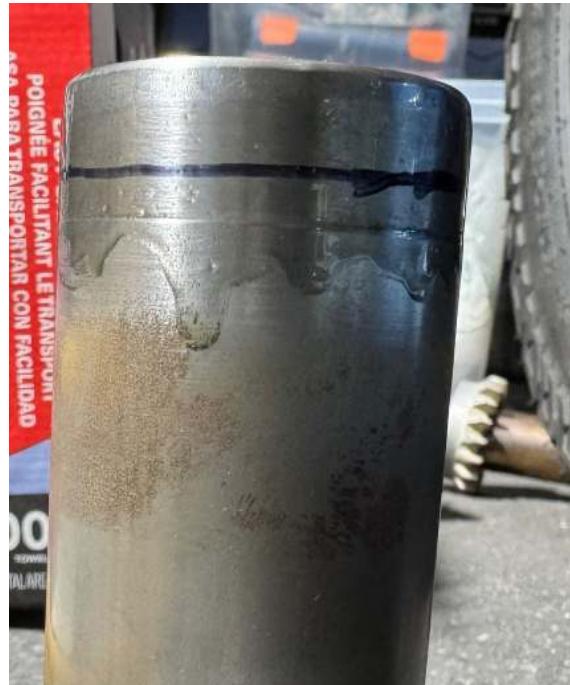
(d) Replacement canister distal end cleaned and lightly oiled prior to insertion. Note the traced insertion depth check line.

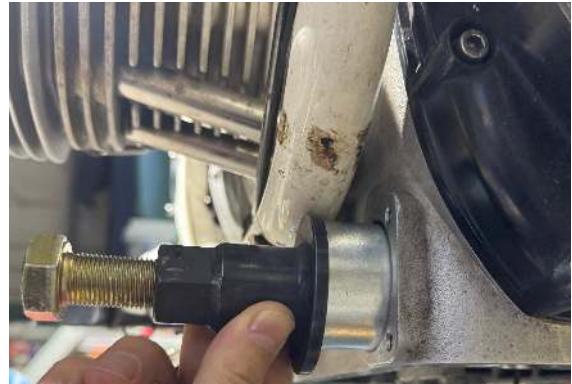
(f) Temporary axial driver assembled from available engine tools.
