Build ID: MTC\_7K\_10s\_1777049033 | Machine: DMP 350 Triple H - LMP126 | Date: 2026-04-24 16:44:15 UTC

NEEDS REVIEW

Build Summary

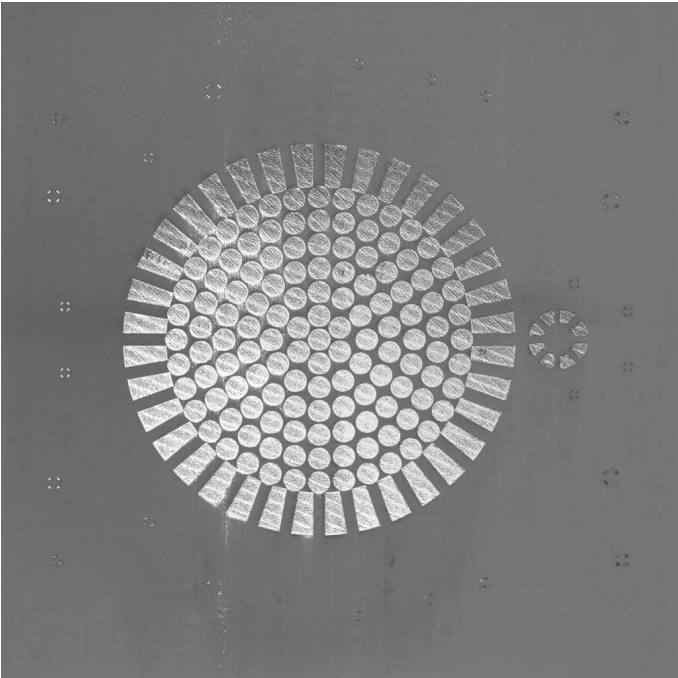
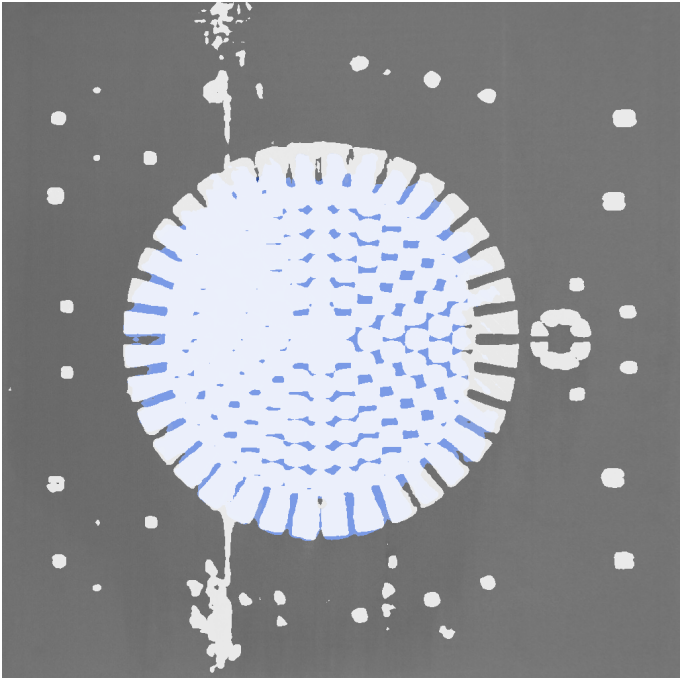
Layer: 1

Type: Short Feed    Area: 27358.78 mm²    Layer Height: 0.06 mm    **Severity: Critical**
