期間 Date 2019/10/23

| 出張先 Customer | UNIROYAL (KUNSHAN) | 相手先 面談者 Attendance | Mr Zhao – HEAD OF ENGINEERING<br>Mr Louise – HEAD OF OPERATION<br>Ms Hong – BUYER |
| 出張目的 Visit Purpose | <input checked="" type="checkbox"/> 3080M – Yellowish<br><input checked="" type="checkbox"/> RA12-4 – No printing on slit<br><input checked="" type="checkbox"/> 7910 – Sample status | 会議フロアアップ項目 Meeting Follow Up | <input checked="" type="checkbox"/> As attach in below table<br><input type="checkbox"/><br><input type="checkbox"/> |

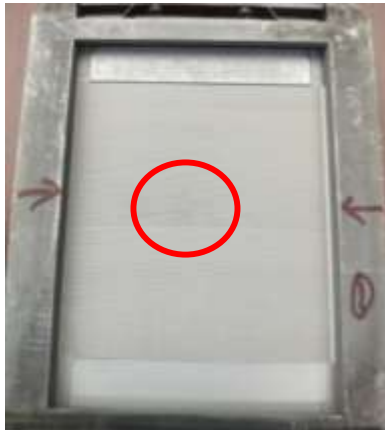
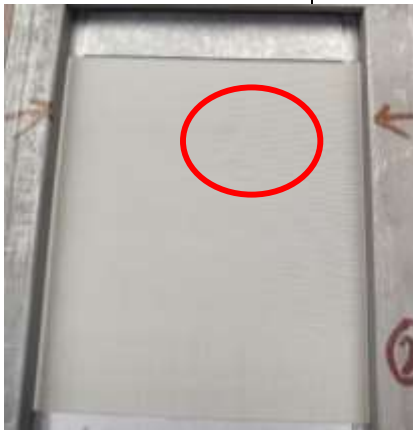
Substrate material sample evaluation result : found 0.6% scribing NG (3/500pcs)

Laser scribe NG samples will courier to Japan for Mr Sasaki to further evaluate the defect.  
Defect % have improved from 3% ==> 0.6%

<table><tr><th>Sample</th><th>2015</th><th>2017</th><th>Sample 1</th><th>Sample 2</th><th>Sample3</th></tr><tr><td></td><td>OK<br/>YIELD : 100%</td><td>3NG/500<br/>0.6%</td><td>OK<br/>YIELD : 100%</td><td>OK<br/>YIELD : 100%</td><td>OK<br/>YIELD : 100%</td></tr></table>

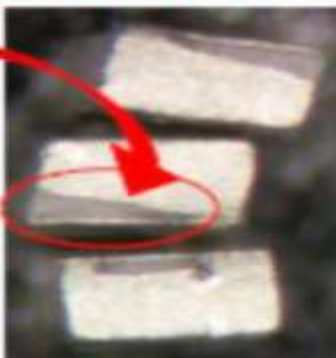
Received claim from Royal's customer for peel off

The grey area where the ceramic peeled and created open defect

Current failure have been shifted from LD to WD.

Royal requested MM to look into

a. WD depth

b. Alignment

c. Material strenght

Will have internal discussion to develop new action plan
